Investigation Report 21/06

Very serious marine casualty

**Death of two crew members
following the crash of a lifeboat of
MT OLIVER JACOB
during a lifeboat manoeuvre
off the coast of Cameroon on
21 January 2006**

1 December 2007

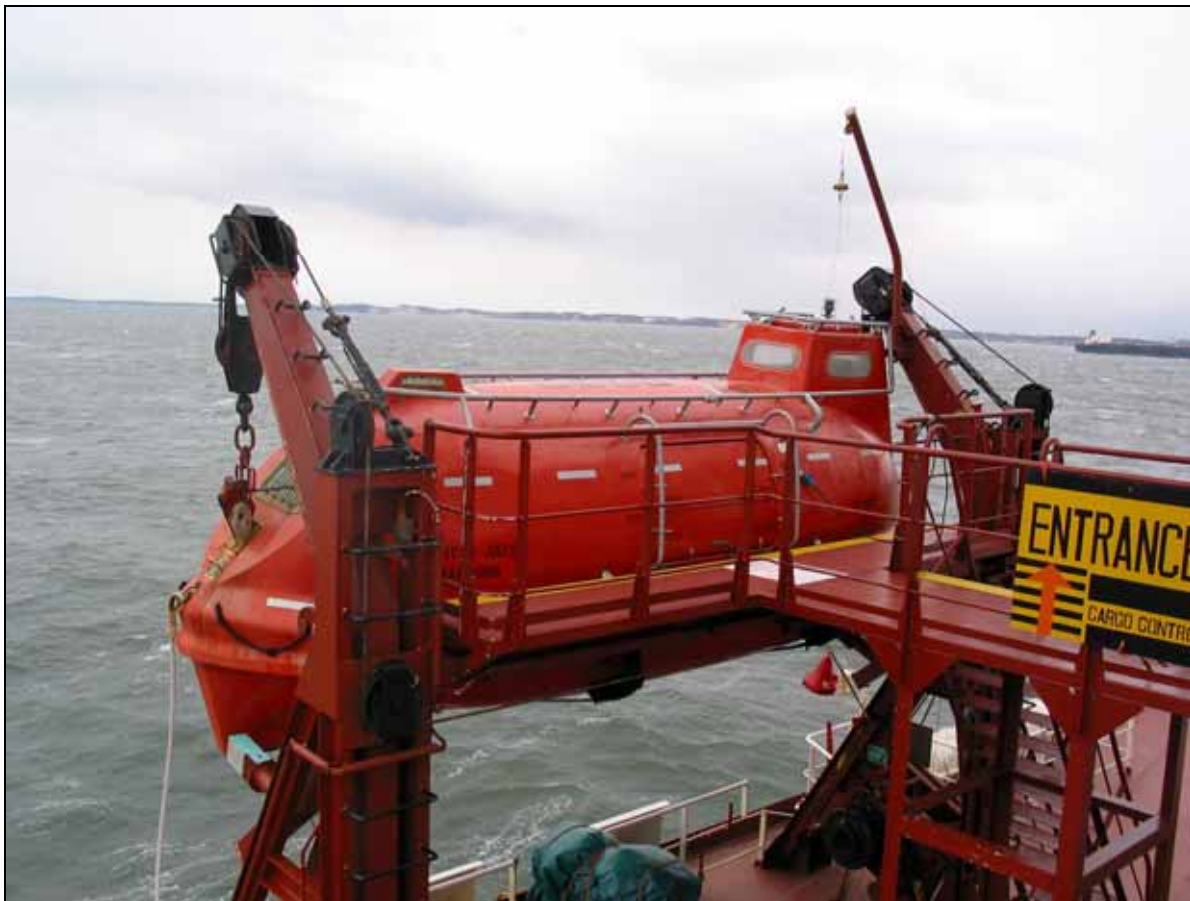
Figure 3: Starboard lifeboat of OLIVER JACOB

Due to its intended use as rescue boat, the port boat has a stronger engine and the heaving winch has a higher performance than for the starboard boat. The two boats are built exactly the same in all other points.

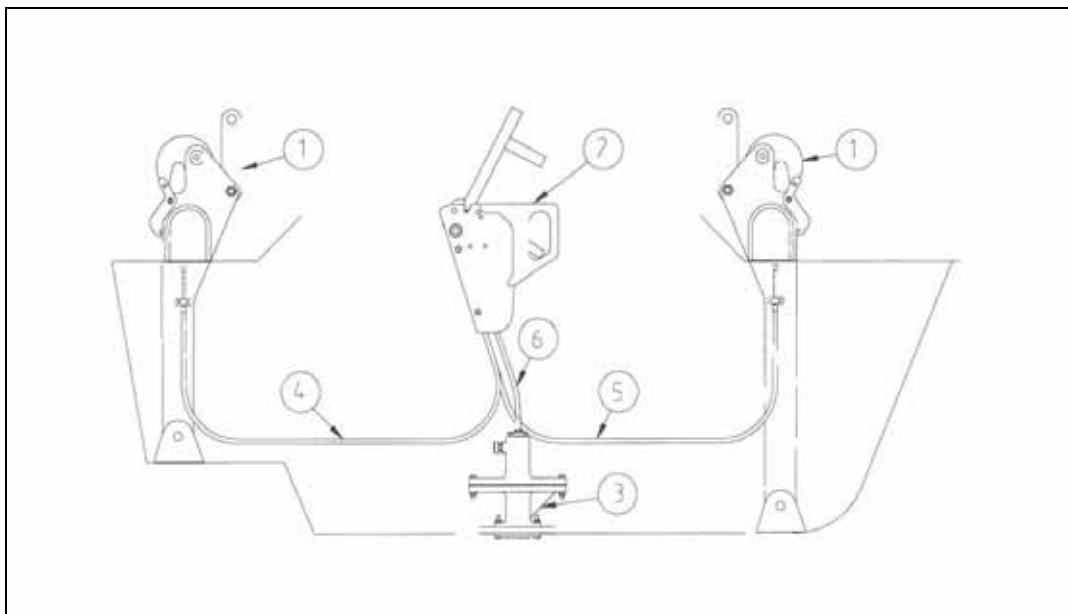
Figure 6: Structure of centrally releasing hook system.

The system on board the port side lifeboat of OLIVER JACOB was in line with the above description.

1 – Releasing hook, 2 – release unit, 3 – hydrostatic unit, 4 – aft bowden cable, 5 – forward bowden cable, 6 – bowden cable from the hydrostatic unit to the hydrostatic interlock

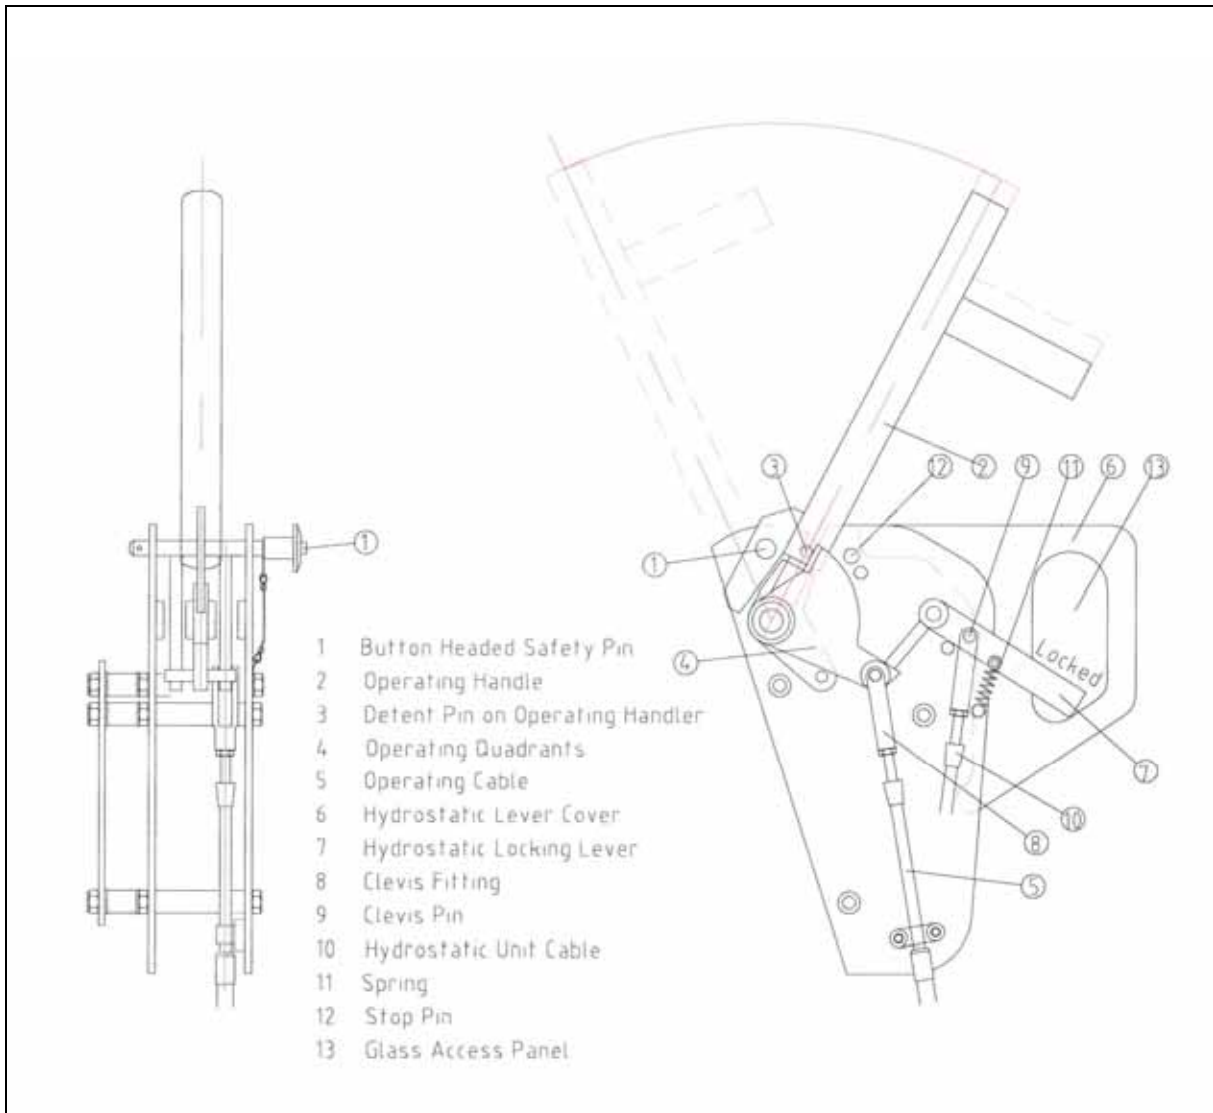
Figure 7: Release unit in schematic representation

On release the driving pins at the release handle move the operating quadrants and the bowden cables are drawn in the direction of the release unit. The operating quadrants can only be turned when they are no longer blocked by the hydrostatic interlock flap. The hydrostatic interlock is thus the third securing mechanism in the release unit (Figures 7, 8).

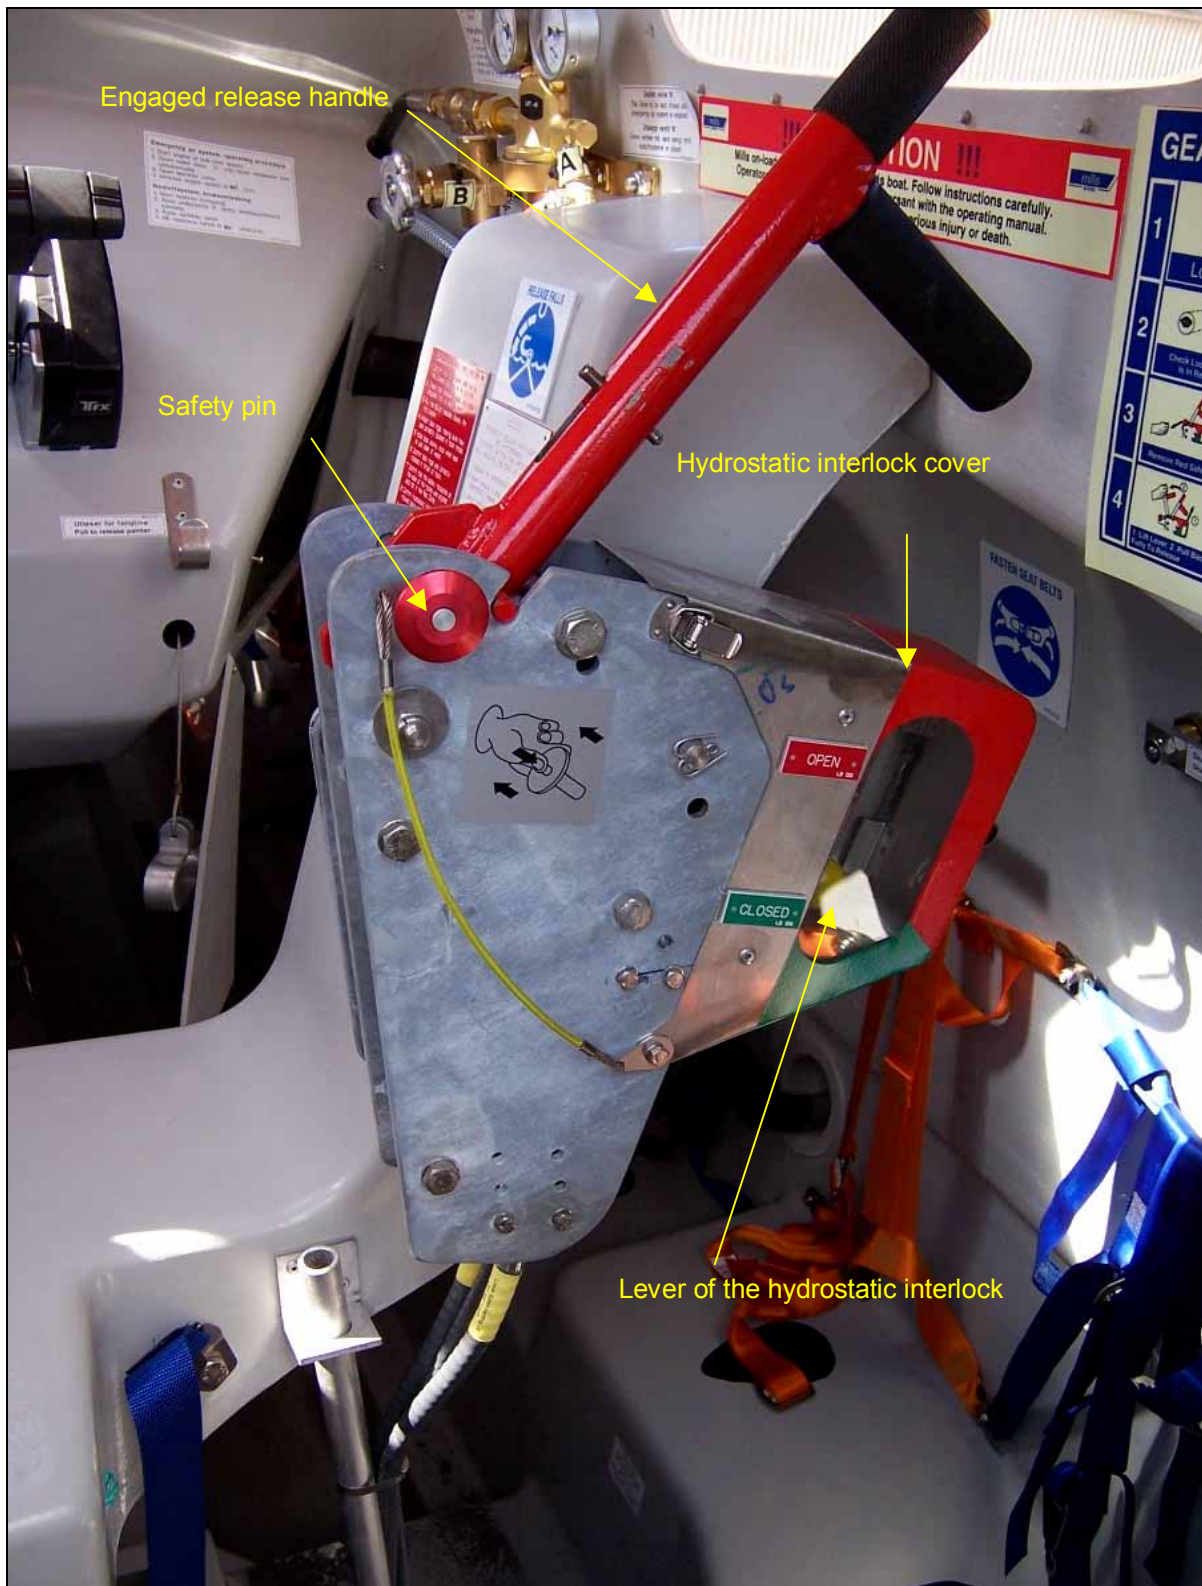
Figure 9: Release unit in completely secured position, i.e. release handle engaged, safety pin introduced, hydrostatic interlock engaged - here yellow lever behind glass disc in "Closed" position; (other vessel)

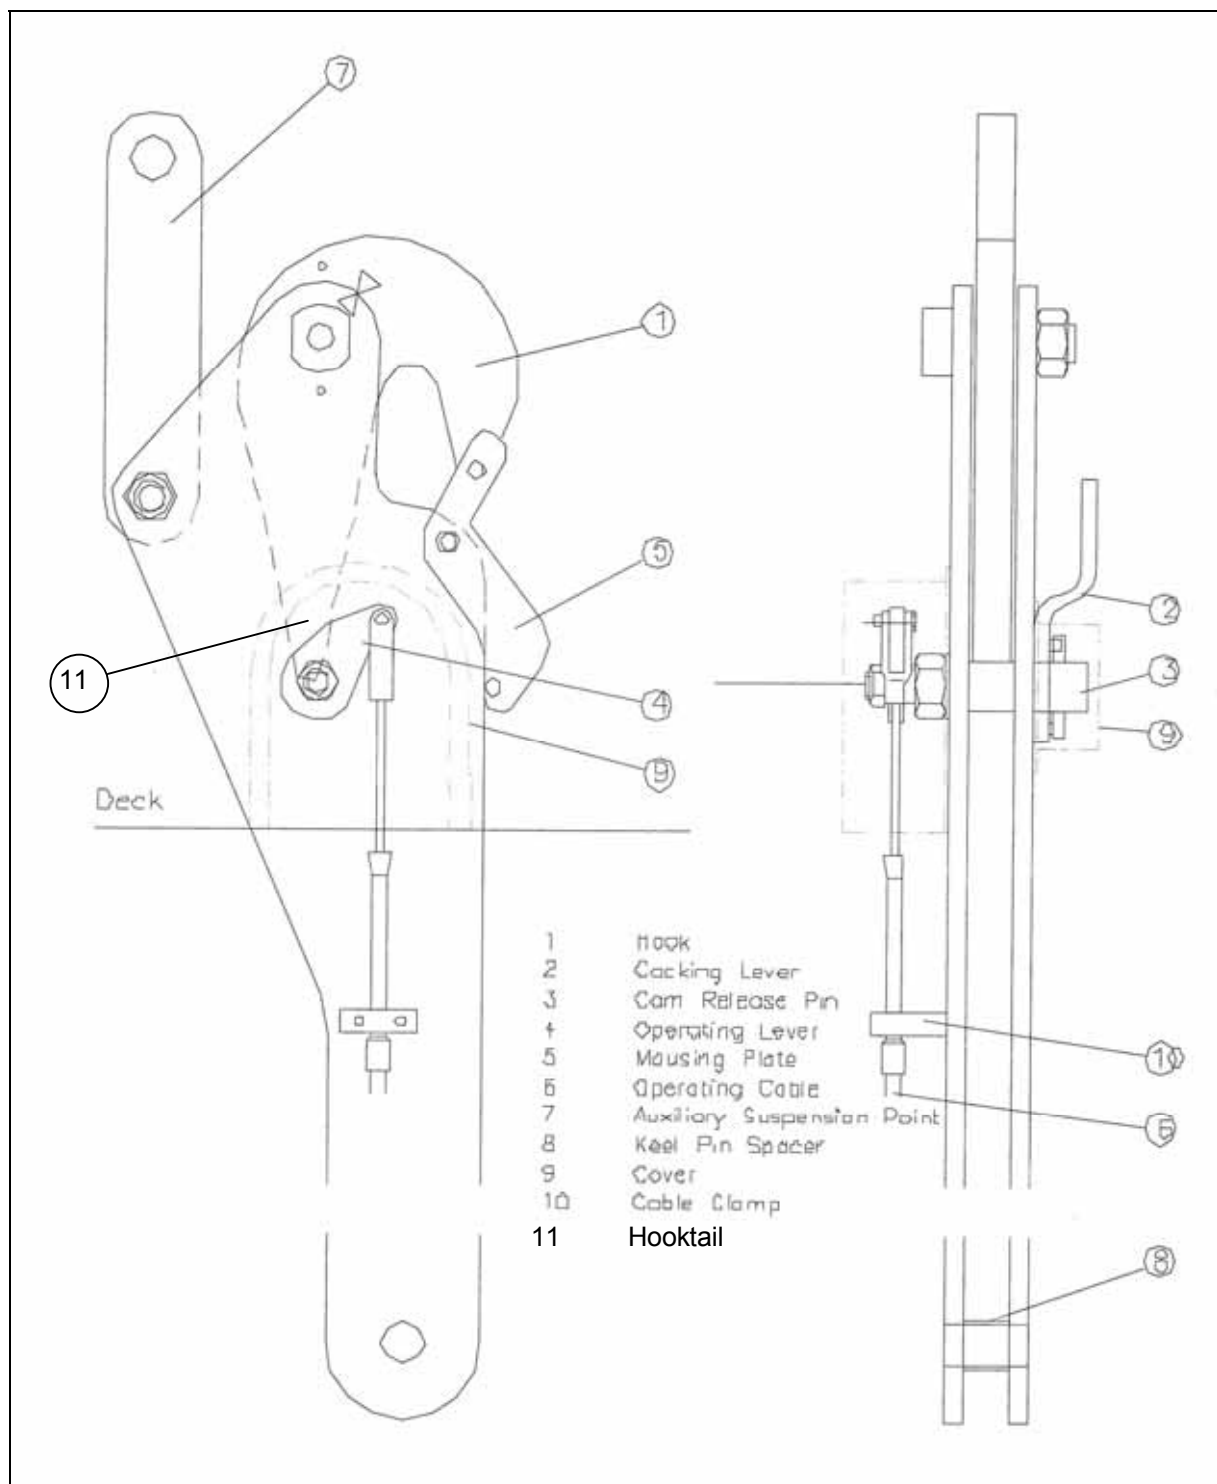
Figure 12: Structure of a releasing hook

The releasing hook consists of two vertical foundation plates and the actual hook between them. The foundation plates of the releasing hook are tapered strongly downwards and are fixed to the keel of the lifeboat. The hook is constructed and placed in bearings between the foundation plates in such a way that in off-load condition the opening of the hook points downwards. Under load the hook would turn around the bearing axis and the opening would point upwards. In order to control this turn, the tail of the hook rests against half the area of a bolt, here a half-round bolt, that is mounted through the foundation plates at right angle and lies parallel with the bearing axis. The bolt represents a kind of cam (cam release pin). In its secured position the cam release pin prevents the hook tail from swinging through under load (Figure 12). The cam release pin is in turn connected with the bowden cable to the release unit via an externally mounted arm (operating lever). The mounting point lies beneath a cover.

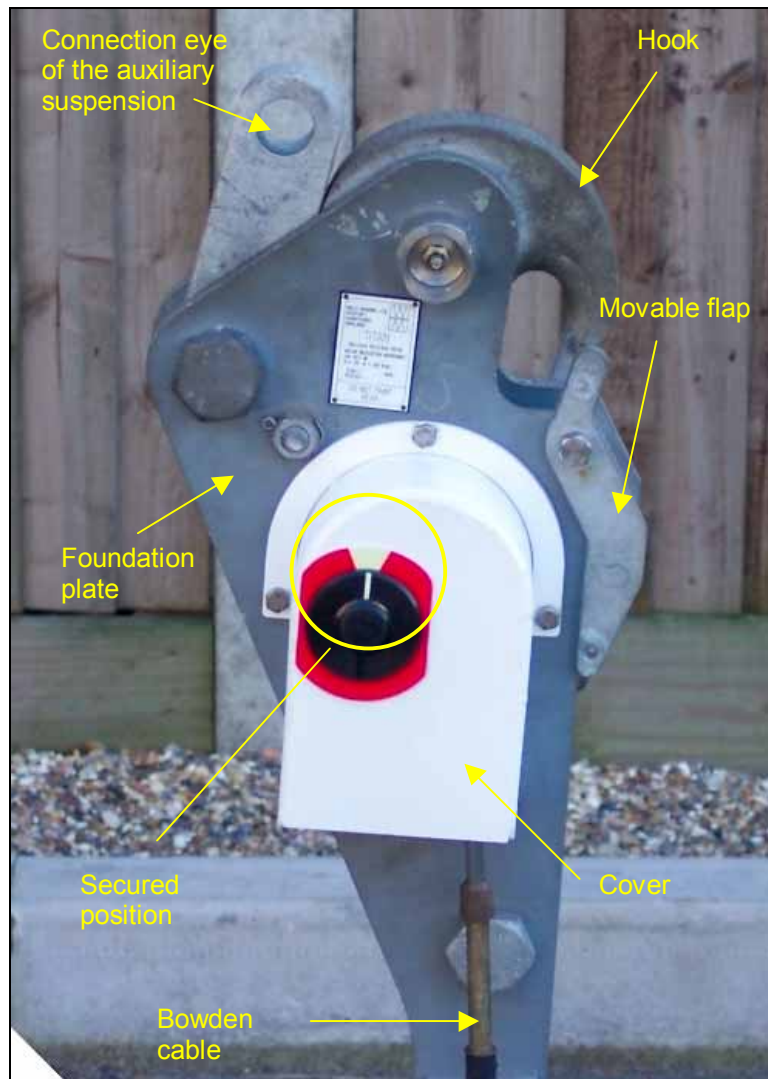
On the side opposite the bowden cable there is a hand-lever (reset lever/cocking lever) on the cam release pin. This lever is used to turn the cam release pin back into the holding position after a release operation. The cam and the hook tail should then rest flat against each other. In the manuals this is described as face-to-face or flat-to-flat-contact. In order to visualise this position there are stroke marks on the outer sides of the releasing hook and coloured sectors (red and white) on the foundation plate/the cover (Figure 13). The mark on the release bolt must stand in the white area when it rests flat-to-flat.

Each releasing hook of this type is furthermore provided with an auxiliary suspension. This allows the boat to be hung-off independently, e.g. for maintenance purposes (Figure 13). For this an appropriate hanging system, two release pennants made of wire (Hanging-Off Pendant or Hanging-Off Pennant) is supplied with the boat. The hanging-off pendants are secured to the auxiliary suspensions of the releasing hooks and secured at the attachments points on the davits provided for this purpose. After this it is possible to relief the load on the releasing hooks and to work on the releasing hook system of the lifeboat safely.

Figure 13: View of a releasing hook with the secured position marked

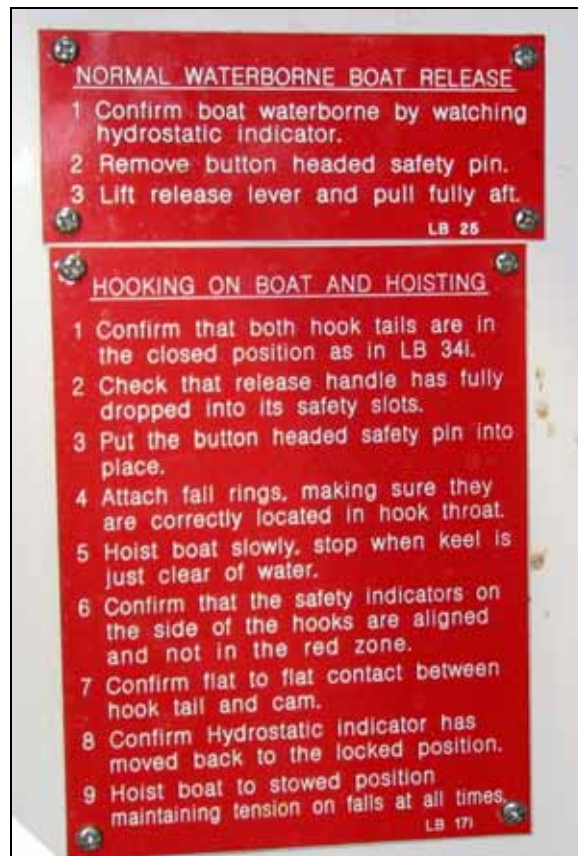
Figure 19: Plates LB 25 and LB 171

- The sign designated as LB 25 (Figure 19) described the normal release of the mechanism in the condition boat in the water.
- The sign LB 17i explained the fundamental reset of the releasing hooks, the hooking in of the rings of the boat runners, the reset of the release unit and the recovery of the boat with the associated controls (Figure 19).
- A further sign (LB 07) described the On-Load-Release (Figure 20).

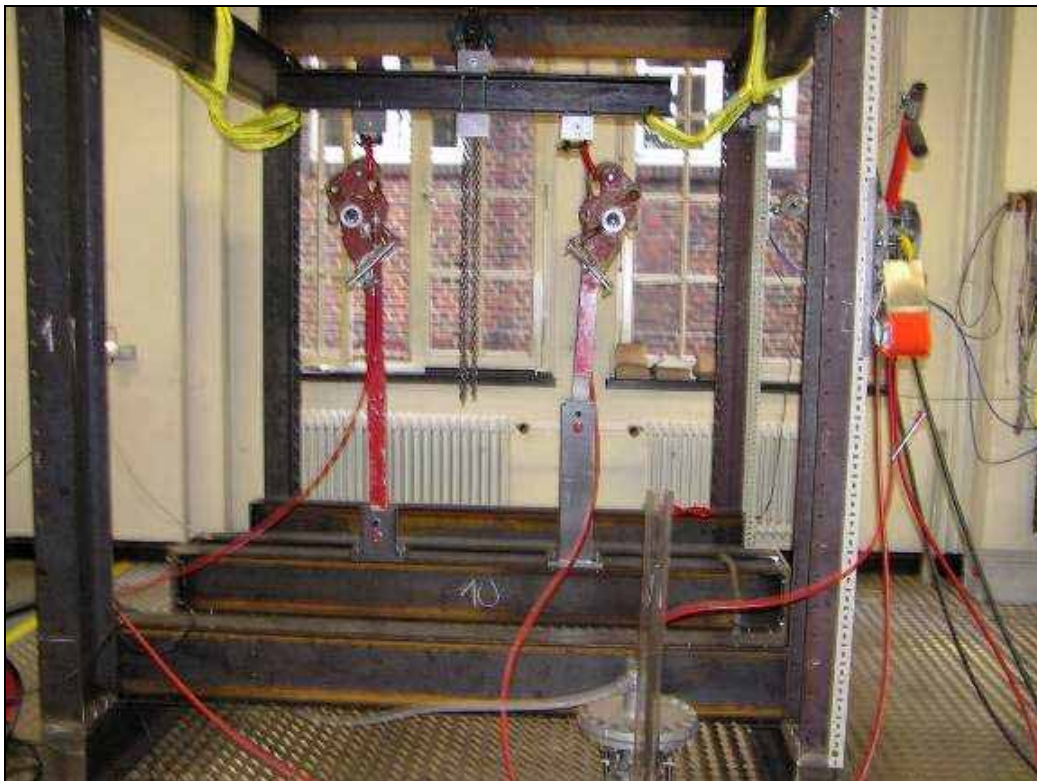
Figure 22: Experimental rig at the Institute for Material Science and Welding Technology

At the IWS the releasing hooks and release unit were secured to a foundation frame (Figure 22). The experimental rig also contained the hydrostatic unit and the bowden cables supplied. Facilities for introducing tensile forces into the releasing hooks, measuring the forces introduced and measuring movement angles were also integrated. By subjecting the hydrostatic unit to different water columns, it was possible to simulate On-Load- and Off-Load Release.
