**Bundesstelle für Seeunfalluntersuchung**  
**Federal Bureau of Maritime Casualty Investigation**  
Federal Higher Authority subordinated to the Ministry of  
Transport, Building and Urban Affairs

Investigation Report 306/05

**Very Serious Marine Casualty**

**Foundering of the Motor Boat  
"SEEHUND I"  
on 9 August 2005  
in the Süderpiep area  
in the North Sea off Eiderstedt**

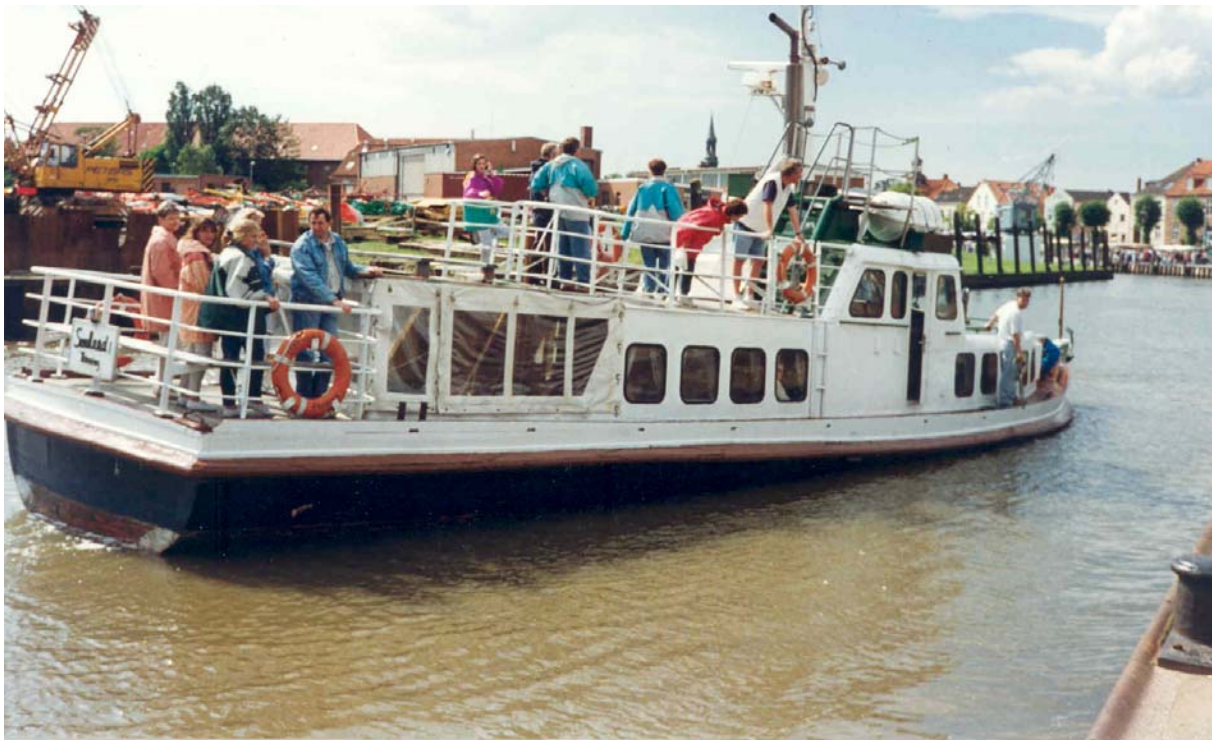
Figure 5: Entering Tönning 19 July 1997

By letter of 8 August 1997, retroactive to 8 July 1997, the operator deregistered the Passenger Vessel SEEHUND I from the See-BG (Marine Insurance and Safety Association). It was pointed out that as a leisure craft the vessel should now be subject to § 2a of the "Regulations on Commercial Renting of Leisure Craft" of 24 July 1996. A photocopy of a boat certificate under the Sea Leisure Craft Renting Regulation issued by the Waterways and Shipping Office (WSA) Tönning, dated 9 July 1997, valid up to 30 June 1999 was submitted as annex. According to this boat certificate sea, the maximum admissible number of persons on board was to be 35. On 19 July 1997 the vessel ran into the port of Tönning with 20 passengers on board. As a consequence of water ingress the fore ship was dipping into the water up to the rubbing strake. The vessel was grounded with the fore ship on a slip facility since drainage using on-board equipment was not possible. The boat certificate was not withdrawn and nothing was noted in the files of Waterways and Shipping Office (WSA) Tönning about the marine casualty and causes of the water ingress.
