Bundesstelle für Seeunfalluntersuchung
Federal Bureau of Maritime Casualty Investigation
Bundesoberbehörde im Geschäftsbereich des Bundesministeriums
für Verkehr, Bau und Stadtentwicklung

Investigation Report No. 347/05

Serious Marine Casualty

**Collision of
SY ALIADO and SY KATTEGAT
in the Fairway of Rudkøbing Løb/DK
on 25 July 2005**

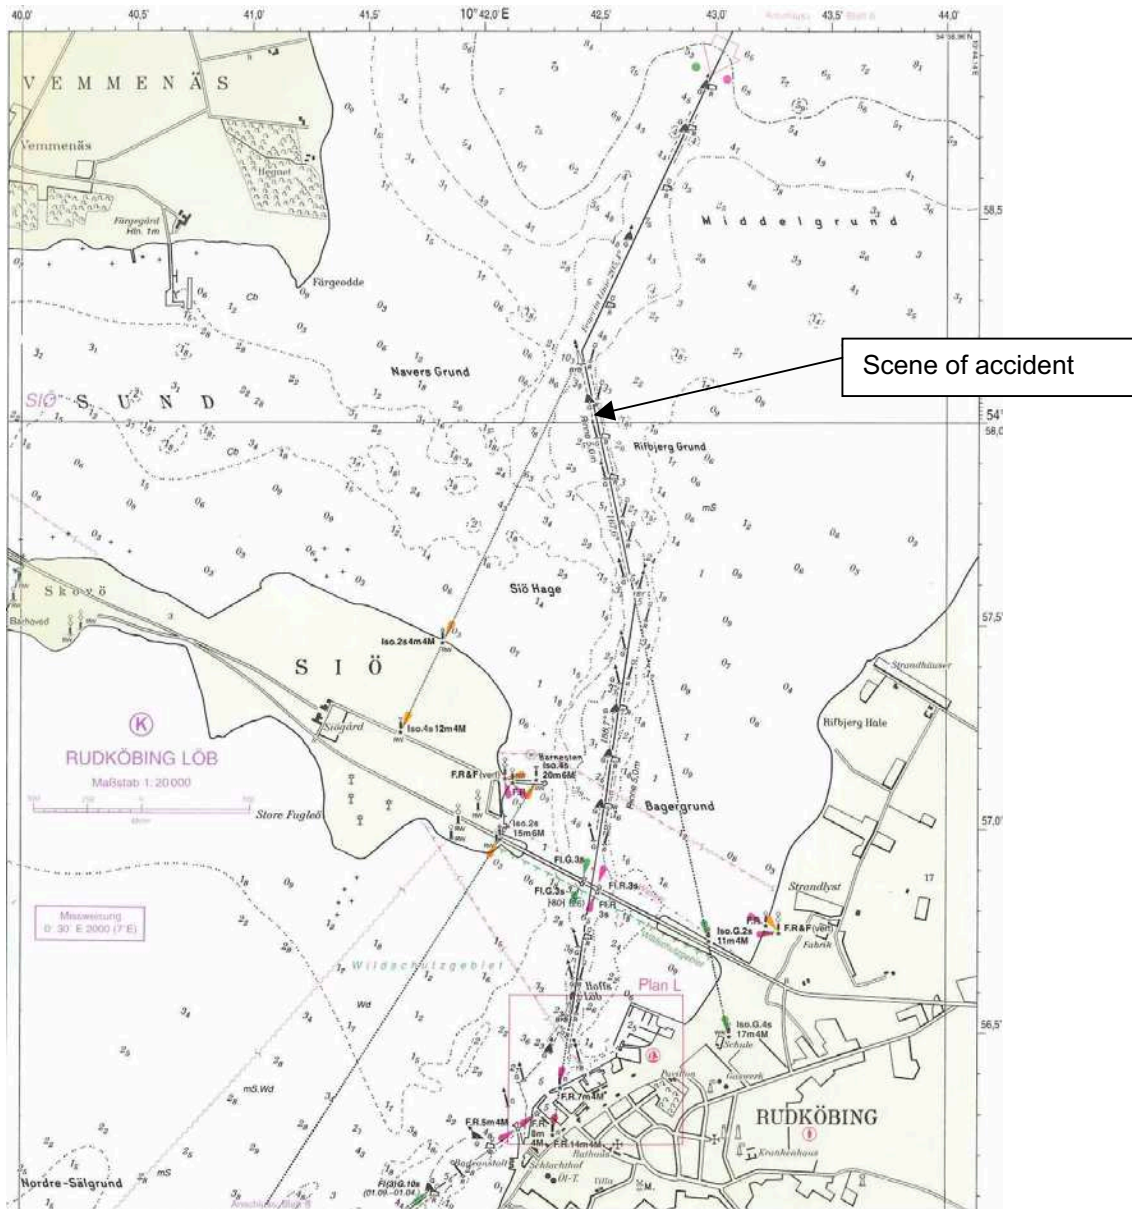
Fig.1: Chart

Nature of the incident: Serious marine casualty, collision with injured person
 Date/Time: 25 July 2005, about 12:55 p.m. CEST¹
 Location: Rudkøbing Løb in Denmark
 Latitude/Longitude: φ 54°58,0'N λ 010°42,5'E

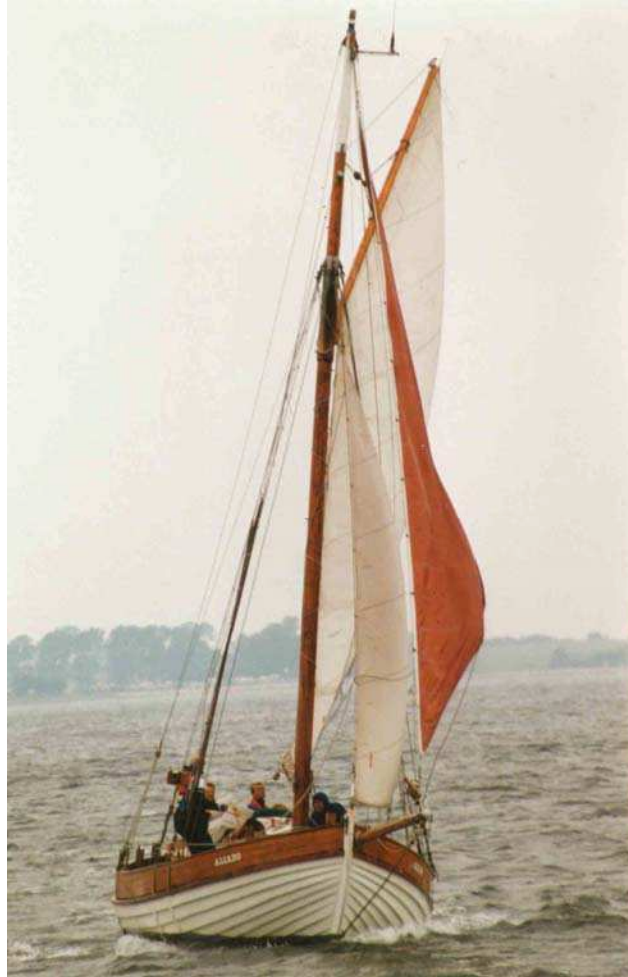
Fig. 2: Photo of the vessel ALIADO

The damages on board the SY ALIADO amounted to 3000.-- €. The jib-boom, the water stay and the jib stays had to be replaced.

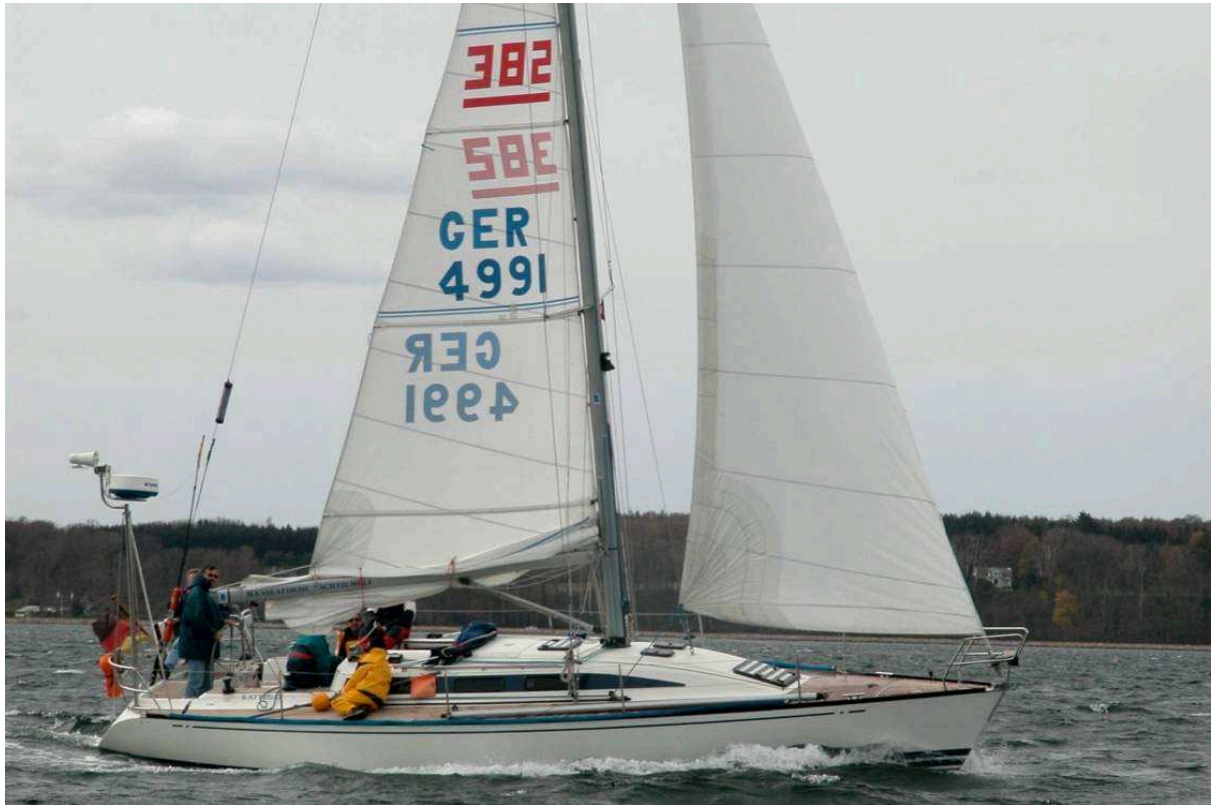
Fig. 3: Photo of the vessel KATTEGAT

The damages on board the SY KATTEGAT amounted to about 10.000.-- € . The steering wheel was completely destroyed. The stern pulpit, some railing stanchions and the railing roped as well as zones of glass fibre reinforced plastic on the hull were damaged.
