Bundesstelle für Seeunfalluntersuchung
Federal Bureau of Maritime Casualty Investigation
Federal Higher Authority subordinated to the Ministry of Transport,
Building and Urban Affairs

Investigation Report 415/06

Serious marine casualty

**Capsizing of the Pilot Tender ELBE 3
while casting off from
MV DELTA ST. PETERSBURG
on 23 August 2006
north of Elbe Buoy (Elbetonne) 1**

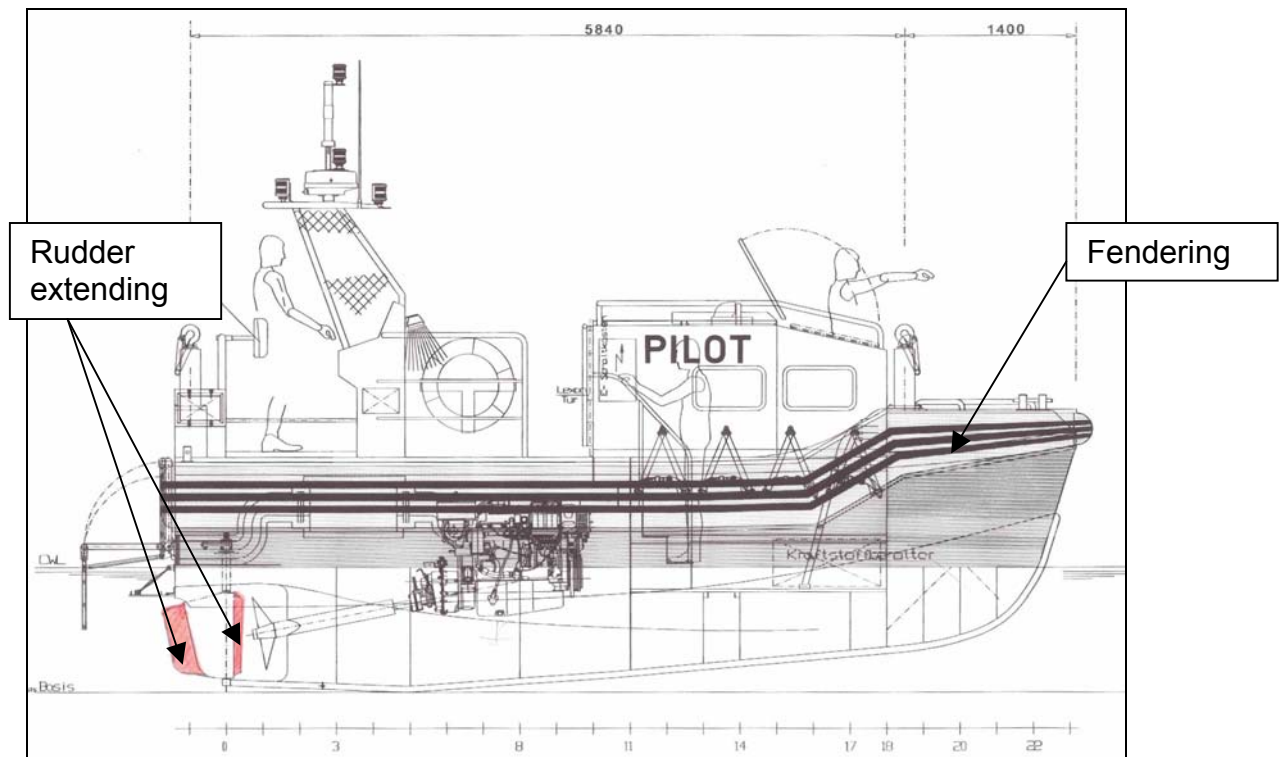
Figure 8: Side view ELBE 3

The Pilot Tender ELBE 3 was built as third copy of vessels "of the same design" in 2002 at the Fassmer yard as a "self-righting boat with open conning position". The hull and engine of the vessels are all the same. Only the superstructures were modified in accordance with findings gained during work assignments to allow even safer transfer of the pilots.

A basic requirement for pilot tenders made by the public authority carrying out the tendering procedure in 1997 was a self-righting and self-draining design. According to the requirements the boat must have positive righting moments over a range of 180° range of stability. In the text of the tendering procedure in 2001 for repeat construction this requirement was changed to an "unsinkable design". Sufficient fendering to absorb the collision energy was also to be provided so that in rough seas it would be possible to go alongside vessels. The rudder was to be extended as in the prototypes ELBE 1 and ELBE 2.

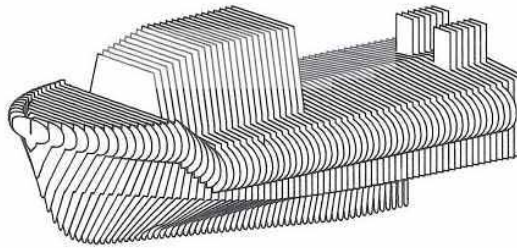
Boat in the present condition

The companionway to the forward superstructure is arranged on the starboard side and is closed by a non-water-tight door made of Lexan (perspex) with two bolts and a Lexan sliding hatch. At the time of the accident this companionway was open. This non watertight condition is not the cause of the accident, as the companionway only comes to the water surface at an angle of heel greater than 100°, while the positive stability range is only approx. 80°.

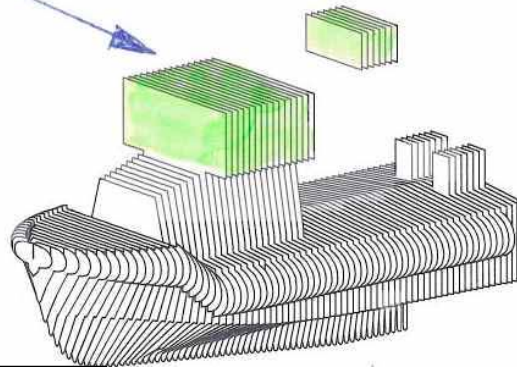
Example as self uprighting boat:
 Volume on the signal mast: 0.36 m³
 Volume on the cabin cover: 2.97 m³

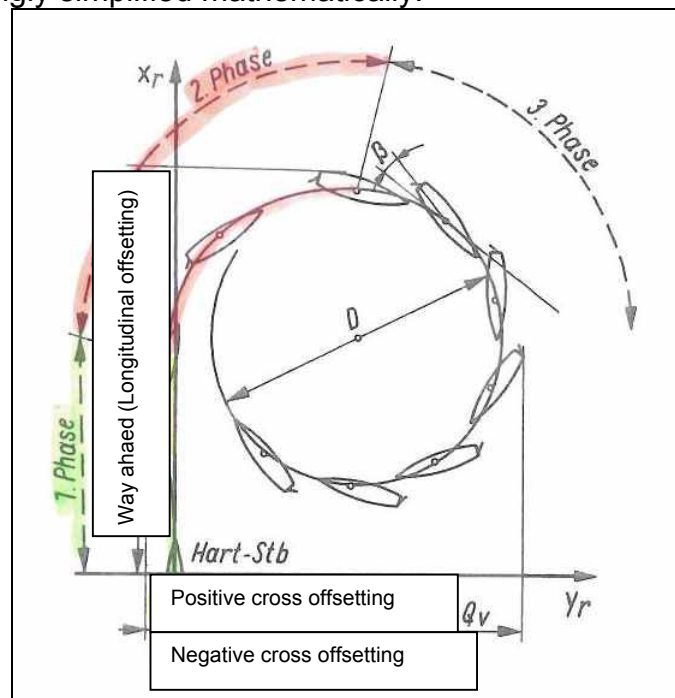
Figure 15: Sketch of turning circle⁴

In the first phase of the turning circle movement the vessel does not immediately begin to turn perceptibly because of the mass moment of inertia and the hydrodynamic mass. The upper sketch shows that initially a "negative cross offsetting" of the centre point of the vessel starts. Although the helm was set to starboard, the vessel first migrates to port and the cross offsetting can be up to two

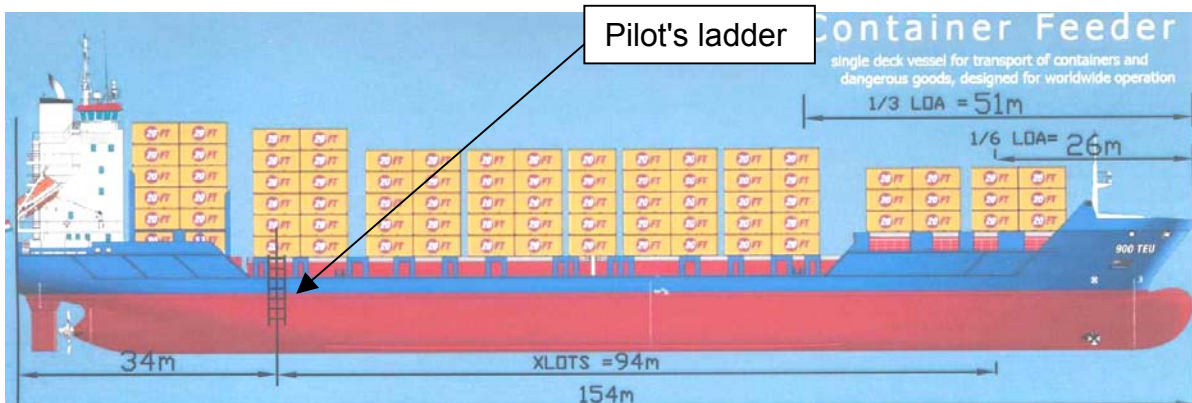
The length X_{pilot} is the distance between the x-position of the pilot ladder at which the pilot boat is taken on to and the so-called tactical pivot about which the vessel apparently turns.

This point can be between 1/3 and 1/6 of the ship's length from the bow and is assumed here to be at 1/6, as shown in the following sketch.

It can be concluded from the comparison of the sum of the heeling moments from the calculation described above and the righting moment of 5.5.3 of 16 kNm that the transverse forces were in any case always large enough to cause the pilot tender to capsize.
