**Bundesstelle für Seeunfalluntersuchung**  
**Federal Bureau of Maritime Casualty Investigation**  
Federal Higher Authority subordinated to the Ministry of  
Transport, Building and Urban Affairs

Investigation Report 474/06

**Serious Marine Casualty**

**Collision of CMV KLENODEN  
with CMV HANJIN CAIRO  
on 9 September 2006  
in Hamburg**

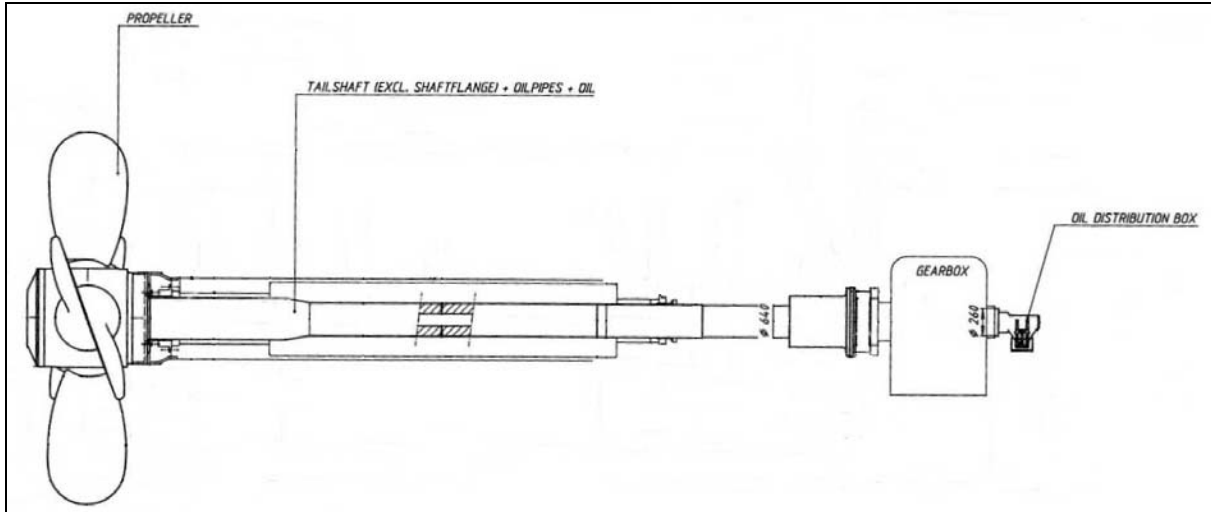
Figure 9: Schematic presentation of control system of the variable pitch propeller

The OD box of the pitch control system is located in the engine room on the outgoing power side of the main engine below the driving shaft (see fig. 9).

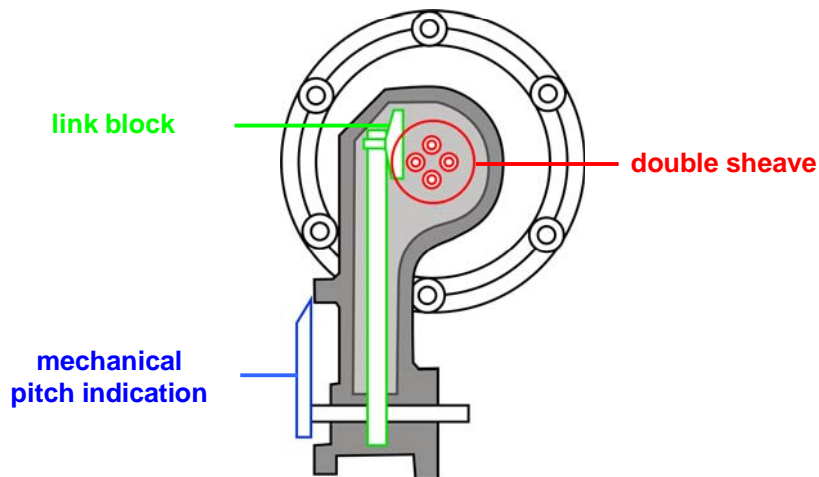
Figure 12: Schematic cross-sectional presentation of the OD box

This double sheave was demounted and remounted by the service technician during the repair of the leakage on the OD box. The groove of the double sheave serves the link block, which again serves as connection to the mechanical pitch indication on the OD box (see fig. 12).
