Report on the investigation of  
the collision between **Arctic Ocean** and **Maritime Lady**,  
capsize of **Maritime Lady** and contact with wreck of  
**Maritime Lady** by **Sunny Blossom**, and its subsequent grounding  
in the Elbe River  
5 December 2005

**Report No 2/2007**  
**February 2007**

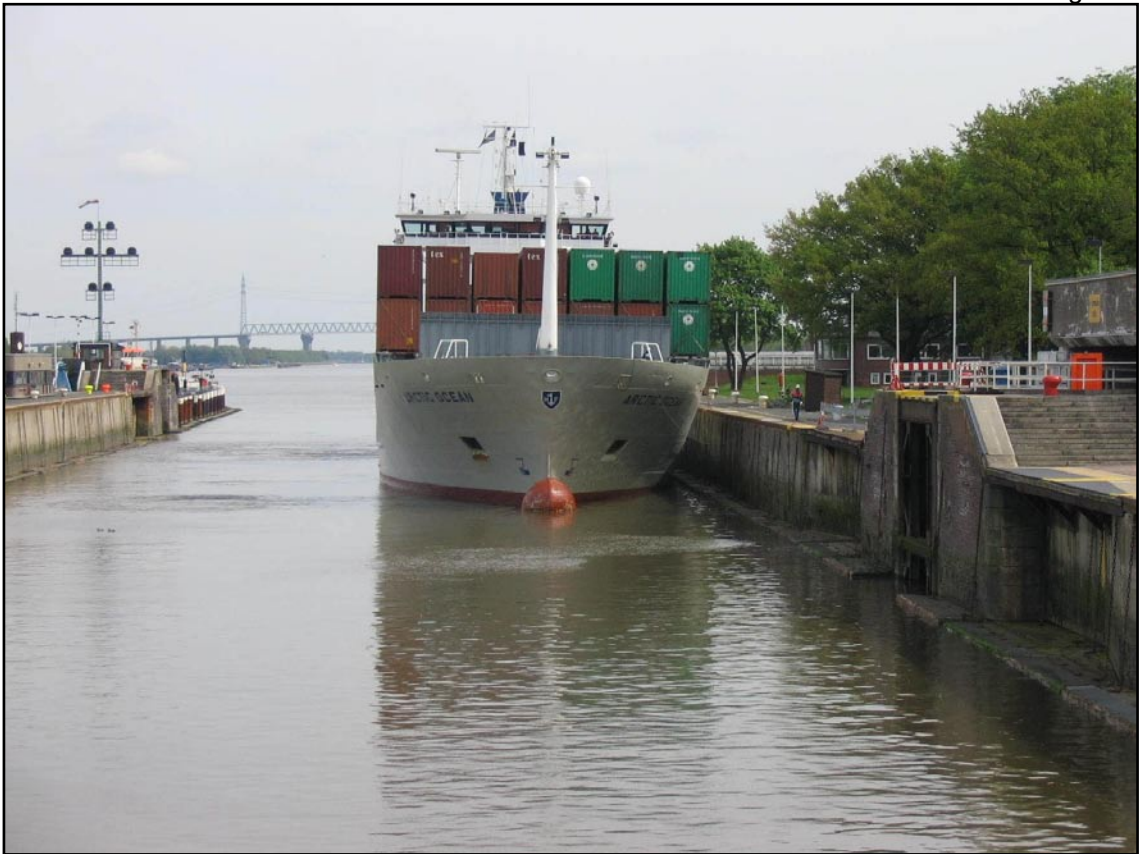
Figure 2

At 1941, *Arctic Ocean's* master contacted Brunsbüttel Elbe Traffic giving: his vessel's position in the lock; Hamburg as his destination; his vessel's draught as 7.1m; and, that no Elbe or harbour pilot was required (**Figure 2**).

*Arctic Ocean* in Brunsbüttel Locks during daylight

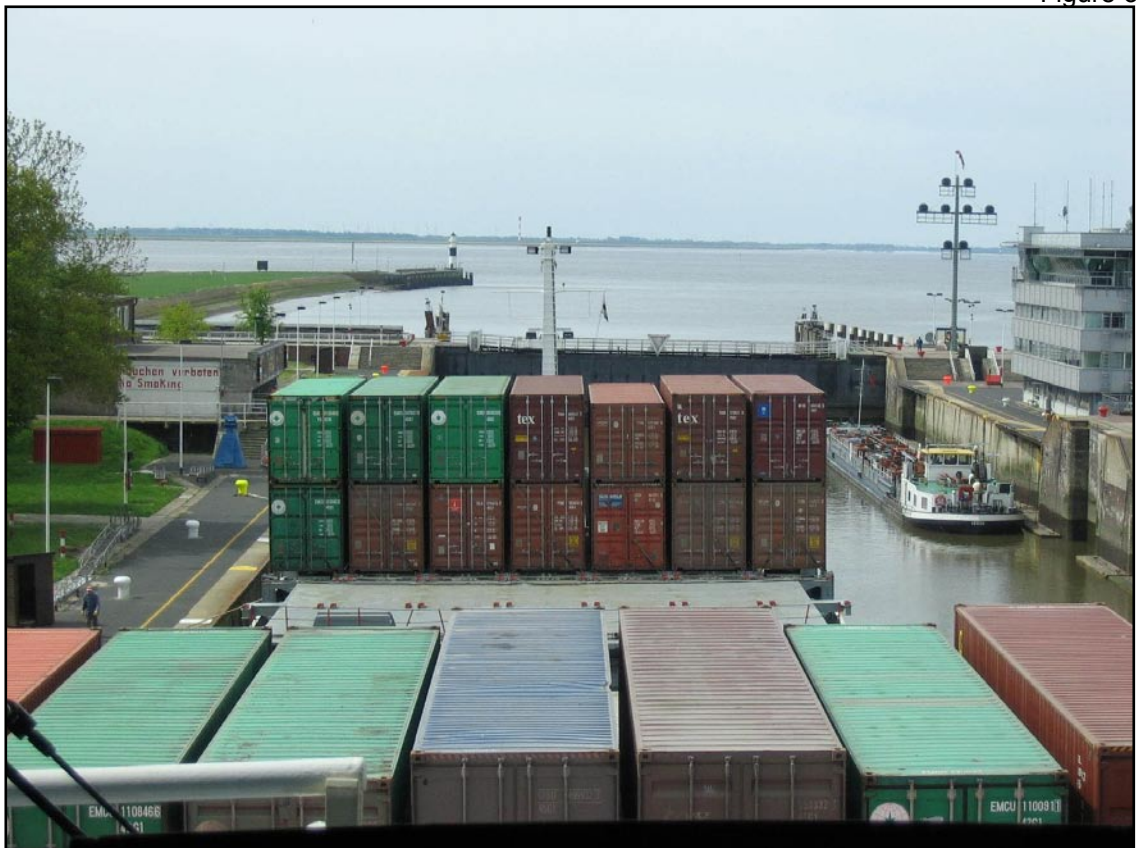
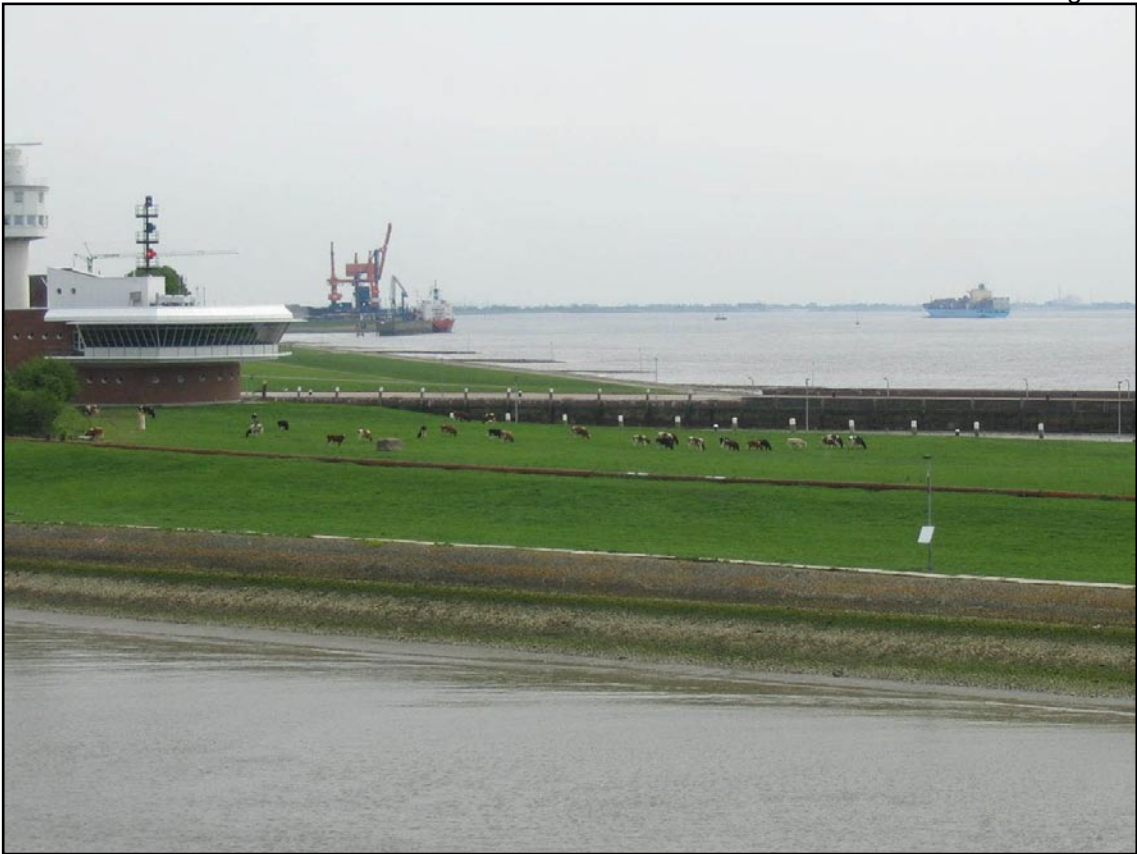
Figure 3

At about 1950, *Arctic Ocean* began to leave the southerly new lock at Brunsbüttel. The master was on the bridge and the chief officer was forward (**Figure 3**). The master, alone on the bridge, put the engine controls to half ahead and *Arctic Ocean* accelerated out of the lock and along the basin until she had reached a speed of between 8 and 10 knots as she entered the Elbe River.

Exit basin from Brunsbüttel Locks - from bridge of *Arctic Ocean* during daylight

View east by day from bridge of *Arctic Ocean* in exit basin from Brunsbüttel Lock

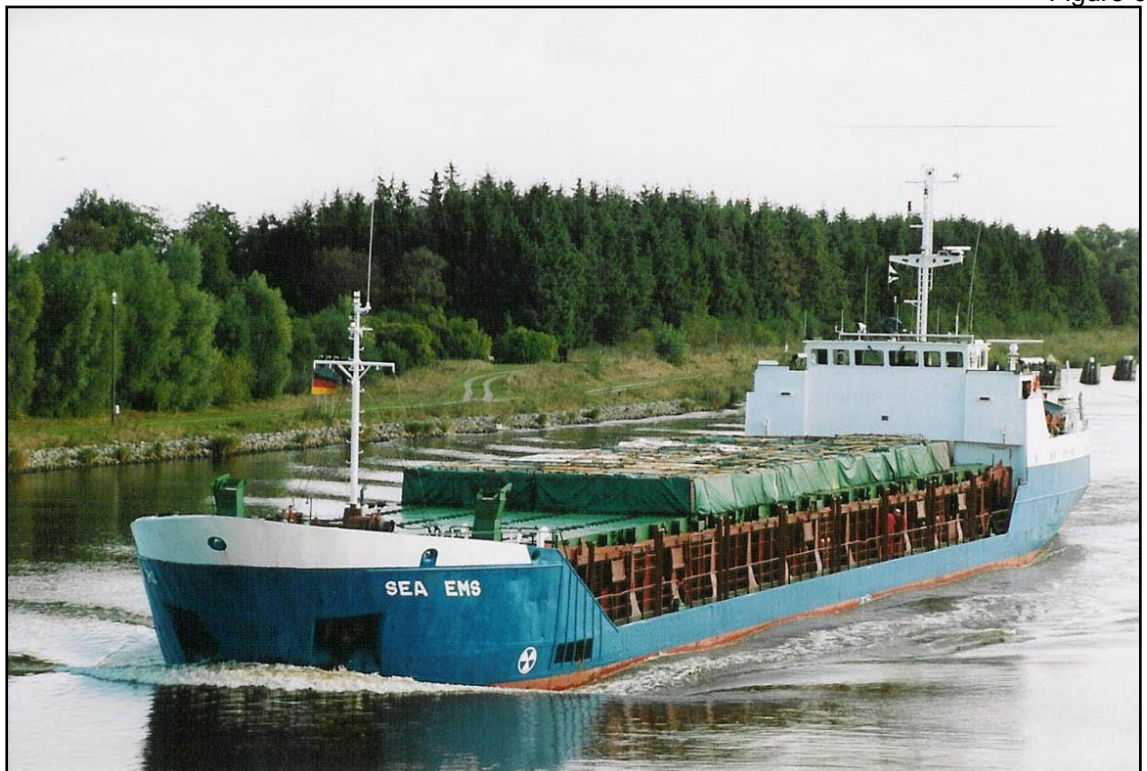
Figure 6

*Maritime Lady* (**Figure 6**) had arrived in Hamburg early on Sunday 4 December 2005, after a ballast voyage from Vlissingen, The Netherlands. She had then loaded a cargo of 1805t of Potassium Chloride, bound for New Holland, UK.

*Maritime Lady* under former name

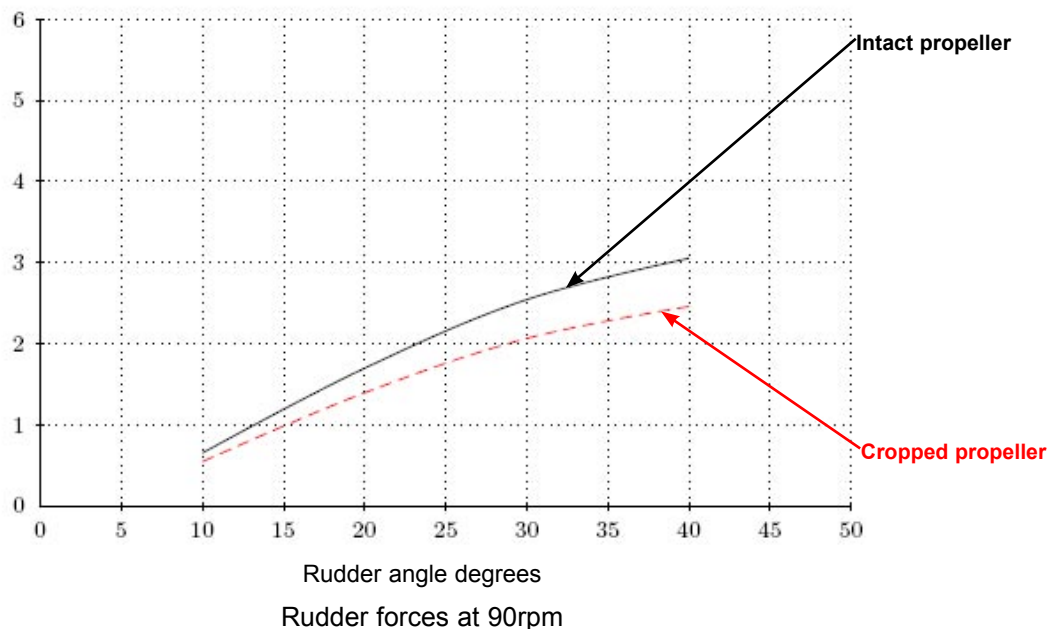
Figure 17

- Cropping of two propeller blades reduced the slipstream over the rudder and transverse rudder force. At 90rpm (full ahead) and 30° of rudder, the calculated reduction was from 254kN to 205kN (**see Figure 17**).
