**Bundesstelle für Seeunfalluntersuchung**  
**Federal Bureau of Maritime Casualty Investigation**  
Federal Higher Authority subordinated to the Ministry of Transport,  
Building and Urban Affairs

Investigation Report 637/06

**Very Serious Marine Casualty**

**Fatal accident involving two crew members  
as well as personal injury to two other  
crew members  
on board the M/V CAP EGMONT  
on 28 December 2006  
off the Japanese coast**

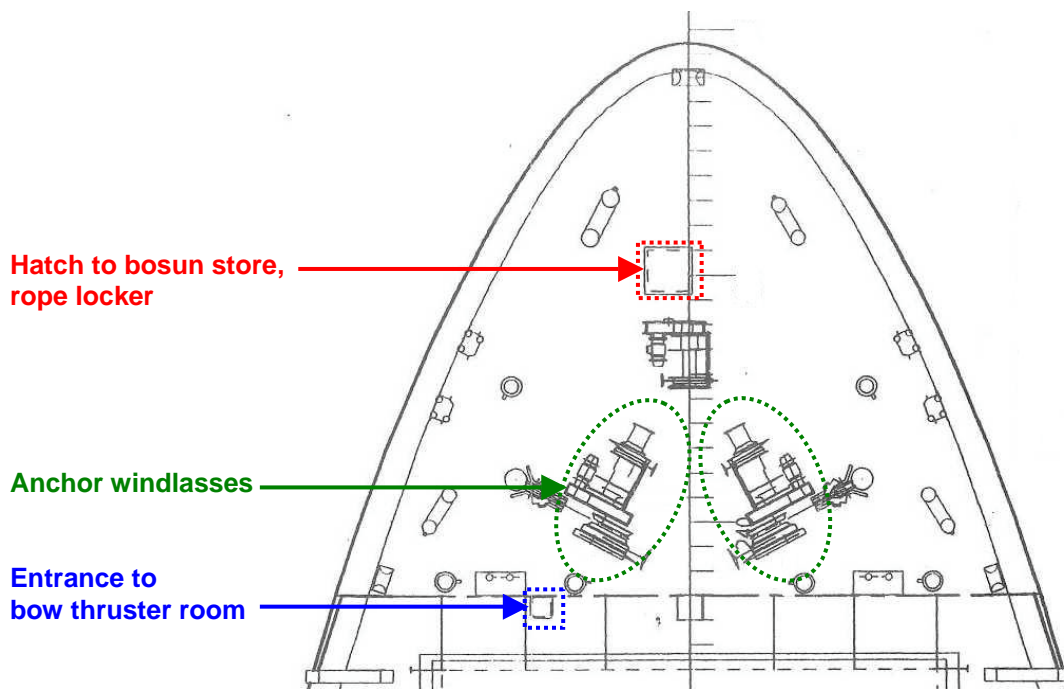
Figure 5: Drawing of the forecastle area of the CAP EGMONT

The arrangement of the anchor windlasses and of the hatch to the bosun's store and the rope locker underneath is illustrated by the following detail from the general plan drawings of the CAP EGMONT (fig. 5) and by the additional photomontage (fig. 6<sup>2</sup>).

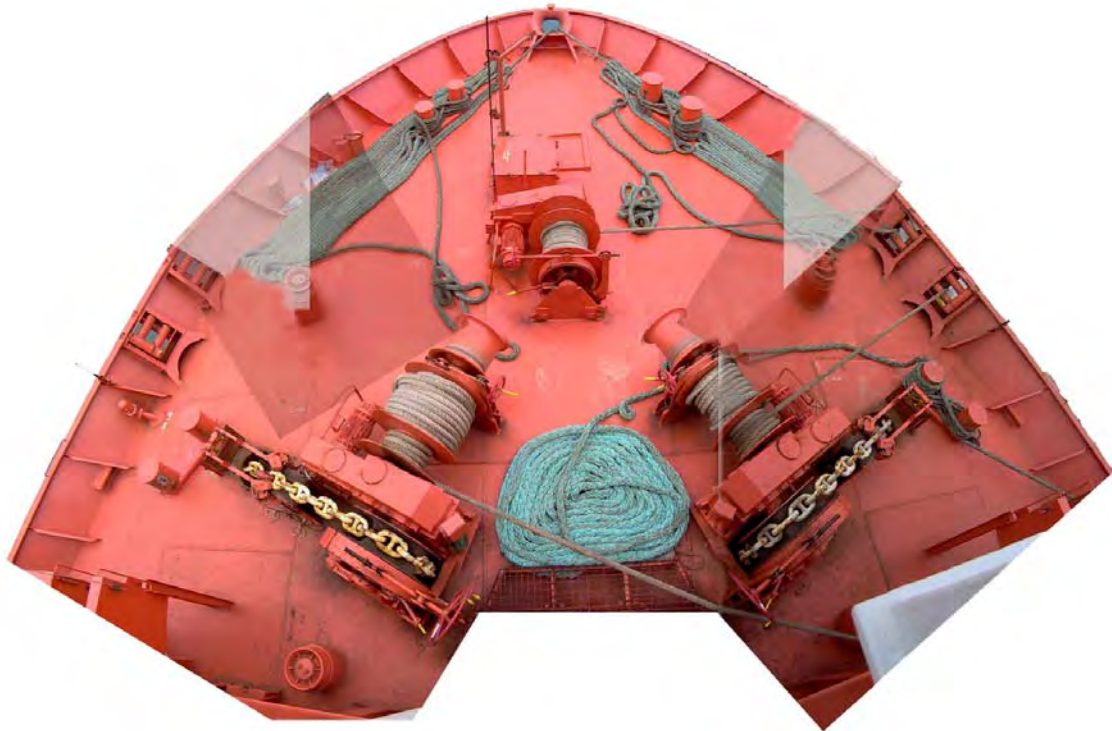
Figure 6: Photomontage of the forecastle area of the CAP EGMONT

There is no connection between the bosun's store or the rope locker and the CAP EGMONT's bilge. The bosun store can be accessed via the entrance to the bow thruster room.

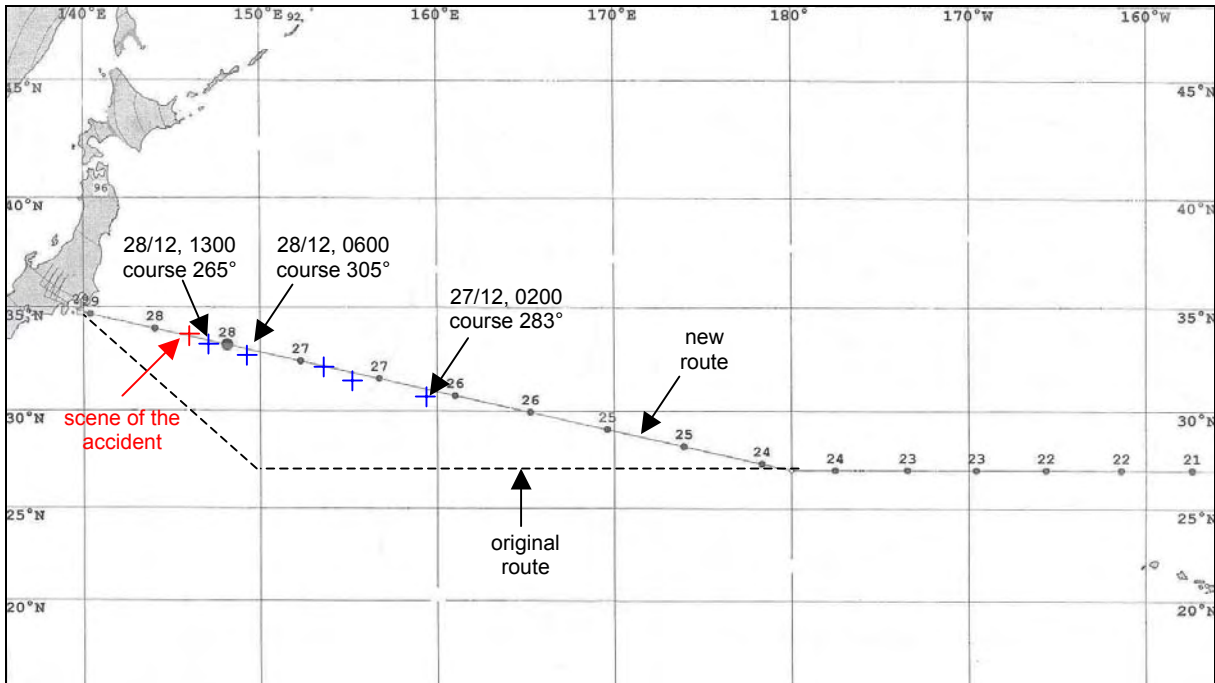
Figure 7: Overview chart with planned routes and plotted courses

The following overview chart<sup>3</sup> shows details of the original and the changed itinerary (Nojima Saki approach) as well as waypoints, indicating the courses actually plotted by the CAP EGMONT as recorded in the bridge log (fig. 7).

The figures entered on the new route refer to the days of the month of December on which the CAP EGMONT was on its voyage from Central America to Japan.

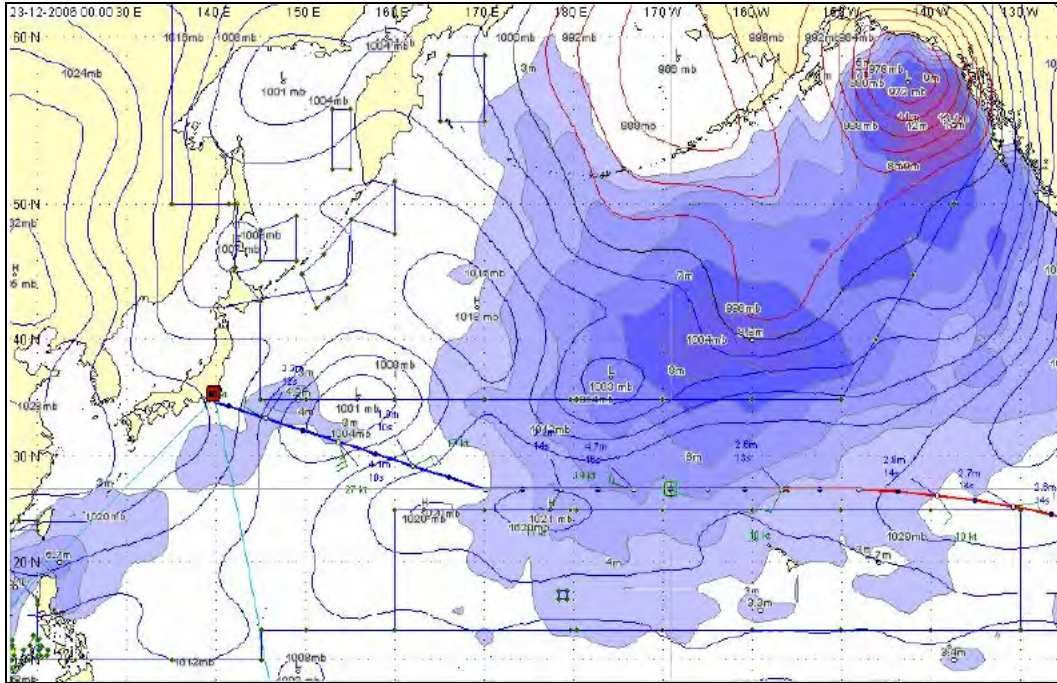
Figure 10: Weather chart produced by the charterer's weather information service of 23 December 2006 for 23 December 2006

route. On 23. December 2006 the weather chart reproduced below was provided (cf. fig. 10). Chart print-outs for previous or following days were not available to the BSU for further appraisal.

By way of comparison both weather charts correspond in mapping the high and low pressure areas. Minor divergences appear with regard to the wind forecast: According to figure 10 the forecast included winds with speed of 25 knots whereas winds with speed of 30 knots were expected according to figure 11 (6 to 7 Bft). No wind forecast for the day of the accident has been provided in figure 10.

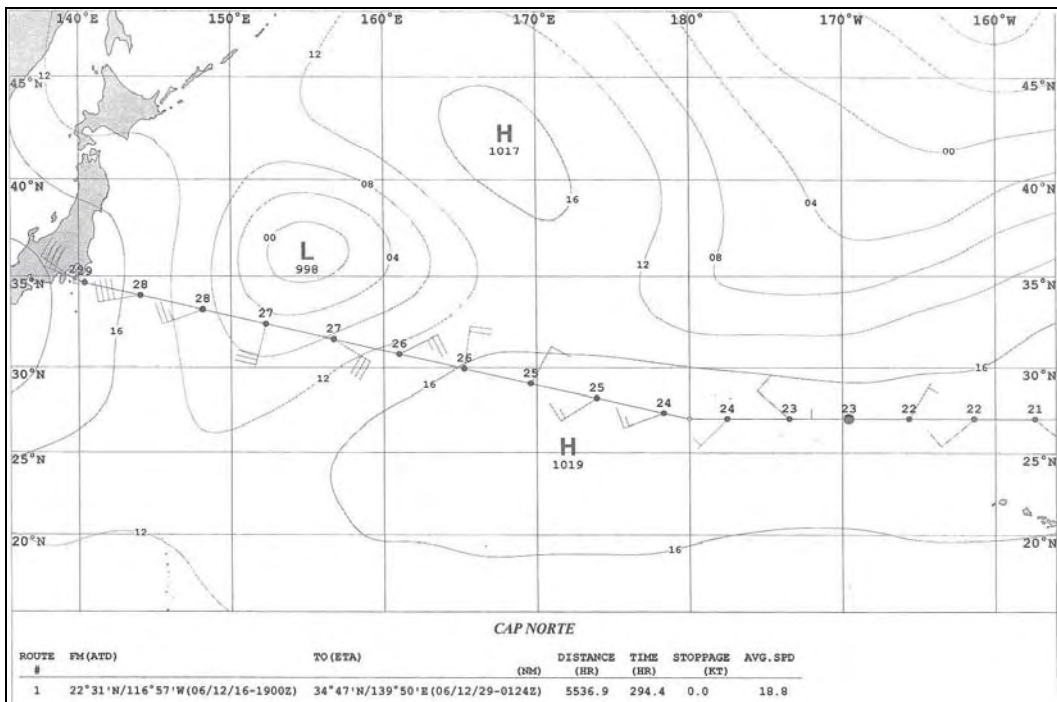
Figure 11: Comparable weather chart of the ship owner's weather information service of 22 December 2006 for 23 December 2006

The weather chart produced by the other weather information service for the same day is reproduced below to allow proper comparability (fig. 11).
