Investigation Report 638/06

Serious Marine Casualty

**Serious Personal Injury
on board MV MAIKE
on 30 December 2006
off the Dutch Coast**

15 August 2007

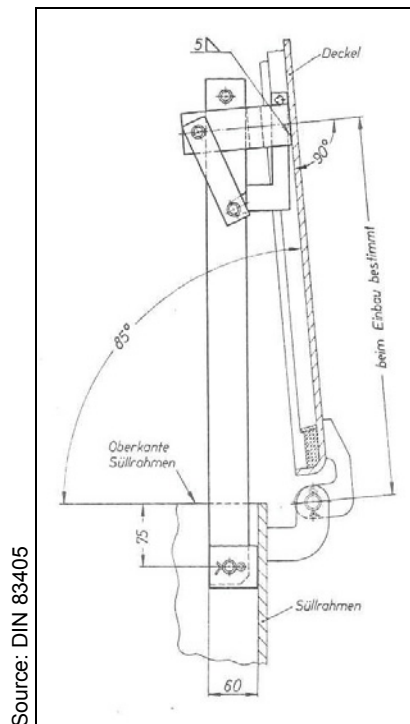
Figure 14: Retaining device form A in conformity with DIN-standards

Since 1976, that is before MAIKE was built, the DIN Recommendation 83405 stipulates a self-locking retainer design for the covers of small hatches following DIN 83404, which establishes the safety standard according to the approved state of the art (form A, cf. fig. 14).

This retaining device in conformity with DIN-standards is to be mounted onto the inside of the hatch coaming. In the present version of DIN 83405 from 2001, for hatches of comparable size, as a device that secures the hatch cover from the outside only one other form (form C) is determined as an alternative. However, even that alternative device has a design fundamentally differing from the retainers that are mounted on the forecastle of MAIKE.

Therefore, the retaining device mounted on the forecastle of MAIKE consisting of a hook picking from outside the hatch, fixed onto a rigid U-profile with multiple kinks, must be considered as non-conforming to DIN-standards. On the contrary, the design's resistance was already weakened by the inserted wedges, regardless of the execution of the welding seams.

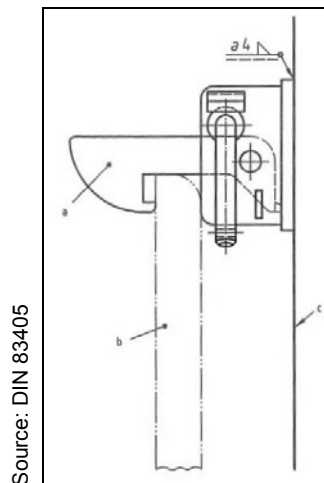
Figure 15: Retaining device form D in conformity with DIN-standards

According to the present standards, the retaining devices of the hatches No 1 and No 3 on the forecastle of MAIKE do no longer correspond to the technical standards established in DIN 83405 as well. The retainers are similar to the retaining device form D (cf. fig. 15) determined in DIN 83405 since 2001, a not self-locking retaining device also to be mounted above the hatches.

However, according to DIN 83405, this type of retainer is only to be provided for hatches with an inside coaming's dimension of more than 1,330 mm, that is, for significantly larger hatches than the one on the forecastle of MAIKE. In addition, such a design requires the hook to directly secure the upper edge of the hatch cover instead of, like on MAIKE, just pick into a lug mounted onto the hatch cover. Over and above, an additional securing clamp is required to be manually put over the hook, in order to prevent any unfastening of the hook.
