## Investigation report

C1/2006M

# MS ESTRADEN and MT WOLGASTERN, collision in the Kiel-Canal on 2.2.2006

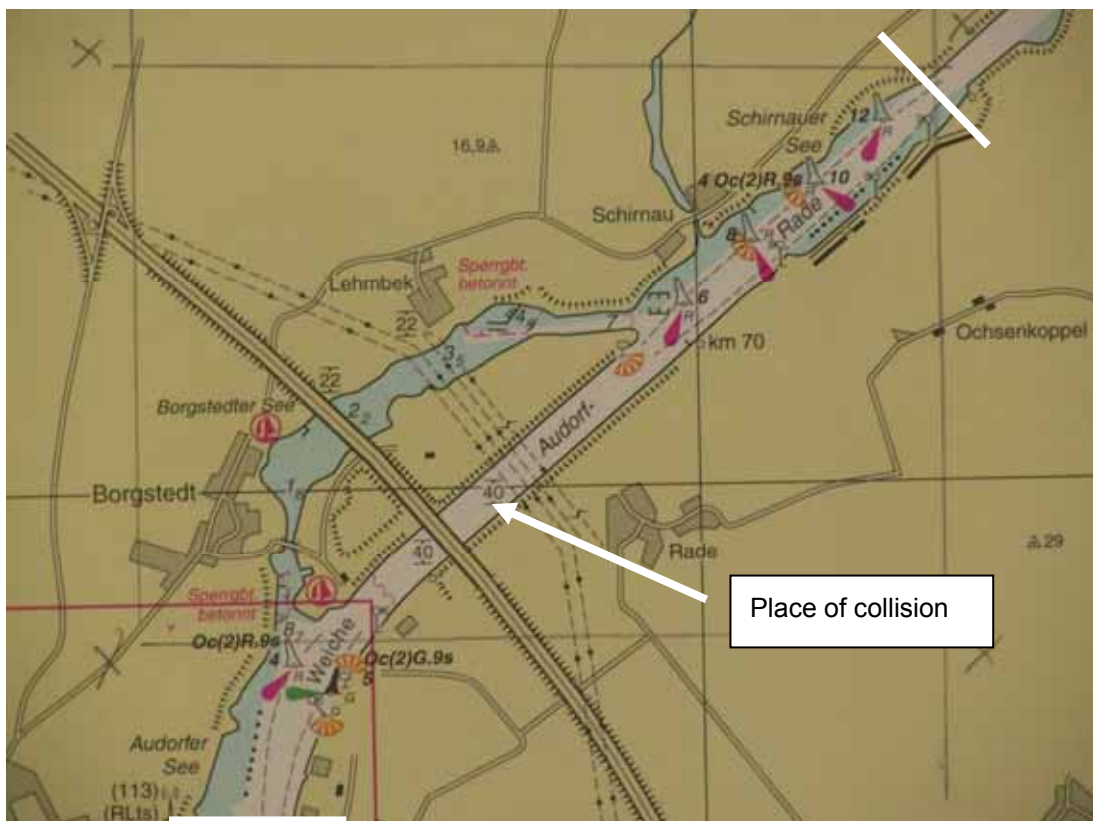
Figure 3 A map of the accident area. The limits of the siding area are shown with a white line (length 5.7km, endpoints at km 66,093 and 71,749). (© Bundesamt für Seeschifffahrt und Hydrographie, Hamburg-Rostock).

At the site of the accident (Audorf-Rade siding area) the width of the Canal bottom having the depth at least 10.5 m varies between 100–110 m outside the Schirnauer See (Figure 3) and inside it between 110–150 m. The widest area is between kilometres 70 and 71. At the nominal depth of 11 m the width is 10–40 m narrower than at depth of 10.5m<sup>7</sup>. The water depth varied both lengthwise and sidewise between 10.5 and 13.5 m, Figures 6 and 9. Figure 7 shows a cross-section of the point where there were three vessels side by side as the LENA was encountered. The map of the area is presented in Figure 3. The ESTRADEN and WOLGASTERN collided just before the end of the straight part of the Audorf-Rade siding area, near the bridge.

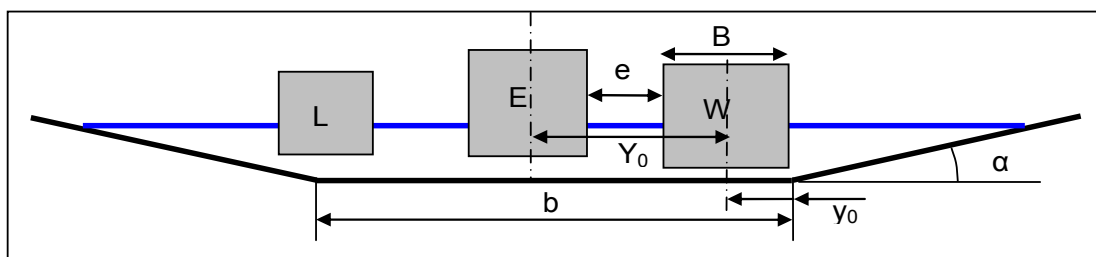
Figure 7. The view of the investigators on the positioning of the vessels in the fairway at 02.30.00: W (WOLGASTERN), E (ESTRADEN) and L (LENA). The figure also shows certain related parameters. The distance between the sides of the vessels is  $e$ , the distance between the centerlines is  $Y_0$ , the distance  $y_0$  from the bank bottom of the Canal has been determined as shown in the figure. The parameters are found in the calculations of Appendix 1. The width  $b$  of the bottom of the Canal varies between 100 and 150 m depending on the longitudinal position. The slope angle  $\alpha$  of the banks is about 13 degrees. The depth of the fairway varies between 10.5–13 m.

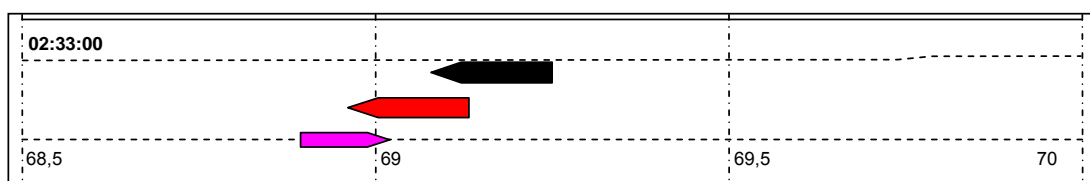
Figure 8. The RIROIL 5 is encountering the ESTRADEN and the WOLGASTERN.

At the moment preceding the accident there were three vessels side by side in a part of the Canal with a nominal width of 100 m, Figure 9. Onboard the RIROIL 5 it was noticed that at the time of the overtaking, the bow of the RIROIL 5 was alongside the sterns of the ESTRADEN and the WOLGASTERN and the overtaking distance between these vessels was smaller than the distance between the ESTRADEN and the RIROIL 5.

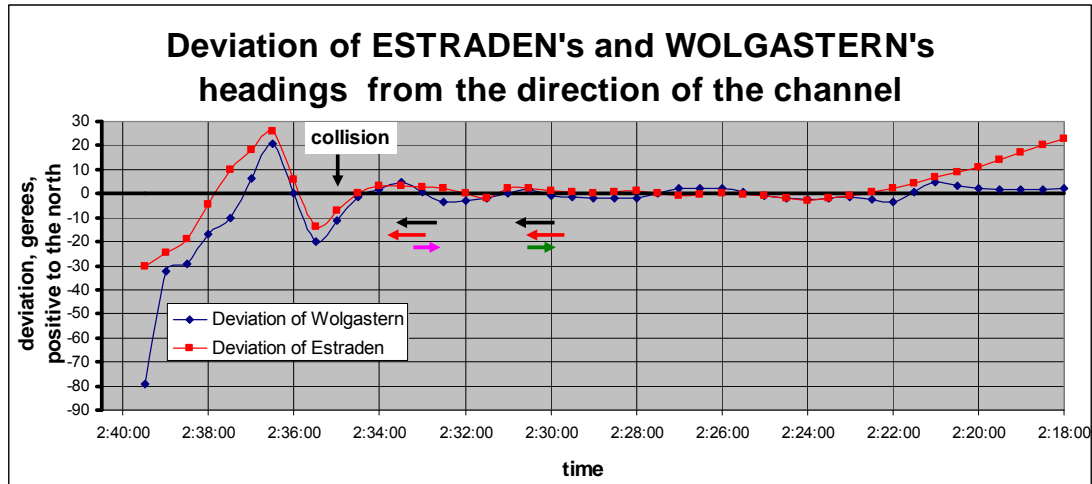
**The heading of the vessels.** Figure 21 presents the headings of the ESTRADEN and the WOLGASTER before and after the collision. The effects of the steering measures onboard and the mutual interaction are difficult to distinguish. However, it can be seen that, especially after encountering the RIROIL 5, the headings of the vessels started to change more strongly than before it.

Figure 21. The headings of the ESTRADEN and the WOLGASTERN. The encounters of the LENA and the RIROIL 5 are also shown.

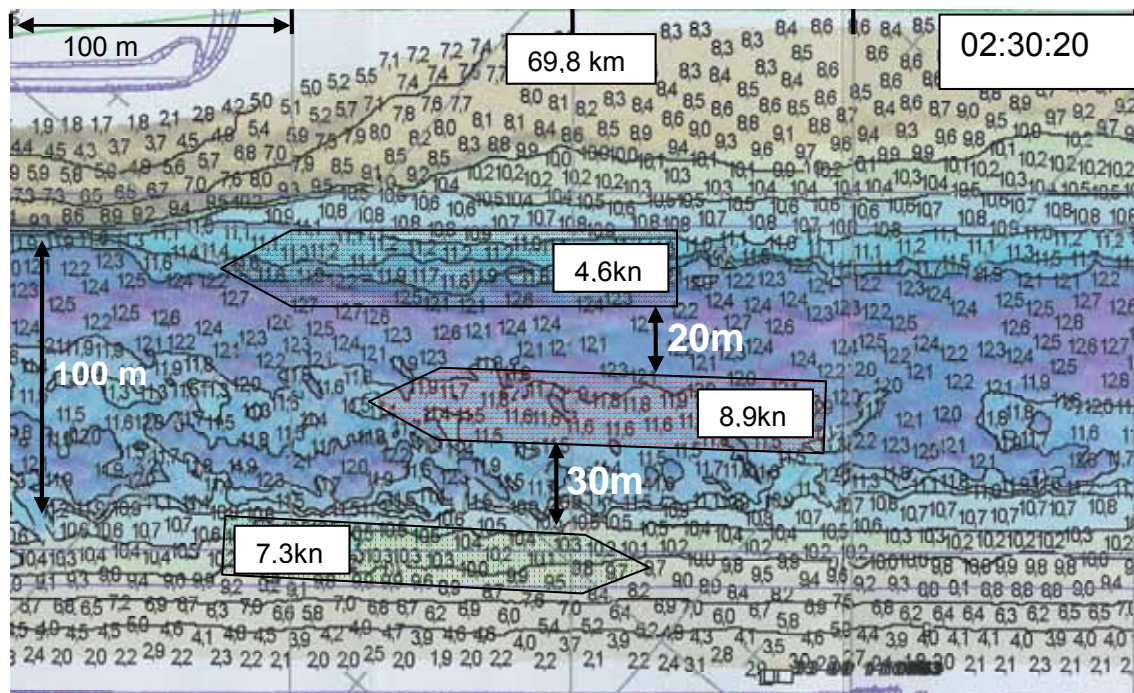
Figure 2. LENA is encountering ESTRADEN and WOLGASTERN. Vessel positions are according to the evaluation by the investigators. The aim has been to position the ships breadth wise as far as possible from each other. The draft of LENA, 6.3m, allows it to be placed into shallower water,  $h/T$  is about 1.6. WOLGASTERN's right side is in about two meters shallower water than the left side,  $h/T$  is about 1.25 on the average. For ESTRADEN, draft 5.9m,  $h/T$  is about 2.0. The encounter with LENA lasted about 40 seconds.

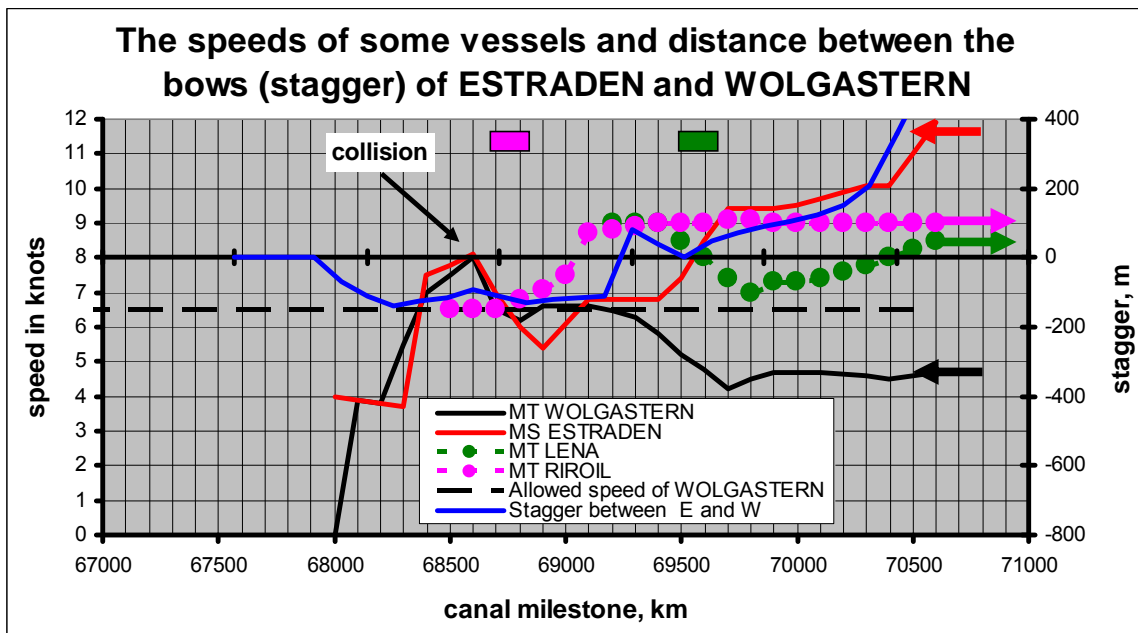
German authorities have announced speed limits<sup>31</sup>. Forces and moments affecting the maneuvering of a vessel are proportional to the square of the speed. Consequently, speed is a very important safety factor. WOLGASTERN's draft was over 8.5 m, and therefore her maximum speed was 6.5 knots. Maximum speeds of other vessels were 8.1 knots. The speeds of some vessels are shown in figure 3. The speeds of ESTRADEN and WOLGASTERN are also shown in figure 4. At some instants the maximum speeds were exceeded as seen in this figure. Relative Froude depth number  $F_{nhR} = F_{nhE} - F_{nhW}$  during the overtaking of WOLGASTERN by ESTRADEN was at the beginning about 0.27. The overtaking did not succeed and therefore relative Froude depth number was around zero for some minutes until the collision.

6,5 knots. When she accelerated the speed before the collision, her highest speed was about 8 knots. Also LENA and RIROIL 5 exceeded the speed limit at some instants. It may be concluded that the increase of speeds increased also the risk of collision.

Figure 3. Speeds of the vessels and stagger between ESTRADEN and WOLGASTERN. The small rectangles show the encounters of three vessels. As seen, the encountering vessels decreased their speed during the meeting.

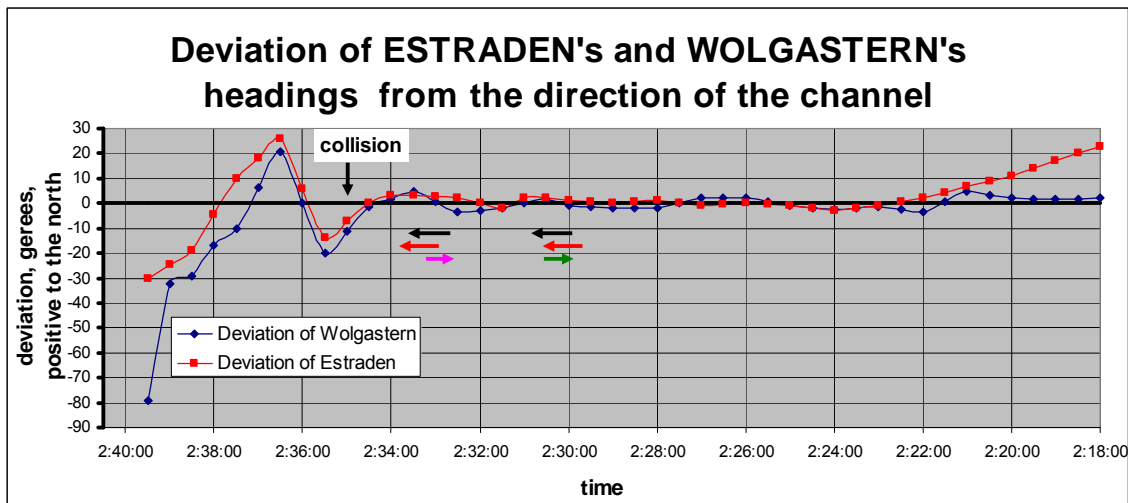
The next Figure 8 shows the deviation of heading of the vessels from the direction of the channel, which is at the straight part of the Audorf-Rade siding area 229 degrees.

Figure 8. Deviation of ESTRADEN's and WOLGASTER's headings from the direction of the channel (229 degrees). Also the instances of encounters with LENA and RIROIL 5 are shown. ESTRADEN proceeded to the straight part of the channel at 02:23.

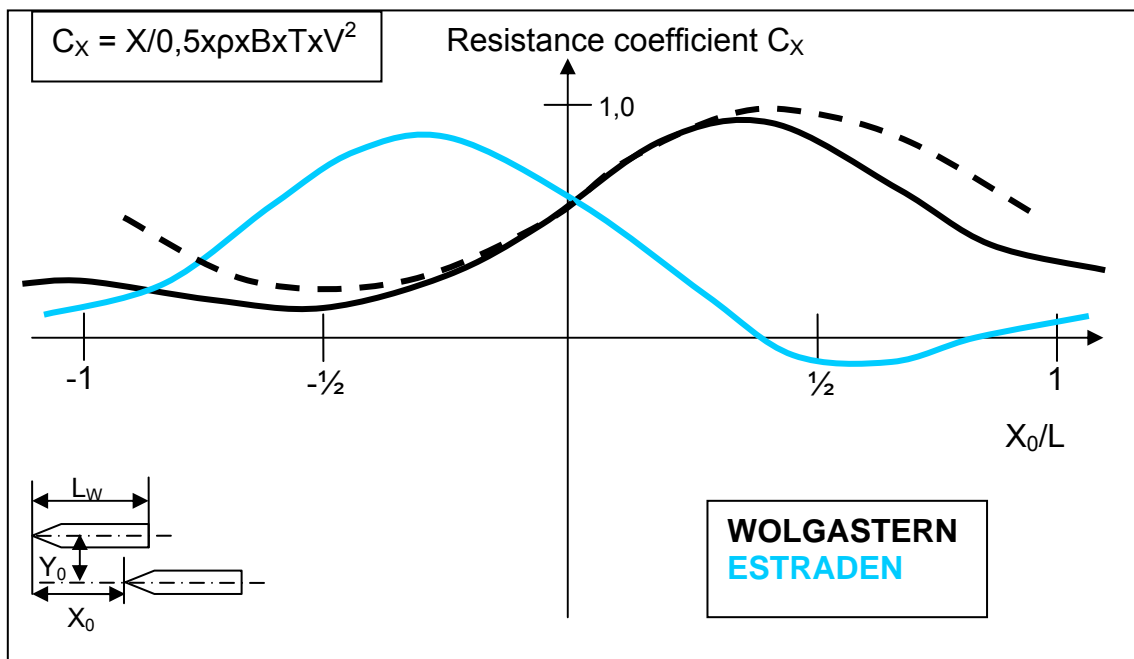
**The case of equal speeds.** ESTRADEN's attempt of overtaking proceeded quite quickly up to position D, figure 9a. This figure shows longitudinal forces acting on the respective vessel. If the speeds are too close and the separation is too small, overtaking will not succeed. ESTRADEN's resistance increased and WOLGASTER's decreased.

Figure 9. Longitudinal (resistance) forces. Broken line: equal speed.

Effectively, ships were trapped with each other. This phenomenon is one reason of the collision. Forces and moments acted then according to the dotted lines (only forces and moments acting on WOLGASTER are shown in this situation). When ESTRADEN was a half ship length ahead of WOLGASTER, the latter increased her speed in order to avoid collision by increasing steering forces. However, the ships had traveled too close each other already about four minutes and the interaction was too strong to be compensated by maneuvering.

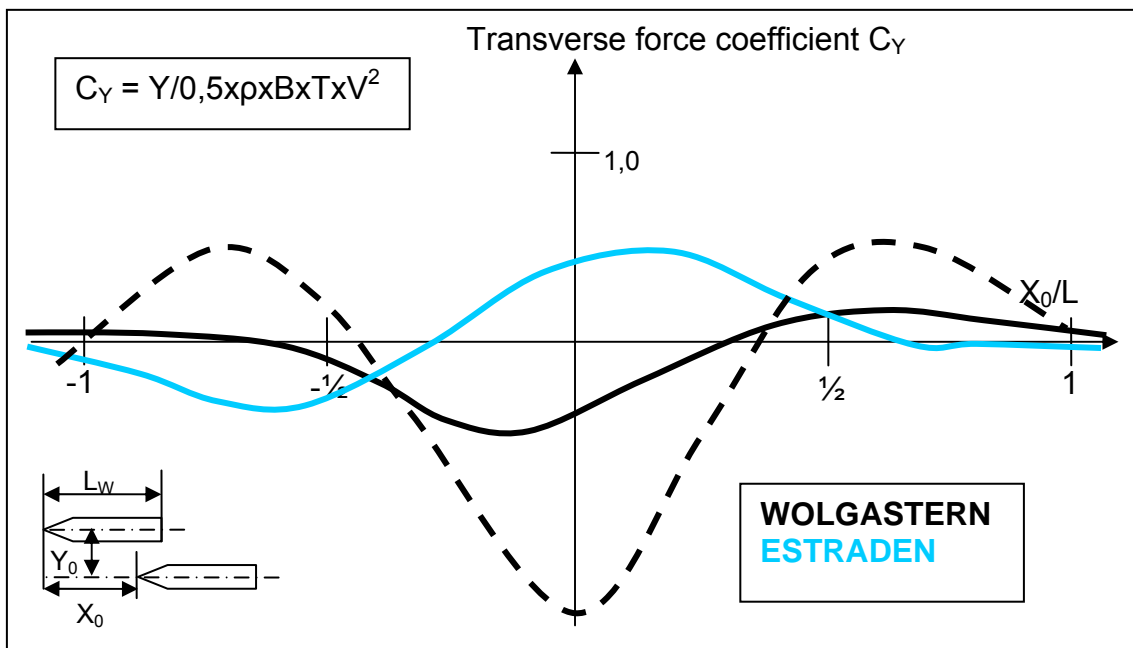
As can be noticed, the transverse forces are attractive when the ships are side by side. At this instant the turning moments are quite small and they can be compensated by rudder moments. When ESTRADEN proceeded a little bit ahead, turning moments started to grow. They can increase so much, that they are greater than steering moments. ESTRADEN had two propellers and rudders and her steering moments could be higher than shown in the figure. Another fact complicating the maneuvering is that the turning moment depends strongly on the stagger. In position D WOLGASTER had a tendency of turning her bow towards ESTRADEN. ESTRADEN had also similar tendency. As a result, the bow of WOLGASTER hit amidships of ESTRADEN. Turning moments were greater than steering moments, and the collision was not possible to be avoided at that instant. Transverse forces tried to move both ships to the left. Additionally, bank effect was affecting WOLGASTER, see chapter 2.9.

Figure 10. Transverse forces. Broken line shows situation at equal speed.

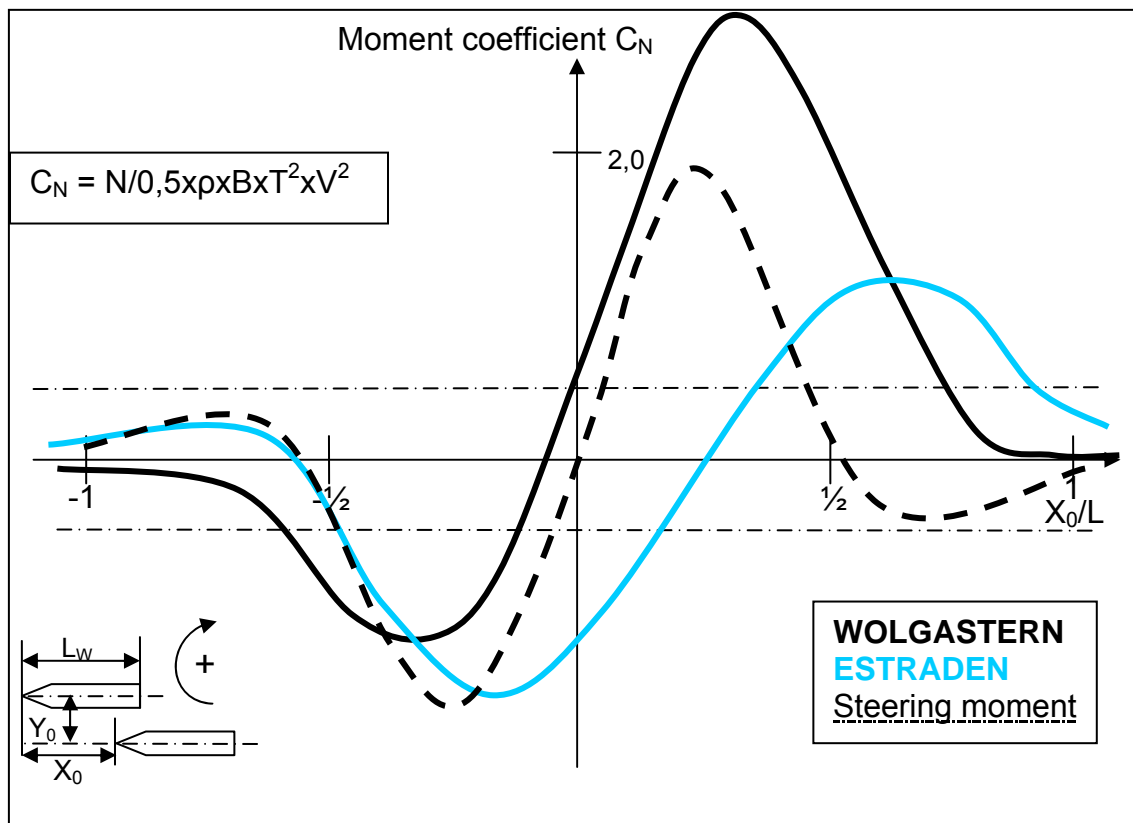
Figure 11. Turning moments. Broken line shows situation at equal speed.

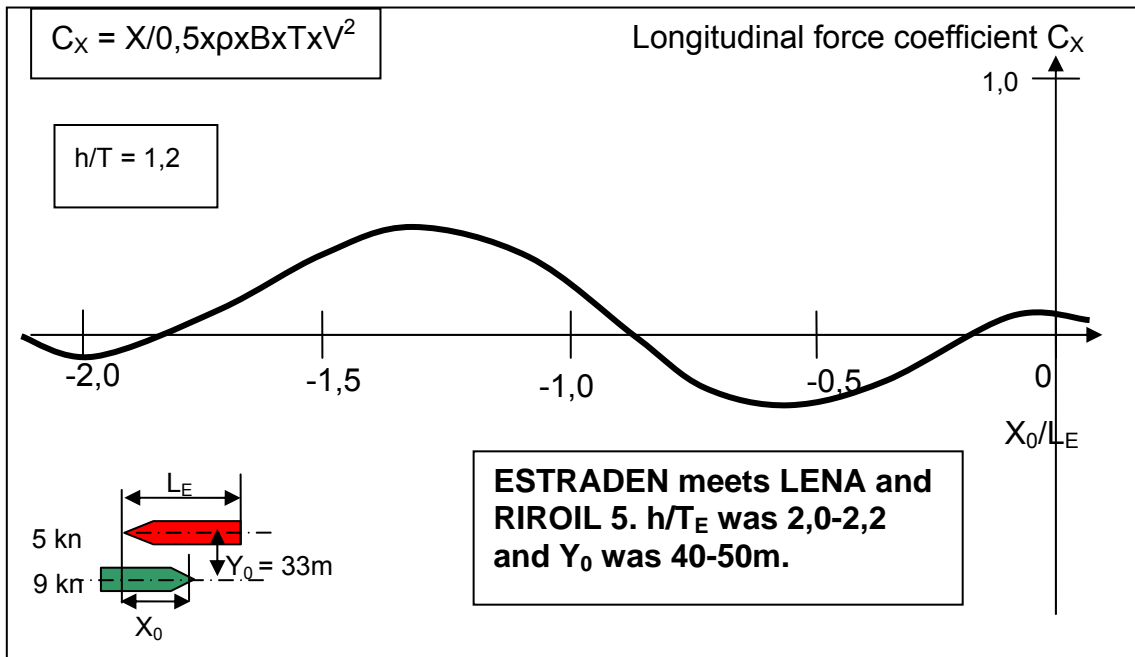
**LENA or RIROIL 5 encountering ESTRADEN and WOLGASTERN.** ESTRADEN met two times an encountering vessel: first LENA and later RIROIL 5. The following figures 12–14<sup>34</sup> show the interaction forces and moments acting on ESTRADEN in this situation, based on reference 4. The effects on the other vessel are opposite. Relative water depth and separation in the model tests deviated considerably from the actual. The separation between LENA or RIROIL 5 and ESTRADEN was 40–50m (distance between sides 20–25m, figures 2 and 6), not 33m as in model tests. The ratio  $h/T$  was for ESTRADEN about 2 and for LENA and RIROIL 5 about 1.5, when model test results are for the value 1.2. In general, however, these results correspond principally with the situation in Kiel Canal. According to the reference 5 the increase of water depth decreases forces and moments by two thirds and the increase of separation decreases them by 20 per cent. Both encounters lasted about one minute, and the interaction did not have time enough to fully develop. The opinion of investigators is that these encounters were not risky because of adequate water depth and moderate separation. However, dangerous situation developed because ESTRADEN was forced to proceed clearly too near to WOLGASTERN due to these encounters.

Figure 12. Longitudinal forces at head on encounter acting on bigger and slower ship.

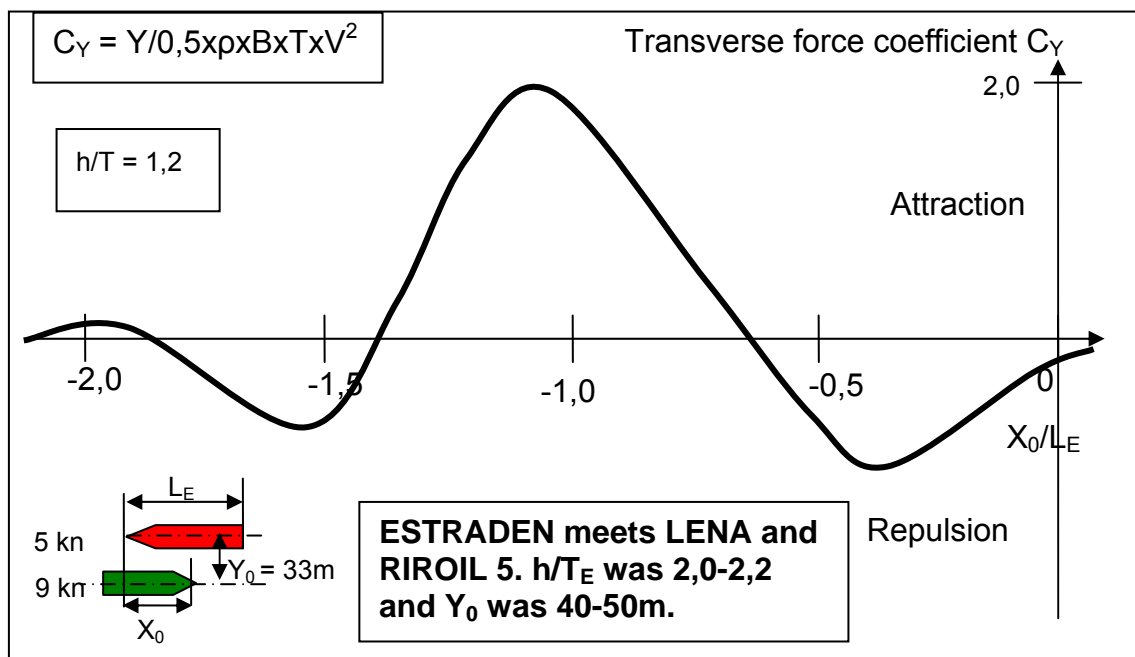
Figure 13. Transverse forces at head on encounter acting on bigger and slower ship.

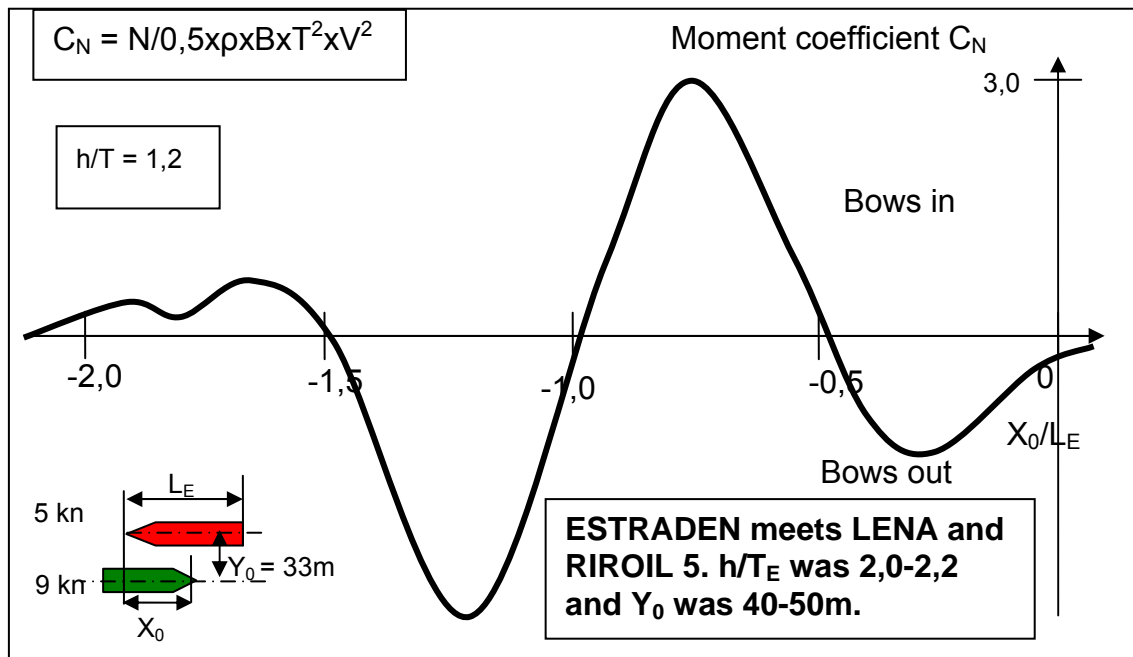
Figure 14. Turning moments at head on encounter acting on bigger and slower ship.
