Investigation Report 329/03

Very Serious Marine Casualty

**Fatal casualty in the scavenge air receiver of
the main engine of the CMS LONDON
EXPRESS
in the night of 24 to 25 October 2003 on the
voyage from Savannah/USA to Norfolk/USA**

15 October 2007

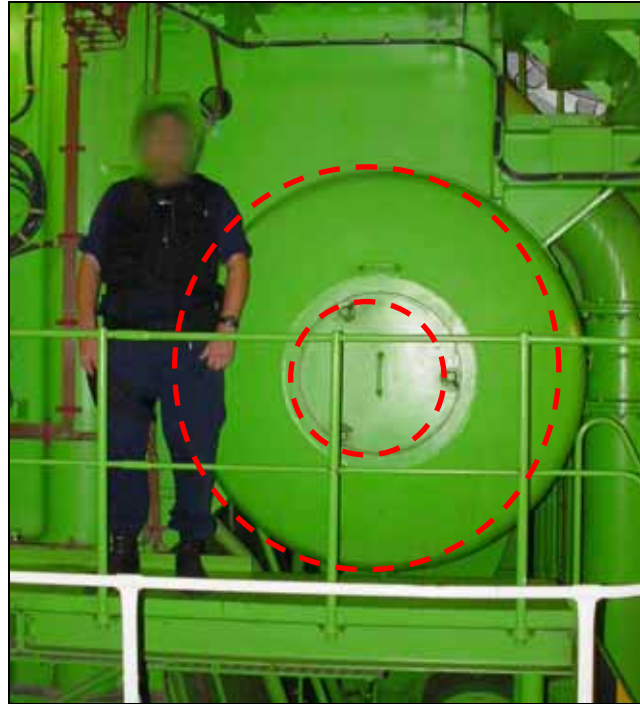
Figure 19: Scavenge air receiver – aft end with access hatch closed

The closing arrangement for the two access openings consists of manhole covers opening only inwards in horizontal gate fashion and mounted on two hinges. The hinges are within the scavenge air receiver. The covers are closed from the outside by reaching into the scavenge air receiver and grasping a vertical handle welded onto the centre of the cover, then swivelling the cover into the opening. By means of a special bolting system consisting of three identical locking devices set at 120° angles the cover is then pressed against the inner circumferential lip of the scavenge air receiver opening.²⁷ This design ensures that the pressure developing within the receiver while the engine is running and the resulting additional contact pressure further assist the cover's sealing function. However, this also means that intentional opening of the hatch with the engine or the auxiliary fan running is not possible using only normal muscle strength.

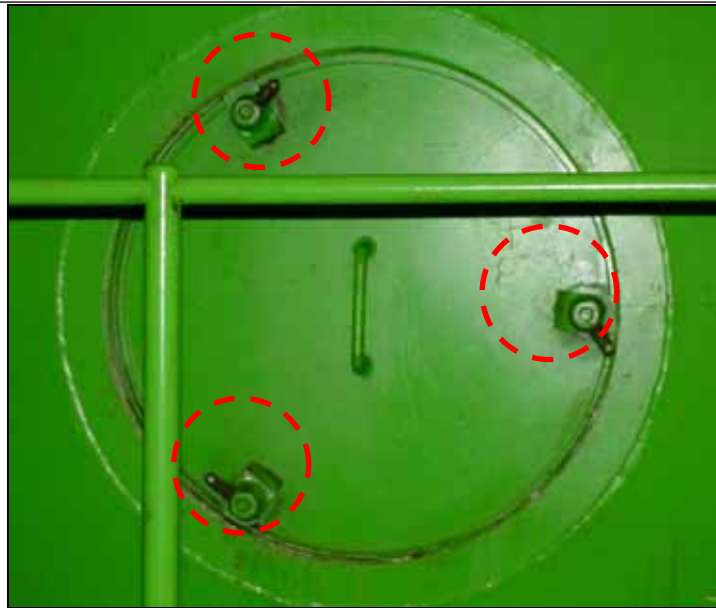
Figure 25: Arrangement of the locking devices

As already mentioned earlier (cf. Point 4.1.3.3), the access openings situated at the forward and aft frontal parts of the scavenge air receiver are closed by manhole covers swinging open gate-fashion and exclusively to the inside and to the right⁶⁵, each of which is mounted on two hinges. The bolting system is identical both forward and aft and consists of, in each case, three closing devices of equal construction arranged at 120° angle arc distances from one another. On the hatch cover of relevance for the accident these locking devices are mounted in the 11, 3 and 7 o'clock positions (cf. **Figure 25**).

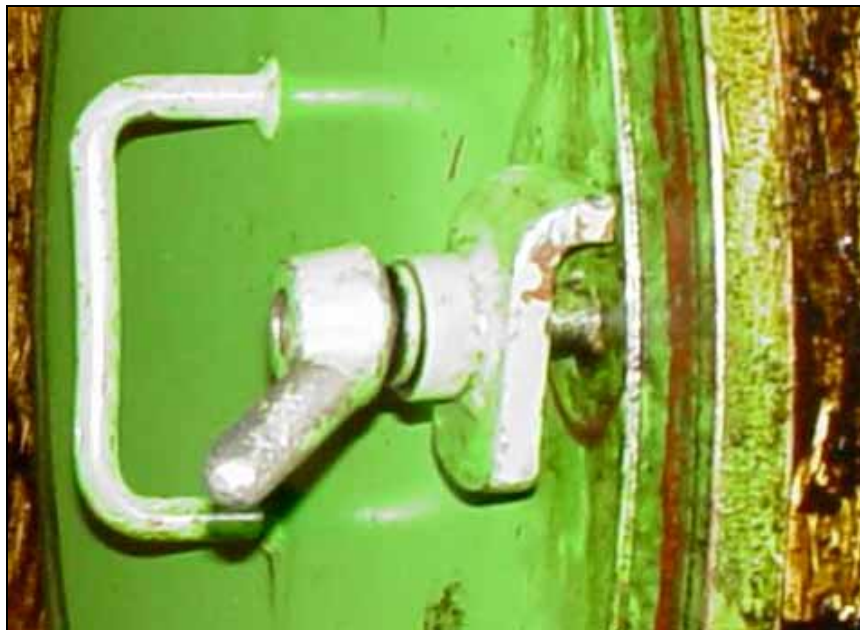
Figure 26: Bolt in open position (L-profile visible)

Each of these devices consists of a stud vertically welded onto the hatch cover and equipped with a thread. The stud is loosely capped with a bolt bent into an L-shape whose central mounting borehole (lock bearing) does not have an inner thread and which can therefore very easily be turned by more than 360° on the stud due to the existing clearance between borehole and stud.

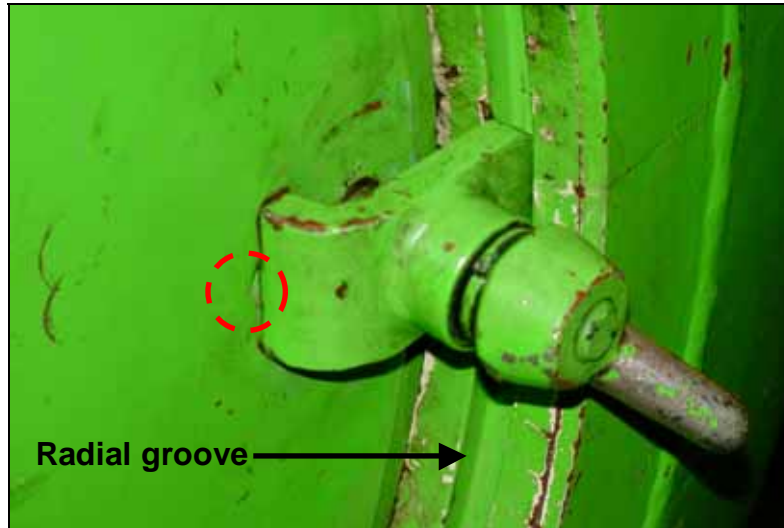
Figure 27: Bolt swung into the full locking position

For regular bolting, after the hatch cover has been drawn shut against its frame the bolts must be swung into a circular groove vertically worked into the frame. Then each

individual bolt must be latched in the locked position by means of a single toggle nut⁶⁶ that is screwed down on the stud. The correct position of the bolt is supported by a nub-like material reinforcement in the central area of the bolt's contact surface, which must be matched to a corresponding notch on the hatch cover.⁶⁷

⁶⁶ N.B.: On LONDON EXPRESS' sisterships that were inspected, regular, i.e. double-wing toggle nut was fitted instead of the single toggle nuts

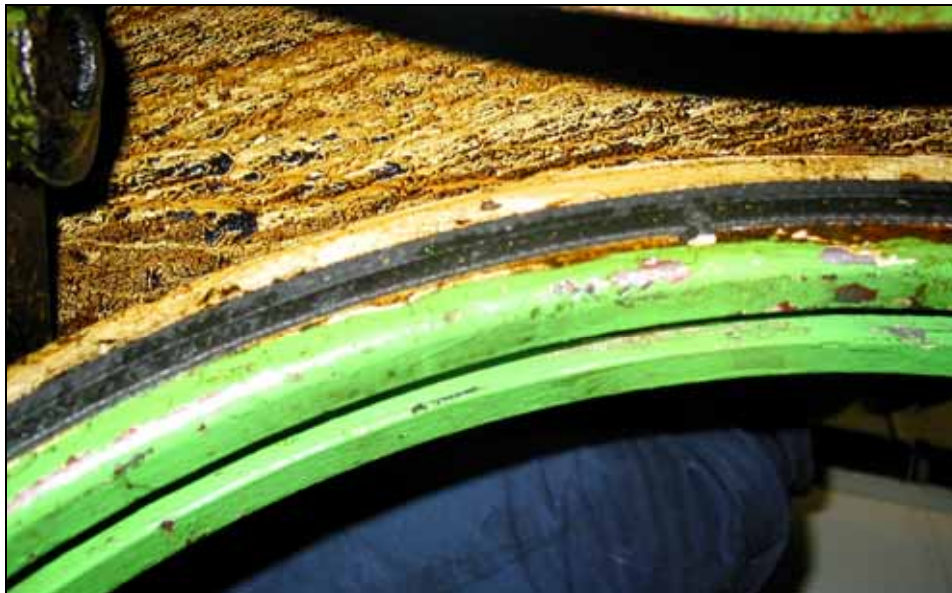
Figure 28: Gasket glued onto the hatch frame

Direct seating between the cover and the frame (“metal on metal”) is prevented by a gasket and glued into a flat groove in the frame⁶⁸. This gasket is compressed when the hatch is bolted down and ensures airtight closure.

⁶⁸ N.B.: In the course of the local inspections, different materials were found even on one and the same scavenge air receiver. The accident hatch had a (black) flat profile textile sealing tape with a very small material excess glued in (cf. Figure 28). The aft hatch had been fitted with an orange circular-section seal ring made of a rubber-like plastic.

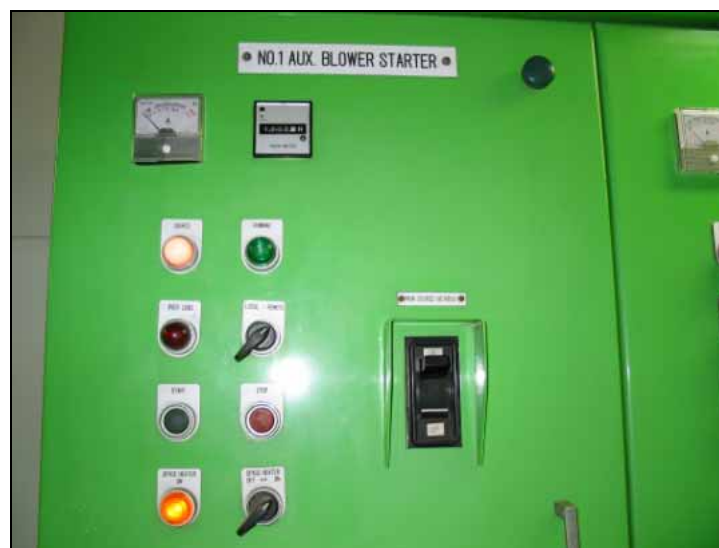
Figure 36: Main auxiliary fan panel – close-up view

(a) The electric auxiliary fans provide additional fresh air supply to the main engine during start-up and at low RPMs. The pertinent main switch panels for the three fans are on the scavenge air receiver level but are separated from the engine and the forward access hatch to the scavenge air receiver by a transversal bulkhead (Figures 35 and 36). It is possible to switch on the auxiliary fans from the bridge console (Figure 37). The switching station is selected by means of a selector switch on the main switching panel, where the “LOCAL” position enables switching on of the fans from the main panel and the “REMOTE” setting enables remote control from the bridge.

Experiments on board have shown that directly upon start-up of a fan an open scavenge air receiver hatch cover will slam with great force against the hatch frame as a result of the air current and overpressure building up in the scavenge air receiver. However, the fans are usually only switched on by the Master from the bridge in connection with the final preparations for departure just before engine start-up. When exactly they were started up on the day of the accident could not be established. Start-up could have begun between approximately 21:00 and 21:42, i.e. in any event at a time when the SOO had already been trapped in the scavenge air receiver. There appears to be no reasonable reason why and/or by whom, and in deviation from the standard procedure, on the day of the accident one or more fans should or would already have been started up several hours earlier.⁷¹ Thus the switching on of the fans can most certainly be ruled out as the cause for the slamming of the hatch cover that triggered the self-confinement process.

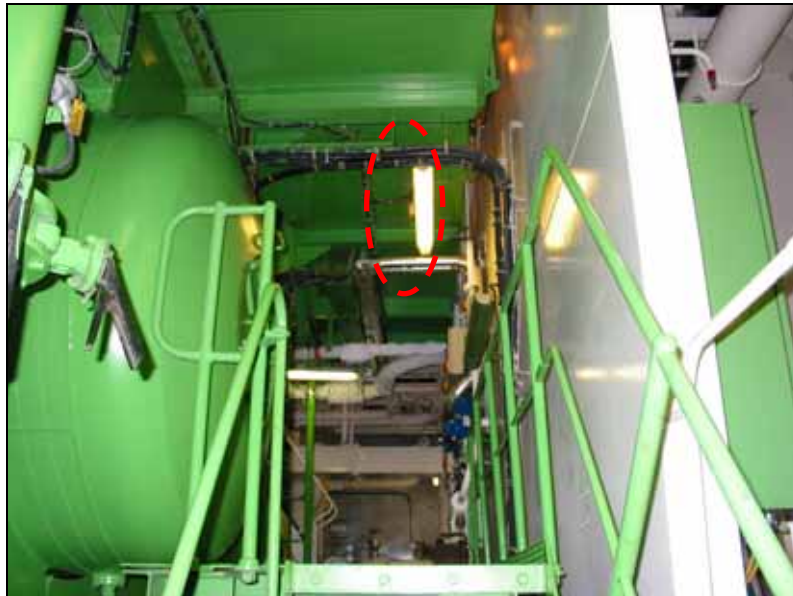
Figure 41: Lighting at the forward access hatch

The various different local inspections revealed that the engine rooms of LONDON EXPRESS and her sister ships are very well lit around the clock. The passageway in front of the two access hatches to the scavenge air receiver, which is delimited by a guardrail, is brightly lit by means of overhead fluorescent lamps (**Figures 41 and 42**).

The passageway is approx. 0.9 m wide in front of the forward access hatch and approx. 0.7 m wide in front of the aft access hatch. This fact clearly shows that irregular bolting of the hatch cover would compellingly be noticed under normal circumstances when using the pertinent passageway even without using a torch and without any specific concentration concerning (unsuspected) irregularities.

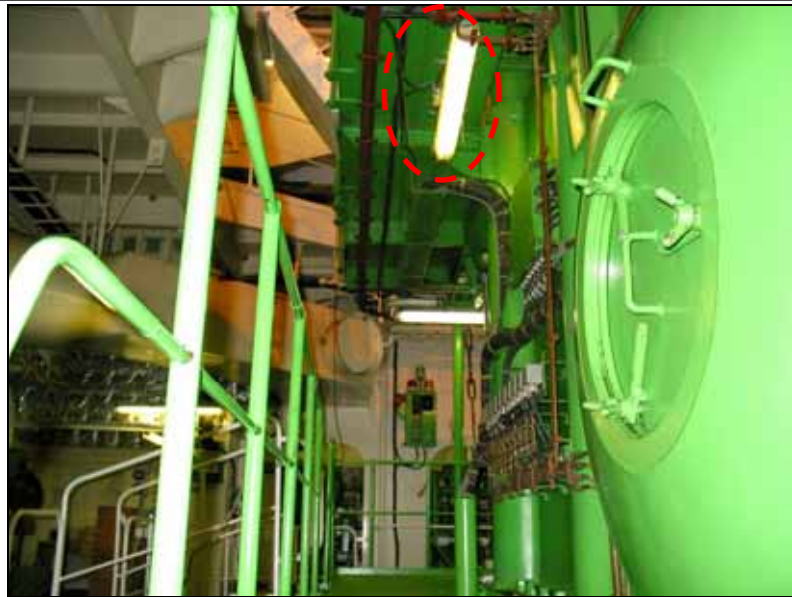
Figure 42: Lighting at the aft access hatch⁸³

⁸³ N.B.: This photograph was taken on 21 Nov 2006 in Savannah and shows the locking bolts as modified after the casualty. Cf. in this context Point 7.4 below.

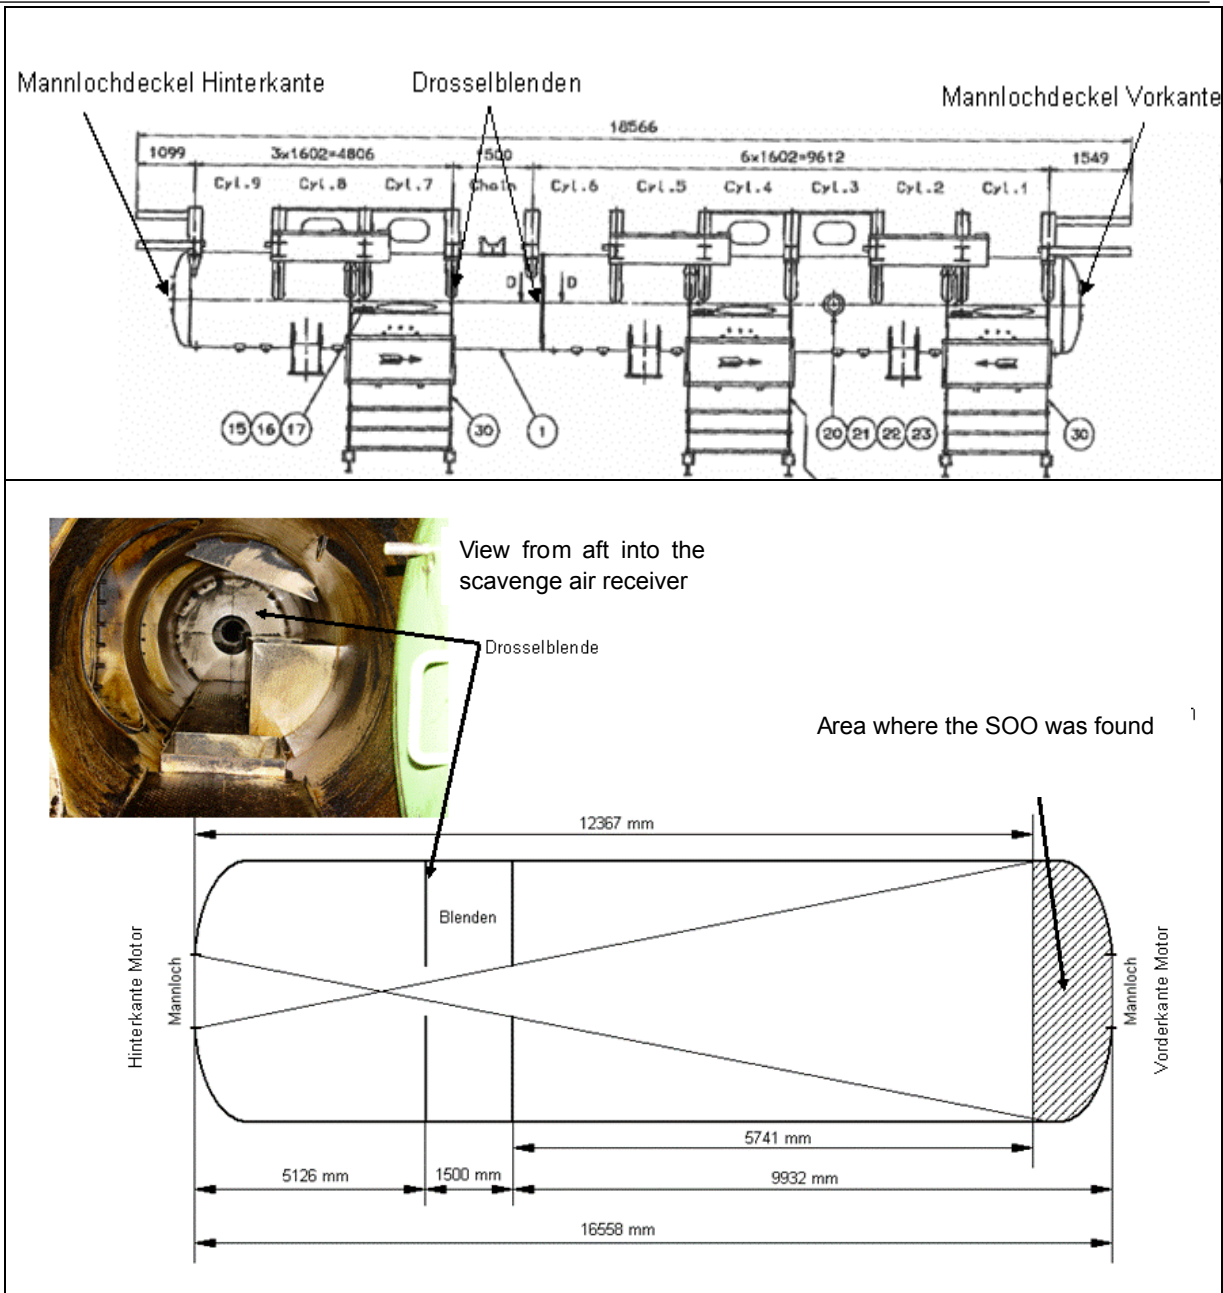
Figure 43: Schematic representation – Visibility in the scavenge air receiver⁸⁴

As **Figure 43** below will show that the visibility into the scavenge air receiver from the aft hatch is limited by its design, namely by the throttle, and this regardless of lighting conditions. It becomes obvious that the easily visible portion practically ends at the throttle before Cylinder 6, and that the area after the next throttle (Cylinders 6 to 1) appears as a “black hole”.

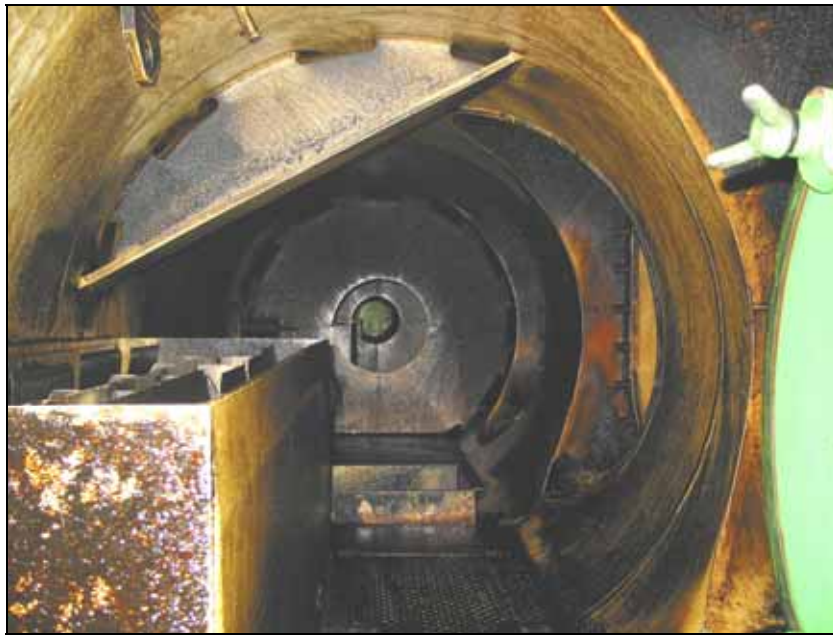
Figure 44: View from the forward end into the scavenge air receiver, with aft hatch open

Figure 44 shows the view through the scavenge air receiver with both access hatches open, from the forward end and with a person standing outside the aft hatch. The entering light enables the opposite open hatch to be recognised as a brightened area.

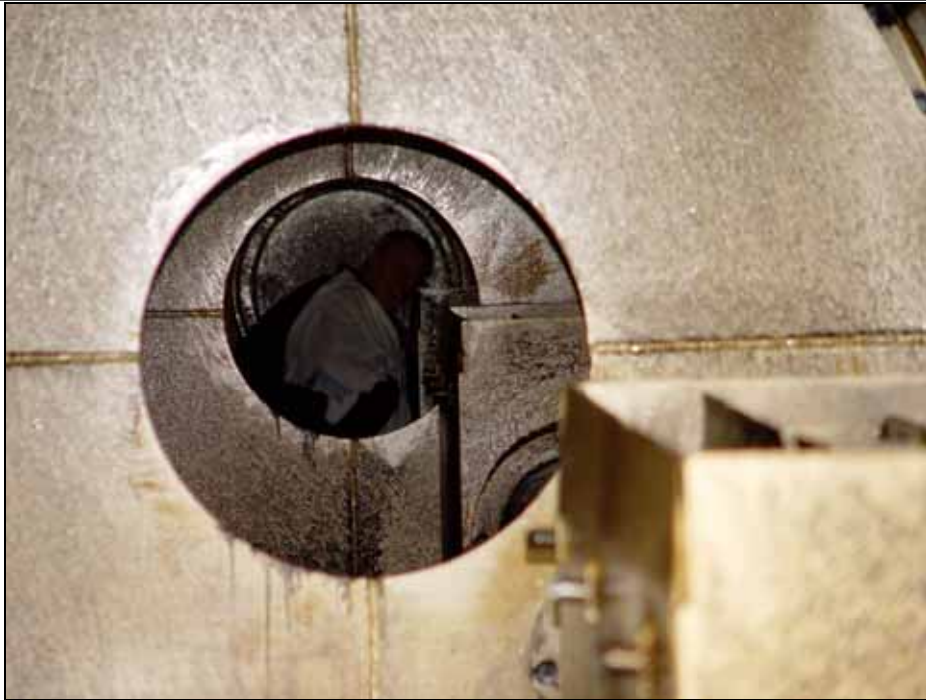
Figure 47: Person with a light coloured cloth at the forward hatch

Experiments in which, with the forward hatch closed, the scavenge air receiver was lit from aft with the standard type of torch found on board showed that the contours of a person dressed in light coloured clothing and positioned in the area of the forward hatch can be discerned with difficulty when concentrating (**Figure 47**).

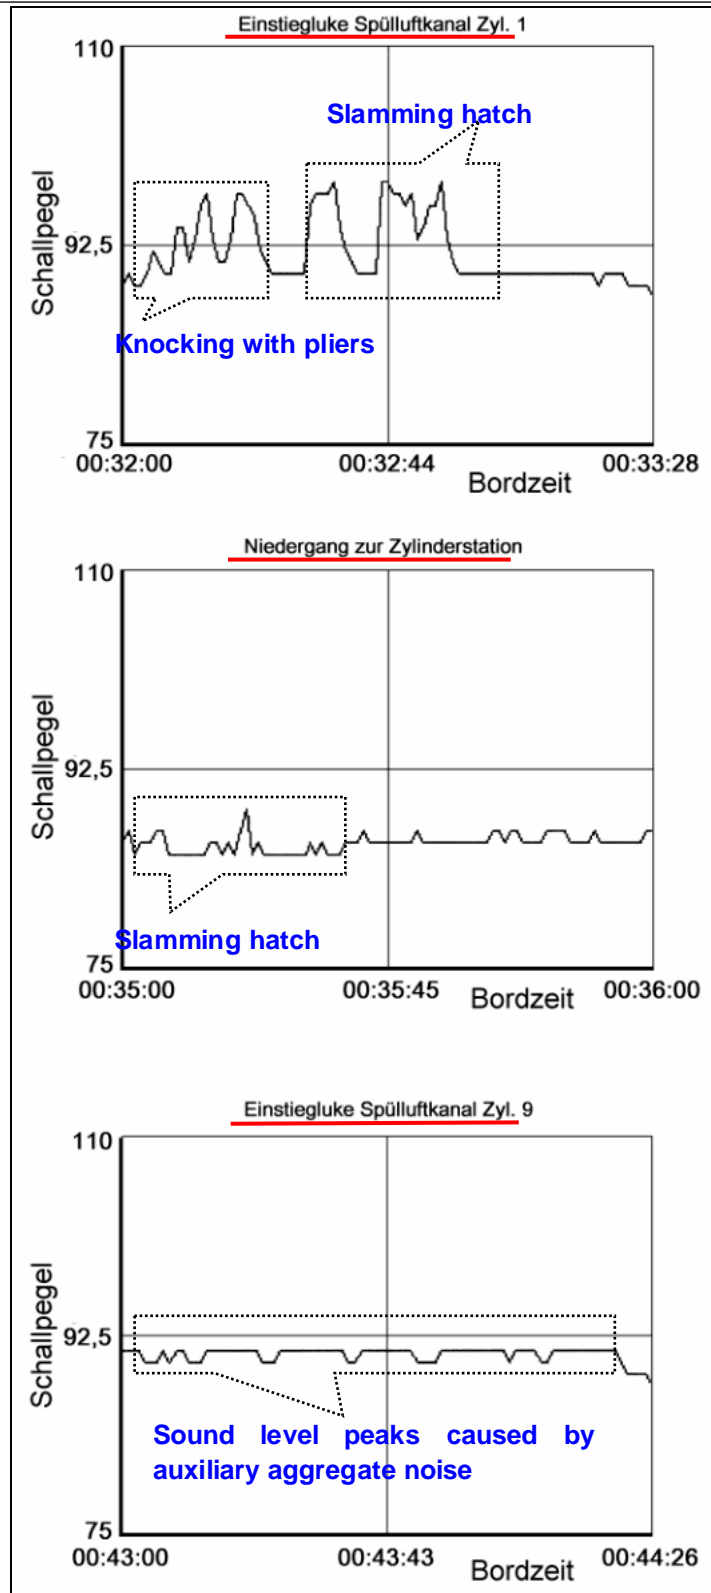
Figure 48: Graph – Audibility of knocking noises⁸⁵

approx. 17 m at the access hatch to the scavenge air receiver at the Cylinder 9 from the other end of the engine, nor could they be recorded for measurement.

The above described special construction of the scavenge air receiver has a sound absorbing effect. In combination with the regular sound background in the engine room, which is significant even at harbour, this means that voice exchanges between the two ends of the receiver are practically impossible. In addition, potential calls directed to the interior of the receiver from the aft hatch within the scope of the search could perhaps potentially be heard at the forward hatch, but as a result of an already developing weakness the SOO might no longer have had the strength to react audibly.

18. The measurements of the propagation of knocking sounds from the interior of the scavenge air receiver revealed that the difference in sound levels generated by such knocking are too small against the general noise background in the engine room. It must be assumed that the people who searched in the engine room and were wearing hearing protection in accordance with occupational safety regulations did not hear any knocking sounds, which in any event could only have been made with a torch, which was not a particularly suitable tool for this purpose.

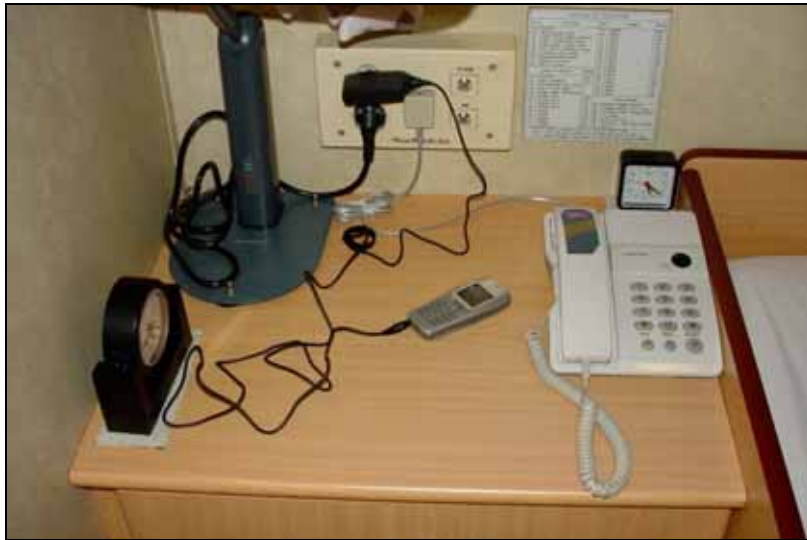
Figure 51: The SOO's mobile phone

14. What is understandable is the follow-up search claimed by both the Master and the Chief Mate that took place on board the ship on the following day. Owing to the lack of positive news from Savannah, in the course of the morning of 25 October the SOO's room was again checked, this time by both witnesses together. It is however difficult to imagine that the SOO's mobile phone, left lying open and switched on on the bedside table, should have been noticed only at this point (cf. **Figure 51**). The US landing permit and other papers were allegedly discovered only now in a drawer (cf. **Figure 52**). From the point of view of the Chief Mate, a search of lockers, drawers etc. the first time that the SOO's room was entered was inappropriate and would have constituted insubordination without the presence of the Master, which is understandable as concerns the period of time in which the first enquiries took place. What is significant is in any event the fact that the second viewing of the SOO's room and the observations made in this context were not mentioned either in the Statement of Facts of 6 November 2003 or in the search report of 21 January 2004. The relevant paragraph from the Statement of Facts of 26 October 2003⁹² prepared for the shipping company – just like the passage concerning the agreement between the Master and the Agent to the effect that “*the search would be carried out on the pilotage waters*” – is no longer contained in the otherwise identical Statement of Facts of 6 November 2003. The only plausible explanation for this change is that it was not desirable that it should become explicitly clear to the Federal Bureau that ship command could possibly have been faced with ever cleared indications on the voyage to Norfolk that the SOO could have been on board all along.

15. Despite the lack of positive information from Savannah and the evidence found in the SOO's room (papers, wallet, watch, mobile phone), which – even if not compellingly so – argued against the hypothesis that he might have gone ashore, ship command undertook no measures in order methodically to search the entire ship again or to interrogate the crew.
16. It could not be determined whether the Chief Mate and/or the Master had obtained information concerning the irregularities at the forward scavenge air receiver hatch. The Chief Mate also had a technical certificate of competency and according to his own statement had personally once more searched the engine room on 25 October 2003. If in doing so he should have passed by the forward hatch to the scavenge air receiver it is unlikely that he would not have noticed the leakage and the jammed object. However, he emphasised that he had no

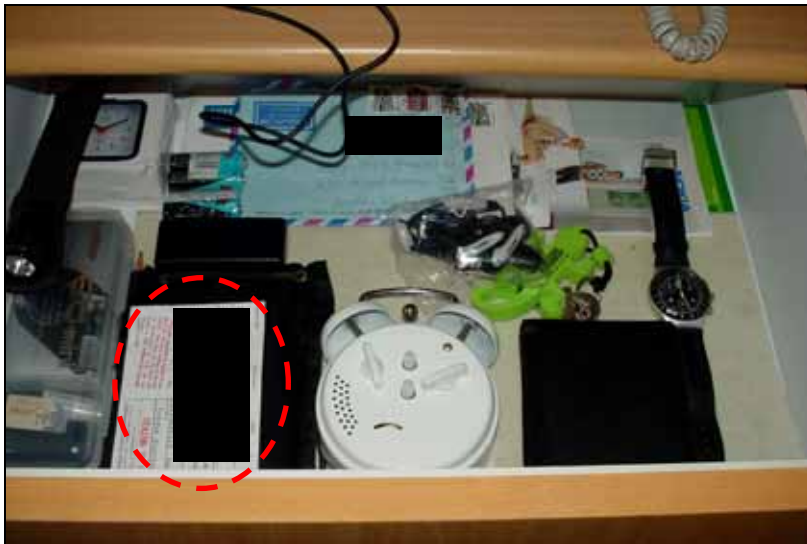
Figure 52: US landing permit

⁹² Content of the text passage: “*In the morning of the following day, Oct. 25, the cabin of Mr. XX was investigated again by Master and Chief Officer. It was found out, that his US Crewmember Landing permit and other personal documents were in his cabin. Furthermore, a private cell phone was switched on*”.

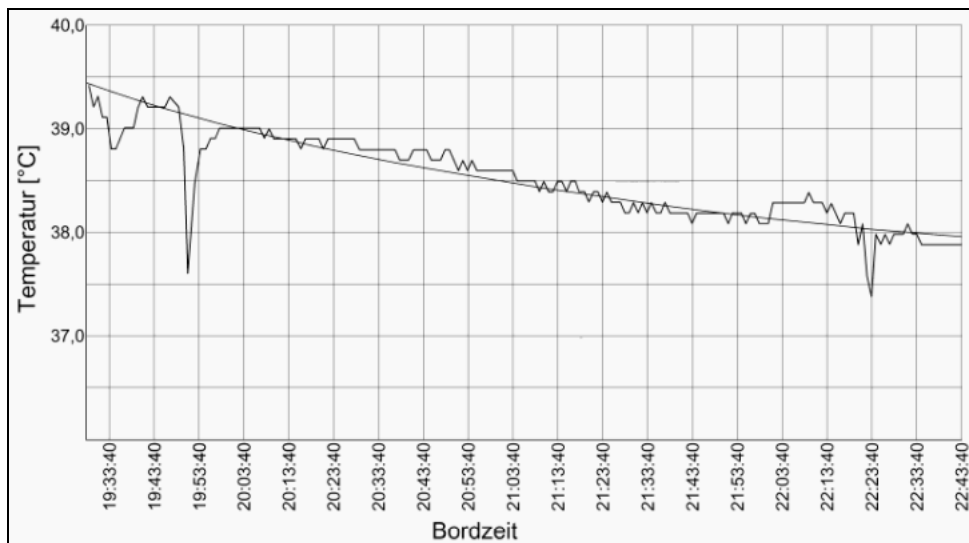
Figure 53: Temperature profile over time in the closed scavenge air receiver

The investigation concluded that contrary to the original presumptions the temperature in the closed scavenge air receiver with the non-operating man engine does not rise significantly, but rather falls very slowly but constantly (cf. **Figure 53**). “Ventilation” of the scavenge air receiver by means of opening both hatches also had no significant influence on the air temperature inside the receiver even after an extended period of time. The calculated mean temperature in the closed scavenge air receiver was 36.6 °C after the engine had been off for six hours. The calculated result was confirmed by the only slightly deviating measured value of 37.7 °C (engine room temperature = 23 °C on 22 November 2006). With an engine room temperature higher by 10 K under assumption of the simulation calculations on the day of the accident the resulting maximum temperature inside the scavenge air receiver was of 41 °C (cf. **Figure 54**). The relative humidity in the receiver is of approx. 25 %.

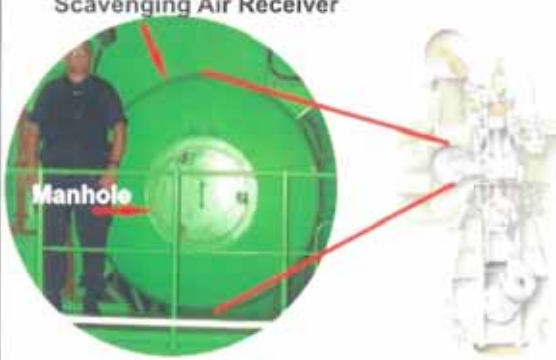
Scavenging Air Receiver

The vessel was powered by a Burmeister & Wain, 9 cylinder two stroke engine that develops over fifty-five thousand horsepower. The engine's scavenging air space can be accessed by two manholes located on both ends of the scavenging air receiver.

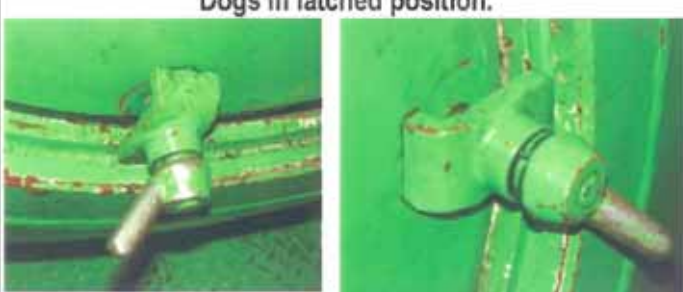
These circular manholes are secured by three L-shaped dogs having an outer edge that is tightened against an inner circumferential lip on the edge of the access hole. Tightening is achieved by the use a handled fastener.

Dogs in latched position.

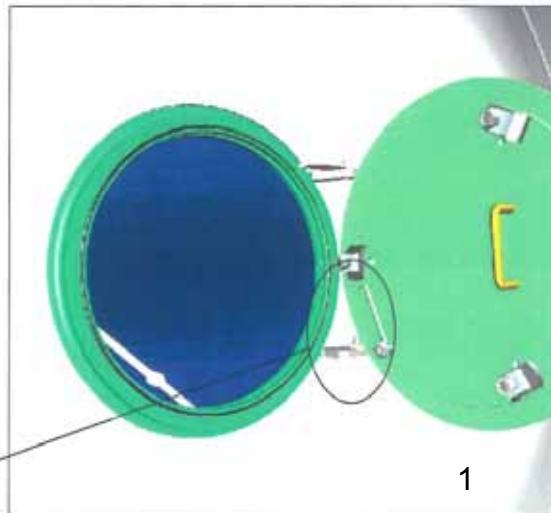
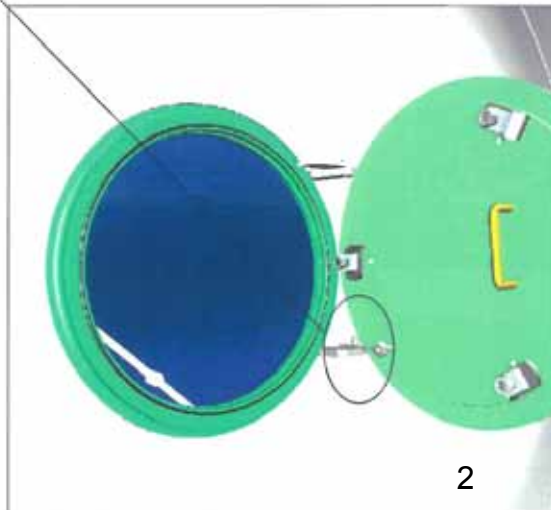
Locking device for scavenge air receiver door (seen from the inside)

Safety snap
preventing accidental
slamming of the door
