Investigation Report 101/06

Very serious marine casualty

Fatal accident on board the
MFV JAN MARIA
on 13 March 2006
approx. 150 nm west of Ireland

1 September 2008

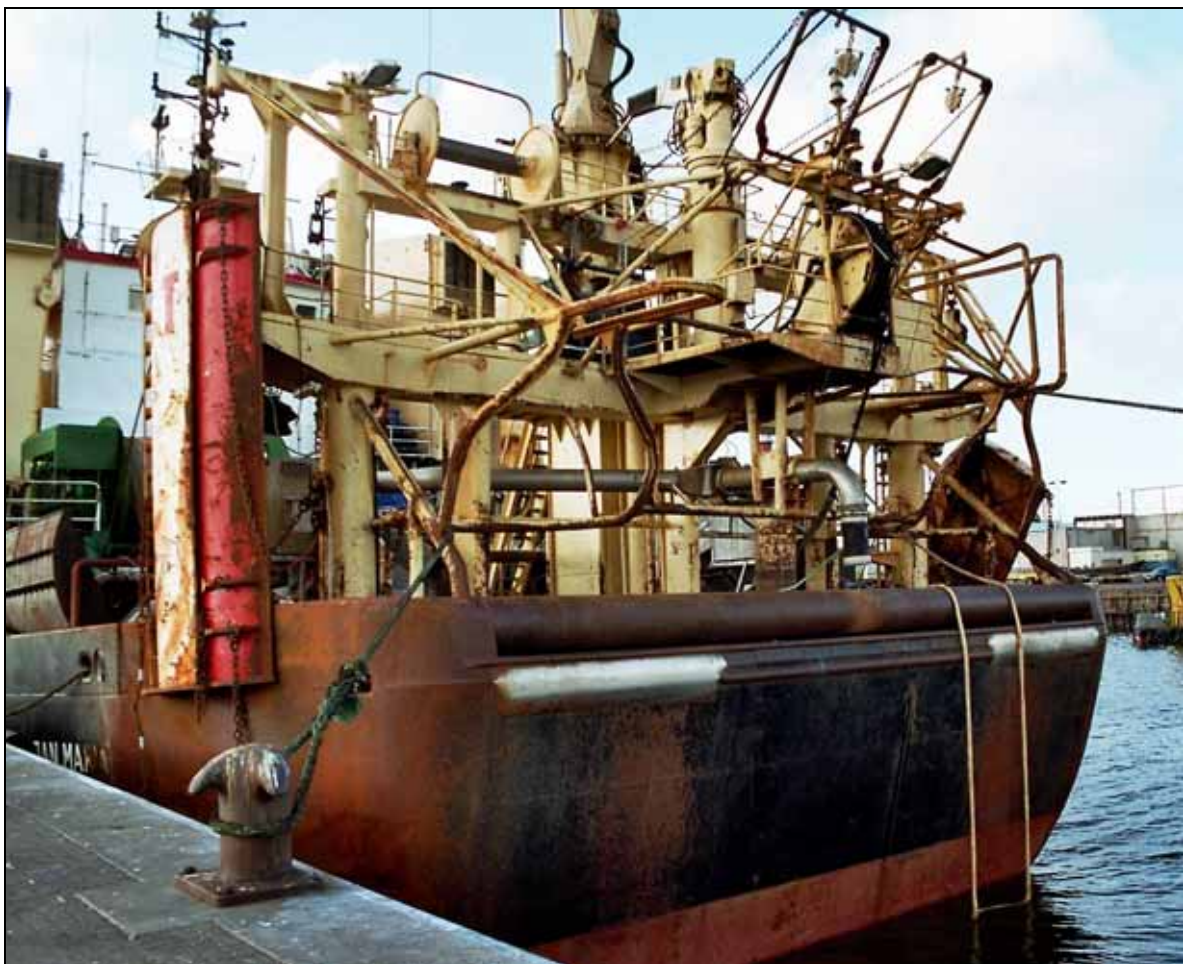
Figure 3: Atypical trawler stern of the JAN MARIA

The JAN MARIA was built in 1988 at the Schichau Seebeckwerft in Bremerhaven and specially designed as stern trawler for catching herring and mackerel in the Atlantic and the North Sea. The ship is equipped with processing and cooling plant enabling it completely to process the catch within four hours and to store it at $-28\text{ }^{\circ}\text{C}$. In order to protect pressure sensitive fish types from excessive mechanical stress when drawing in the net, the JAN MARIA, as opposed to conventional stern trawlers, does not have a stern ramp slanted towards the surface of the water. Instead, depending on its sensitivity, the catch is hauled onto the working deck in divided net units called “purses ” or aspirated by means of a fish pump and then conveyed into the processing room (Figs. 3 and 4).

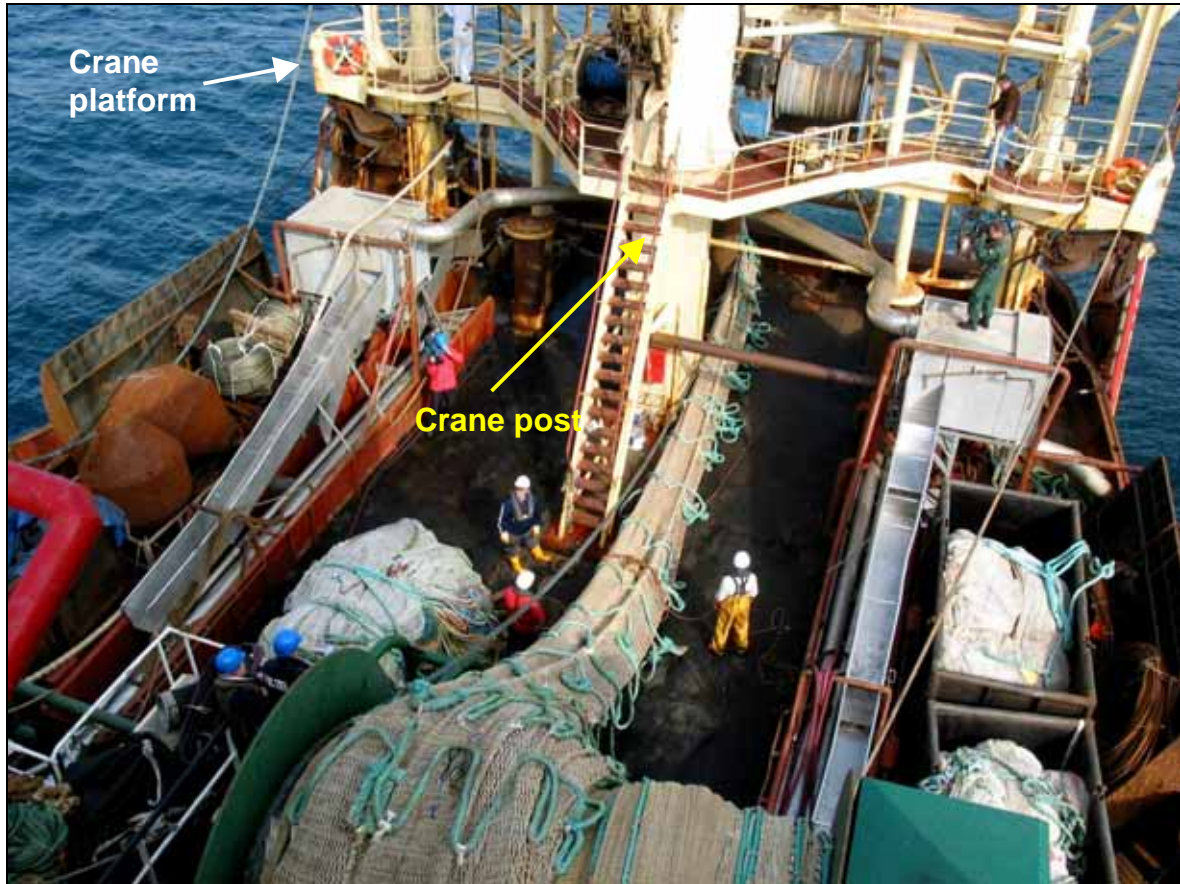
Figure 5: View onto the fishing deck during the net setting process⁷

Midships and directly before the vessel's after edge, is the vertical guide roller involved in the accident; its diameter is 0.6 m (Figs. 7 and 8). The distance between the aft bulwark and the guide roller is also 0.6 m. Figures 5, 6 and 10 make clear the fact that the dimensions of the crane column create a relatively large blind spot, so that the area immediately around the guide roller cannot be seen from either the winch operating control position on the bridge or from the platform companionway.

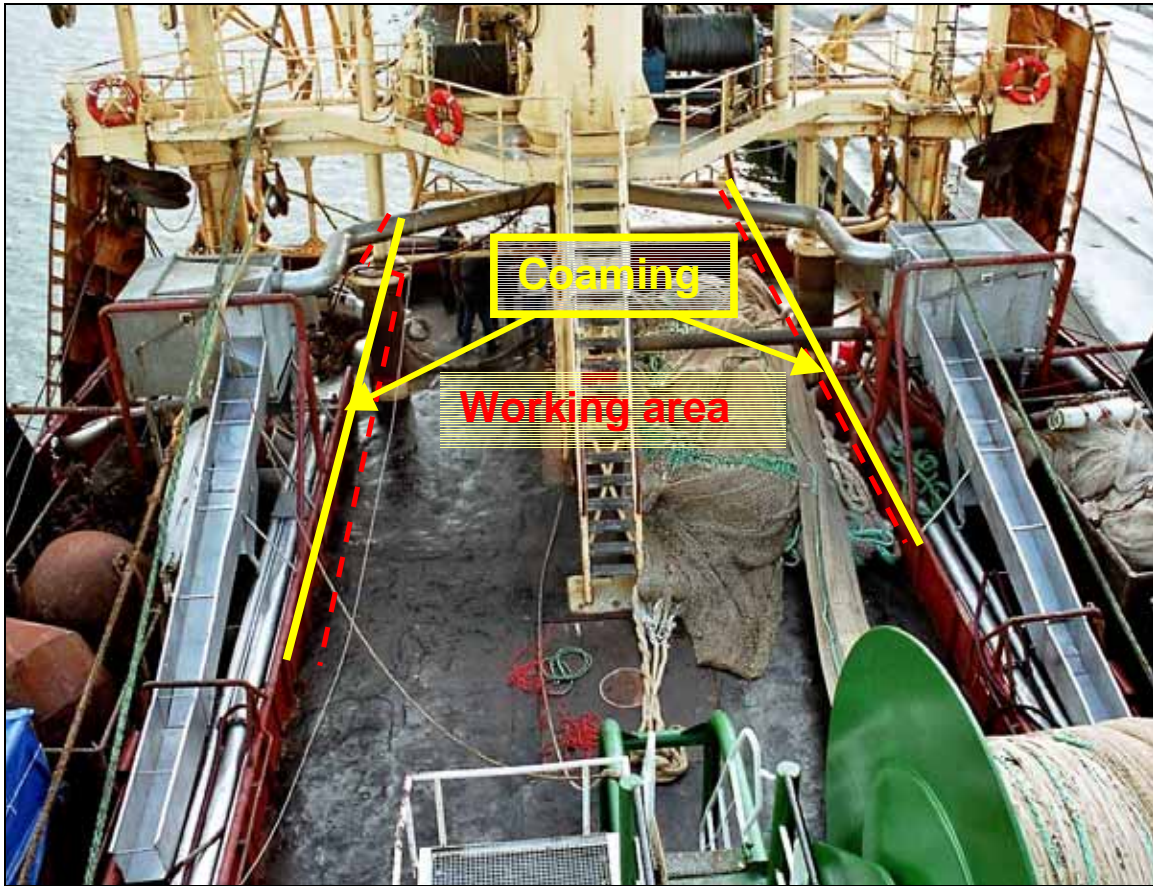
Figure 10: Working area on the fishing deck

The regular crew working area on the fishing deck for net and line handling is limited to starboard and port by an approx. 1 m high coaming leading from the “winch shelf” to the aft bulwark (Fig. 9 and 10). The width of the working area is 6.70 m aft, 7.80 m at the platform companionway and approx. 8.20 m in the area of the companionway leading to the superstructure.

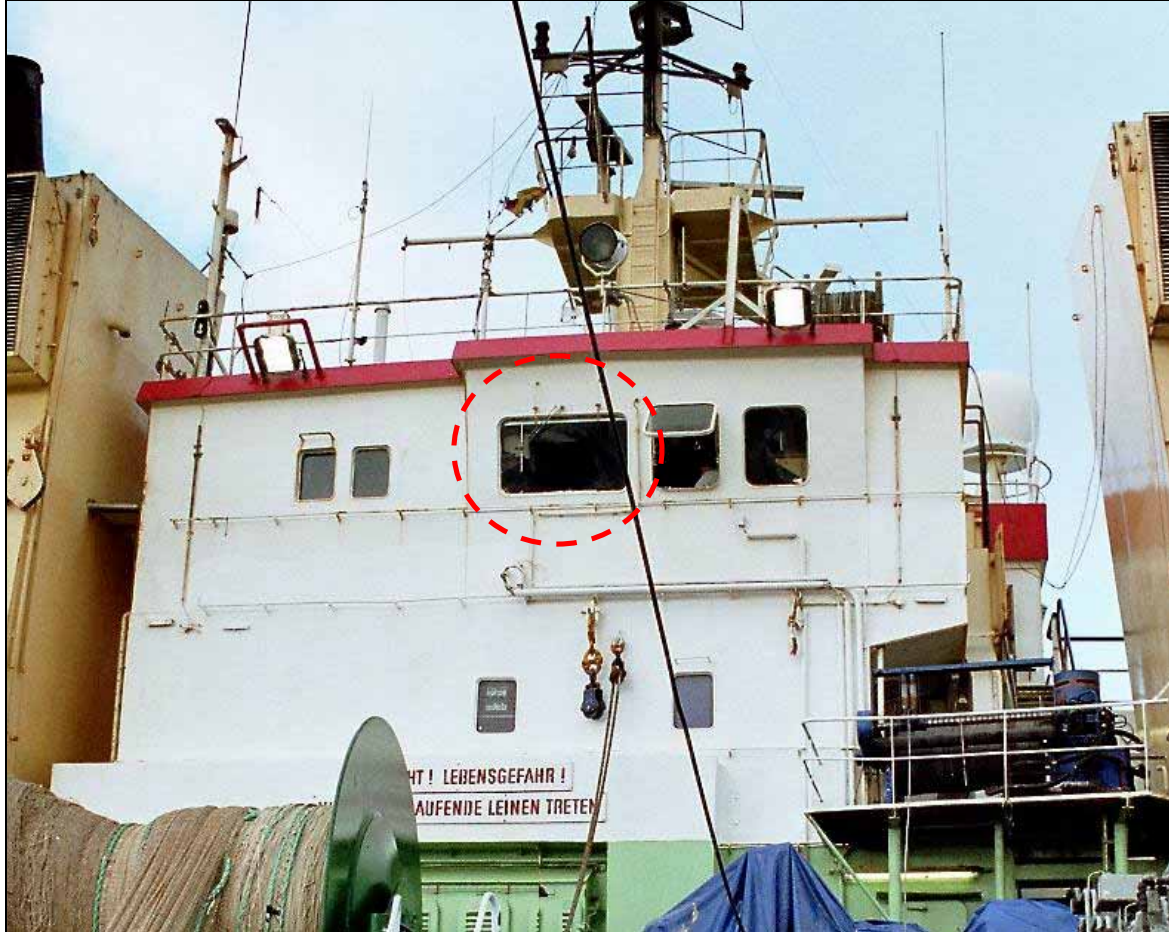
Figure 14: Bridge windows for the winch operation control position

The control position for the operation of all winches required for setting and drawing in the net gear is located amidships in the aft part of the bridge house (Figs. 9, 13, 14 and 15).
