Investigation report 215/07

Very Serious Marine Casualty

**Death of two crew members
due to crash of the lifeboat
of the MV FOREST-1
during a lifeboat drill in Emden on
16 May 2007**

16 June 2008

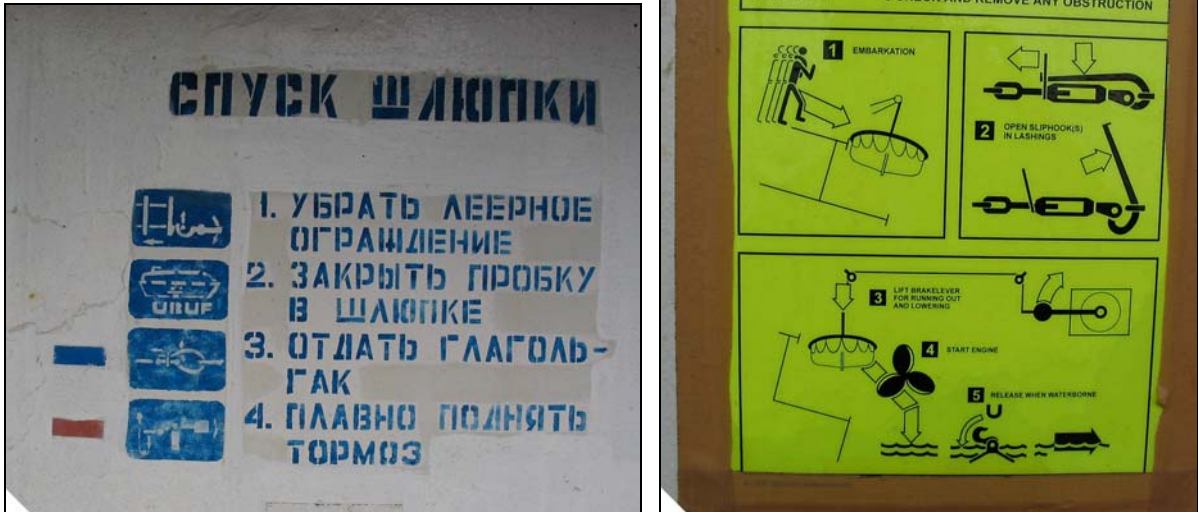
Figure 3: Description of the launching procedure in Russian and English, posted on the boat deck

Short descriptions in Russian and English, drawings and pictograms concerning the operation of the lashings, the davit system and the winch were posted on the sides of the superstructure in the boat deck area (Fig. 3).

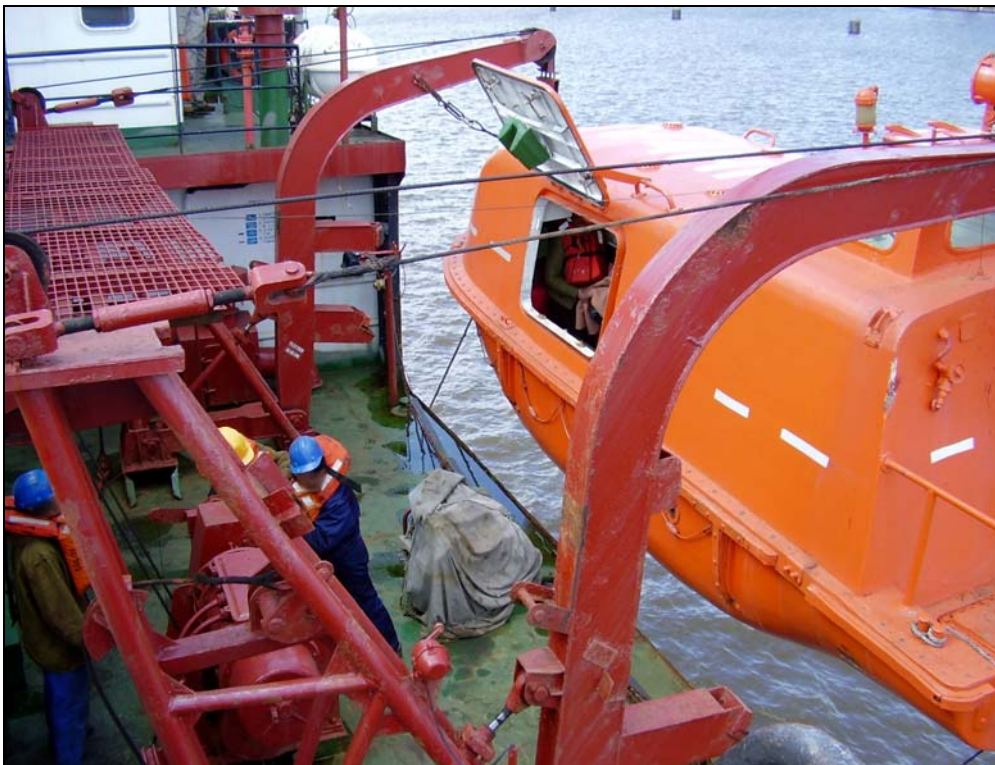
Figure 6: Combined life and rescue boat of the FOREST-1

The starboard lifeboat was a product of the Severnav S.A. company, i.e. of the yard that had built the vessel. It had been built as an enclosed, combined life and rescue boat and according to the classification certificate of the Romanian Register of Shipping had the following specifications:

- Classification number: 40/1864
- Yard number: 4182
- Year built: 1993
- Length: 7.15 m
- Breadth: 2.70 m
- Weight (incl. motor, equipment and crew): 4,260 kg
- Number of occupants: 32 as a lifeboat, 6 as a rescue boat
- Engine output: 28 hp
- Material: Glass-fibre reinforced plastic

The BSU assumes that the weight of 4,260 kg mentioned in the inspection certificate of the Romanian Shipping Register is not correct. The certificate states the weight to include the engine, equipment and passengers. At a standard weight of 75 kg per person the total weight for 32 people would be 2,400 kg. The boat including its motor and all equipment would therefore only weigh 1,860 kg. This is an unrealistic value. For this reason, for all further considerations it was assumed that 4,260 kg was the weight of the fully equipped boat. The fully manned boat would therefore weigh 6,660 kg. From that it could be concluded that the hook test carried out according to the abovementioned classification certificate with a weight of 6,650 kg would refer to one hook and would have been carried out at 2 x SWL³.

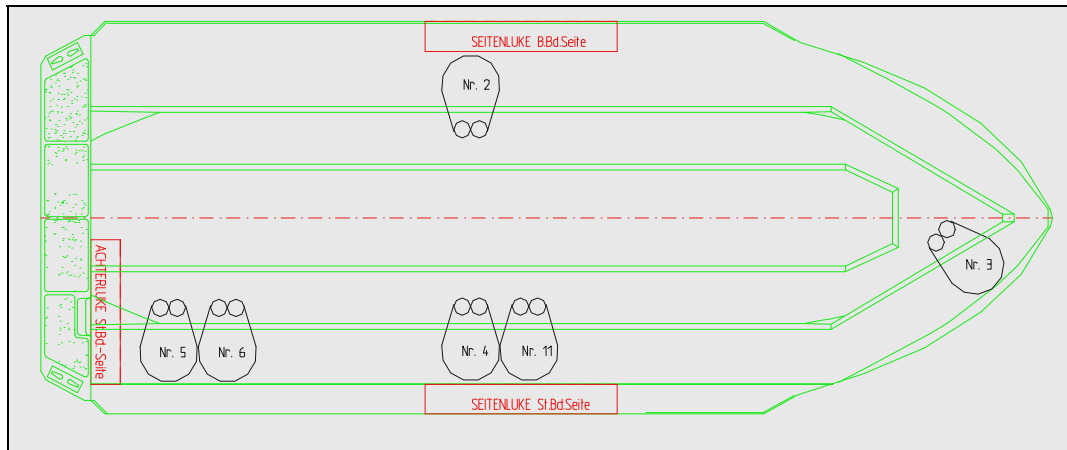
Figure 8: Seating locations in the lifeboat

At the time of the accident six people were in the lifeboat (Figure 8). The numbers in Figure 8 refer to the position in the crew list:

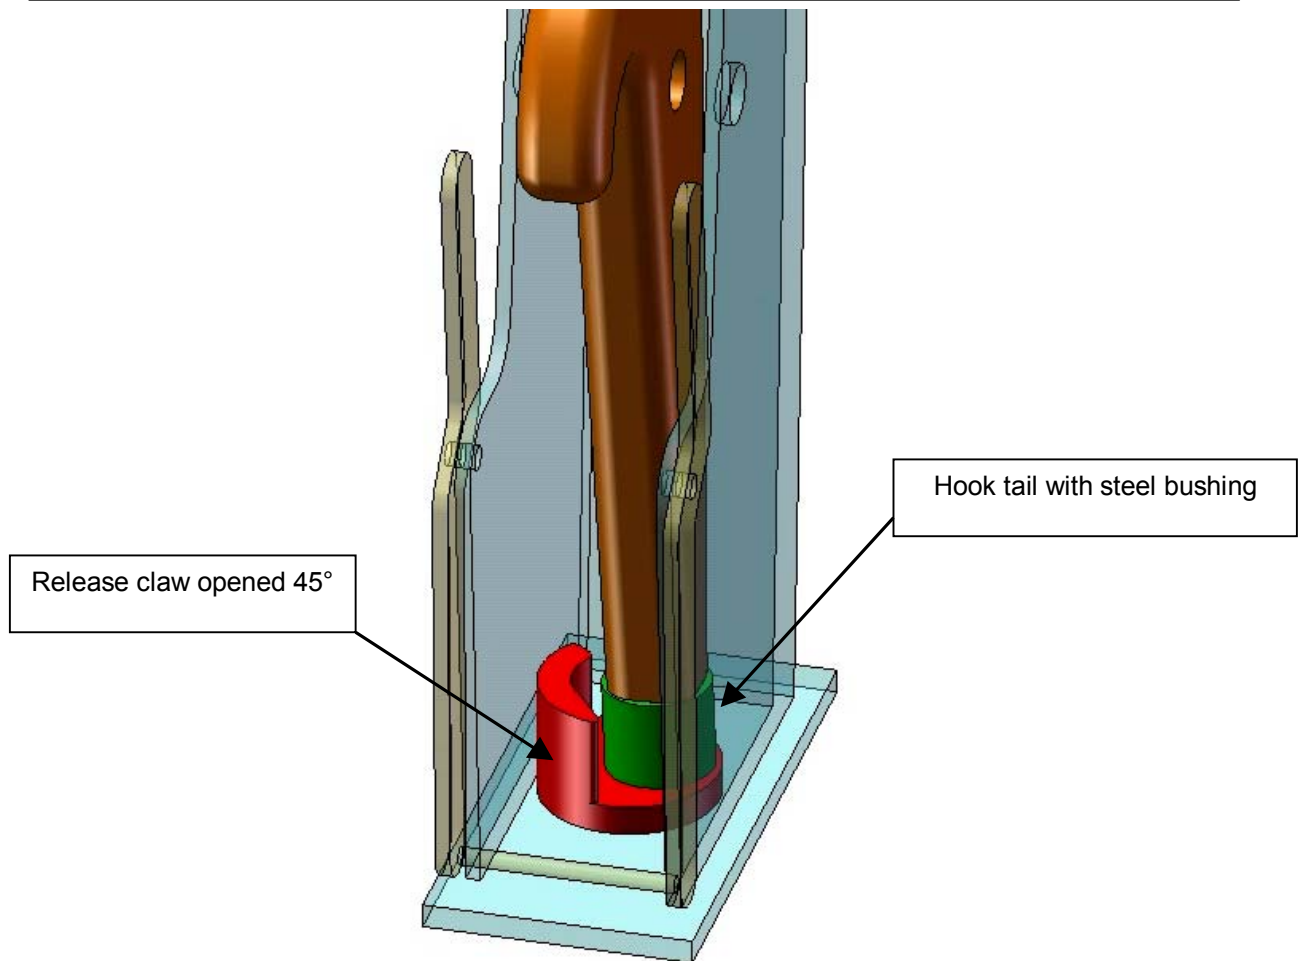
Figure 13: Interlock mechanics of the releasing hook

The hook was designed, built and positioned between the plates in a manner such that when not under load (pull on the hook) its opening pointed downwards. Under tensile load via a suspension ring hooked into the device, the hook would have turned around the bearing shaft. The opening would then have pointed upwards and the hook would have released the suspension ring. In order to control this rotation and therefore the opening of the hook, in the secured position the tail of the hook abutted a rotatable socket. The socket, described as a release claw, was open at an angle of approximately 180° and connected with the release lever via the release rod below. Turning the release lever simultaneously also turned the release claw and released the hook (Figure 13).

Originally, a rotatable steel bushing was set on the end of the hook tail and secured with a snap ring. This bushing was supposed to reduce the mechanical wear on the release claw during release.

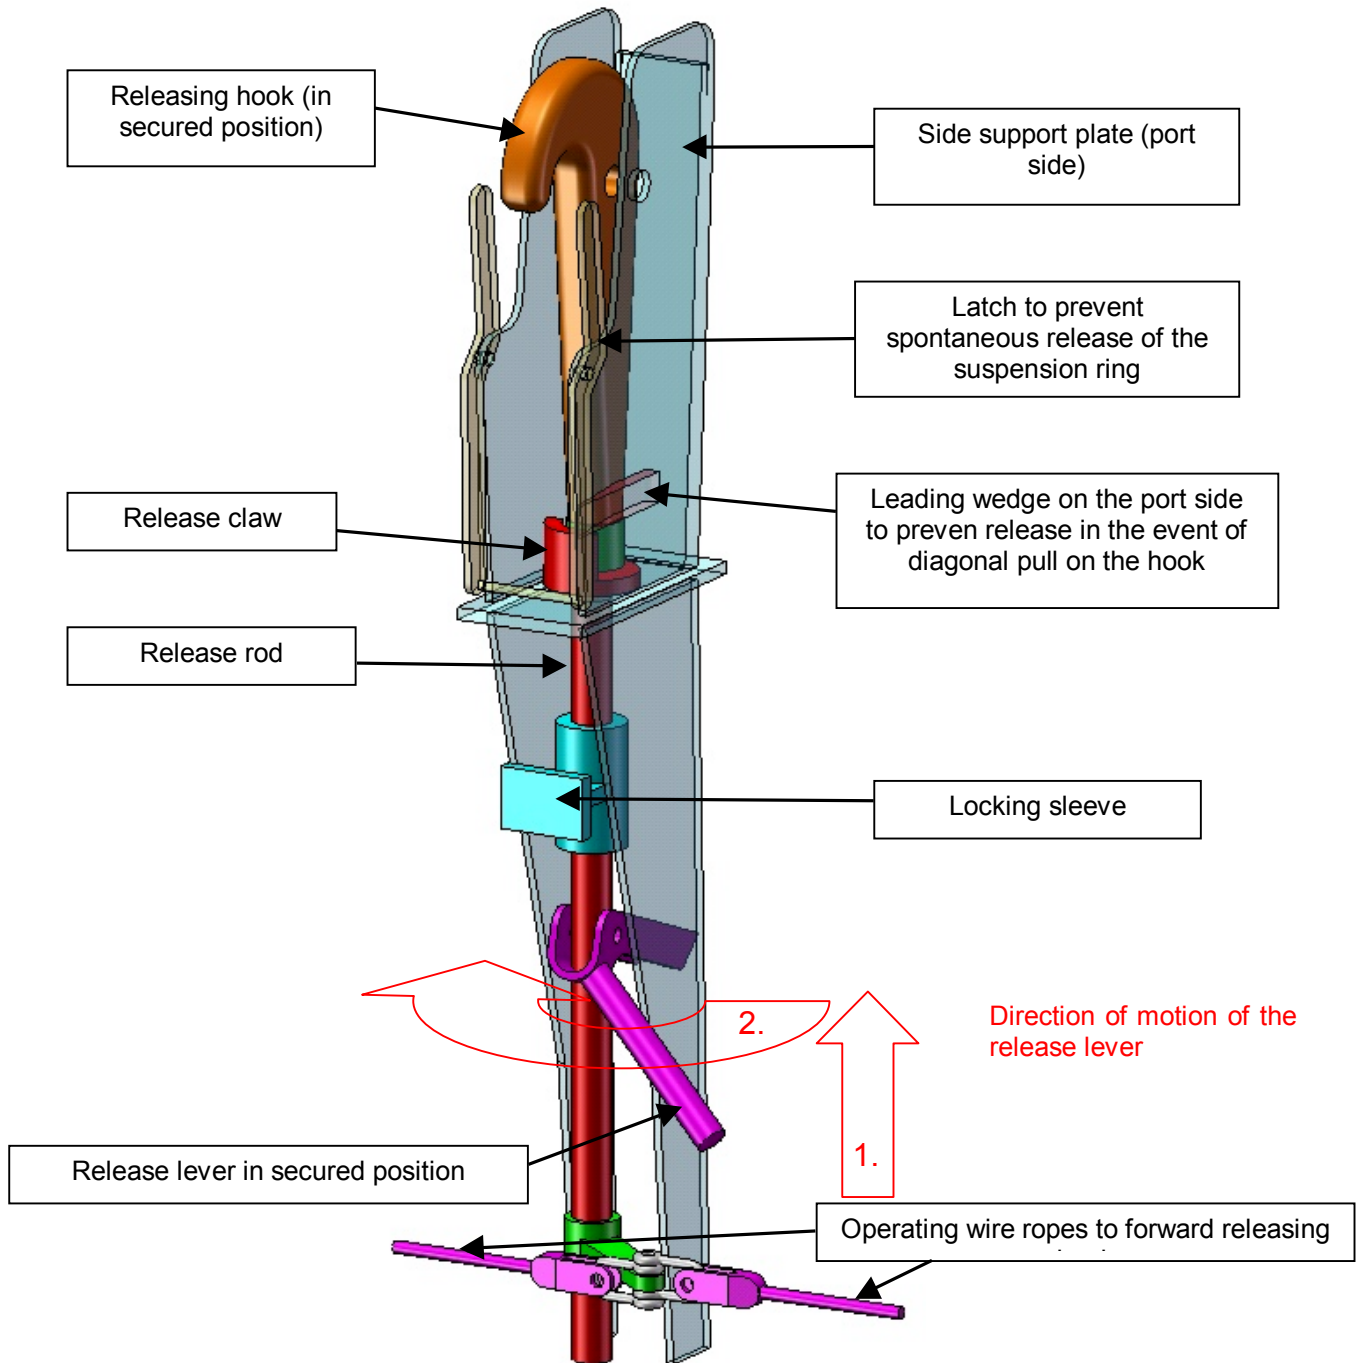
Figure 14: Aft releasing hook with release lever and wire rope linkage

Release was effected by means of a horizontal rotational motion of the release lever to starboard (Figures 14, 16 and 18). This movement was theoretically supposed to be possible only when a locking sleeve that was also mounted on the release rod had been manually lifted (Figures 14 and 17). This locking sleeve therefore also fulfilled the function of a second safeguard against unintended release. In the tests conducted on board the lifeboat of the FOREST-1 the safeguard could be overcome with a normal effort, and without lifting, as a result of wear on the locking sleeve.

onto this arm. The motion of the aft releasing hook rod assembly was in this way transferred to the forward releasing hook (Figure 14).

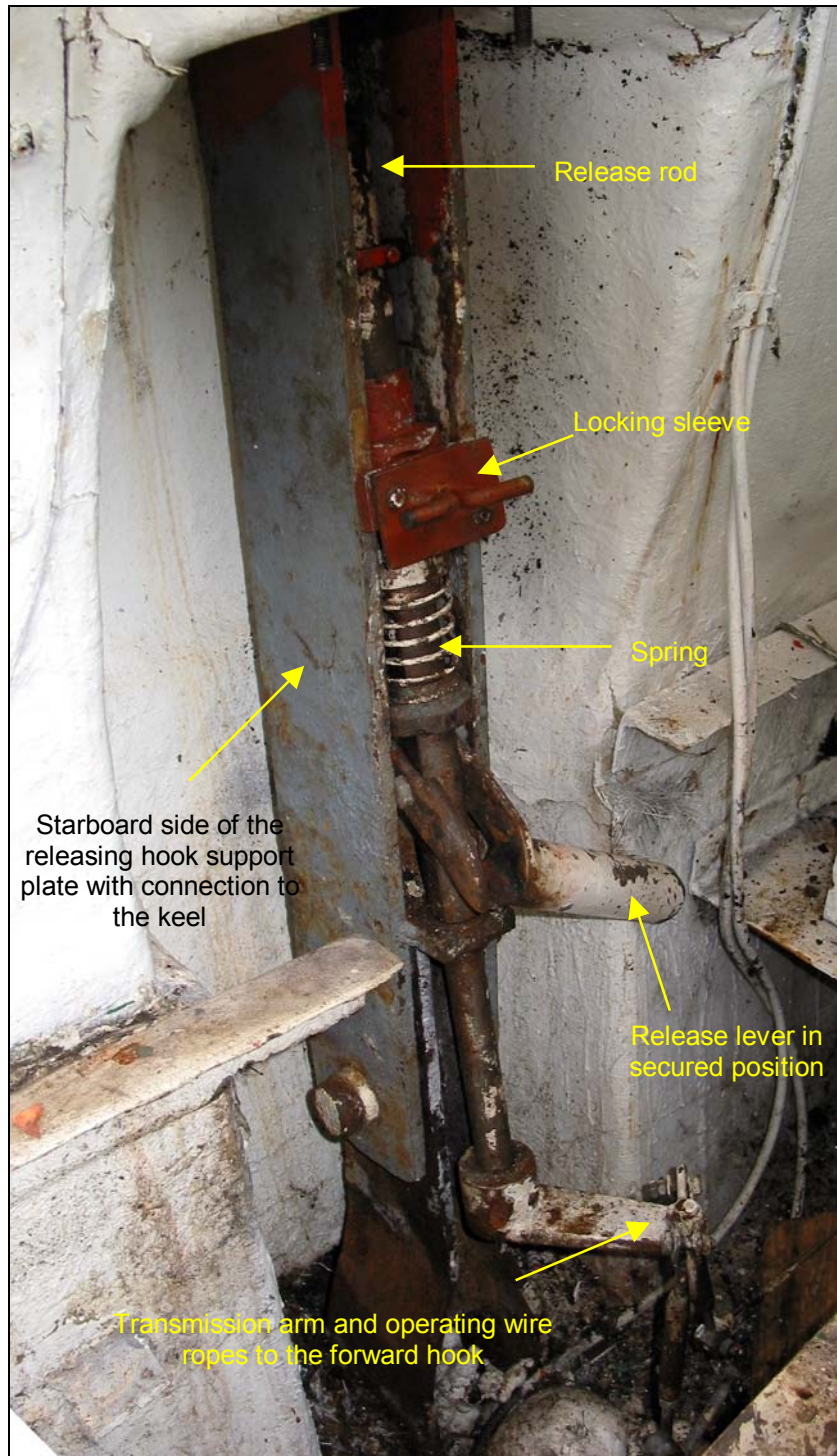
Figure 15: Aft release unit, release lever in secured position, pointing to port

At the beginning it was necessary to raise the release lever from a downward pointing position into a horizontal position. This movement was carried out against the resistance of a spiral spring set onto the release rod and thus representing a kind of safeguard (Figures 15 and 16).

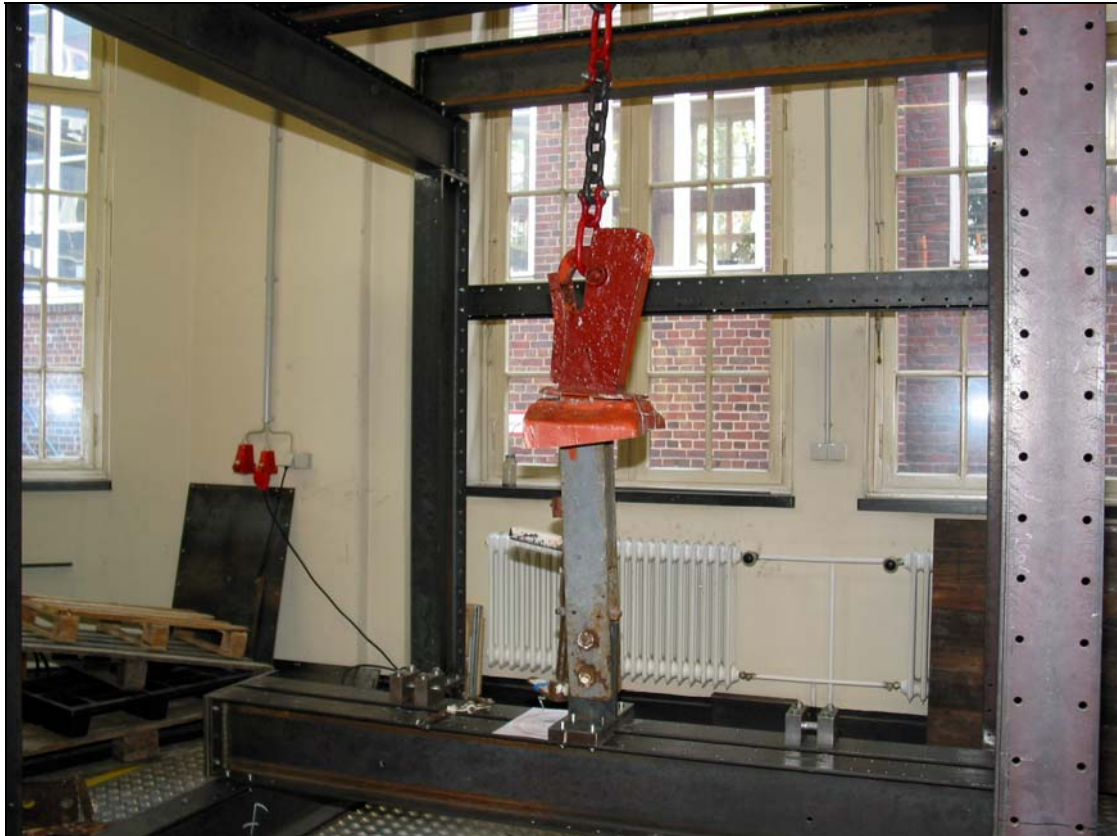
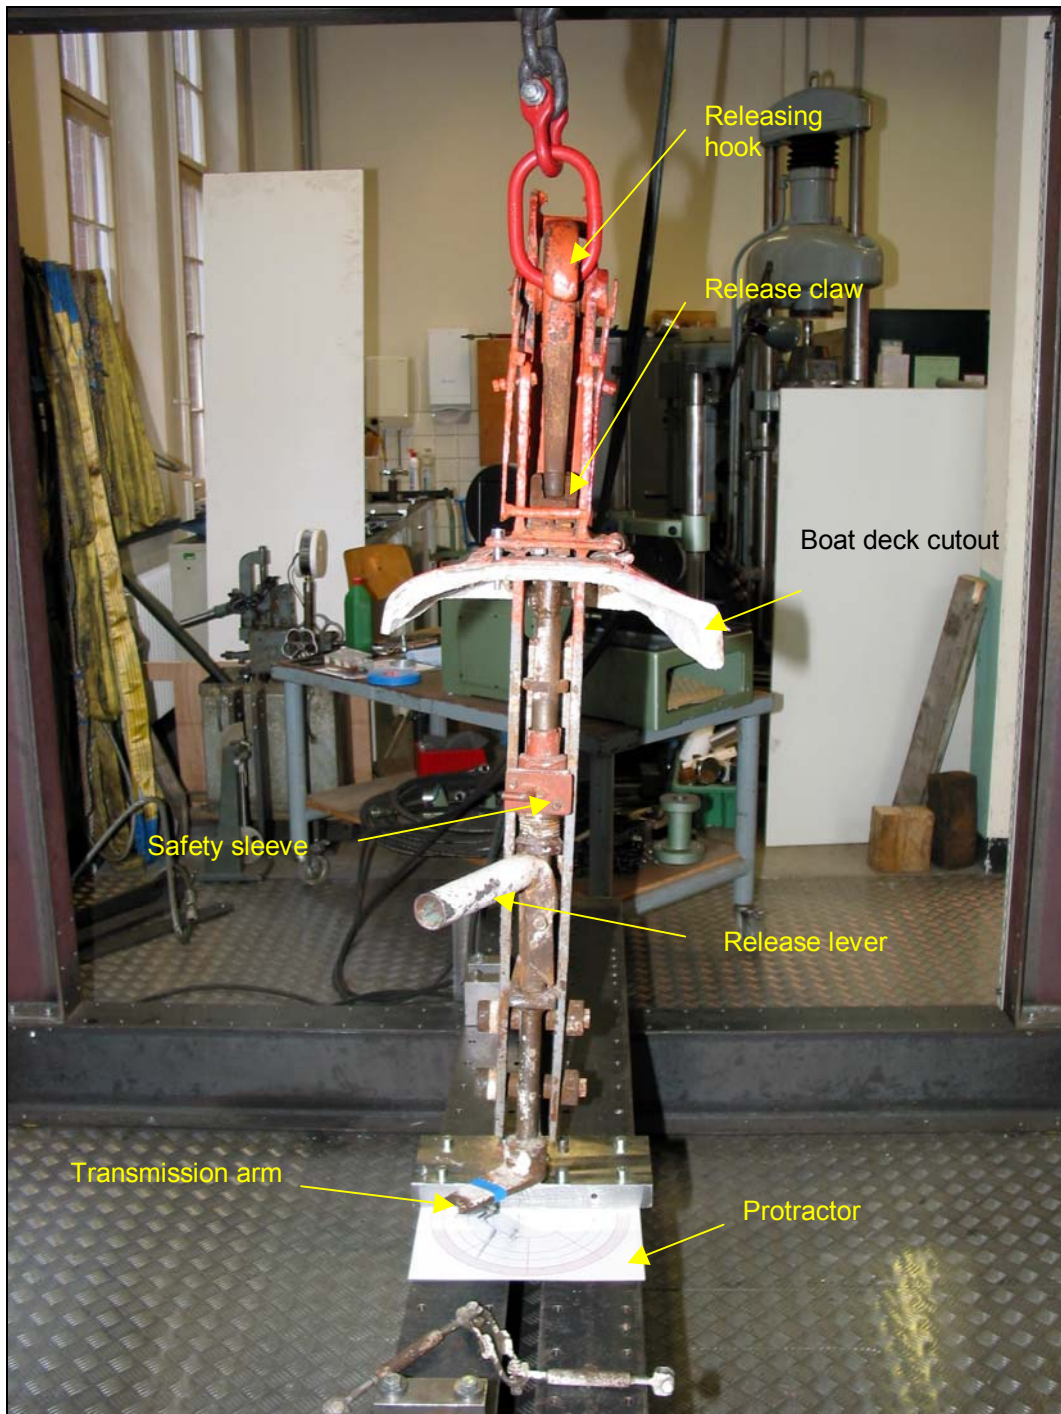
Applied Sciences in Hamburg. There, the aft releasing hook was built into a frame that enabled application of varying forces to the hook (Figures 20 and 21). The forward releasing hook had been so severely damaged during the accident that no further tests could be carried out on it. BSU representatives were present during the experiments.

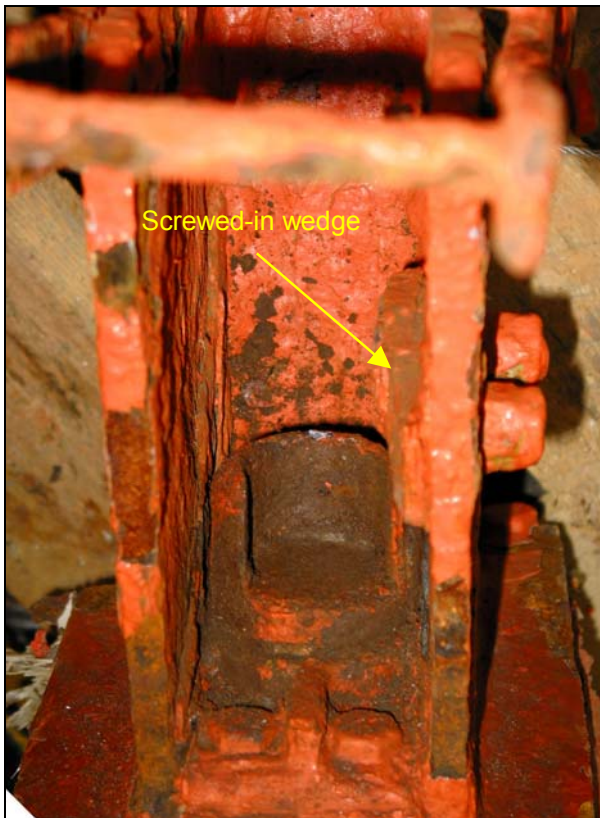
Figure 23: Forward releasing hook

- **Missing wedge** on the inside of the port support plate of the releasing hook (Figures 22 and 23). This wedge had also been missing for some time. Both the attachment area and the drill holes were thickly covered in old paint. With load on the hook, the missing wedge causes the hook tail to move to port (Figure 24). This in turn reduced the holding performance of the release claw.
