Investigation Report 305/06

**Serious Marine Casualty**

**Collision between M/V LASS URANUS  
and M/V XIN FU ZHOU  
on 12 July 2006  
on the Elbe River**

2 May 2008

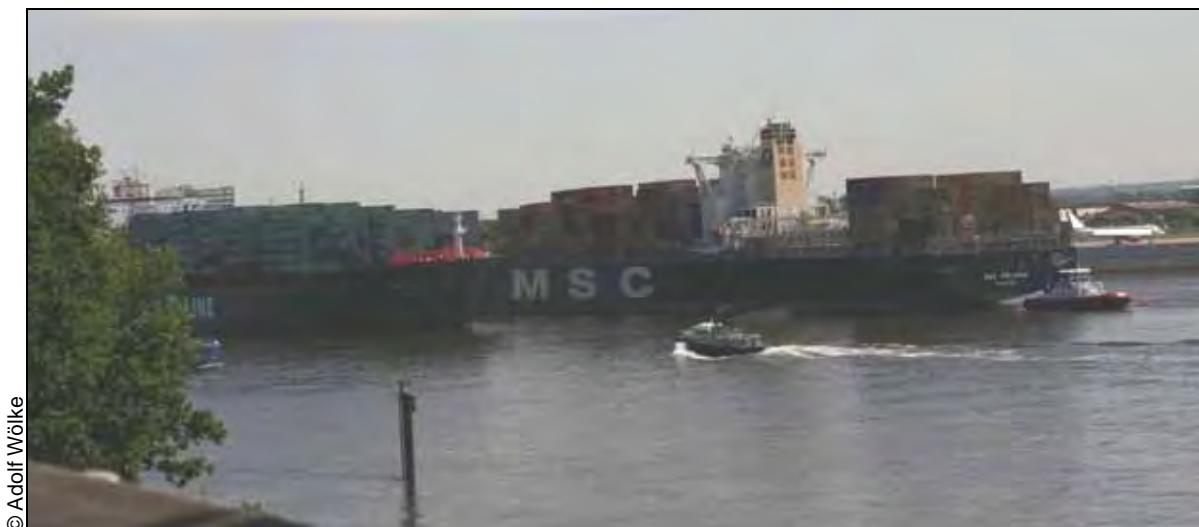
Figure 9: Photo of triple encounter (detail)

The following image (fig. 9) shows all vessels within the relevant section of the river.

The IPI calculation result evidences a distance of approx. 65.5 m between the LASS URANUS and the XIN FU ZHOU at the time recorded in figure 9. As the measurement points were at a great distance from the camera location (approx. 650 to 700 m) and the distance between the upper edge of the ship's side and the waterline could only be determined with a margin of error of +/- 30 cm, this results in a tolerance in the calculated distances of +/- 9.7 m.

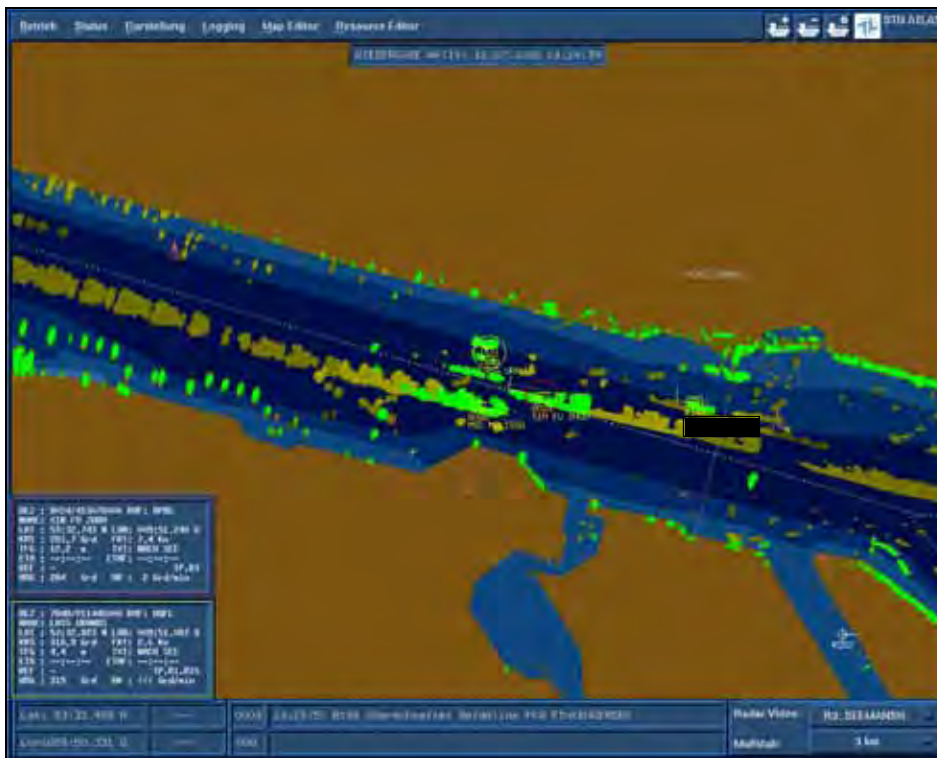
Figure 27: Shore based radar image at 14:24:39

Figure 27 shows the situation as a result of which the LASS URANUS is proceeding on the line of buoys and is at almost the same level as the oncoming MSC MELISSA. The LASS URANUS appears to proceed constantly ahead, but the speed over ground transmitted is now distinctly lower (2.6 instead of 4.2 kn).

According to the radar image, the bow of the XIN FU ZHOU is not yet at the level of the stern of the LASS URANUS at this point. The course steered by the XIN FU ZHOU as pictured enables the conclusion of an initiation of takeover, as a change of course to port towards the radar reference line becomes visible. The MSC MELISSA on the other hand keeps her course in the middle of the southern fairway.

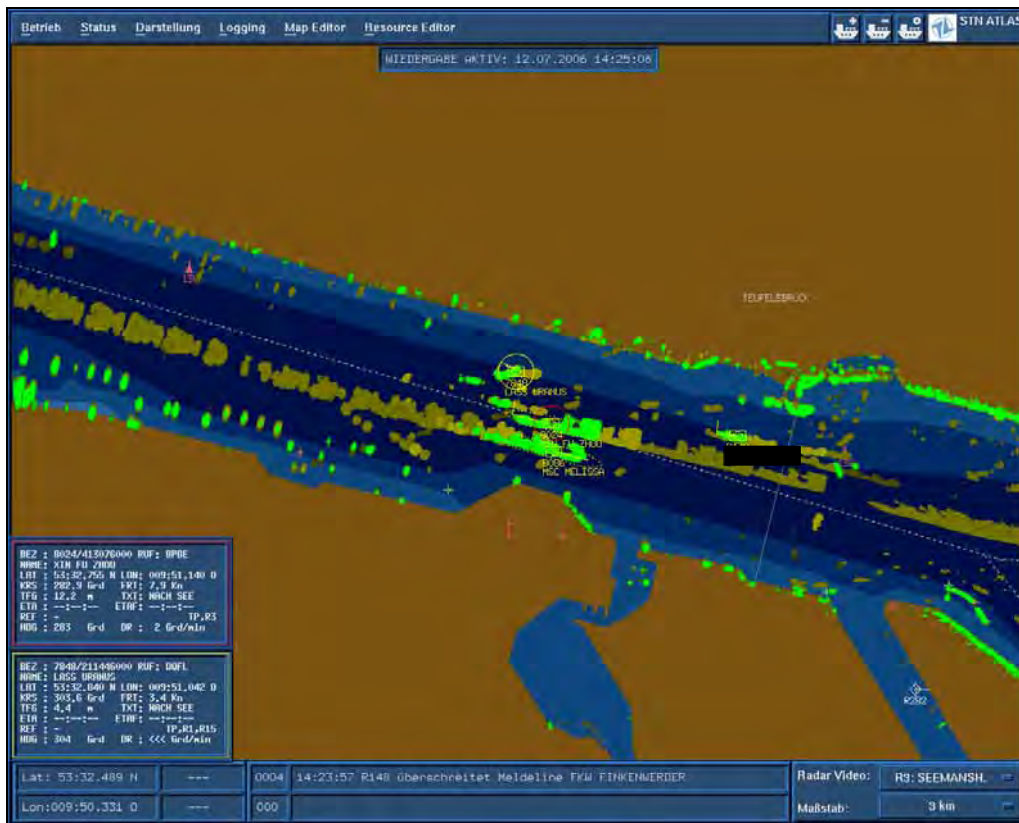
Figure 28: Shore based radar image at 14:25:08

The following radar plot, 29 seconds later, shows the radar echo of the LASS URANUS turning to port (cf. fig. 28).

The XIN FU ZHOU and the MSC MELISSA are almost at the same level, with the radar signal of the XIN FU ZHOU already on the radar reference line.

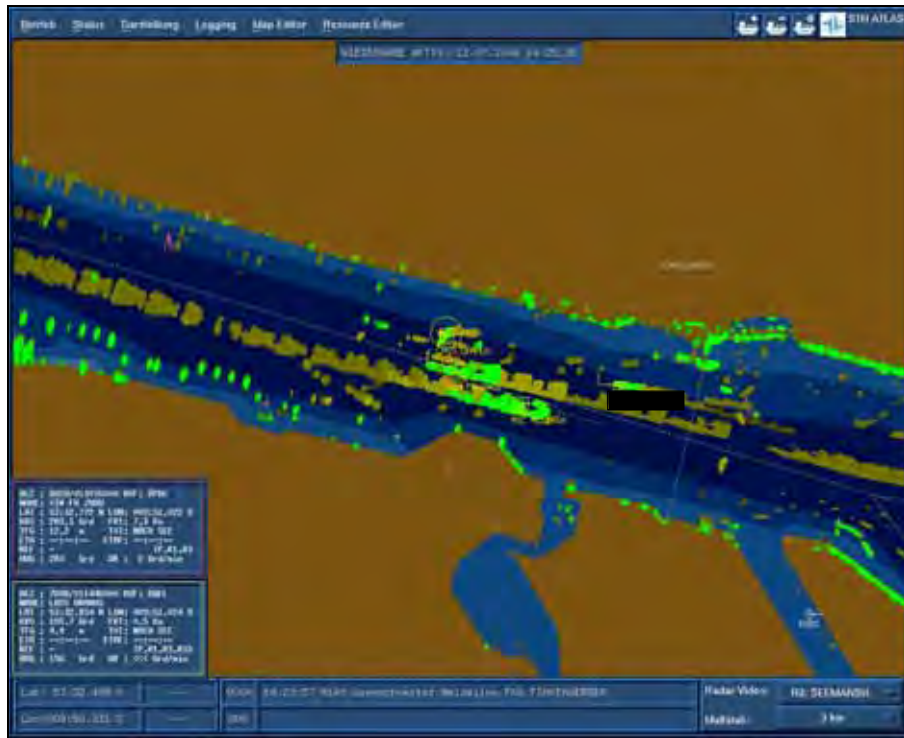
Figure 29: Shore based radar image at 14:25:38

Another 30 seconds later, the radar plot shows the LASS URANUS distinctly turning to port at the time when the radar echo of the XIN FU ZHOU is approximately at the same level as that of the LASS URANUS (cf. fig. 29).

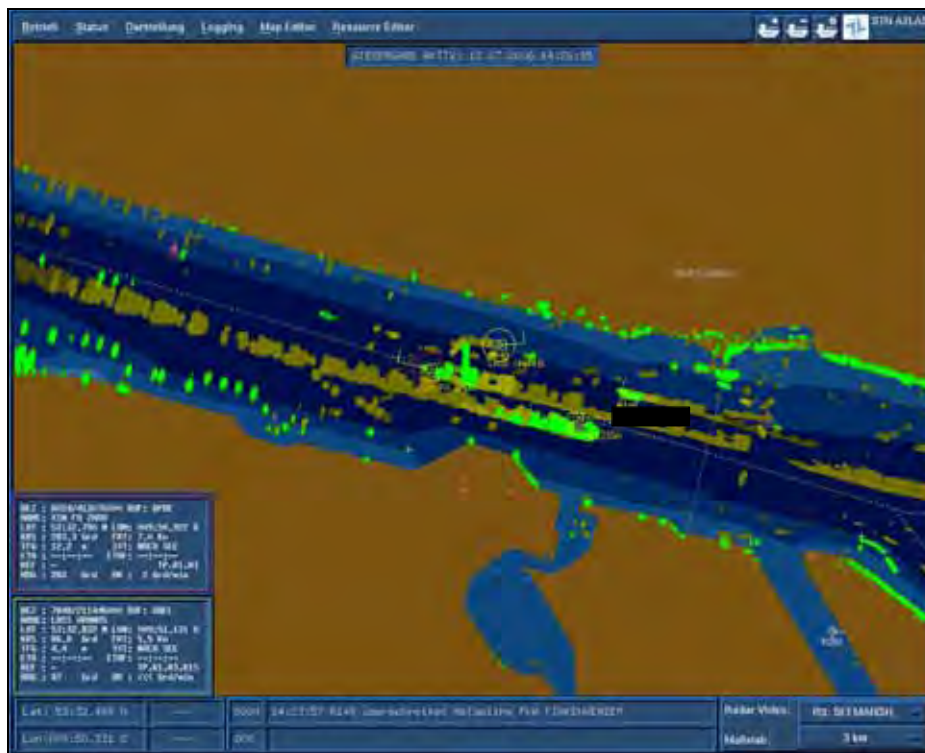
Figure 30: Shore based radar image at 14:26:15

The radar plot of 14:26:15 finally shows the collision between the LASS URANUS and the XIN FU ZHOU at an almost right angle (cf. fig. 30) The vessels' tracking signs again show a more significant deviation in regard to their actual positions.

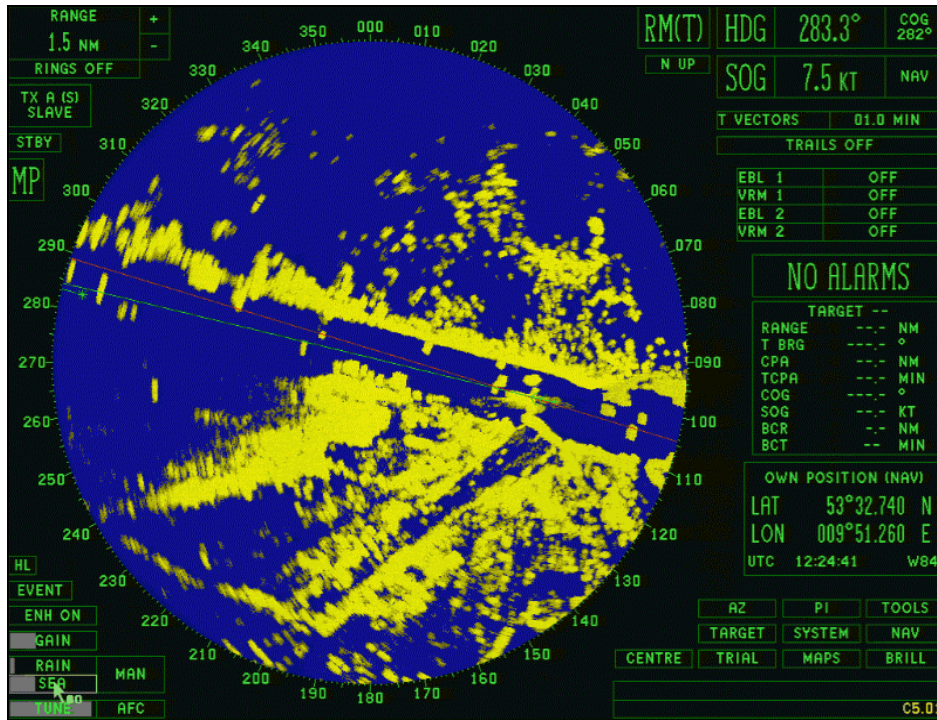
Figure 36: Ship radar image at 14:24:41

Fourteen seconds later the radar shows the LASS URANUS turning to port (cf. fig. 36).

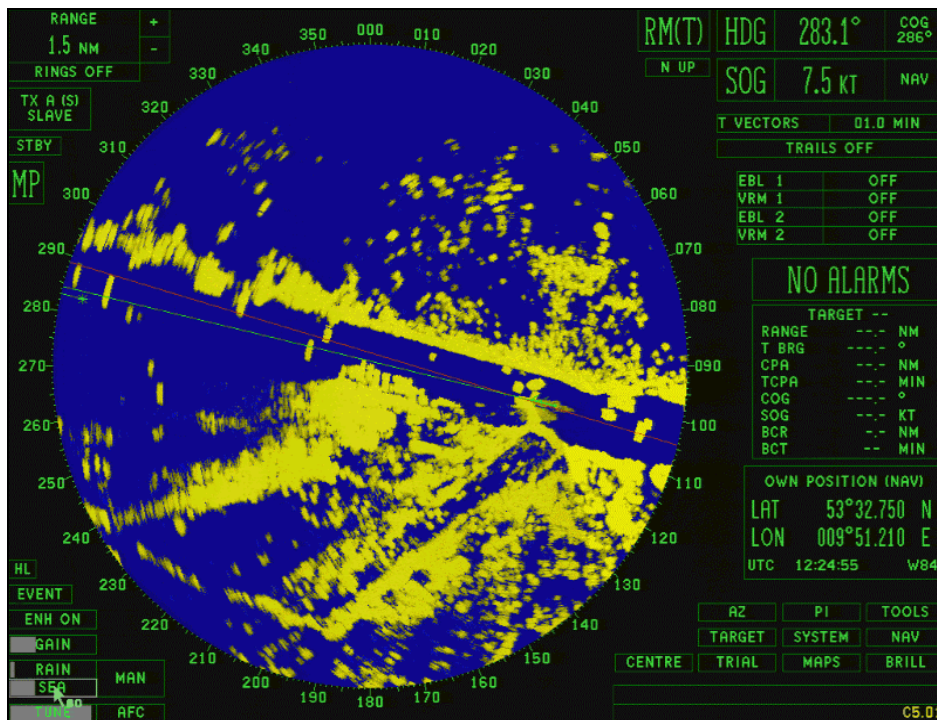
Figure 37: Ship radar image at 14:24:55

Another 14 seconds later the MSC MELISSA and the XIN FU ZHOU are almost alongside, LASS URANUS has turned further to port, and LOTSE1 is just about to proceed between the LASS URANUS and the XIN FU ZHOU (cf. fig. 37).

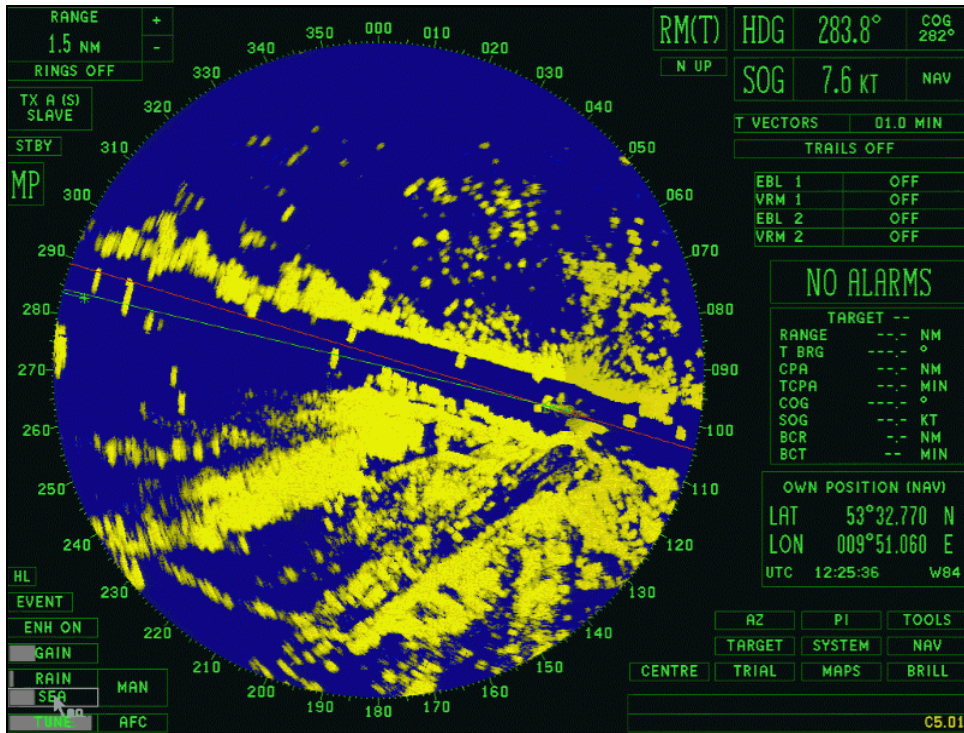
Figure 40: Ship radar image at 14:25:36

On the following radar images the echos of the individual vessels can barely be distinguished at a 1.5 nm radar range (cf. figs. 38 to 40). According to the interpretation, the collision took place at approximately 14:25:36 (cf. fig. 40).

In conclusion, it should be remembered that the LASS URANUS first reported a failure via VHF channel 74 one to one and a half minutes before the collision with the XIN FU ZHOU. If the above graph is additionally synchronised with the witness' photograph taken immediately before the collision (cf. fig. 42, time linked 14:25:34), then the collision took place one minute after the radio contact. This assumption is confirmed by the XIN FU ZHOU's ship radar records (cf. fig. 40).

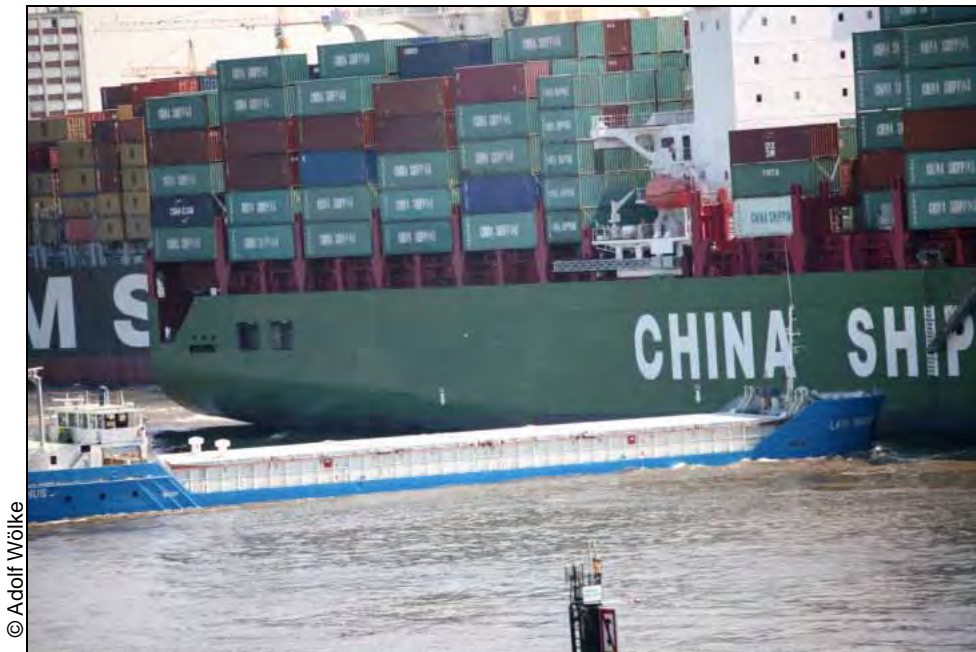
Figure 42: Additional photo of the vessels involved in the accident immediately before the collision

According to the digital time links, half a minute later two photographs were taken in which the LASS URANUS and the XIN FU ZHOU can be seen immediately before the collision (cf. fig. 10 of 14:25:26 and the following fig. 42 of 14:25:34).

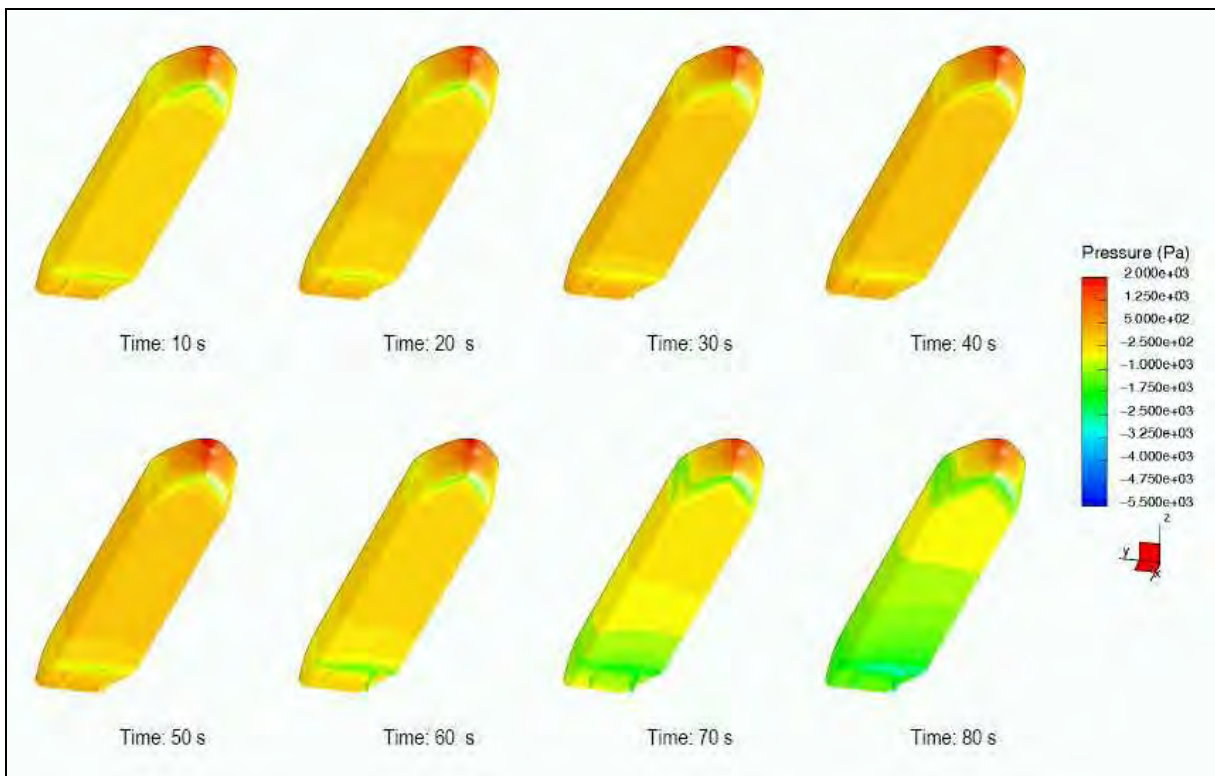
Figure 46: Pressure distribution on the hull plating of the LASS URANUS

The pressure distribution on the underwater hull plating of the LASS URANUS calculated in the simulation constituted the foundation for the determination of the transverse forces and yaw-moments. The following figures show the pressure distribution from the underwater perspective. While just two minutes before the collision the pressure distribution is still even (cf. fig. 46), in the temporal approximation to the collision (approx. "Time: 120 s") the formation of a low-pressure area (marked in blue) at first at the stern (Time: 110 s) and later at the bow (Time: 130 s) can be clearly recognised (cf. fig. 47).

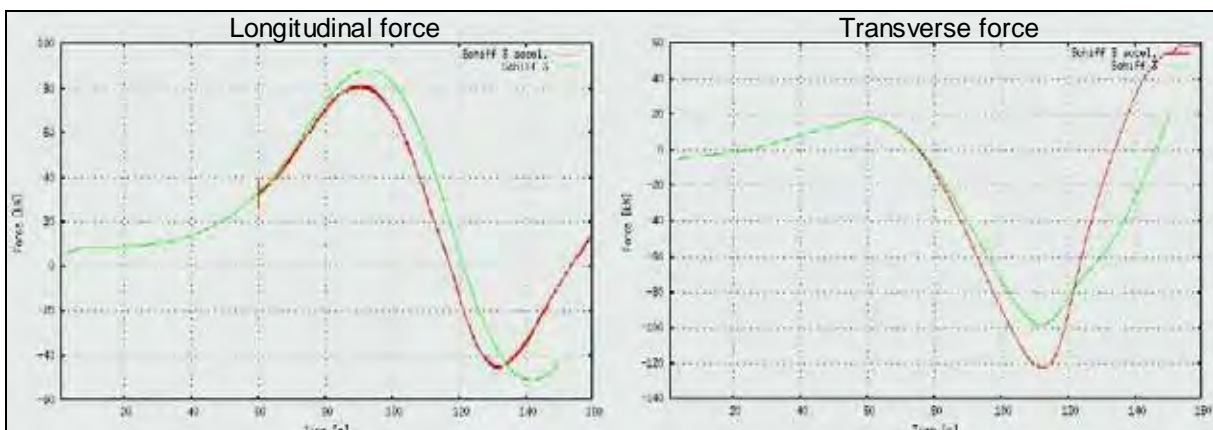
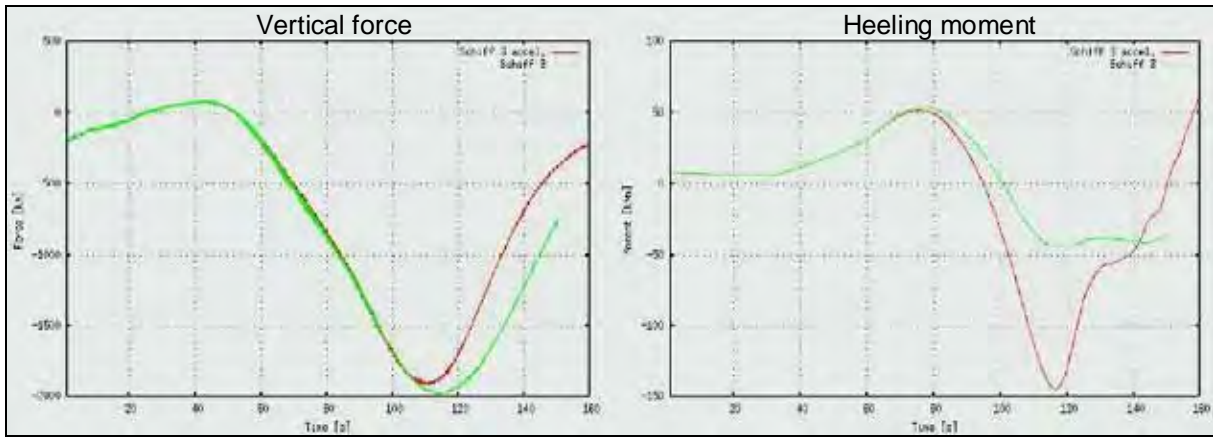
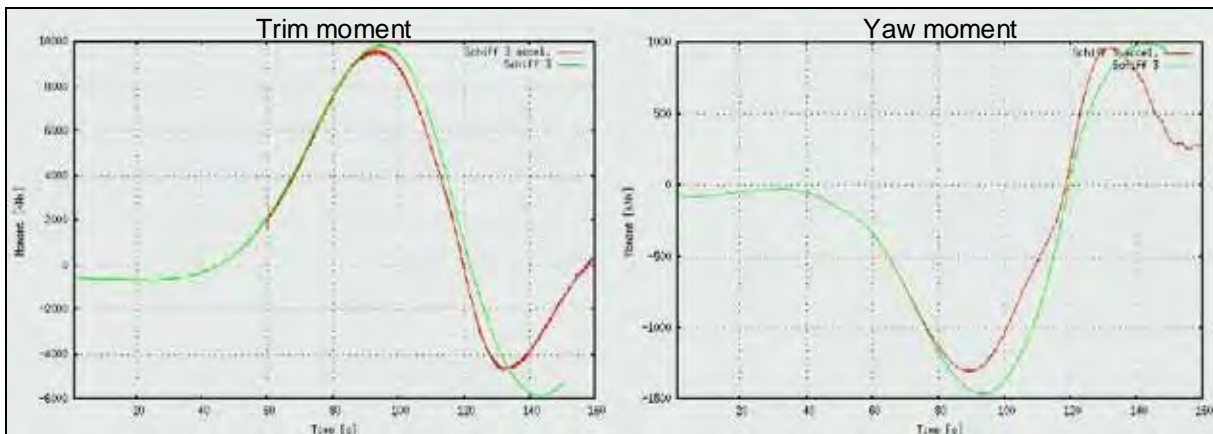
Figure 48: Longitudinal and transverse forces acting on the LASS URANUS

The integral parameters of the forces and moments occurred are contrasted in figures 48 to 50. The green curve corresponds to the respective integral parameter assuming the above defined constant vessel speed for the LASS URANUS. On the basis of the calculated dimension of the longitudinal forces however the GL assumed that the vessel's speed would change under the effect of these forces. For this reason, for a further simulation series a speed profile was estimated assuming constant propeller thrust. The red curve corresponds to the respective integral parameter under the assumption of a change in speed.

Consideration of the adapted velocity trend of the LASS URANUS (cf. figs. 48 to 50, red curves) results in a slightly increased lateral force with an almost unchanged trend in the yaw moment.

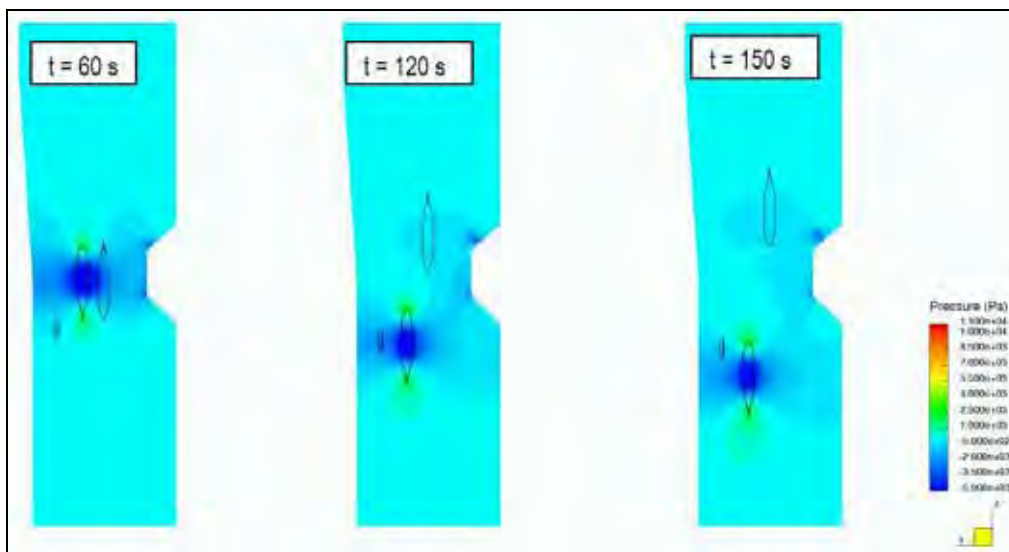
Figure 51: Pressure outline at the static water level

The GL produced both graphic and text interpretations for the simulation results. The following figure 51 shows the pressure in the modelled section of the Lower Elbe during the triple encounter.

The low-pressure area generated by the XIN FU ZHOU due to its displacement effect can be clearly distinguished. In the simulation the LASS URANUS and the MSC MELISSA proceed at distinctly lower speeds through the water, so that their effect is present, but comparatively much smaller. In the overtaking model represented here with a constant overtaking distance, at approximately  $t = 60$  s the LASS URANUS enters into the XIN FU ZHOU's low-pressure area, at approximately  $t = 120$  s both vessels are at the same level and at  $t = 150$  s the effect decreases again.

The shifting of the low pressure area acting on the LASS URANUS from the aft section of the ship (port,  $t = 110$  s) to the forward section (port,  $t = 130$  s) generate a transient yaw moment and the presence of a starboard/port asymmetry causes a lateral suction force.

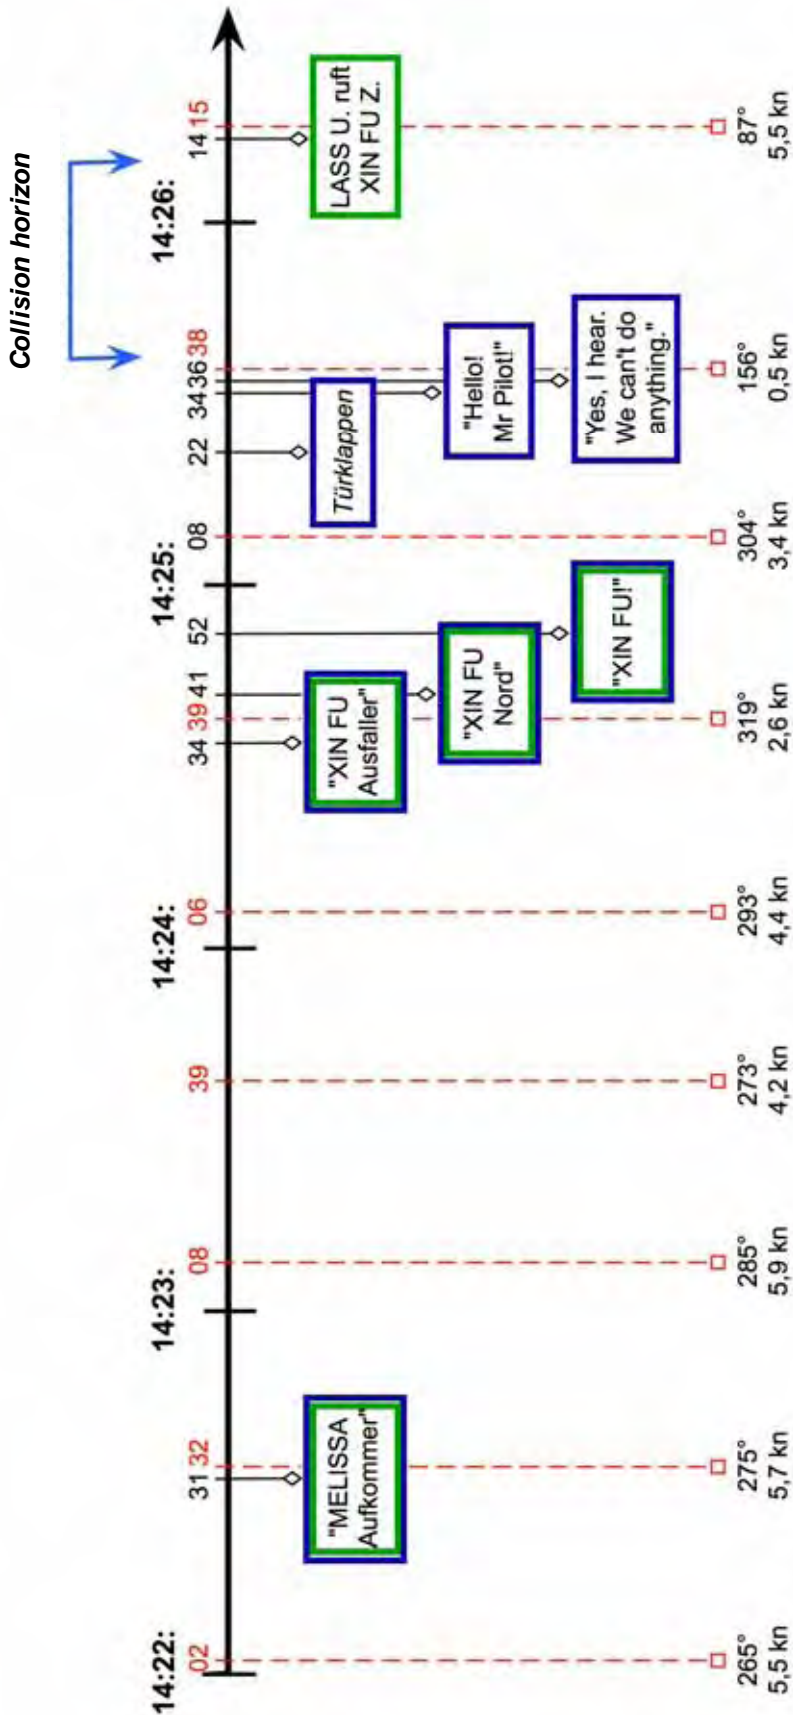
Figure 52: Time line graph of the events of the accident

The distances between ships were not included in the graph, as the radar records provide indications of the positions of the relevant vessels, but the actual positions can vary as to individual details. The record synchronisation limits the collision period to the time between 14:25:36 and 14:26:14.
