Investigation Report 450/07

**Very Serious Marine Casualty**

**Collision between  
M/V HANJIN GOTHENBURG  
and M/V CHANG TONG  
on 15 September 2007  
in the Bohai Strait/PR of China**

15 September 2008

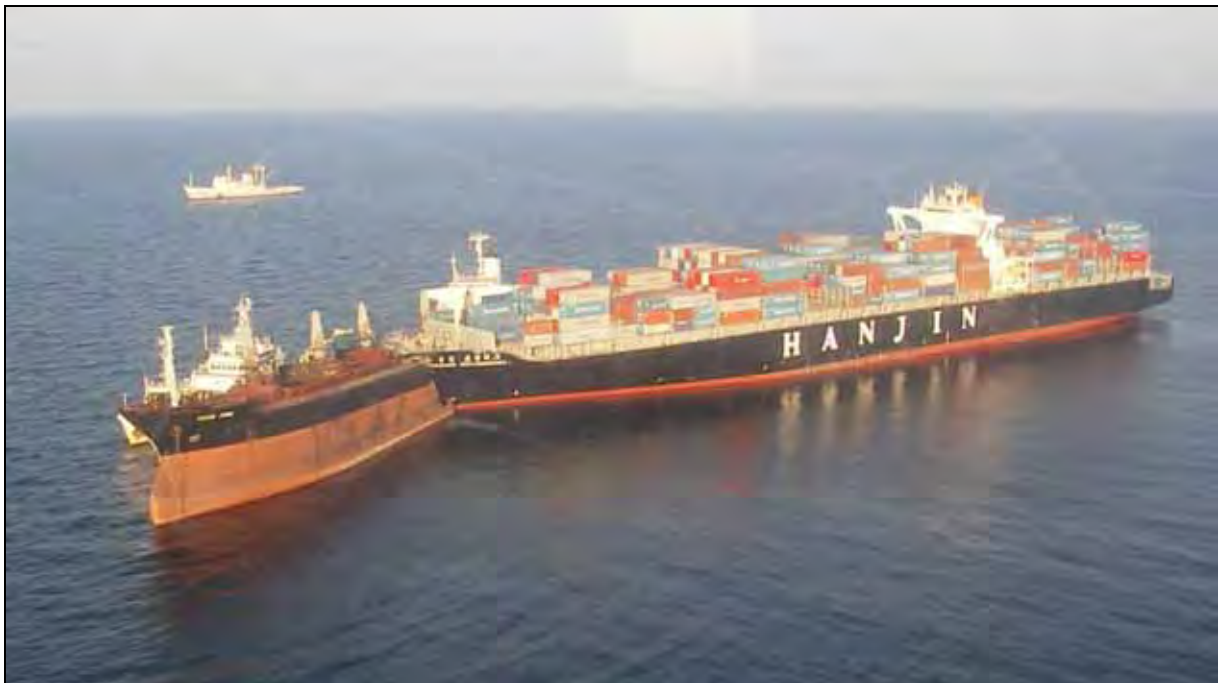
Figure 8: Wedged vehicles following the collision

The vibration due to the ordered full rudder position was said to have been quite strong, resulting in a speed reduction carried out by the assistant engineer on his own accord. The engine had reportedly been stopped immediately prior to the collision. The Master of the CHANG TONG rushed to the bridge. Shortly afterwards both vessels collided at an angle of 40° (cf. figure 8), when the HANJIN GOTHENBURG’s bow hit the portside of the CHANG TONG.

During the collision the forecastle of the HANJIN GOTHENBURG penetrated CHANG TONG's hull on port side beyond the central plane (see figures 8 and 21).

The bow tore apart the bulkhead between cargo holds 3 and 4 which caused substantial deformation and breaking of the bulkhead and the frames. The upper and lower side tanks in these areas were destroyed. Water penetrated cargo holds 2 to 5.

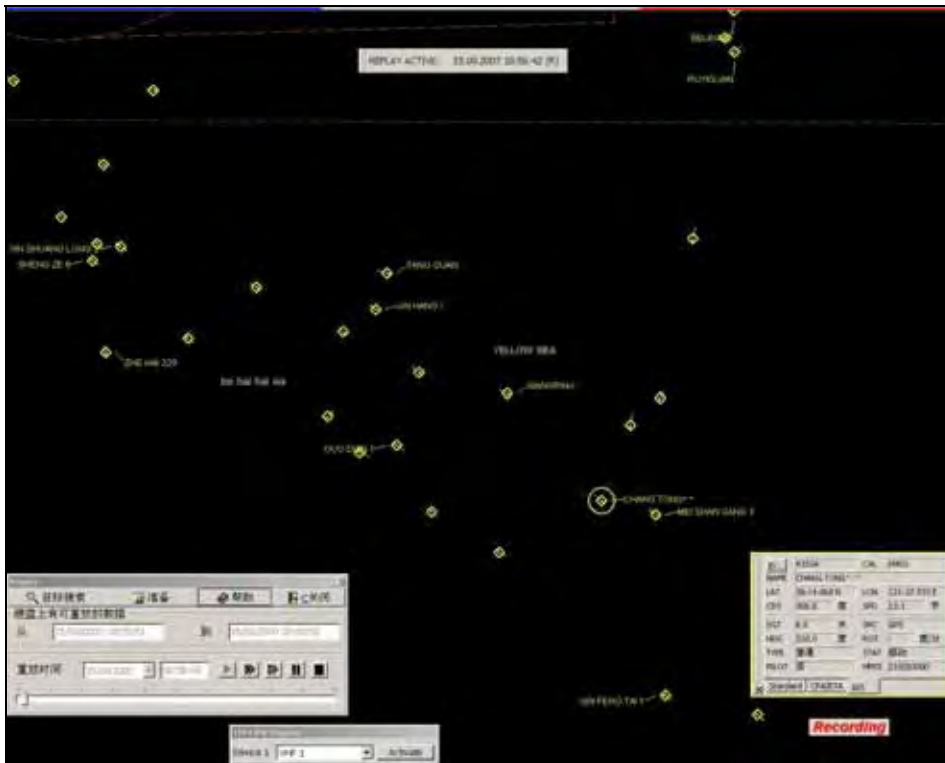
Figure 23: AIS record from 18:56:42, without a vessel position display for the HANJIN GOTHEBURG

The BSU evaluated records for the time period between 18:56:00 and 20:00:48. The vessel positions and data (course, speed) displayed in the recordings without sea chart overlay sometimes deviate significantly from the actual positions and data. Temporarily data has been recorded for only one or in some cases even none of the vessels involved in the accident. In these cases either the vessel position shown did not change or the vehicle symbol disappeared completely from the screen (cf. figure 23).

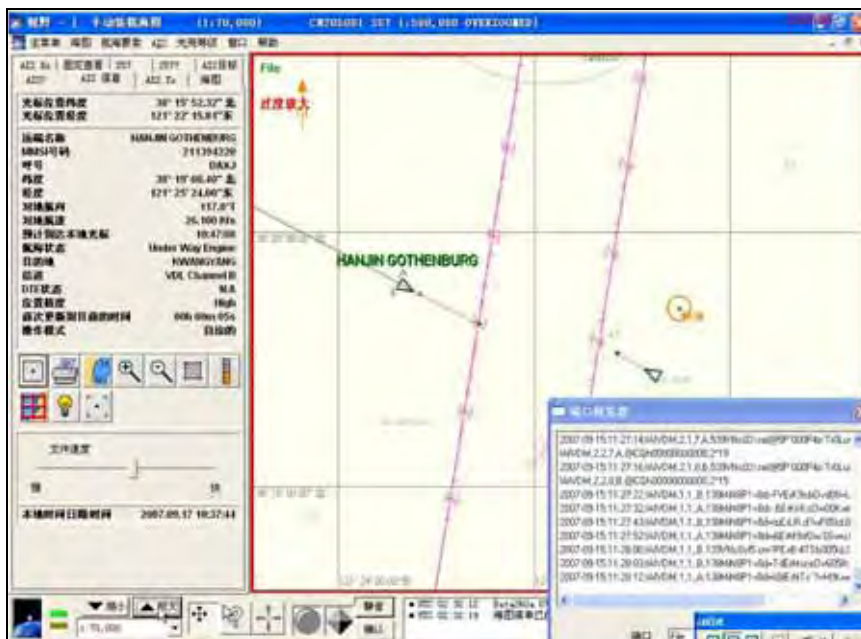
Figure 25: Reciprocal courses of the vessels involved in the accident

In addition to the above records, AIS tracks were also stored with an electronic sea chart overlay from which the tracks of both vehicles involved in the accident can be traced in detail<sup>4</sup> (cf. figures 25 to 32). According to this, both vehicles were navigating on reciprocal courses before the collision (cf. figure 25).

proven by figures 25 and 33, a CPA<sup>23</sup> of much less than a nautical mile was to be expected when there was less than 6 nm distance between the vehicles. It was only approx. 8 minutes by the time the collision happened and the combined approaching speed was approx. 38 kn.

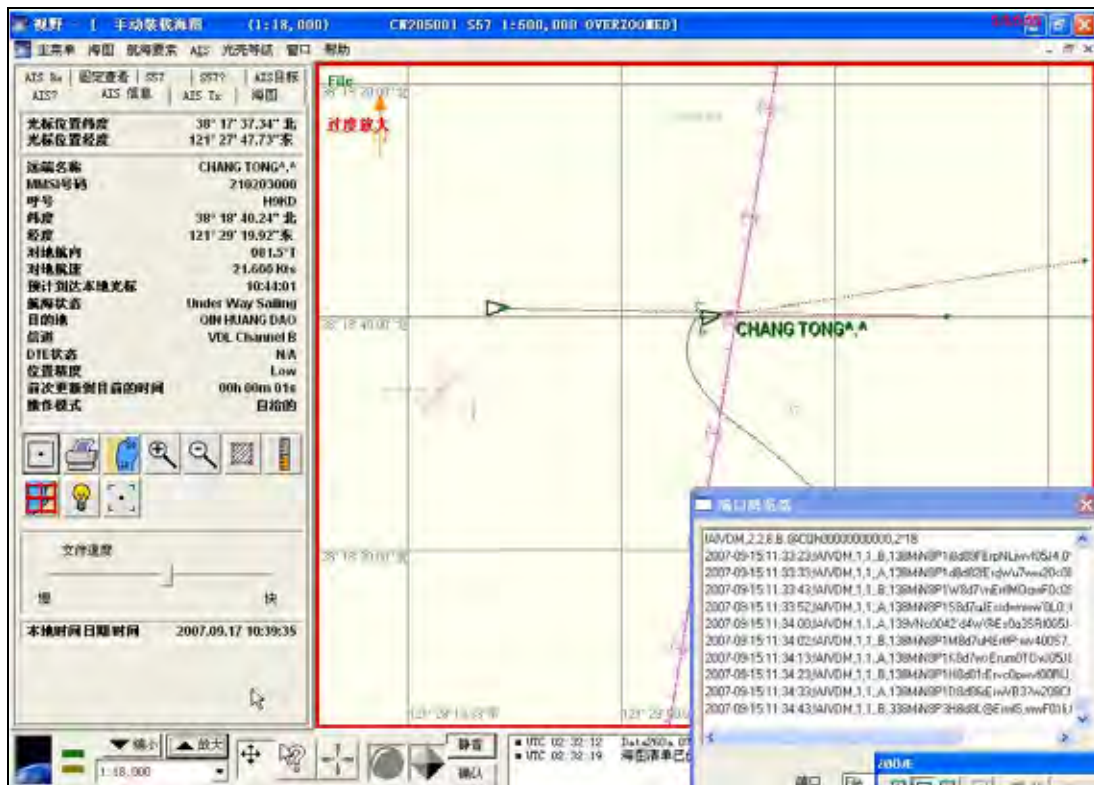
Figure 32: Probable time of collision

In the following figure 32, CHANG TONG's speed suddenly increases to 21.6 kn. It can therefore be assumed that the collision had already taken place at this point in time, although the vessel positions shown still imply distance. The discrepancy between the illustrated and actual vessel position is due to inaccurate data relating to the statistical data sent by the vehicles (including the location of the GPS antenna, the length of each vehicle) and/or dynamic data (including the vessel position according to the GPS).

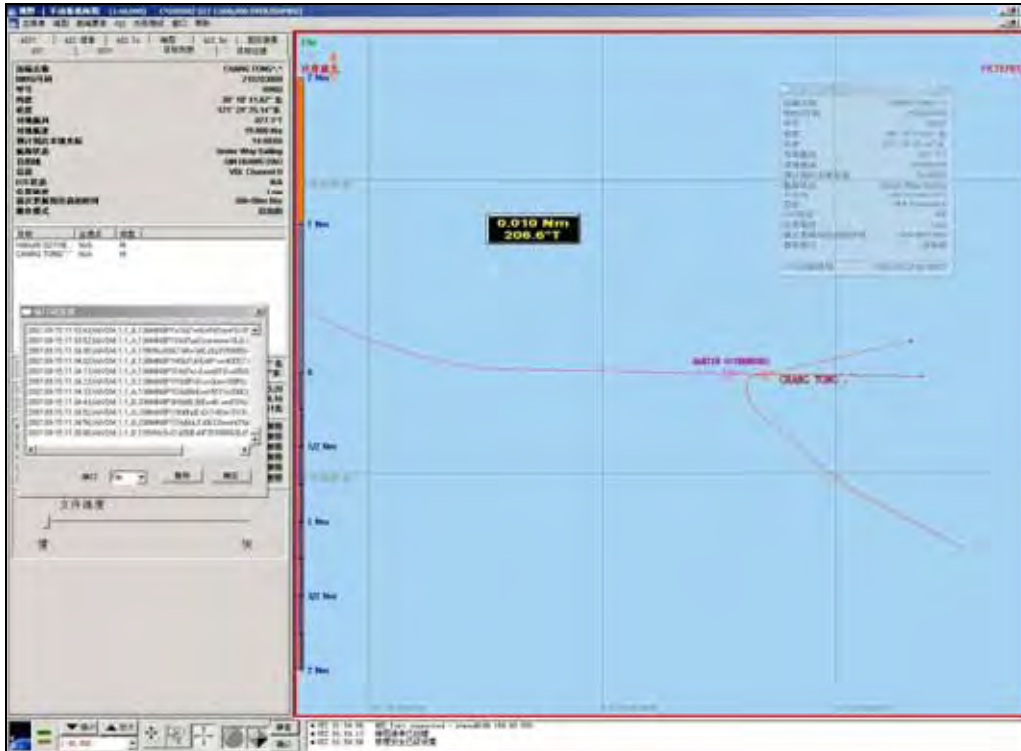
Figure 37: Both vehicles after the collision

In the following figure 37 the suddenly increased speed displayed for the CHANG TONG (19.9 kn) is again attributed to the collision.

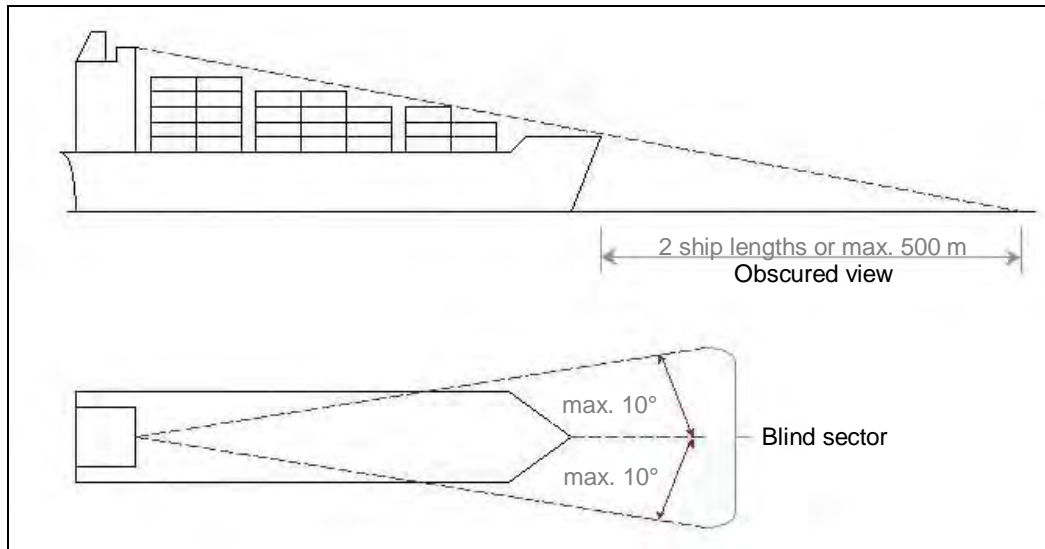
Figure 45: SOLAS navigation bridge visibility requirements

According to Chapter V Regulation 22 of the SOLAS Convention<sup>9</sup>, view of the sea surface from the conning position shall not be obscured by more than two ship lengths, or 500 m, whichever is the less, forward of the bow to 10° on either side (cf. figure 45).

With the draught of the vessel and the height of the containers stowed on deck, the obscured view from the navigation bridge of the HANJIN GOTHENBURG to the sea surface on the day of the accident was approximately 268 m. The visibility requirements stipulated by SOLAS were therefore complied with.

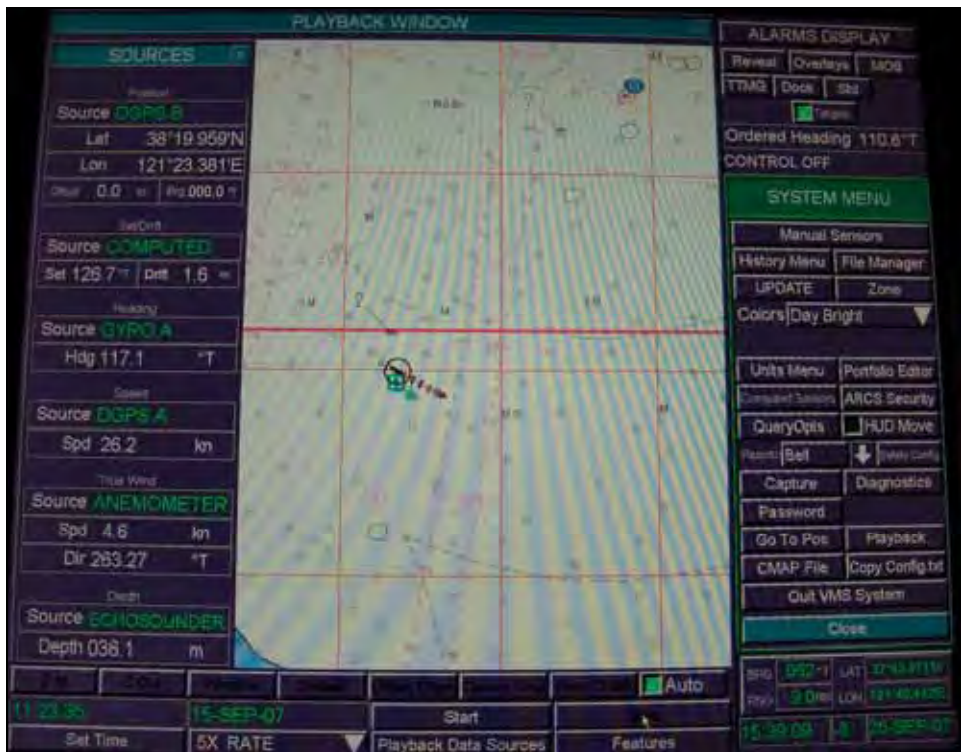
Figure 49: ECS record from 19:23:35

The vehicles were overtaken at approximately 1923 on starboard (cf. figure 49). The overtaking distance was estimated at approximately 0.5-0.6 cable.

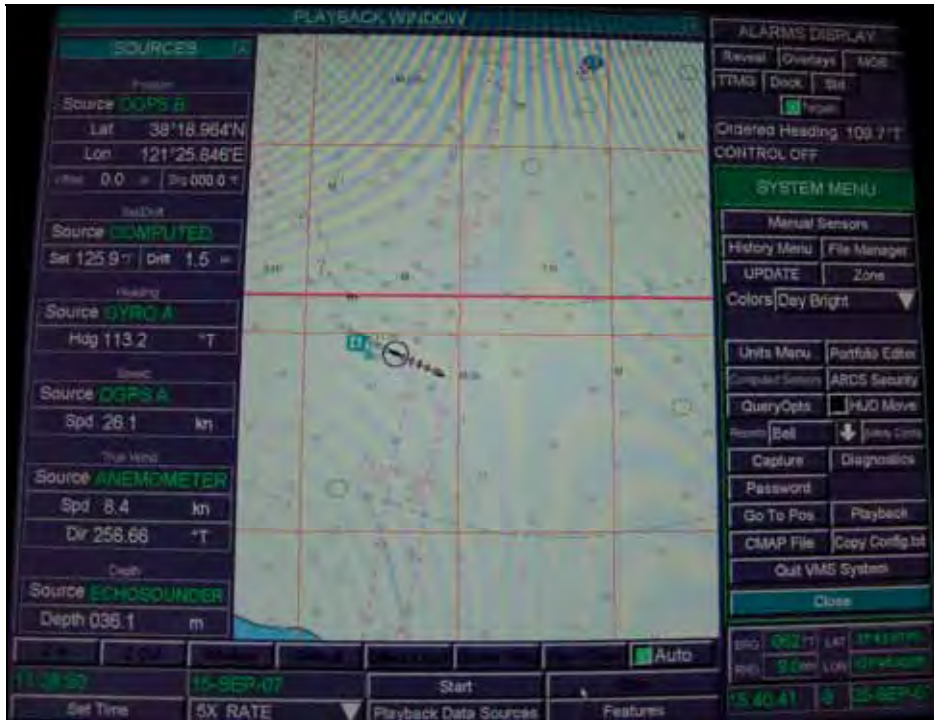
Figure 50: ECS record from 19:28:30

After the vehicles were overtaken, target plotting was not terminated (cf. figure 50).

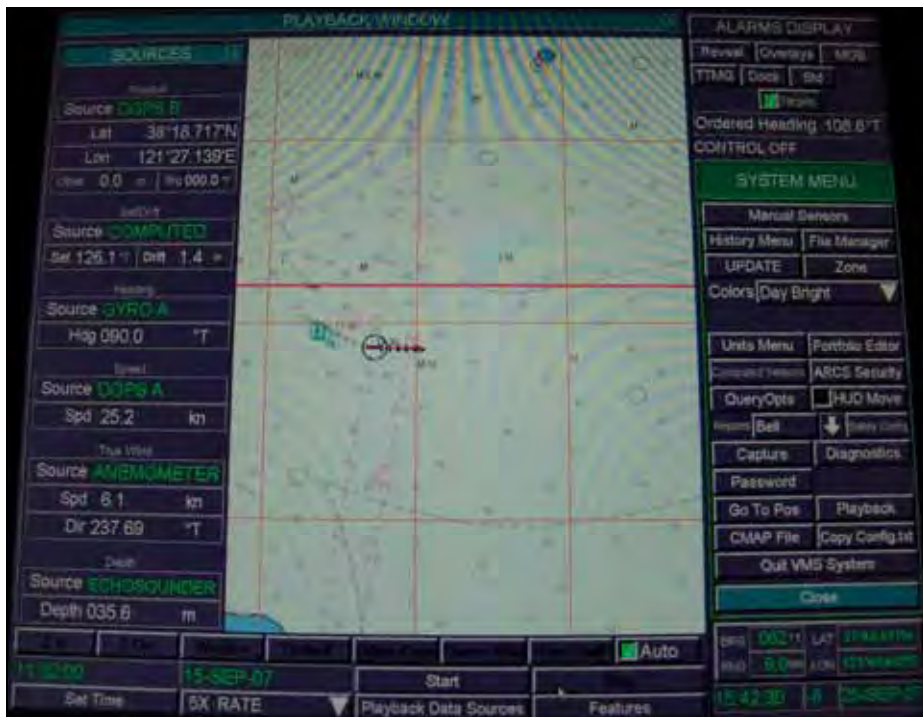
Figure 51: ECS record from 19:32:00

The port manoeuvre was continued without new targets being plotted using the ARPA function (cf. figure 51).

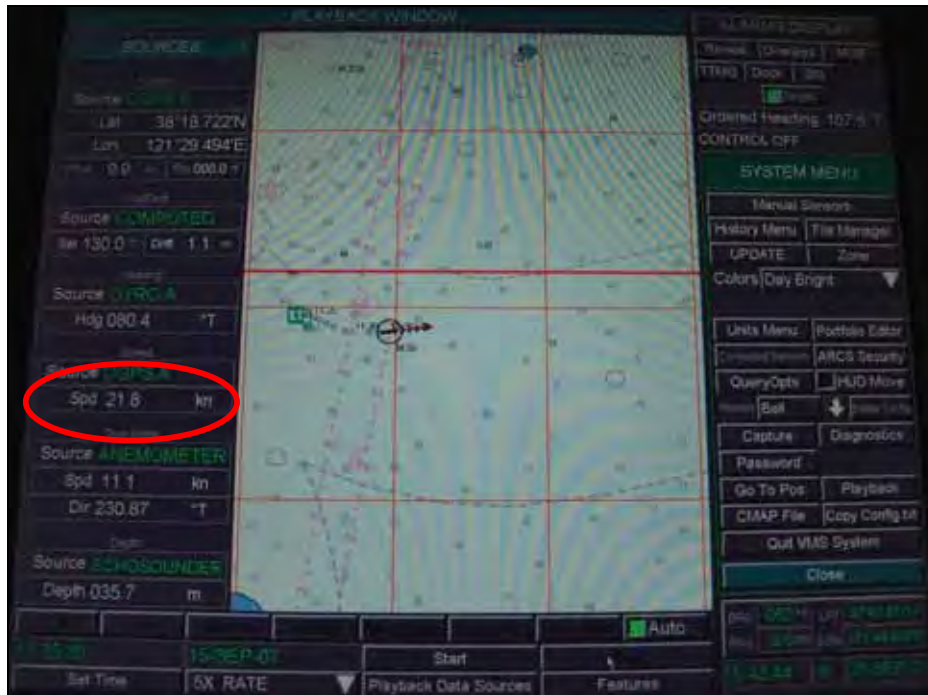
Figure 52: ECS record from 19:35:30

The collision occurred at 1935, when the HANJIN GOTHENBURG's speed rapidly declined (cf. figure 52).
