Bundesstelle für Seeunfalluntersuchung
Federal Bureau of Maritime Casualty Investigation
Federal Higher Authority subordinated to the Ministry of Transport,
Building and Urban Affairs

Investigation Report 537/06

Person overboard
from MS BELUGA STIMULATION
on 27 October 2006 at 08:20
in the German Bight

1 June 2008

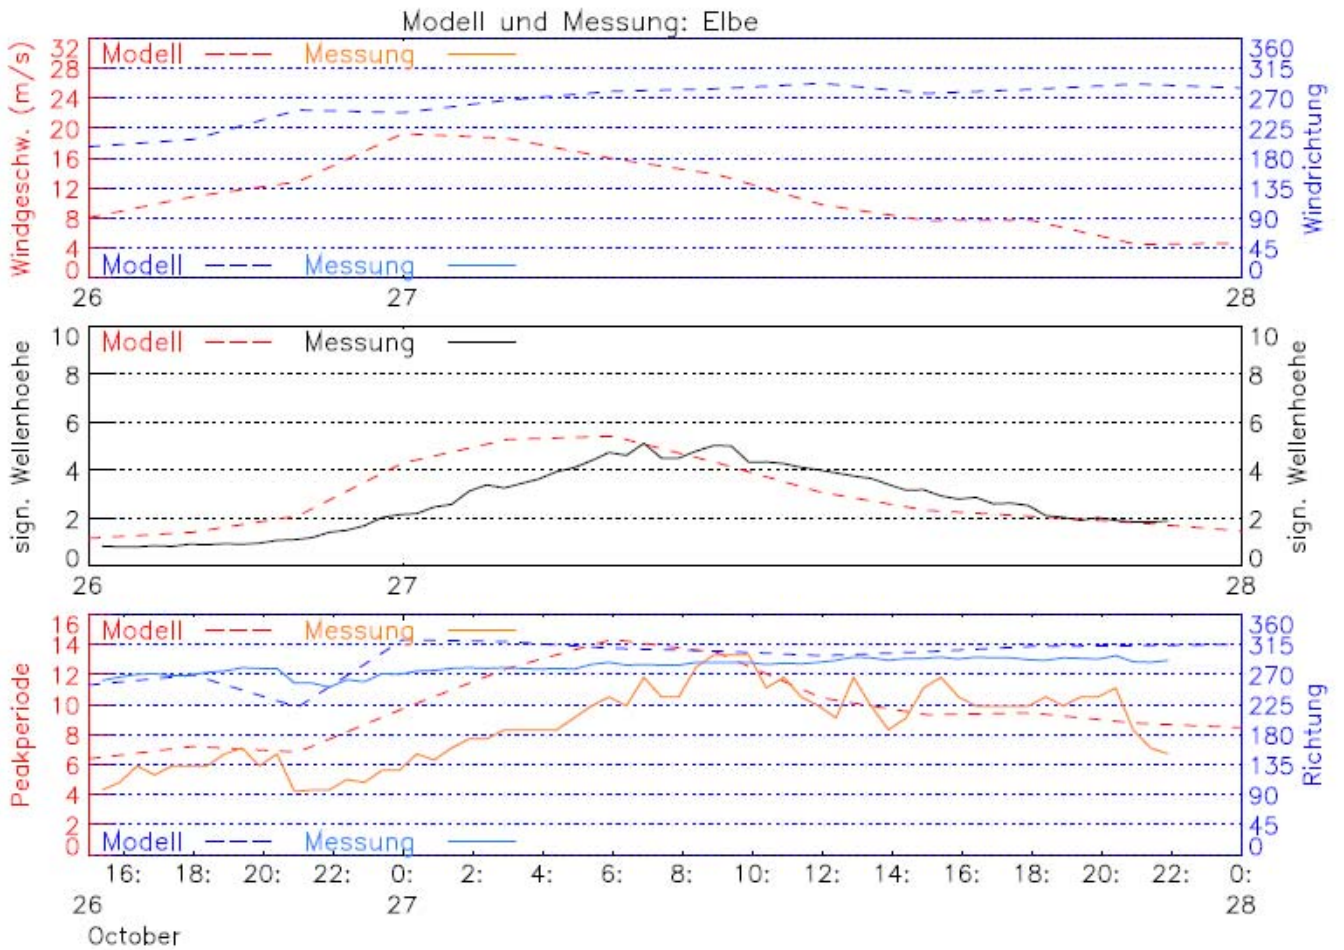
Figure 9: Environmental diagram

Significant wave height:	Hm = 4.20 m
Average period:	Tm = 7.7 s
Max. wave height:	Hmax = 6.93 m
Max. period:	Tmax = 9.4 s
Average swell direction:	Dir = 286°
Directional scatter:	Spr = 13°
Water temperature:	WT = 15.9 °C

Measured data for wind velocity and wind direction were not available.

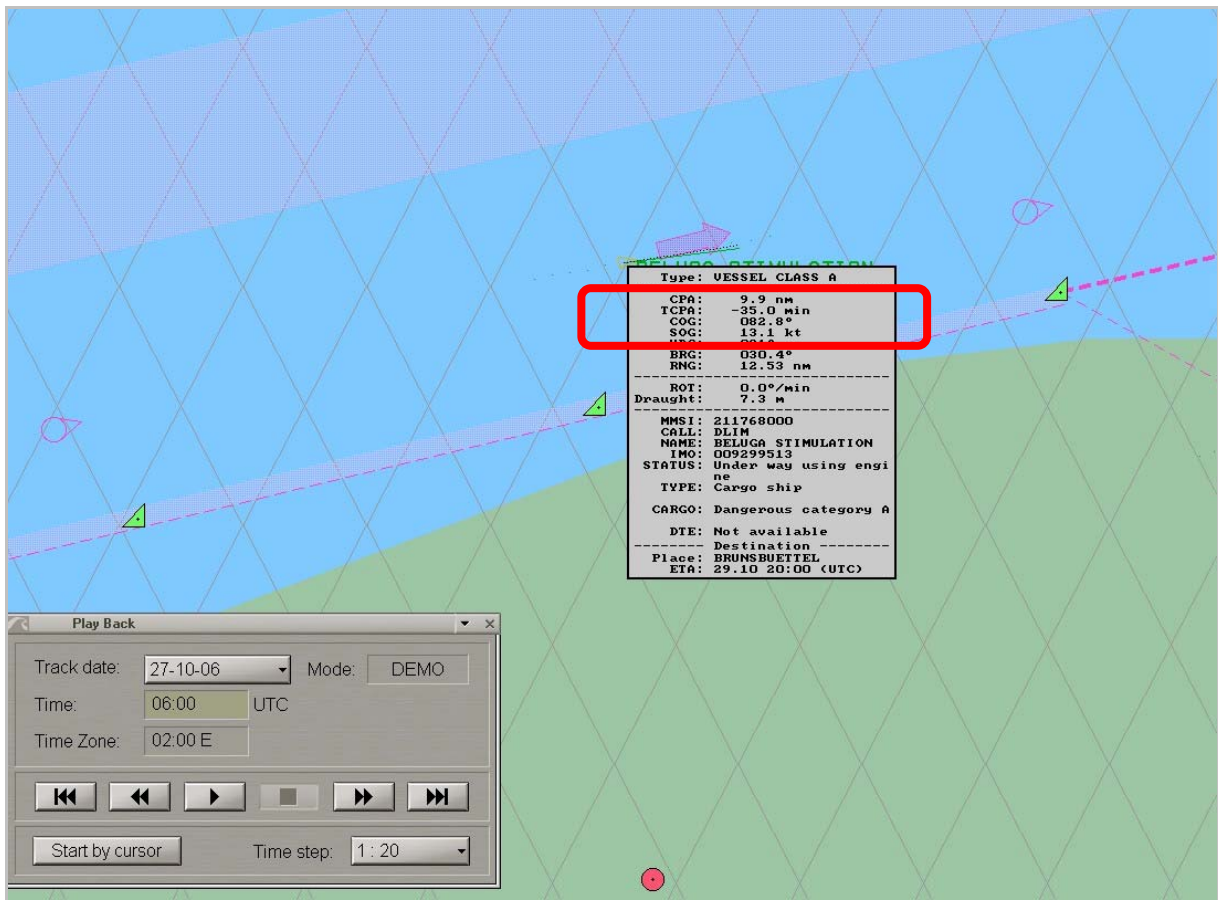
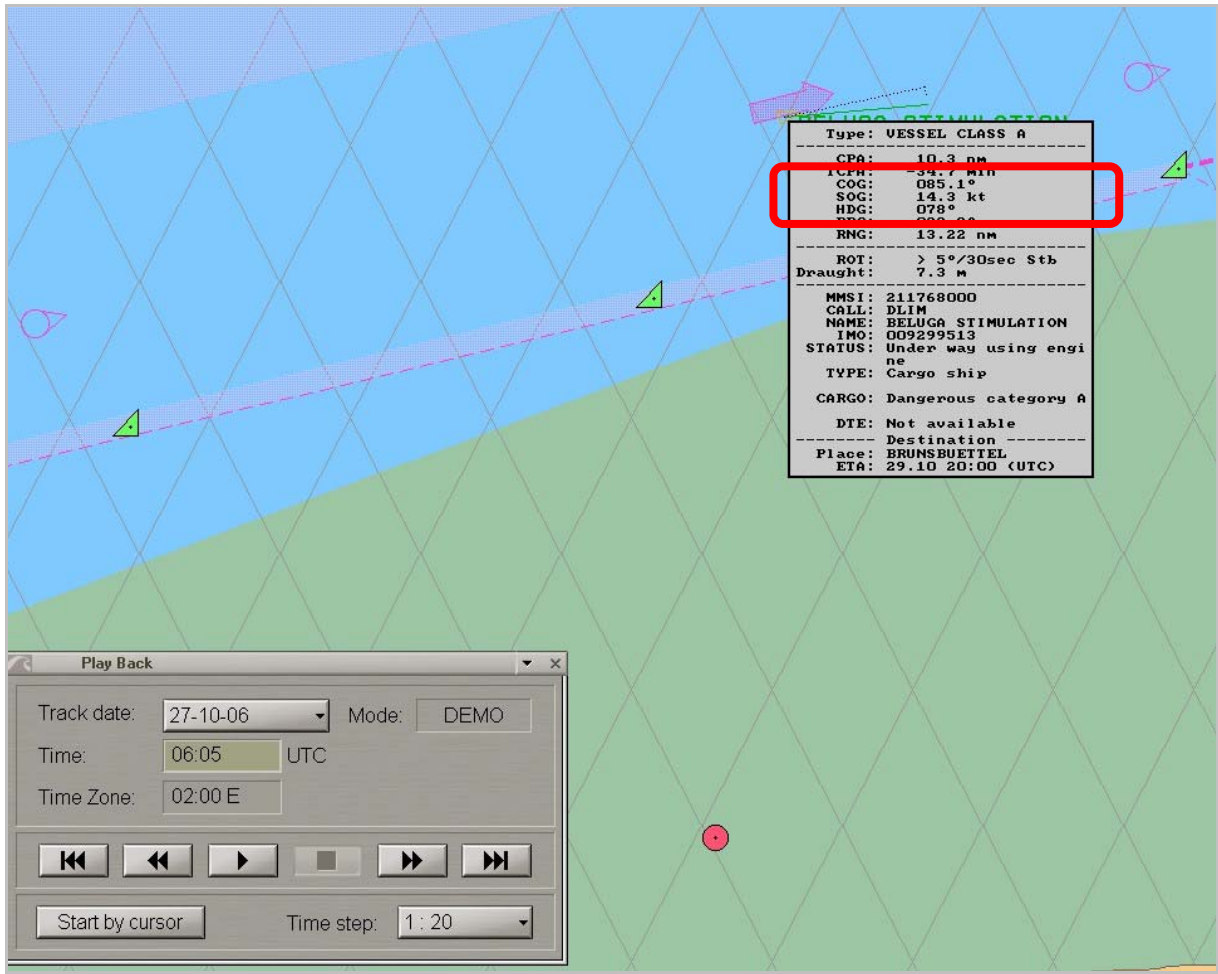
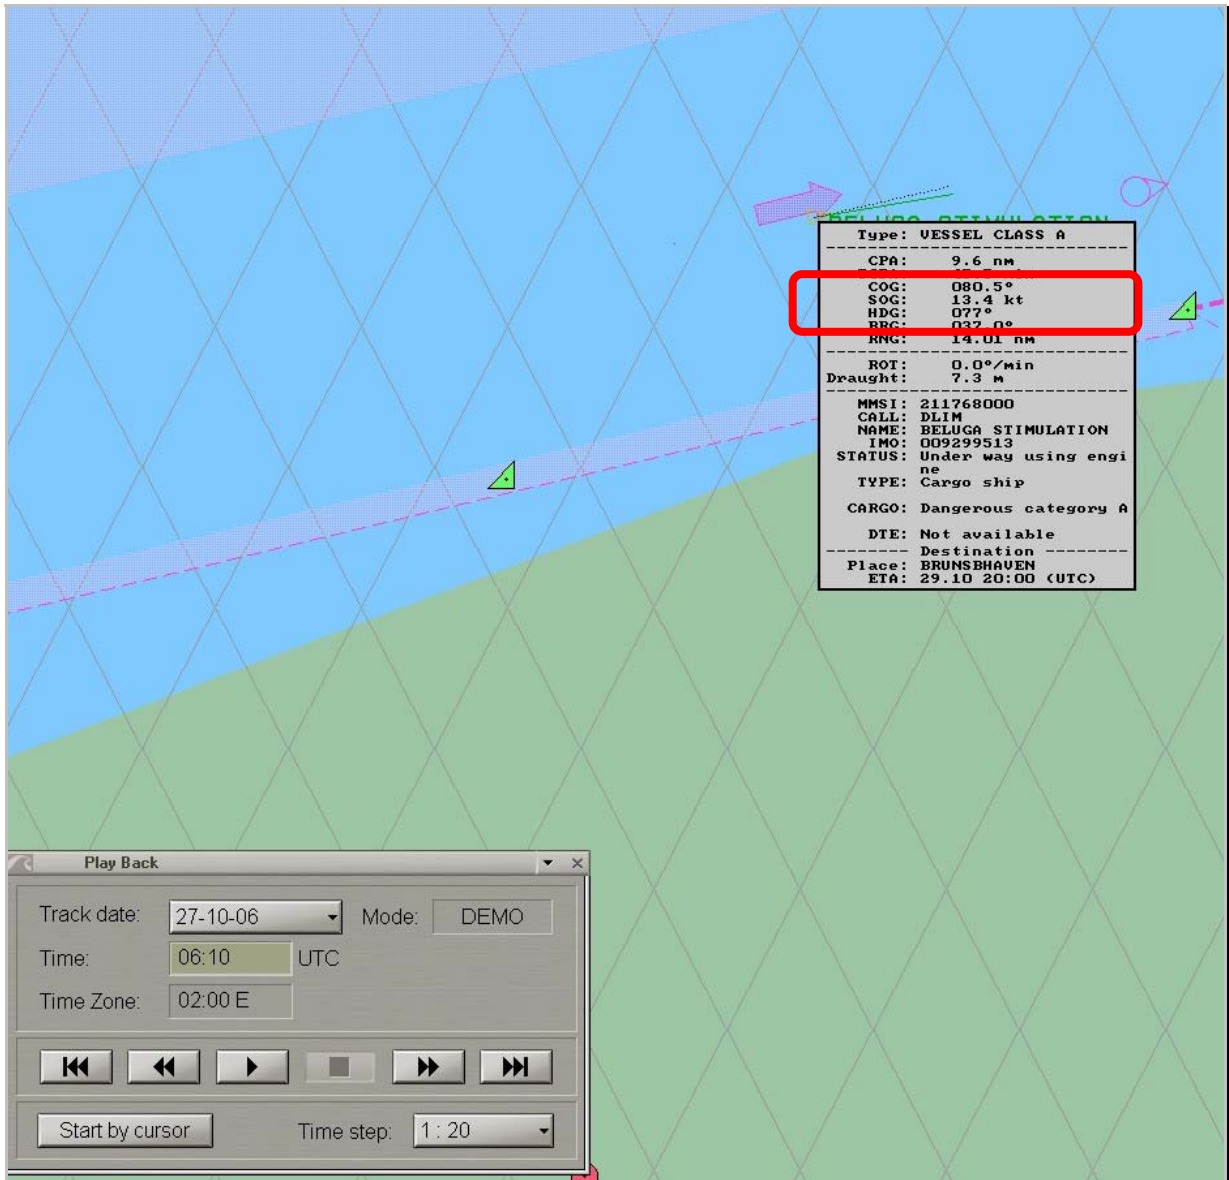
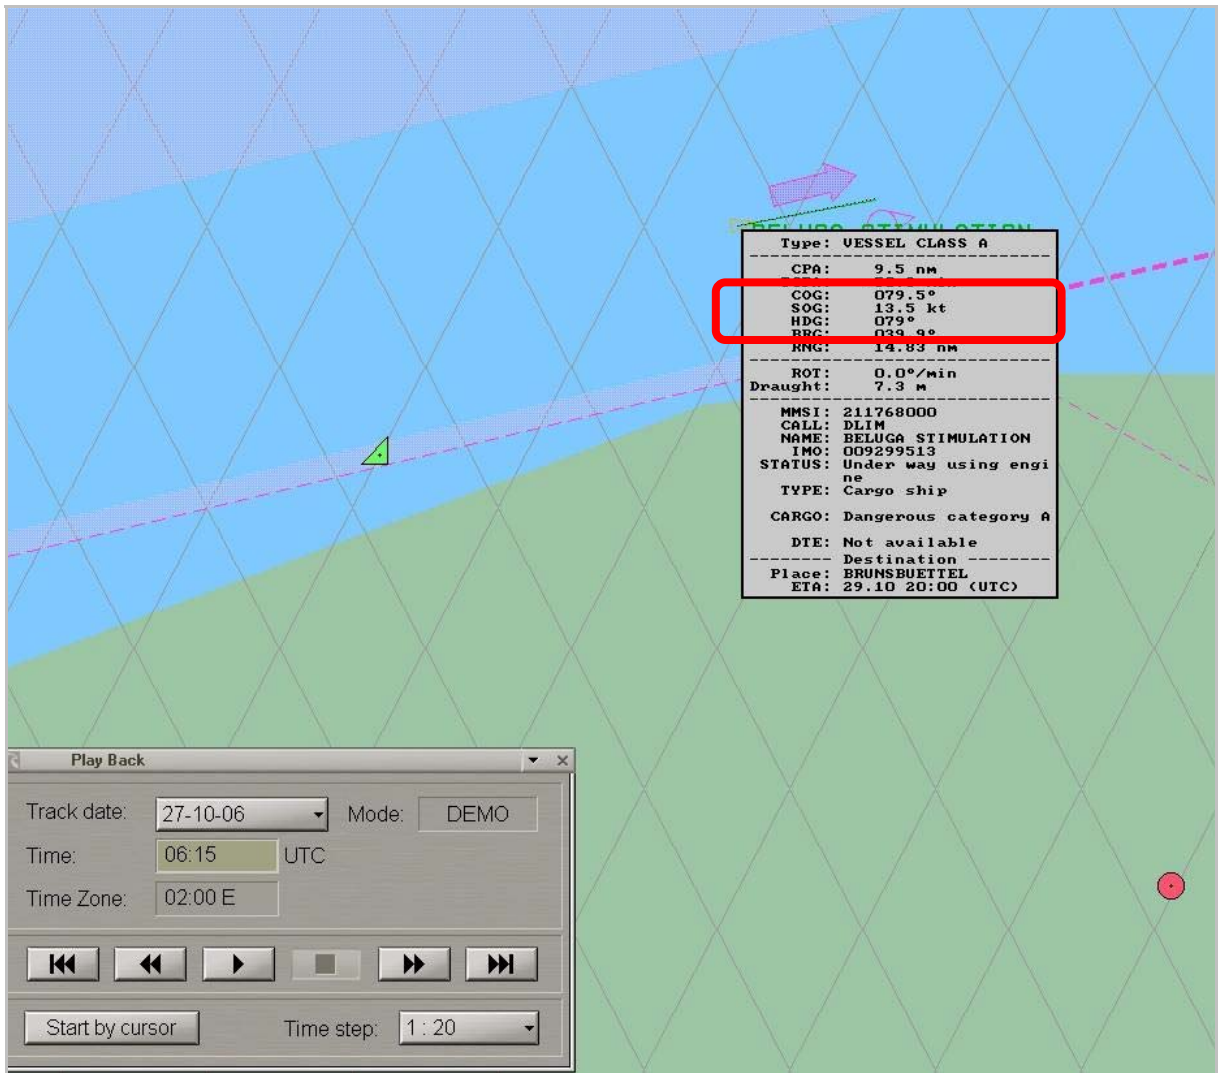
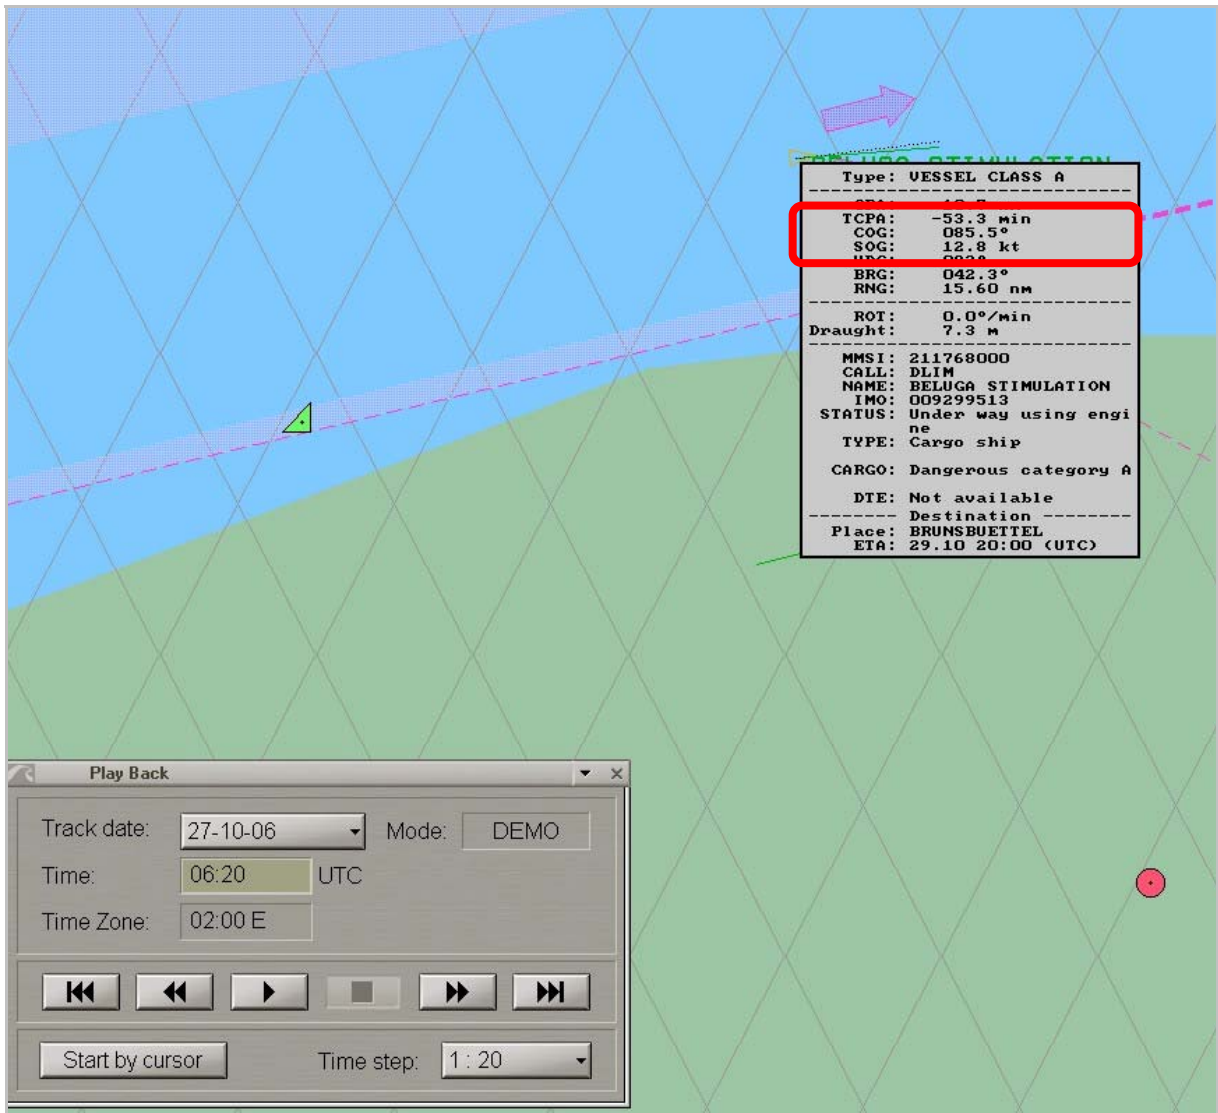
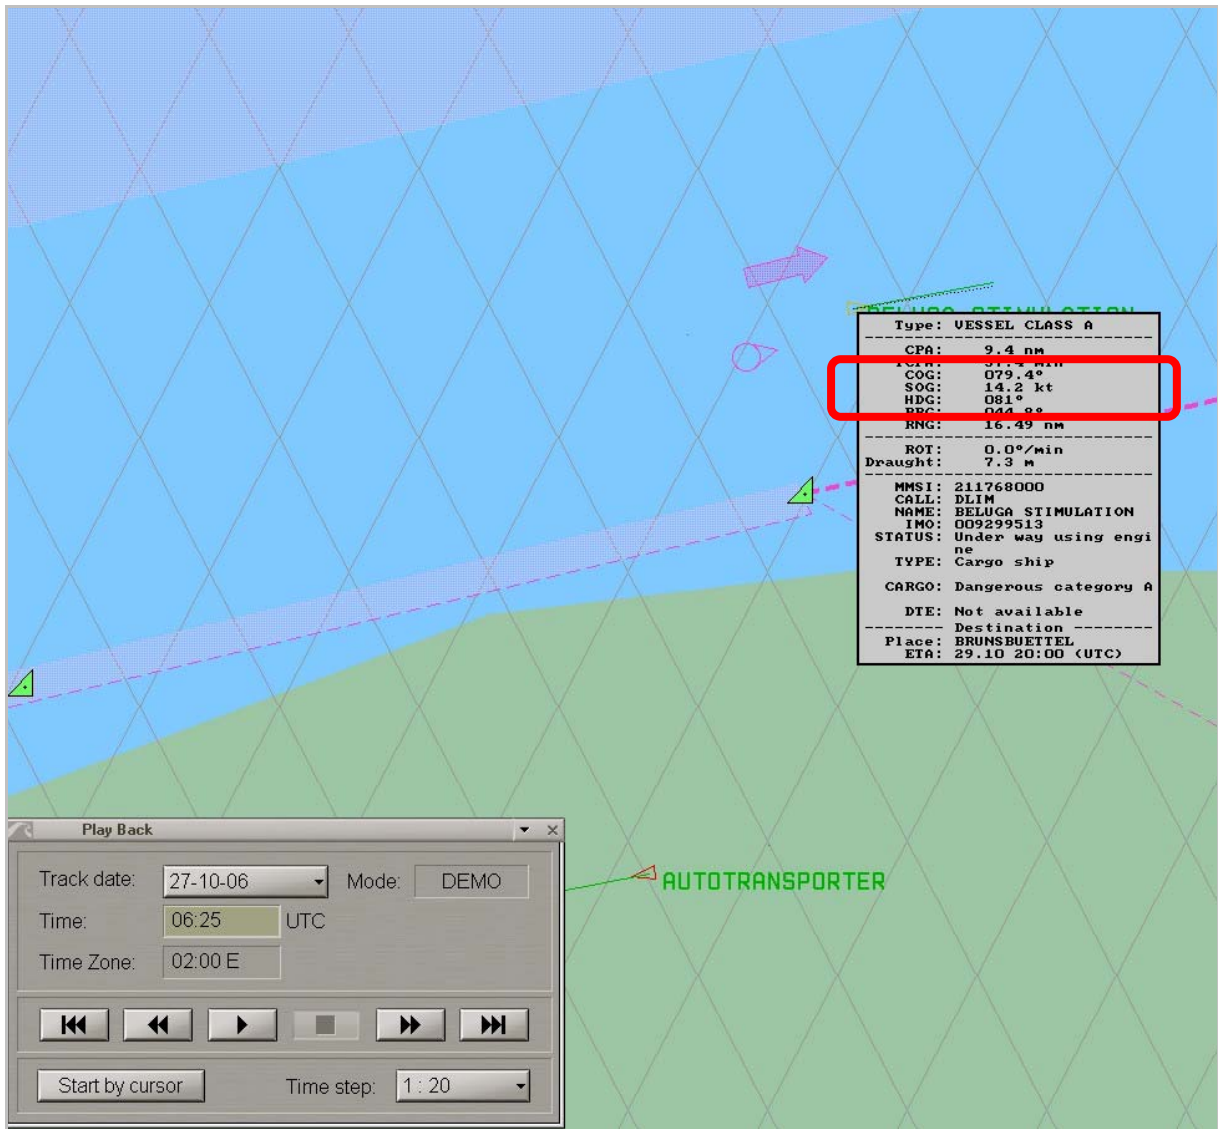
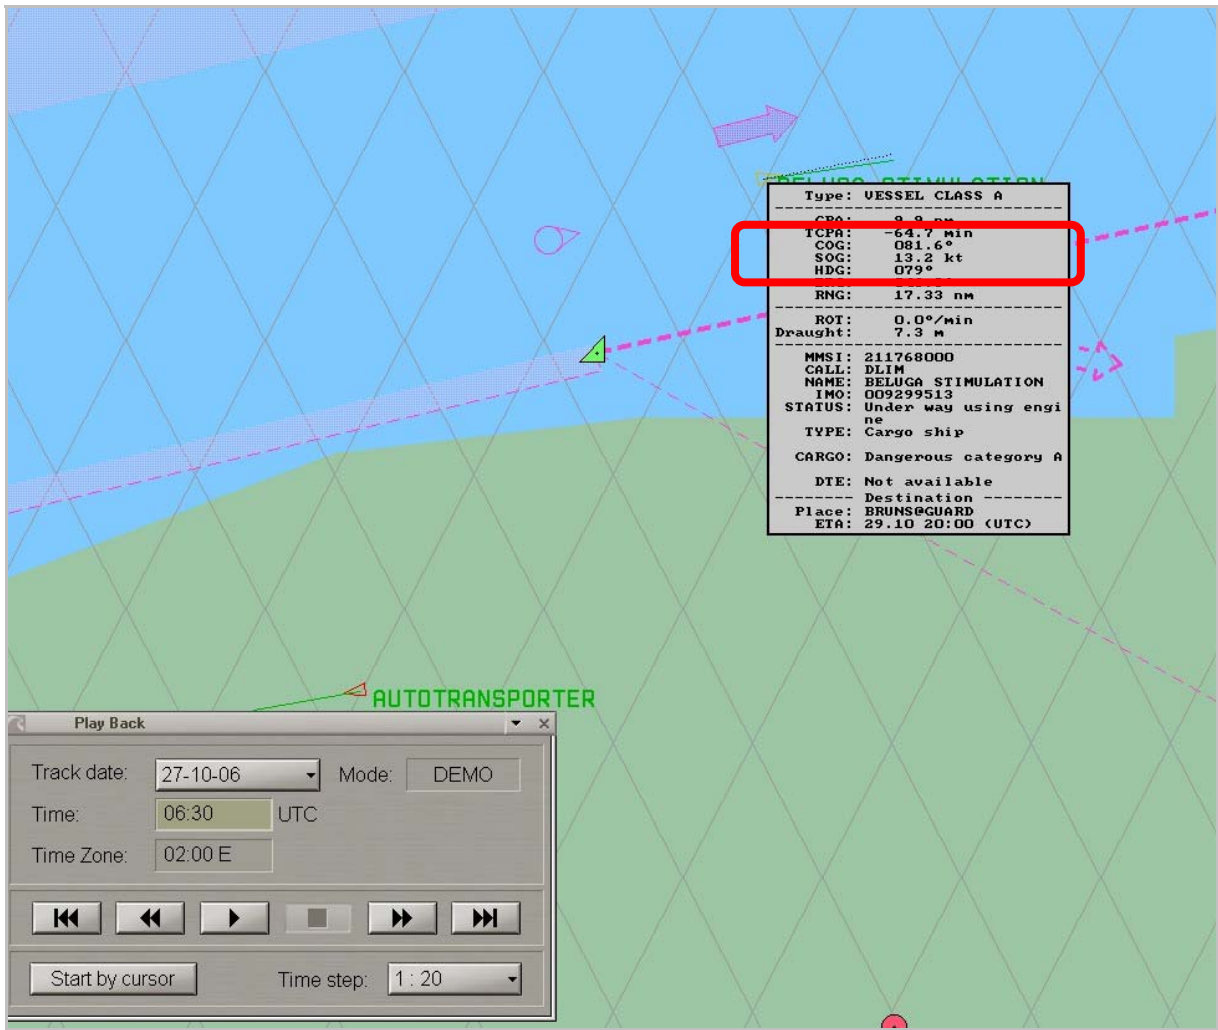
Apart from a tabular listing of courses and speeds, the VTS Centre Wilhelmshaven supplied the following plots with the course of the voyage of the BELUGA STIMULATION beginning a half an hour before the accident. The AIS data of the vessel recorded here, confirm that the vessel neither changed its course or speed to make it easier to walk the forecandle prior to the accident or to support rescue measures after the fall overboard.
