Investigation Report 564/06

Very serious marine casualty

**Foundering of the Fishing Vessel HOHEWEG
on 8 November 2006
in the Alte Weser area, western Nordergründe**

15 March 2008

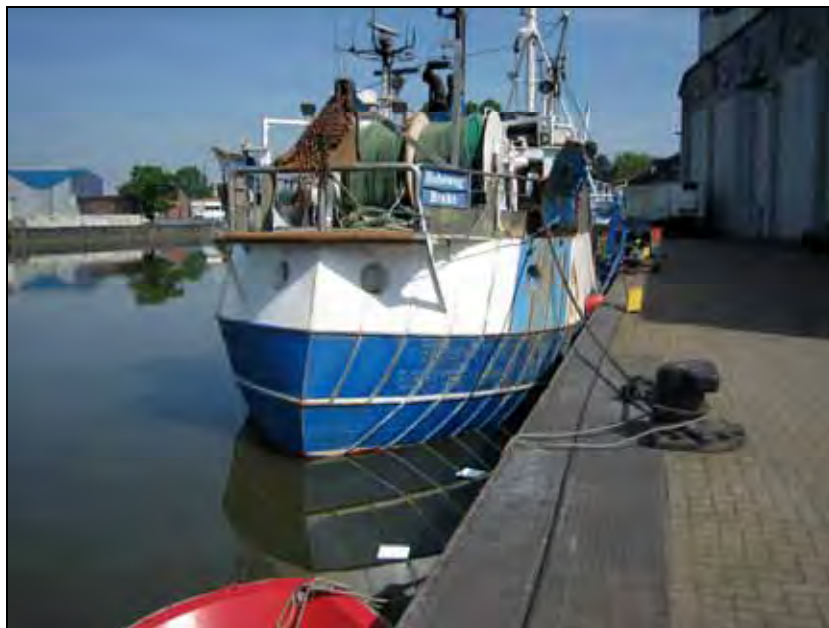
Figure 3: Fitting out condition 9 June 2006

With this work Fishing Vessel HOHEWEG was re-equipped from a side trawler to a "stern trawler"⁵. Basically, with this altered catching method fishing is carried out with three trawl warps and two nets instead of only two trawl warps and one net. For this purpose a net winch with two rollers including the launch device, chains and rollers was installed on the poop deck directly aft of the wheelhouse. The trawl boards were stowed above poop deck height on the port and starboard sides aft on the railing on newly installed massive holders. The old trawl warp winch with two warp drums and a net roller stood on the main deck in the fore-and-aft line of the vessel and was replaced by a winch arranged crossways on the vessel with three drums, a hydraulic system and foundations. The changed catching method made it necessary to install additional rollers and guide pulleys on steel foundations on the forecastle deck for the catching gear. Behind this, on a level with the main deck, a heavy steel rail mounted in approx. 1980, running all round and used as a towing carrier was removed, as well as the fish-processing material installed on the main deck after the heeling test in 1974 and the slaughtering machine. In the way of the fish hatches beneath the weatherguard on the port side, the new fish-processing installation consisting of conveyor belts, washing drum, water container and slaughtering table was installed. All wooden boards of the fish pounds were also taken from on board the vessel. In order to not to have to carry so much dry ice when running out, a cooling aggregate and cooling coils were installed in fish hold number 2 under the forecastle.

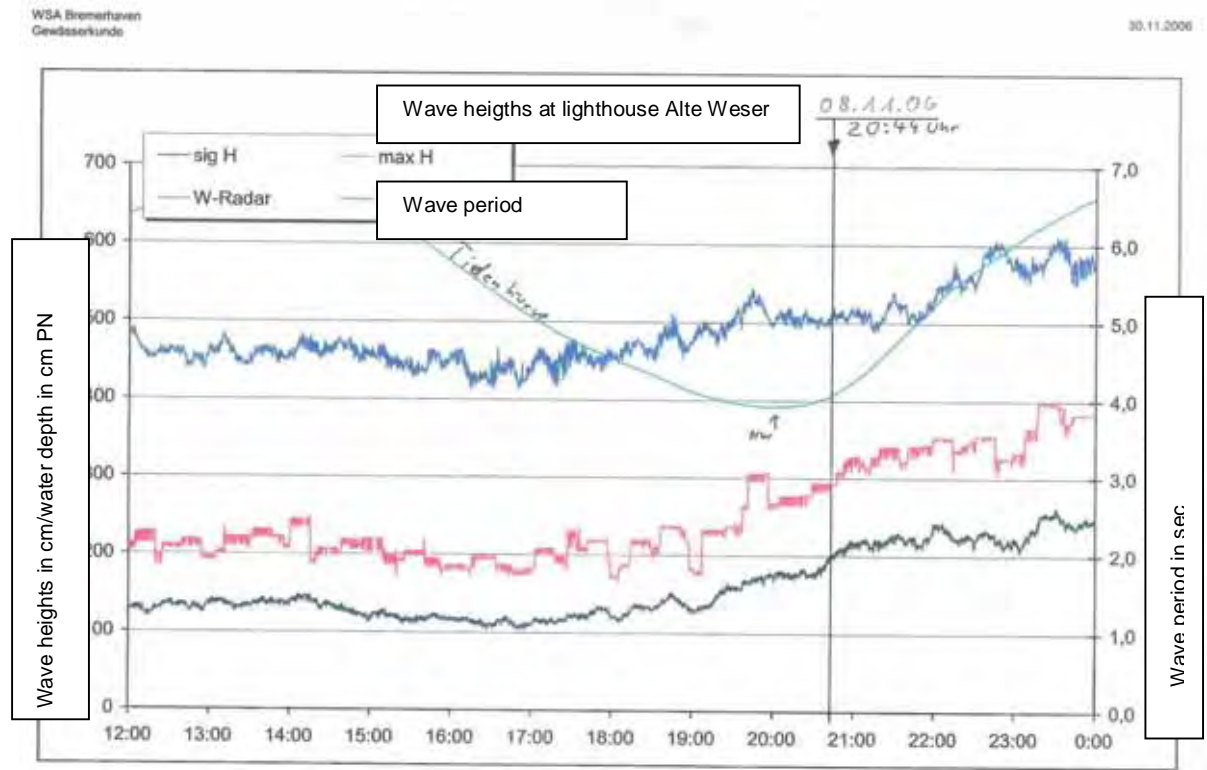
Figure 5: Wave heights on 8 November 2006 at Alte Weser Lighthouse

In the following figures the greenish continuous curve shows the tide curve, the upper bluish curve shows the wave period in seconds, the reddish curve the maximum wave height in centimetres, and the lower dark-blue curve the significant wave height also in centimetres. It can be seen from the representations that at the time of the casualty, an average wave height of 2 m and a maximum wave height of 3 m were measured at Alte Weser Lighthouse. The tide curve shows rising water and a wave period of one wave every 5 seconds.

The wave length is not recorded at Alte Weser Lighthouse. According to the Nordsee Handbuch (North Sea Sailing Directions) of the BSH (Federal Maritime and Hydrographic Agency), Eastern Part, for a wave period of about 5 sec. a wave length of 25 m to 40 m is stated. In literature (BARTHEL 1979, DIETZE 1989), the wave length is stated with mathematical functions with which the wave length can be roughly calculated on the basis of the wave period. For the Outer Weser there are the two equations: $L [m] \approx T^2 [sec]$ and $L [m] \approx 1.56 \times T^2 [sec]$. The application of these two functions leads to a result comparable with the BSH (Federal Maritime and Hydrographic Agency) North Sea Sailing Directions.

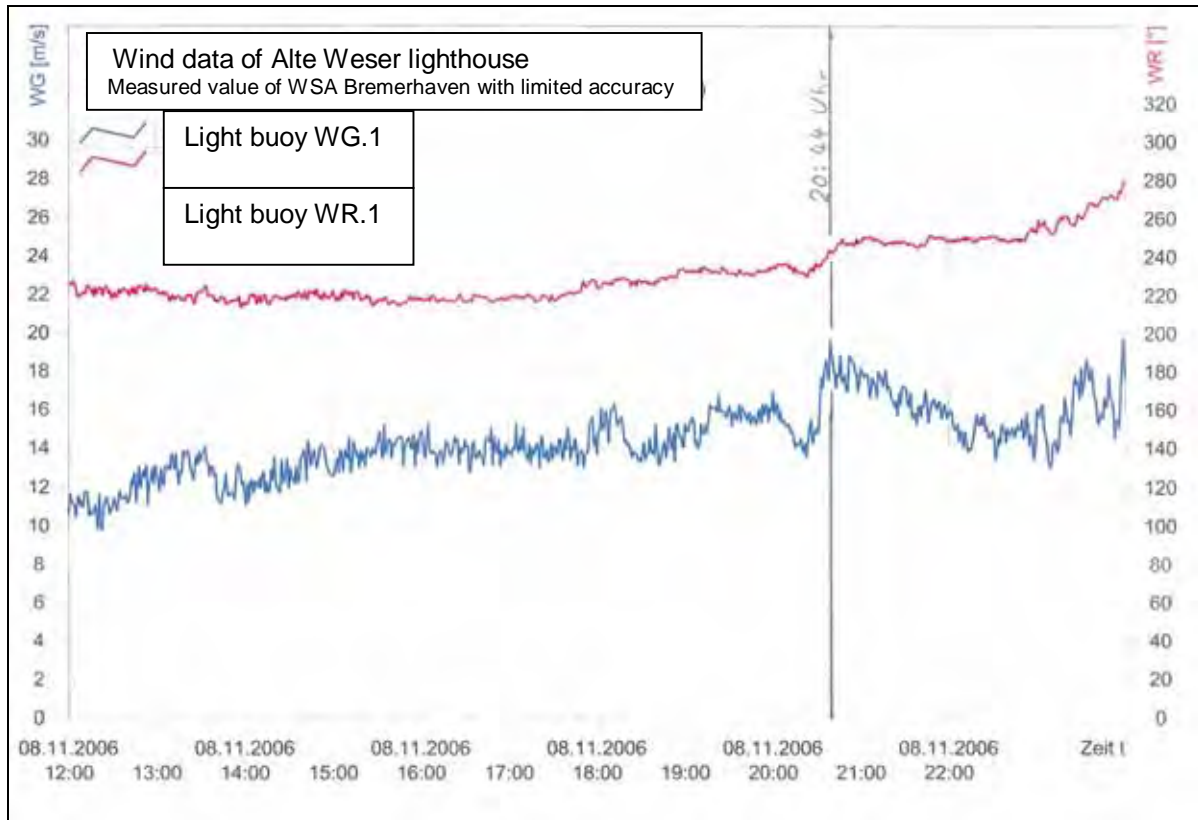
Figure 6: Wind direction and force at Alte Weser Lighthouse

Related to the time of the casualty at 20.44 h, a wind direction of 243 degrees can be read off at Alte Weser Lighthouse. The wind force was between 17.5 m/s and 19.5 m/s, corresponding to a wind force of 8 Bft.

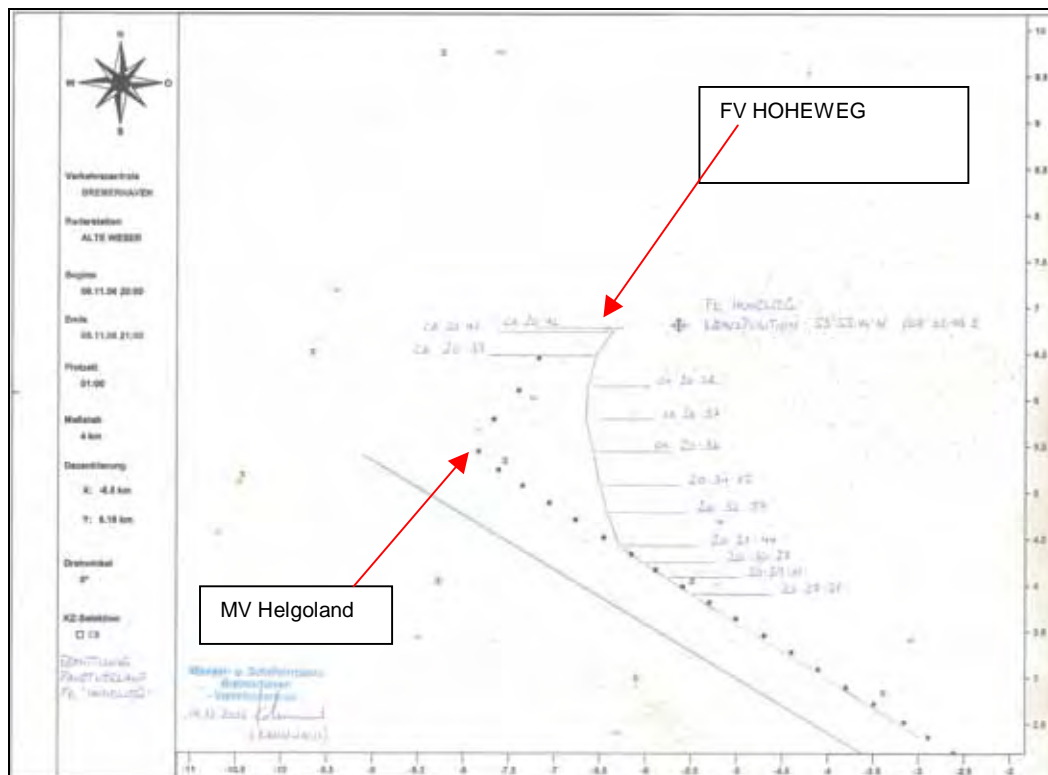
Figure 7: VTS data course of voyage

On the basis of its size, FV HOHEWEG was not announced to VTS Bremerhaven and was therefore not issued with any tracking sign. After the event, the recordings were evaluated and set out as follows. The final recording from radar station Alte Weser of VTS Bremerhaven was accordingly registered at 20.42 h.

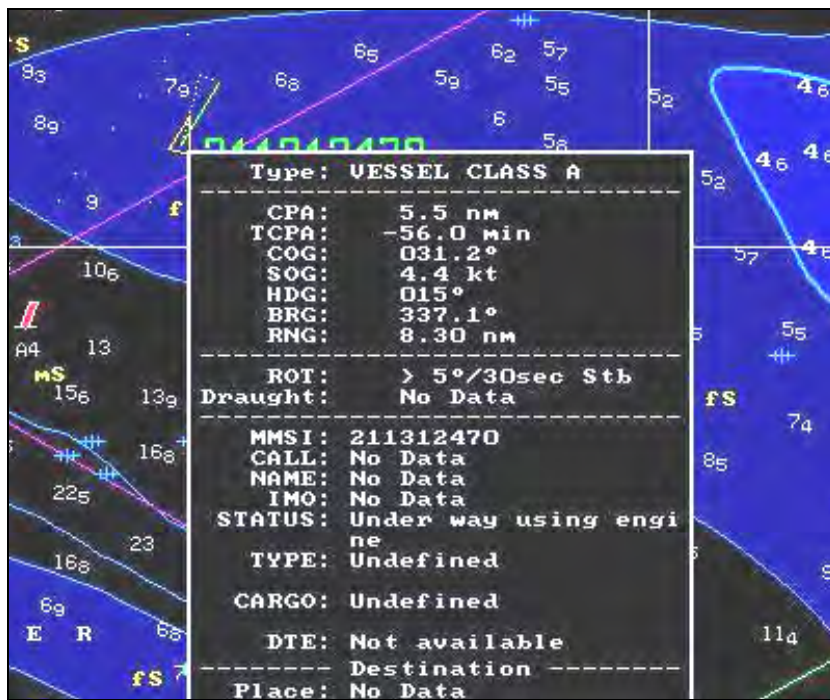
On Fig. No. 4 the FV can be seen at 20.42 h with the following data:

COG = 031.2°
 SOG = 4.4 kt
 HDG = 015°

Here a distinct reduction in the speed of travel from 9.3 kn (kt) on Fig. No. 3 to now 4.4 kn can be seen.

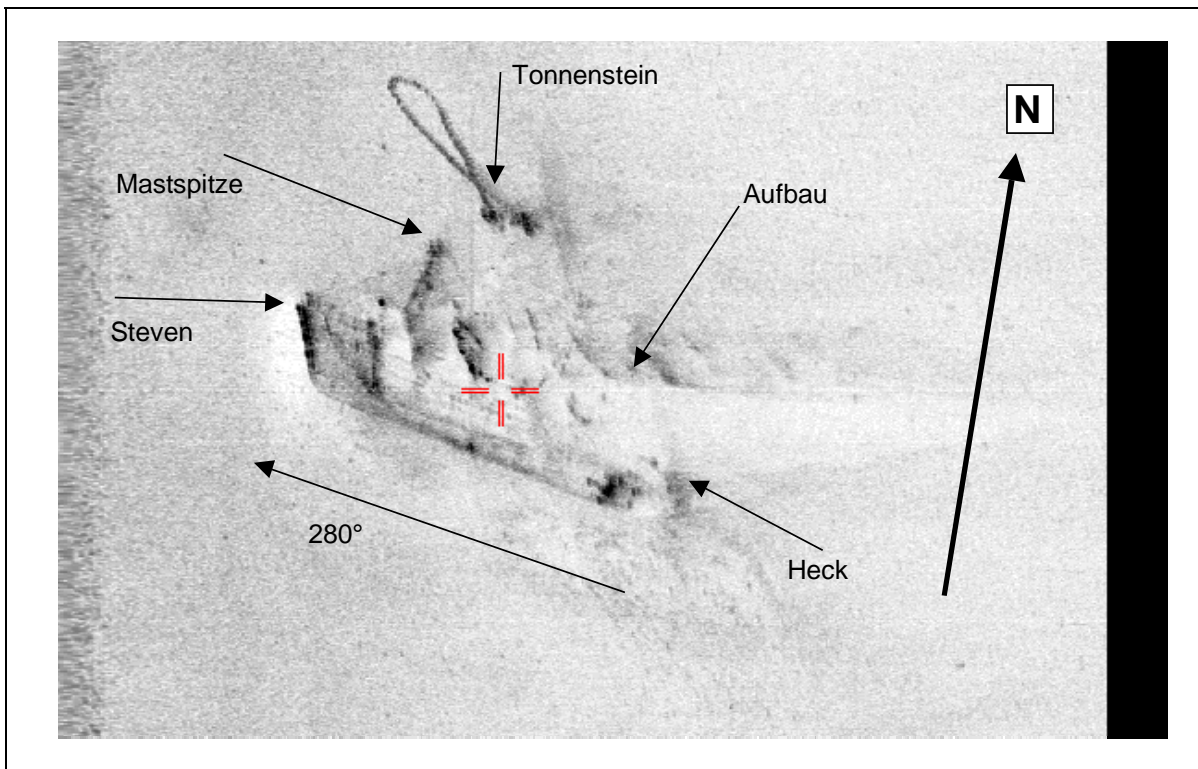
Figure 13: Side-Scan-Sonar image

Also because of the weather it was not possible to send down divers at once to examine the wreck more closely. The first and second diving assignment thus only took place on 17 November 2006 at under-water visibilities of 10 cm to 50 cm. The vessel was reported to be lying at a water depth of approx. 7 m on its starboard side with the stem in 280° and the stern in a direction of 100°. No damage could be ascertained on the hull, superstructures and rudder blade. The rudder was lying at approx. 15° to starboard. The fore mast with the stays was intact. The trawl board on the port side aft and the anchor on the port side forward were missing.

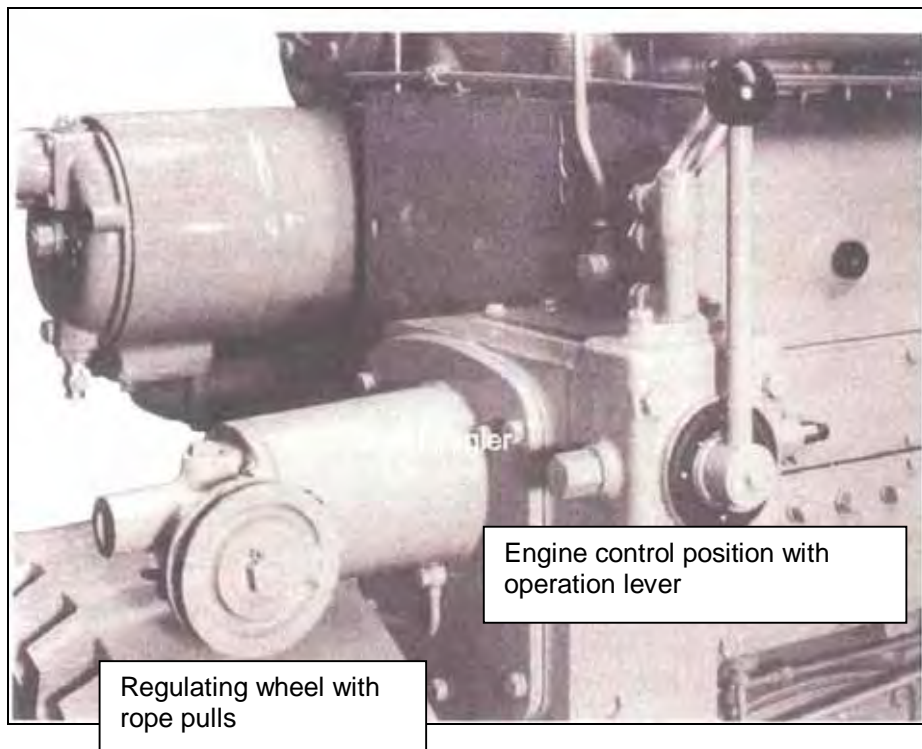
Figure 26: Engine control position

The engine can only be started from the engine room. Figure 26 shows the series-mounted conning position on the engine with operating lever serving to start and start-up the engine.

On the bridge next to the control lever a threaded spindle and adjusting nut are also arranged that are connected with the rope pull to the speed regulator. This setting arrangement is not standard and was retrofitted later in order to be able to change the engine speed in idling position too, i.e. with the propeller shaft uncoupled, for example if the engine is only to be used to drive the oilpump for the deck winches coupled to the transmission.

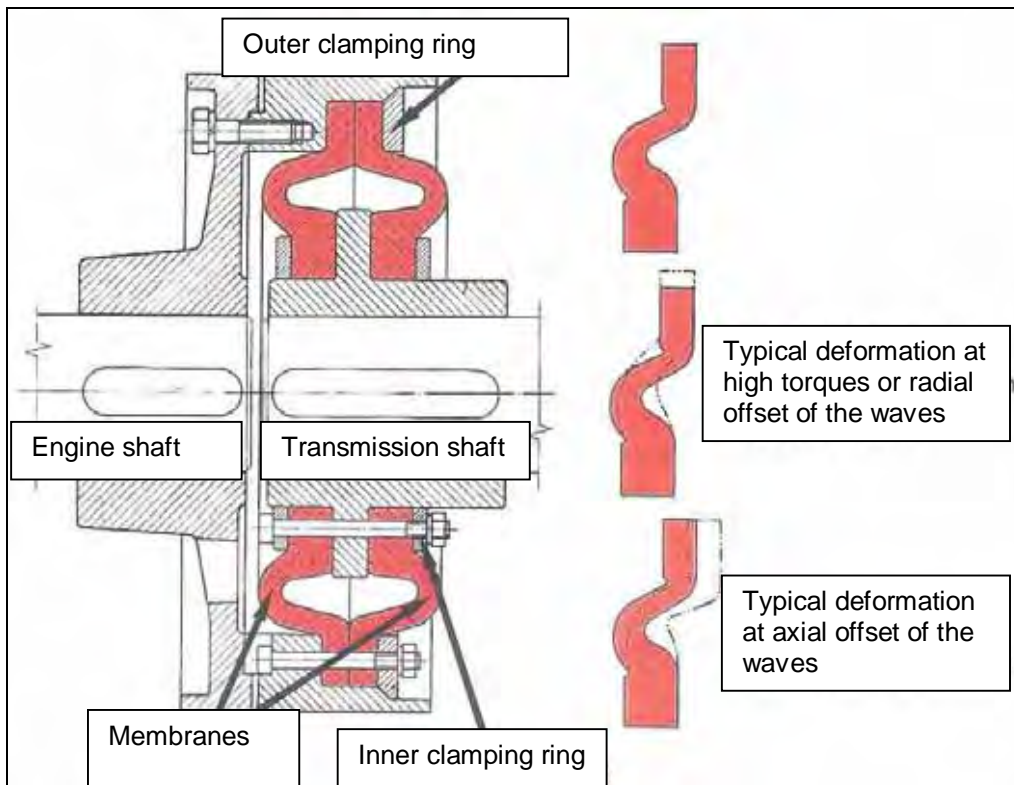
Figure 29: VULKAN EZ coupling

The power is transmitted by tensile forces inside the membranes which is why after a relatively long operating time typical permanent deformations can occur in the membranes. Conversely, jerky overloads can lead to the formation of cracks in the membranes that are visible on the surface.

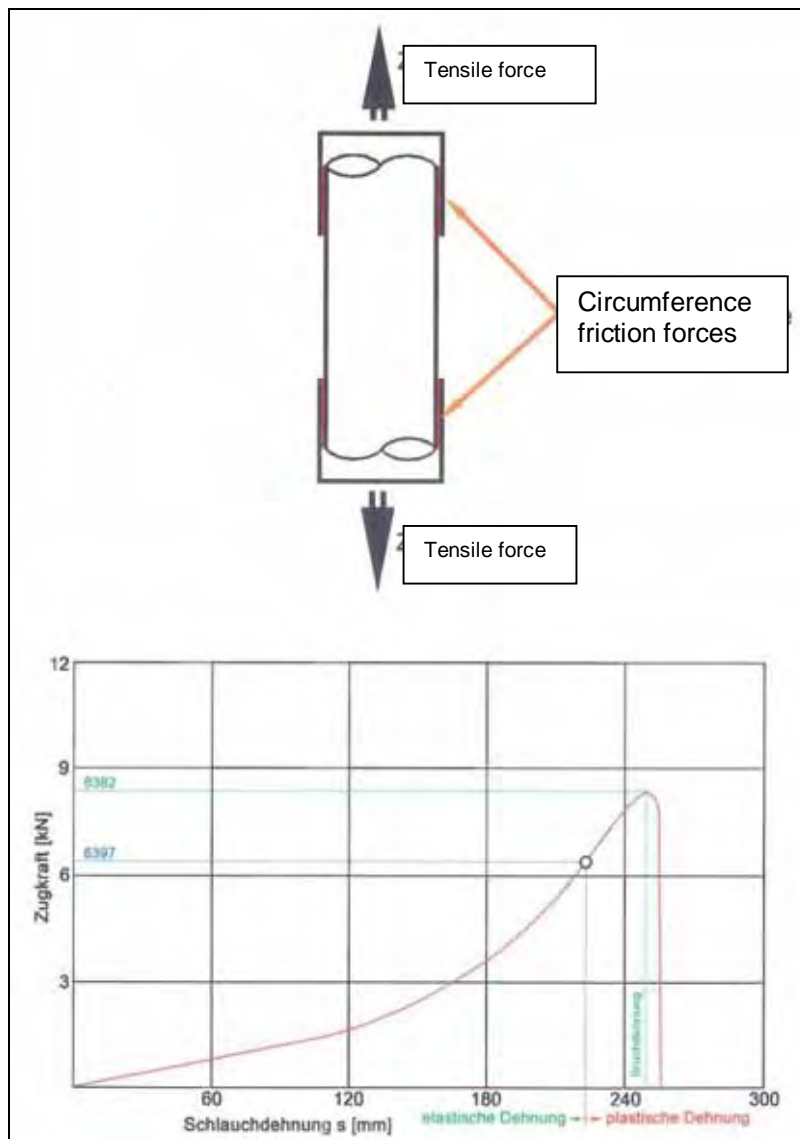
Figure 36: Tensile force and tensile length diagram

Strong crack formation starts in the hose jacket from a tensile force of approx. 6500 N onwards. At a tensile force of 8382 N the hose jacket became completely detached from the fabric in the way of the clamping device; it was not possible to increase the tensile force any further.

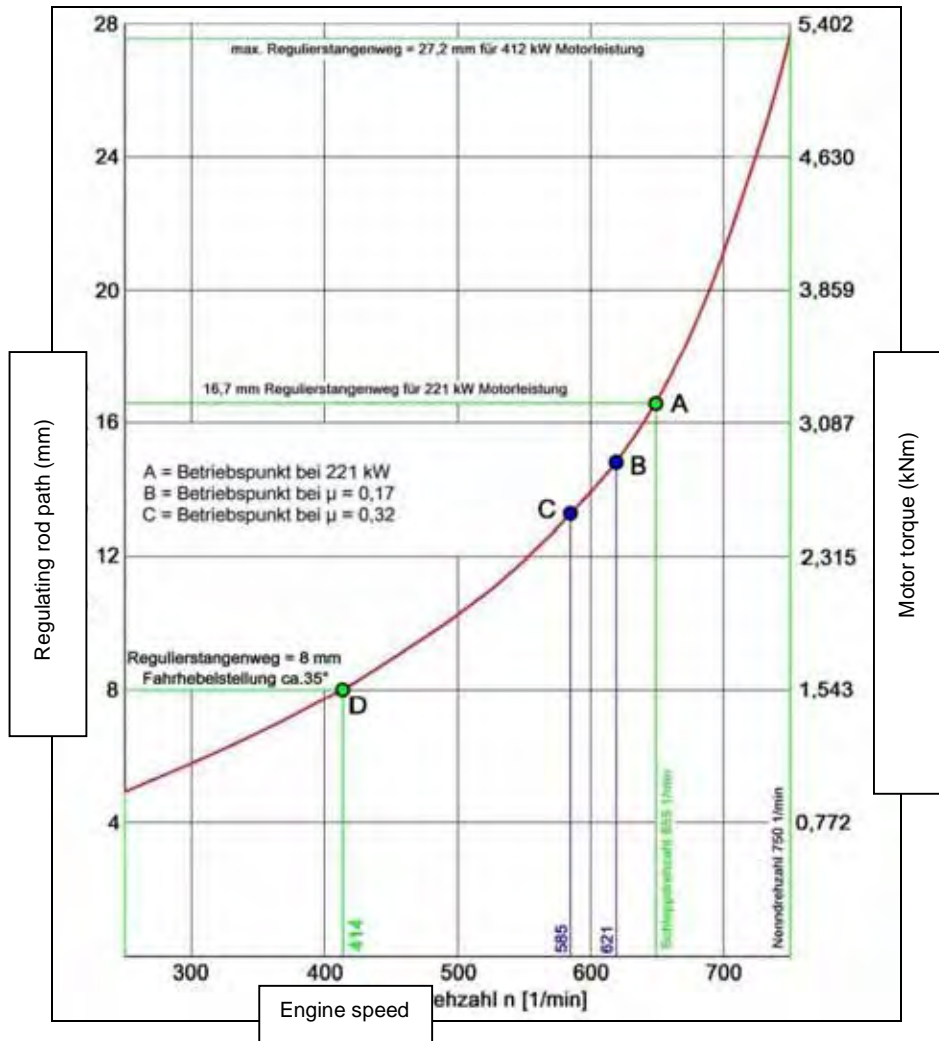
Figure 38: Operating points of the facility

The hose is in turn caught by the propeller, but the friction force at the propeller is now determined more strongly by the mixed friction than by the sliding friction. A higher relative additional torque is now confronted by a lower stored rotation energy. Accordingly the short-term reduction in speed becomes larger. The speed regulator promptly increases the filling up to the stop level of 16.7 mm in order to balance the speed loss, at the same time the combustion air ratio drops strongly. As a result of the speed reduction and the regulator intervention the filling remains above the initial level even after the additional torque is no longer applied and returns to the starting position with a time lag with rising engine speed. However, the air ratio is still

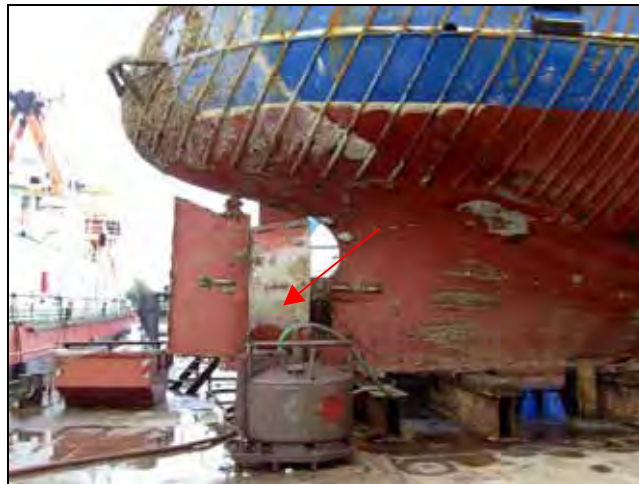
Figure 39: Kort nozzle

A Kort nozzle was installed in the year 1980. The Kort nozzle was weighed and the weight was established as 1.13 t.

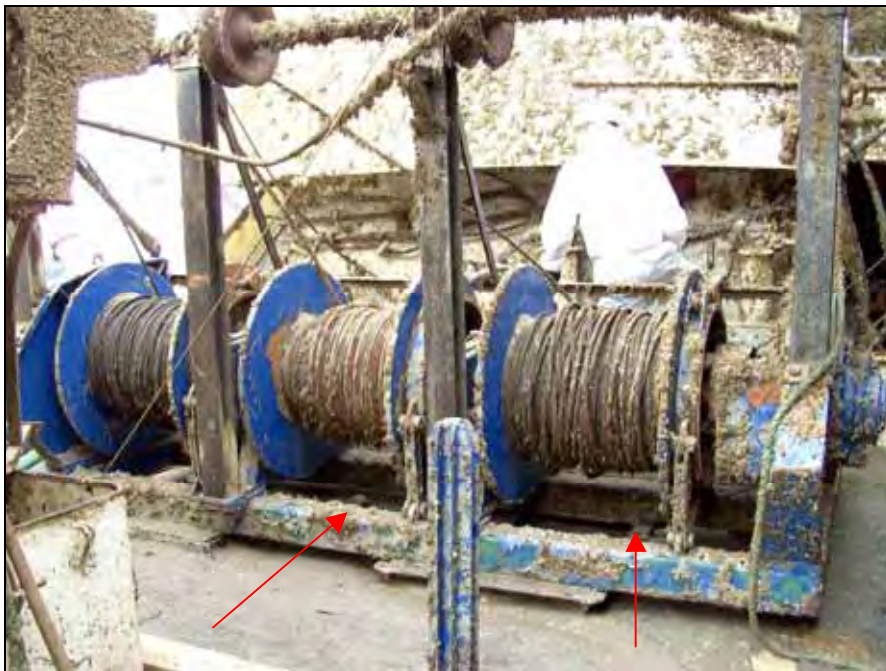
Figure 41: Trawl warp winch with foundation

However, in connection with this conversion this winch was mounted raised on a new foundation with light grating. These masses of the foundations and the centre of gravity could be determined. Furthermore, a guide pulley with bracket was mounted above the stack for the net warp. Additional total weight: 0.66 t.

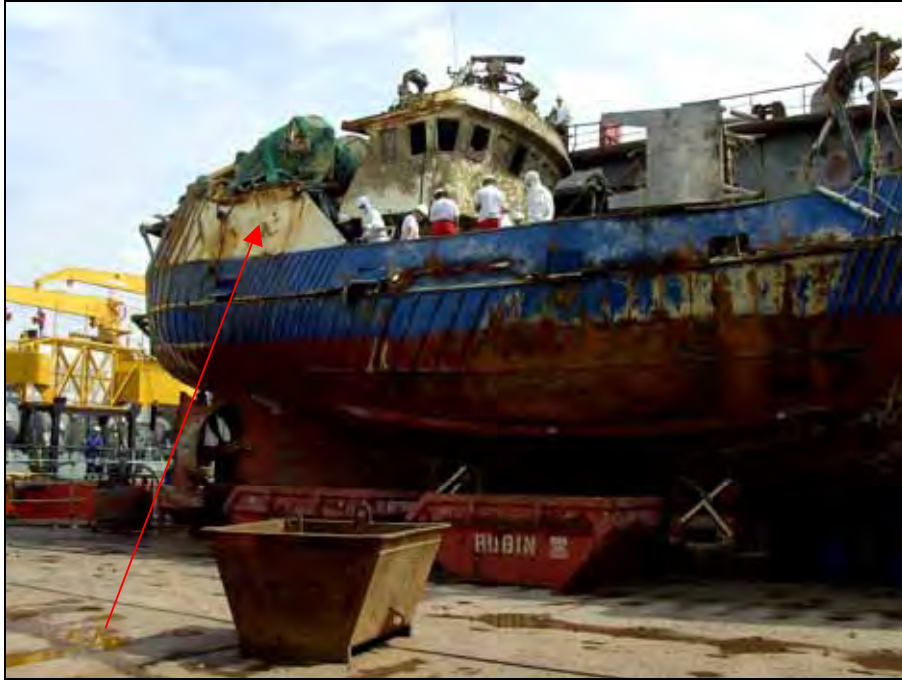
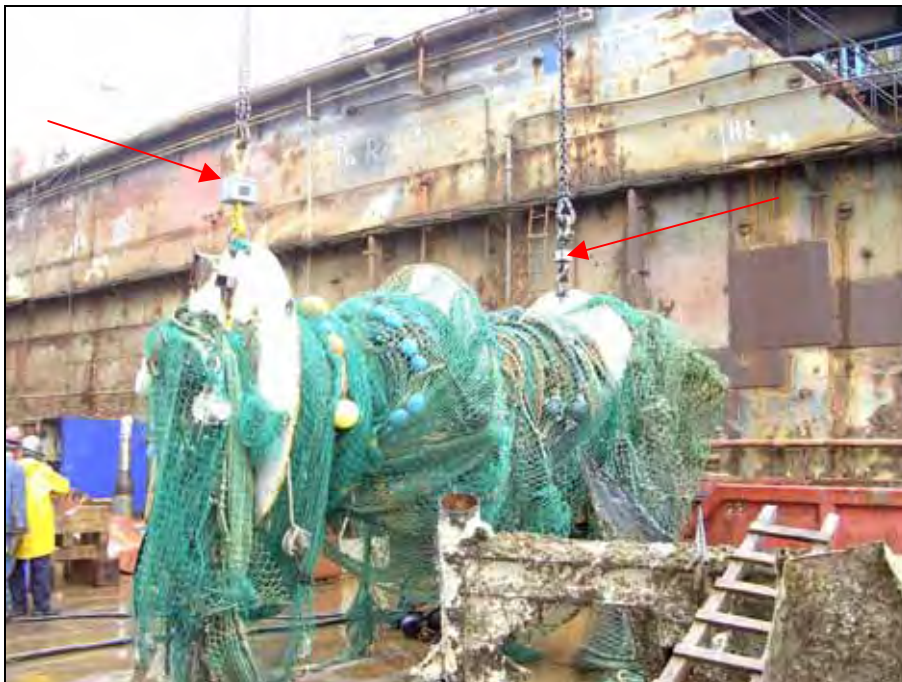
The largest conversion was carried out on the poop deck in 2003/2004 by mounting a new net winch with two drums, complete with foundations and side brackets for the trawl warp blocks. In addition a hauling-up facility and a transom guard were installed at the transom. The masses and centre of gravity of the winch with coiled net and the side blocks and trawl warp guides as well as the foundations were measured. The total weight was 9.40 t.

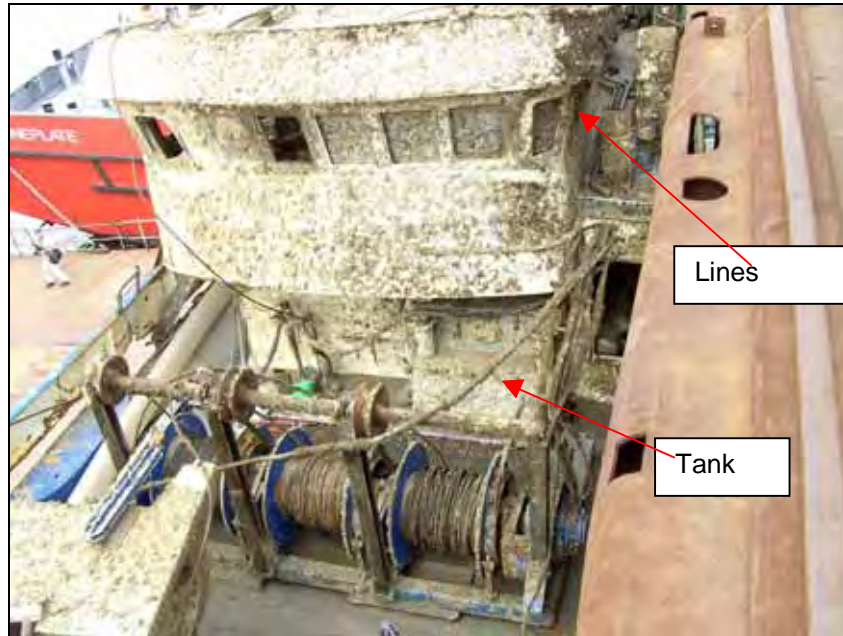
Figure 47: Hydraulic system

An additional hydraulic set with tank and lines weighing 1.19 t was installed on the poop deck to actuate the net winch.

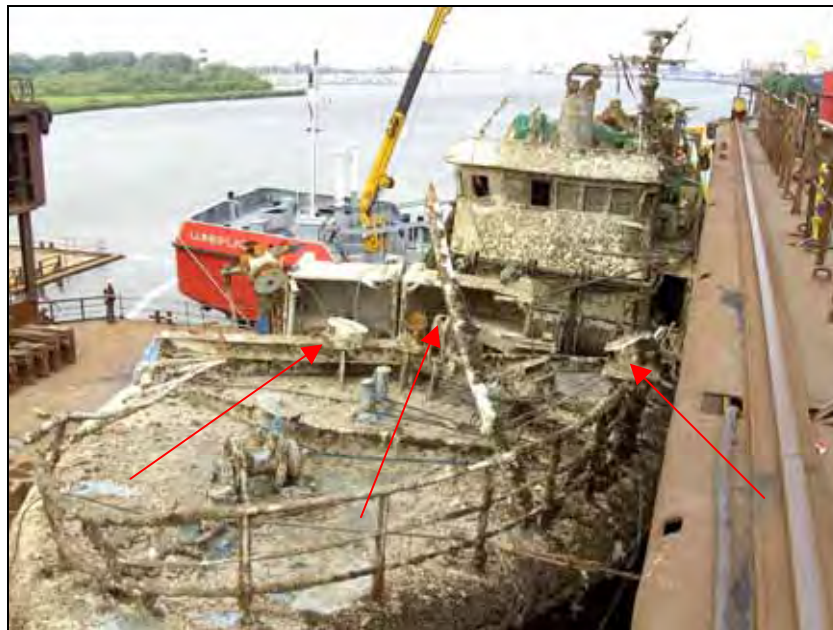
Figure 48: Supports with guide rollers

At the time of conversion in 2003/2004 a support with guide pulleys was mounted on the forecastle for the trawl warp guidance, weight 1.31 t.

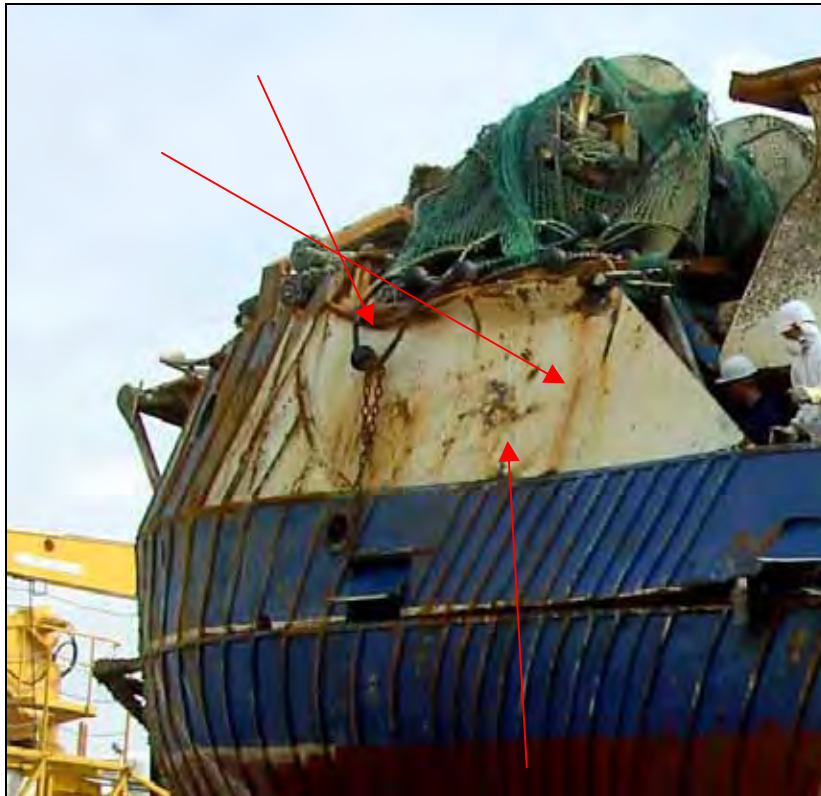
Figure 49: Extension of poop deck, close at side

In order to accommodate the net winch on the poop and as a holder for the starboard trawl board, the poop deck and side plating were extended in 2003/2004. Additional weight: 0.26 t.

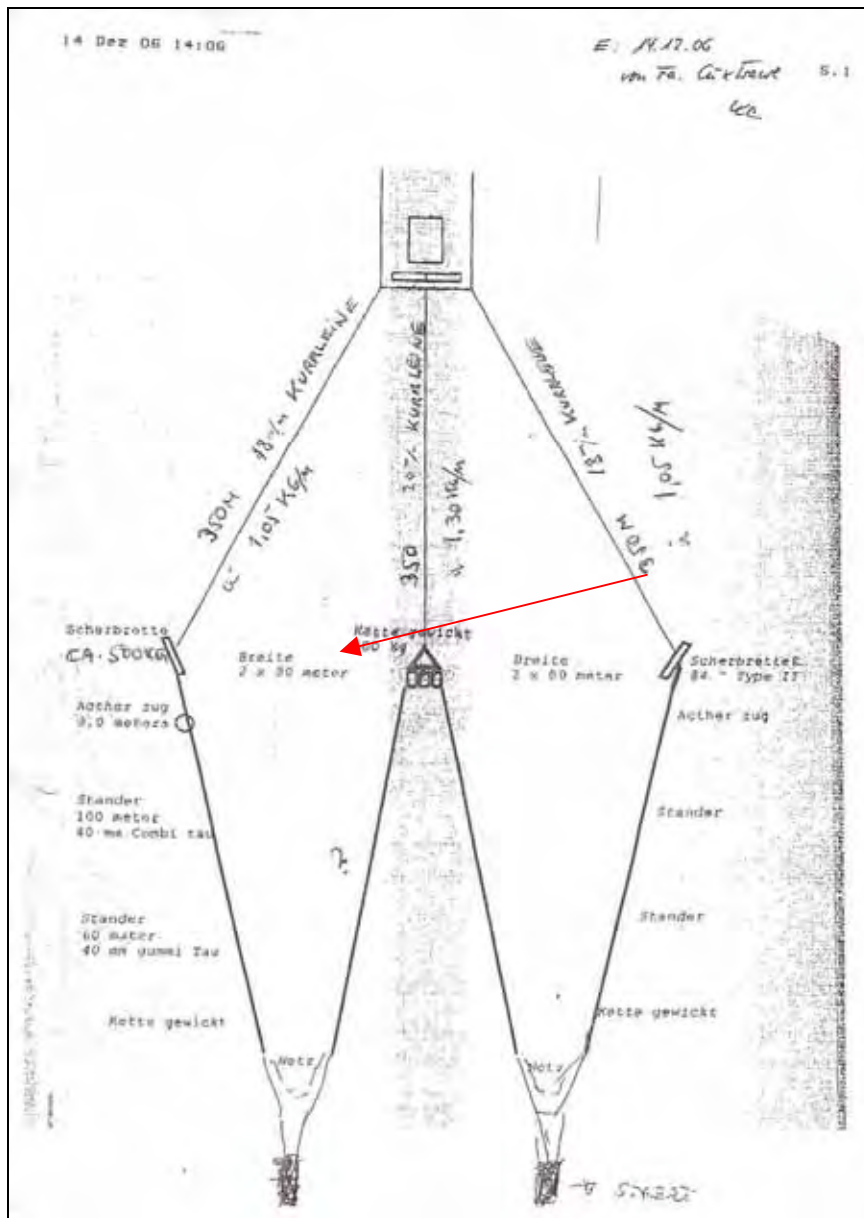
Figure 52: Net arrangement with weights and trawl board

As a result of the change in catching method, the trawl boards were no longer run on the gallows on the main deck, but instead at the time of the casualty were hanging on their brackets aft on the poop deck. The trawl boards with a total weight of 1 t were accordingly arranged with a centre of gravity approx. 2.5 m upwards.

In order to draw the net down an additional chain weight of 400 kg was run on the middle trawl warp.

The chain weight and also the starboard trawl board were not salvaged. The weights were taken from the following sketch of Messrs. CUXTRAWL from Cuxhaven. This sketch also shows the altered catching method and the two renewed port and starboard trawl warps each 350 m long and 18 mm thick.

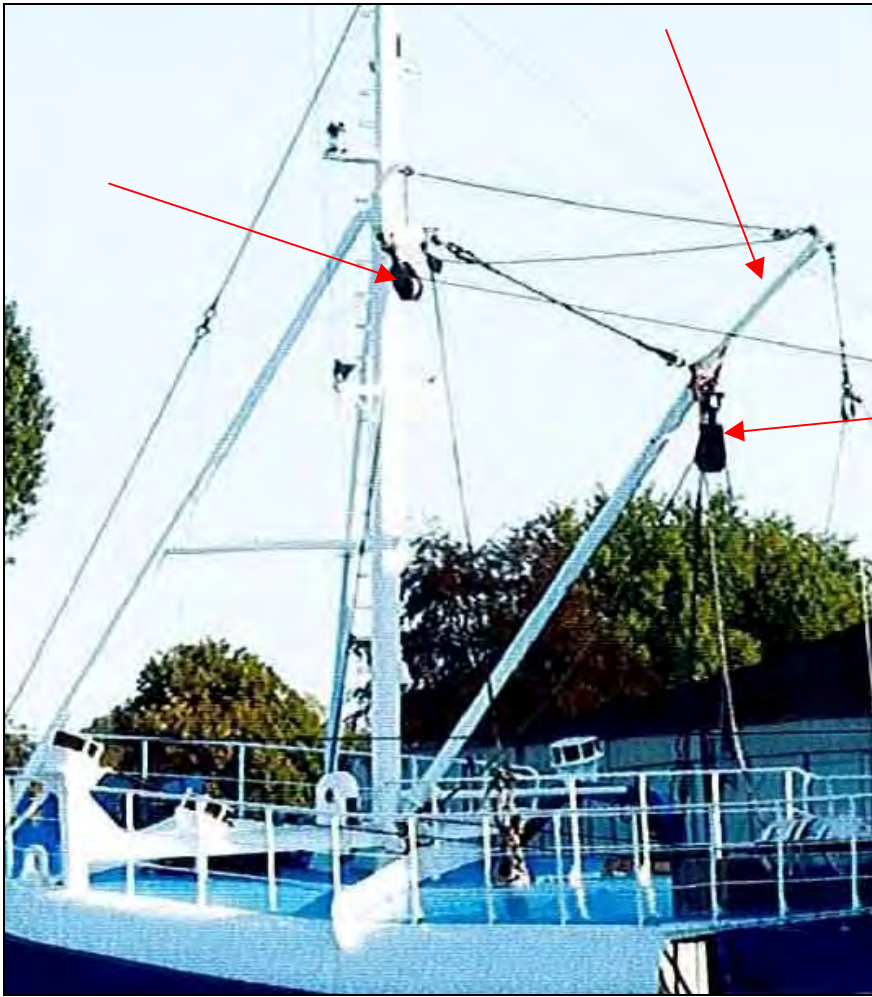
Figure 54: Mast with various pulleys

A boom was mounted on the fore mast as tail gallows and derrick. An additional winch was installed on the main deck below the mast to operate the running rigging on the fore mast. The total weight of the additional blocks, bearings, running rigging and winch was determined as 630 kg.

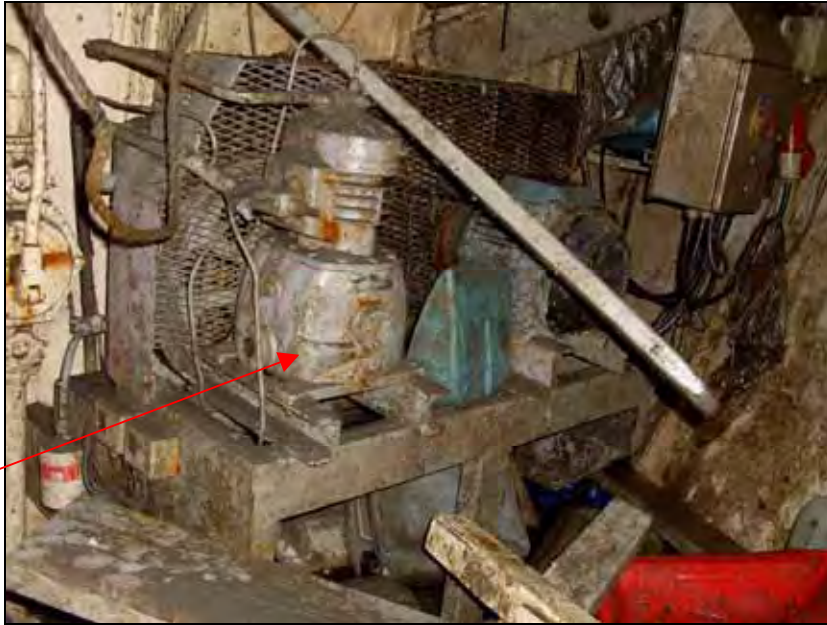
Figure 56: Cooling set

In the course of the operating period a cooling unit was installed in the forward forecastle. In addition the associated cooling coils were mounted on the insulation in the fish hold. The total additional weight amounted to 300 kg.

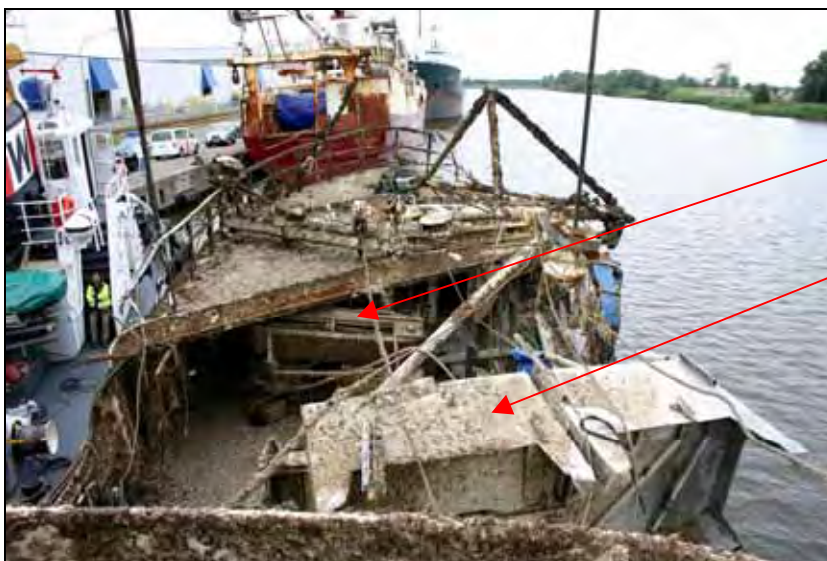
Figure 57: Fish-processing facility

The fish-processing facility with an additional weight of 2.24 t was mounted on the main deck in the way of the fish hatches. The individual weights were weighed and measured after the recovery.

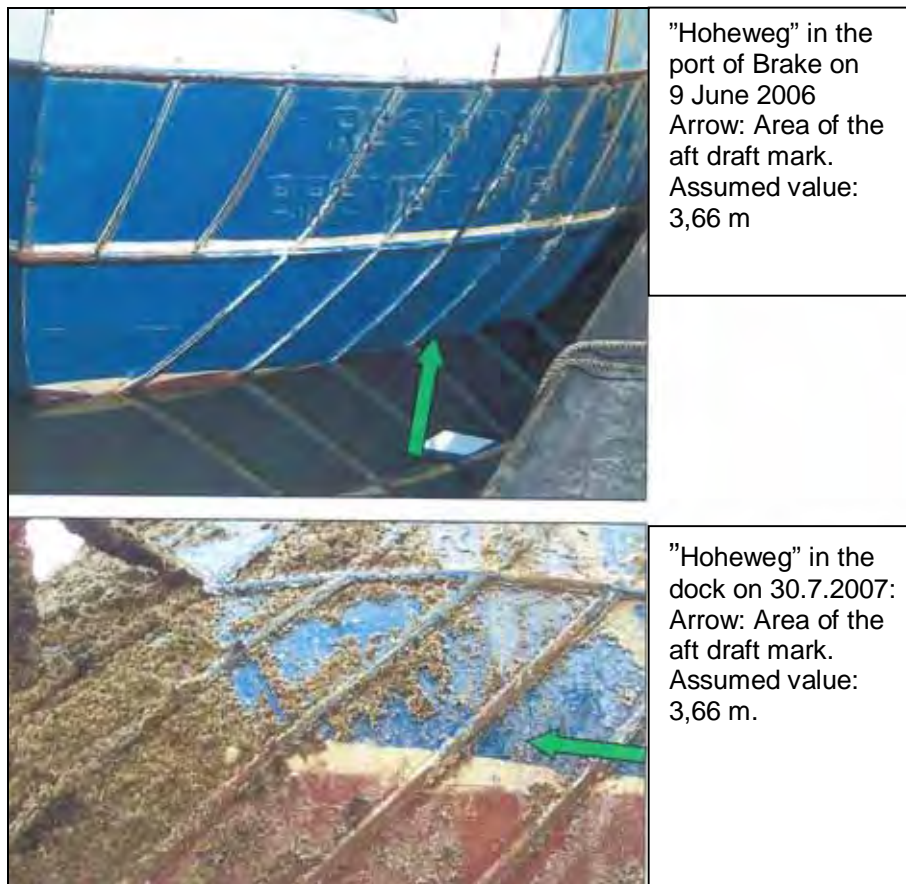
Figure 59: Draft mark aft

The aft draft was determined on the basis of the photos and the draft marks in the dock after salvage as 3.66 m. It was not possible to determine the forward draft precisely in the dock, so that the Institute for Photogrammetry and Geoinformation was commissioned with calculating the forward draft on the basis of the photos taken by the waterway police. The Institute determined the forward draft of 2.37 m by measuring via comparative calculation and evaluating the reflected draft marks on the surface of the water using two different paths.

The mounting of the anchor at the time of the accident was thus presumably not identical with the mounting of the anchor at the time of the survey in July 2005. This is also documented by a photo of the vessel at the pier in Brake (see Fig. 59) that was evidently taken after the last survey by the See-BG and that shows the anchor in the meantime in the hawse pipe on the port side. No traces of the anchor were found on the wreck so that it appears questionable whether the anchor was in fact on board at all.

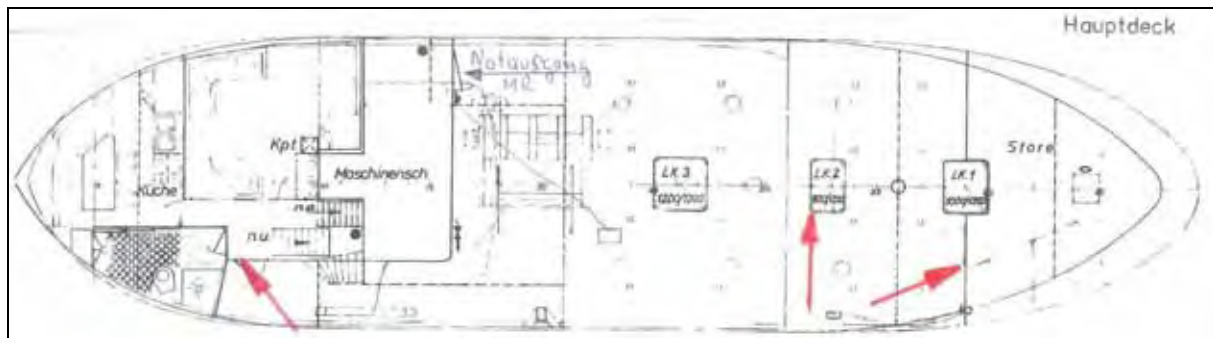
Figure 61: Flooding points

Prior to reaching the maximum range of stability of 33.4°, only the flooding point of the aft superstructure door (3) comes to water at a value of 27.8°. This door in the poop on the starboard side was found on salvage in a non-barred condition. It can therefore be assumed that watertight integrity was thus not established and that additional water made its way into the aft hull of the vessel at this point. This water will have led to accelerated sinking via the starboard side.

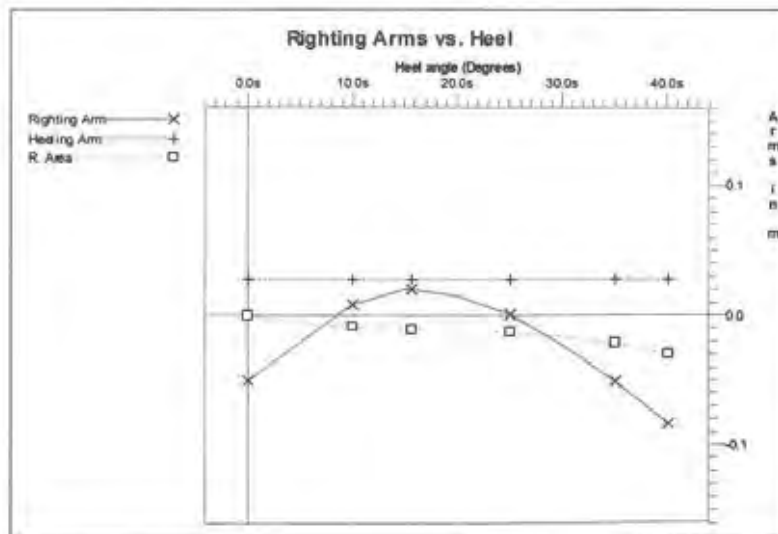
If in addition to the load of wind at 10 Bft and the slipping of the 3 t ice cargo a further moment resulting from the slipping of the 2.24 t heavy fish-processing facility with a side slipping path of 1.5 m to starboard is added, the vessel no longer has any positive righting arms and capsizes to starboard.

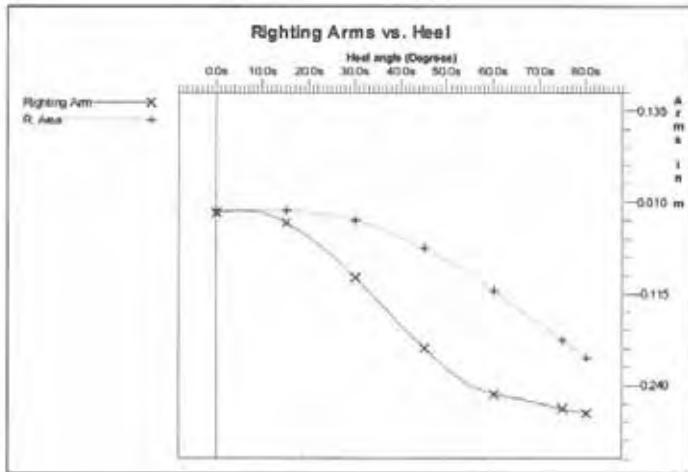
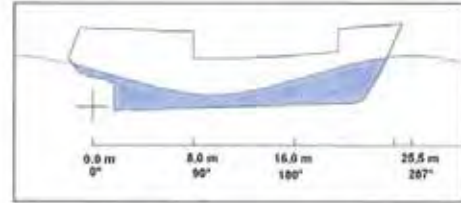
Phase of crest relative to origin:
 225.0 degrees (**20.0 m**)
 Wave length: 32.0 m
 Crest-to-trough height: 3.0 m
 Angle of encounter:
 0 degrees (following sea)

It can be seen on the above figures that the vessel is unstable without any positive righting arm if the wave crest of a 32 m long and 3 m high wave in the vessel's area is between **20.0 m** and **25.5 m** from the aft perpendicular.

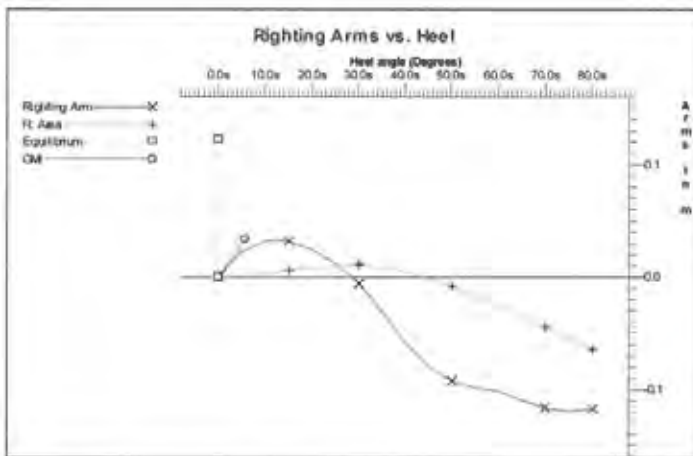
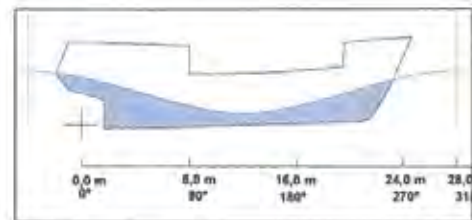
Phase of crest relative to origin:
 287.0 degrees (**25.5 m**)
 Wave length: 32.0 m
 Crest-to-trough height: 3.0 m
 Angle of encounter:
 0 degrees (following sea)

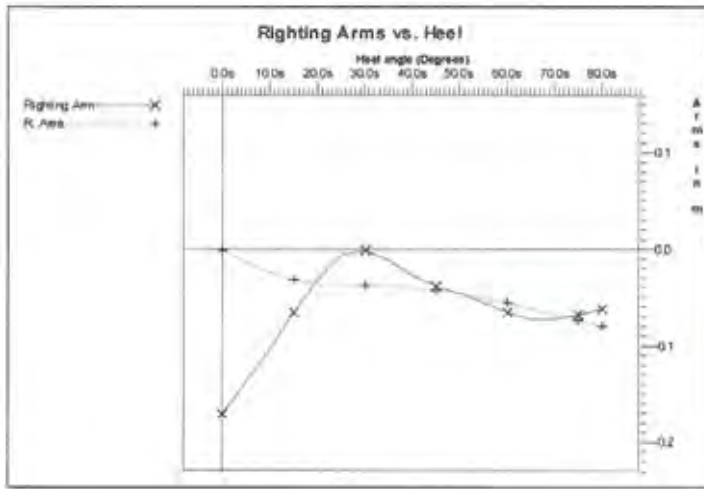
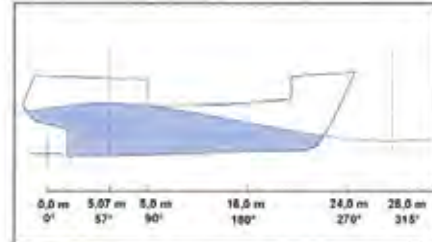
Phase of crest relative to origin:
 57 degrees (**5.07 m**)
 Wave length: 32.0 m
 Crest-to-trough height: 3.0 m
 Angle of encounter:
 -45 degrees (port quartering sea)

The vessel is stable with righting arms if the wave crest of a wave coming up at an angle of 45° from aft on the port side is between **5.07 m** and **24.9 m** from the aft perpendicular in the area of the vessel.

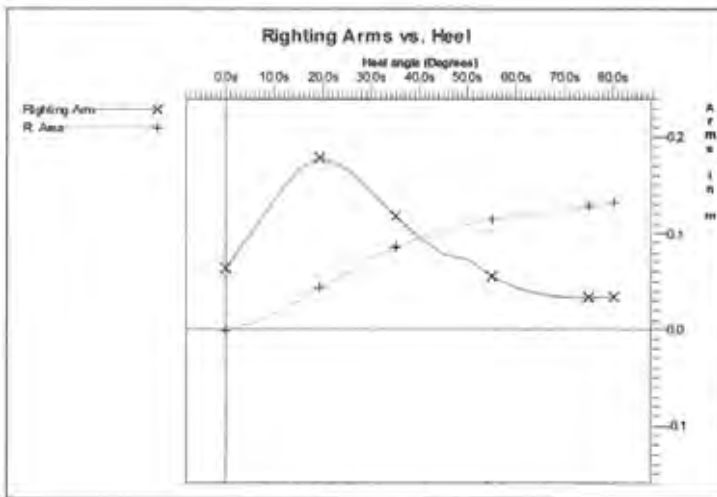
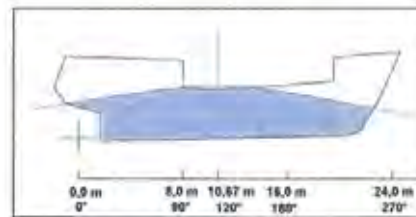
Phase of crest relative to origin:
 120.0 degrees (**10.67 m**)
 Wave length: 32.0 m
 Crest-to-trough height: 3.0 m
 Angle of encounter:
 -45 degrees (port quartering sea)

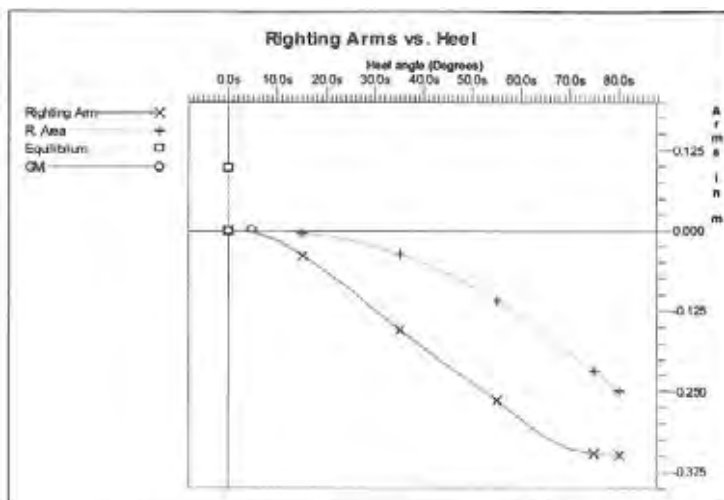
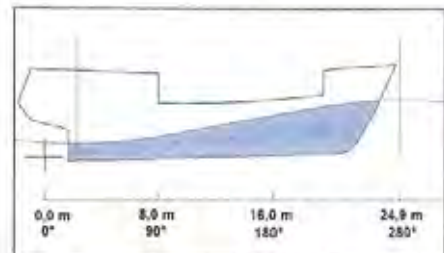
Phase of crest relative to origin:
 280.0 degrees (**24.9 m**)
 Wave length: 32.0 m
 Crest-to-trough height: 3.0 m
 Angle of encounter:
 -45 degrees (port quartering sea)

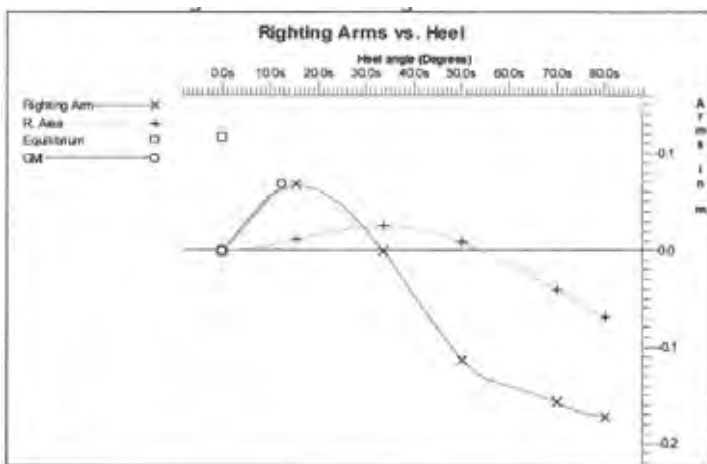
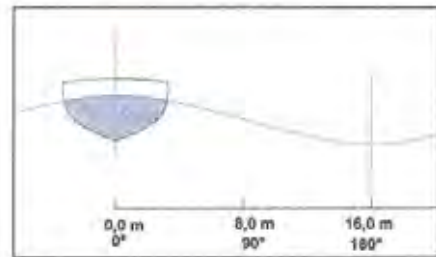
Phase of crest relative to origin:
 0 degrees (**0.0 m**)
 Wave length: 32.0 m
 Crest-to-trough height: 3.0 m
 Angle of encounter:
 -90 degrees (port beam sea)

The vessel is then unstable with out a righting arm if the wave crest of a 32 m long and 3 m high wave running up at an angle of 90° is located at a distance between **0.62 m** and **14.93 m** from the fore-and-aft line of the vessel on the port side. The result is plausible, as the vessel tends to tilt over to the starboard side and there is not enough buoyancy there due to the asymmetry of the poop. If the vessel is located in the rising wave area, the asymmetrical superstructure on the port side has a stabilising effect.
