Investigation Report 564/06

Very serious marine casualty

**Foundering of the Fishing Vessel HOHEWEG
on 8 November 2006
in the Alte Weser area, western Nordergründe**

15 March 2008

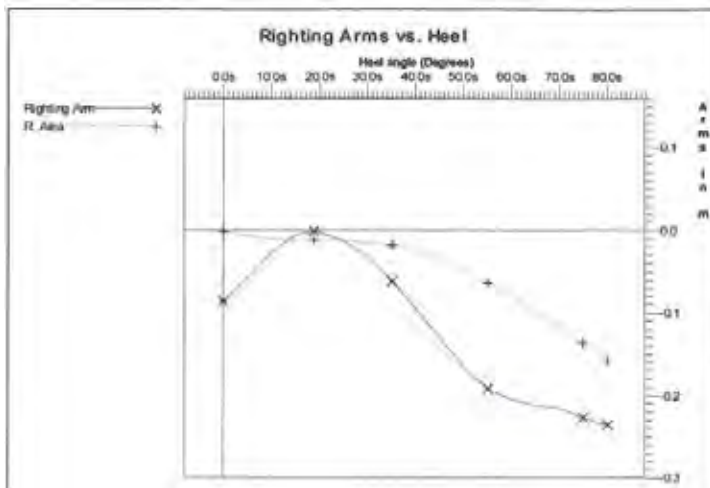
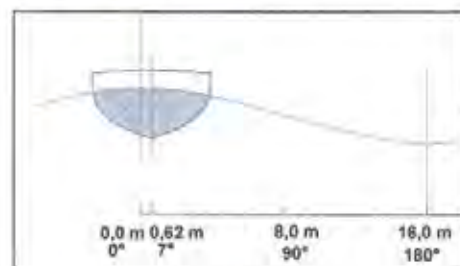
Phase of crest relative to origin:
 7.0 degrees (**0.62 m**)
 Wave length: 32.0 m
 Crest-to-trough height: 3.0 m
 Angle of encounter:
 -90 degrees (port beam sea)

The vessel is then unstable with out a righting arm if the wave crest of a 32 m long and 3 m high wave running up at an angle of 90° is located at a distance between **0.62 m** and **14.93 m** from the fore-and-aft line of the vessel on the port side. The result is plausible, as the vessel tends to tilt over to the starboard side and there is not enough buoyancy there due to the asymmetry of the poop. If the vessel is located in the rising wave area, the asymmetrical superstructure on the port side has a stabilising effect.

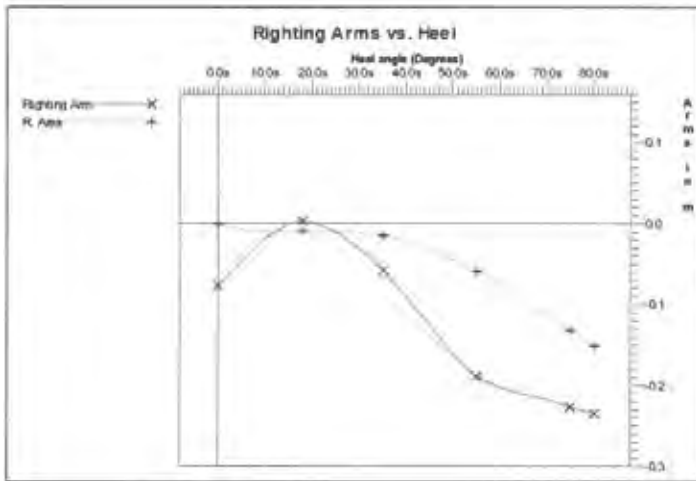
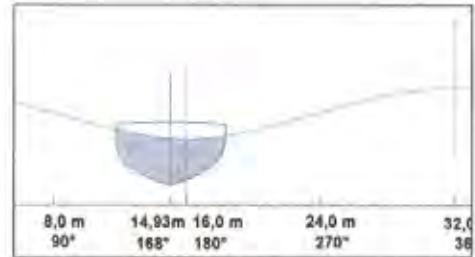
Phase of crest relative to origin:
 168.0 degrees (**14.93 m**)
 Wave length: 32.0 m
 Crest-to-trough height: 3.0 m
 Angle of encounter:
 -90 degrees (port beam sea)

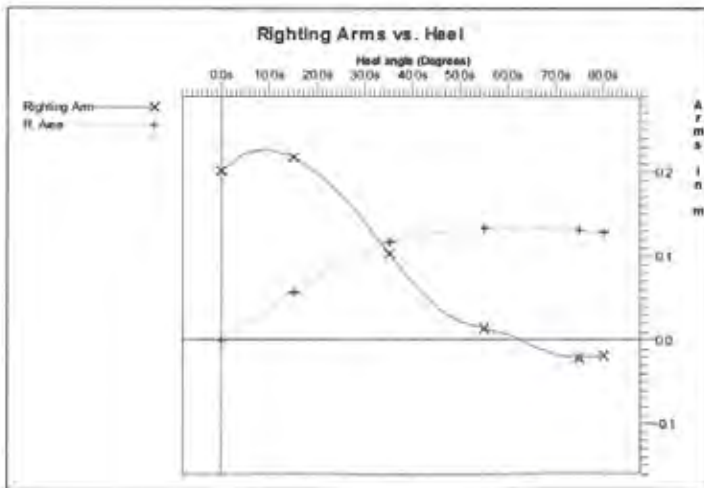
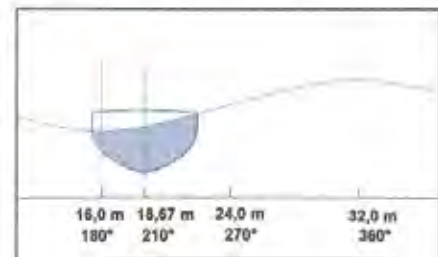
Phase of crest relative to origin:
 210.0 degrees (**18.67 m**)
 Wave length: 32.0 m
 Crest-to-trough height: 3.0 m
 Angle of encounter:
 -90 degrees (port beam sea)

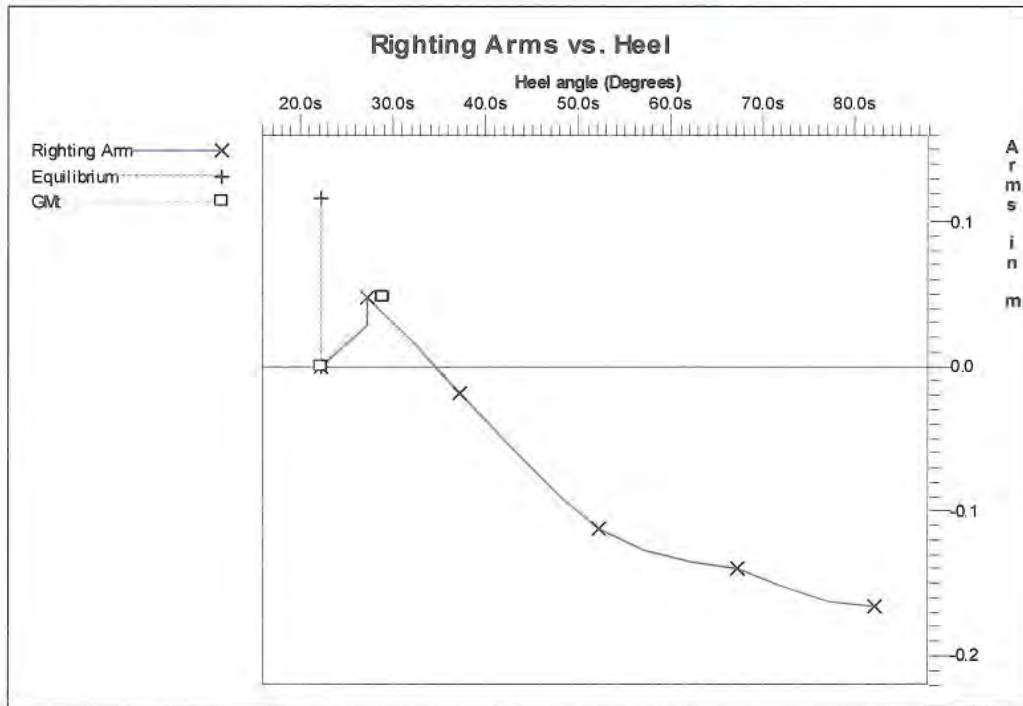
Figure 62: Lever arm curve with 16.5 cm water on deck

Heel Angle (deg)	Trim Angle (deg)	Origin Depth (m)	Righting Arm (m)	Flood Pt Height (m)
22.15s	3.84a	3.391	0.000	0.000 (1)
22.15s	3.84a	3.391	0.000	0.000 (1)
27.15s	3.69a	3.226	0.029	-0.255 (1)
27.15s	3.67a	3.212	0.048	
32.15s	3.56a	3.071	0.018	
34.58s	3.48a	2.991	0.000	
37.15s	3.39a	2.899	-0.018	
42.15s	3.20a	2.700	-0.051	
47.15s	2.96a	2.474	-0.084

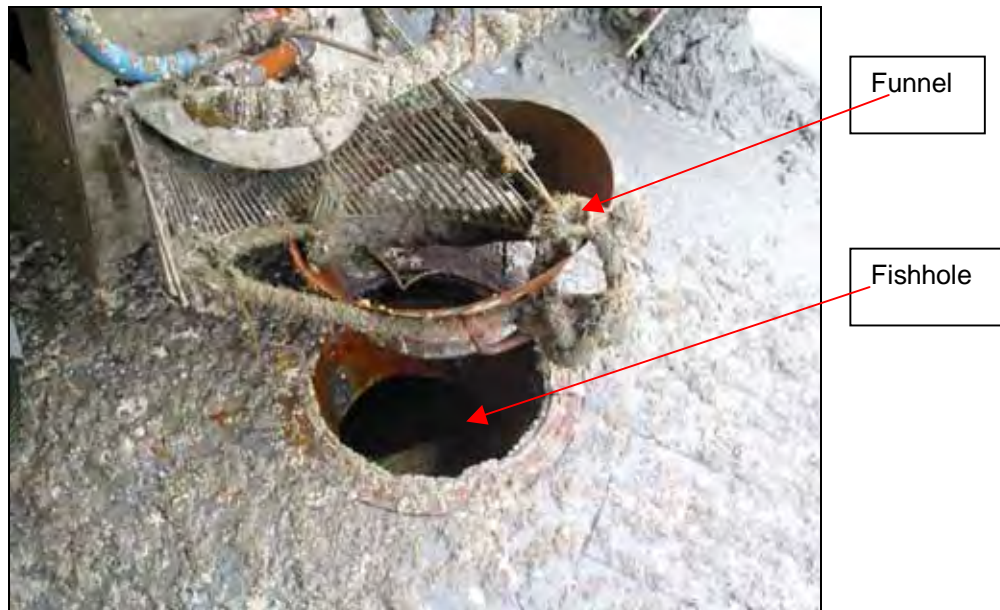
Figure 63: Fish hole port side

With the situation found on board it must be assumed that at the time of the casualty not all the openings were closed properly in sea-worthy condition. It was technically possible to secure all doors and hatches on board with sliding bolts and cage nuts and rubber seals accordingly. Only the “fish hole” on the port side between fish hatches I and II could technically not be closed in seaworthy condition.

An angled funnel with a diameter of 0.38 m was located lying loosely over the “fish hole” and only sealed with sealing compound. The lowest height above deck was 0.13 m and the highest 0.44 m. It is possible that water could have entered the hold unnoticed already through this non-lockable opening on the River Weser, leading to a negative influence on the stability (free surfaces). This case was not calculated separately when investigating the stability.
