**Investigation Report 607/07**

**Serious marine casualty**

**Personal accident on the tug**  
**BUGSIER 11**  
**on 17 December 2007**  
**in Brunsbüttel**

**1 December 2008**

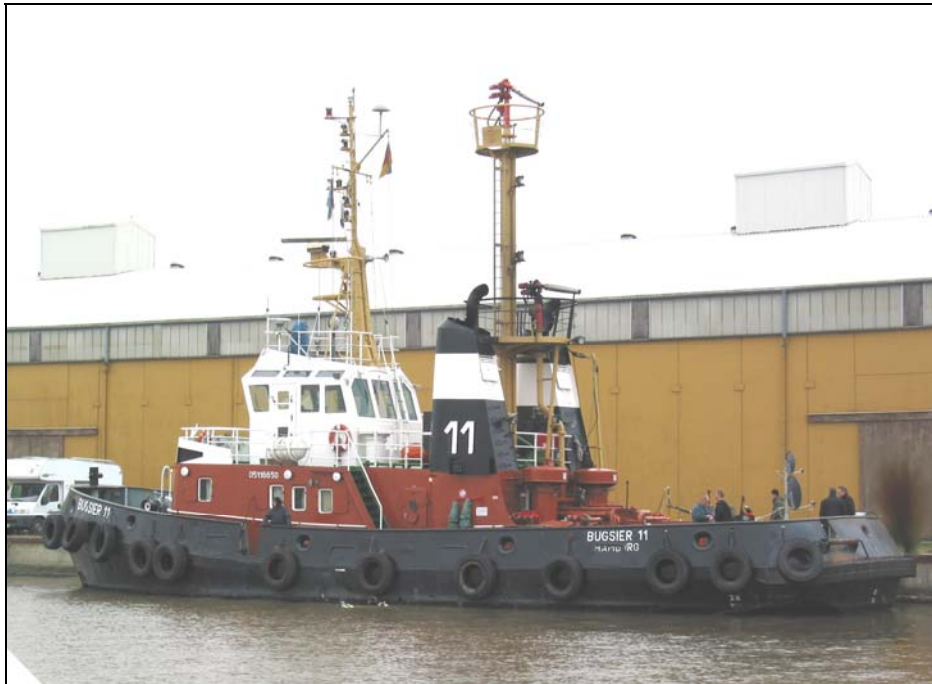
Figure 3: Photo of the BUGSIER 11

His direct visibility to aft was limited by the two funnels and the aft mast with the fire extinguish tower (Figure 3 and 9).

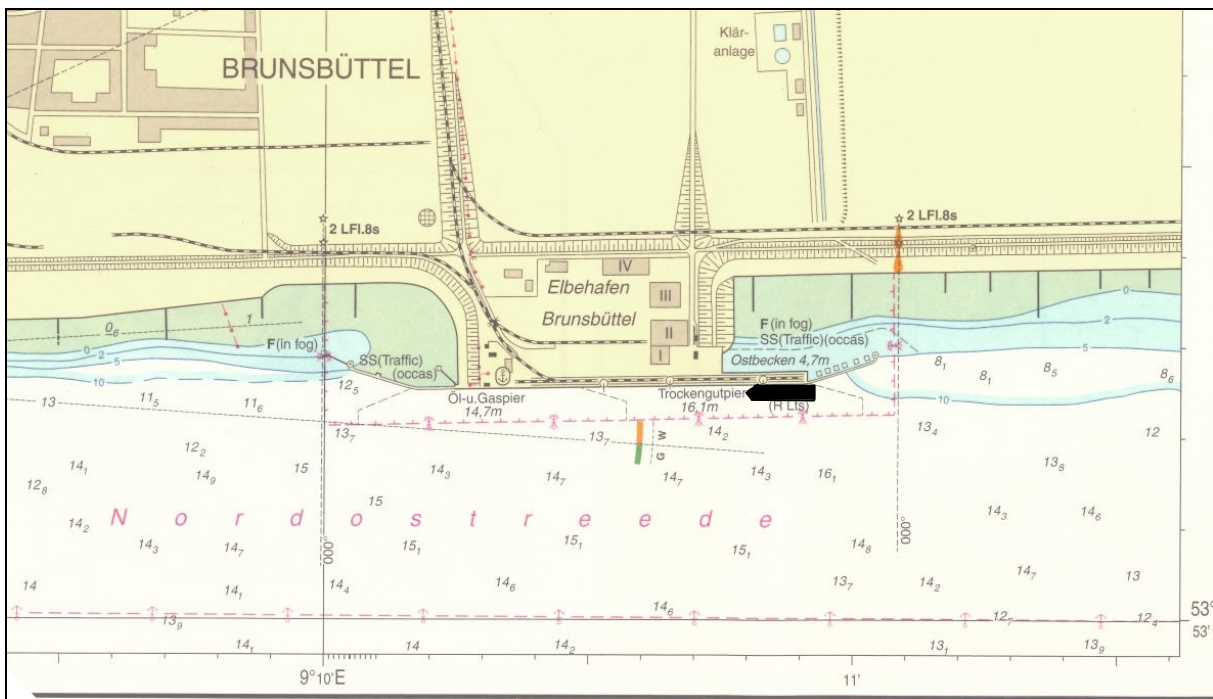
Figure 4: Wharf and berth of the vessel, section from chart 46, Plan B of the BSH

The turning manoeuvre and berthing at the wharf had been carried out without difficulty or abnormality. Communication between the vessel's command and tug boats had been established in German language on VHF channel 06. Once the SENANUR CEBI had been brought into a berthing position with the assistance of both tugs, she had been held there initially using her own engine power and the stern tug. At the same time, the crew of the SENANUR CEBI had brought out the mooring lines. The pitch of the variable pitch propeller had been laid to zero at 13:46. The bow tug BUGSIER 12 had cast off the tow at 13:50 on request of the pilot and had been used to push against port side between shipboard cranes 1 and 2. Due to a bend in the shape of the wharf at the intended berth, approx. 20 m of the aftship of the SENANUR CEBI had been lying non-parallel to the wharf.

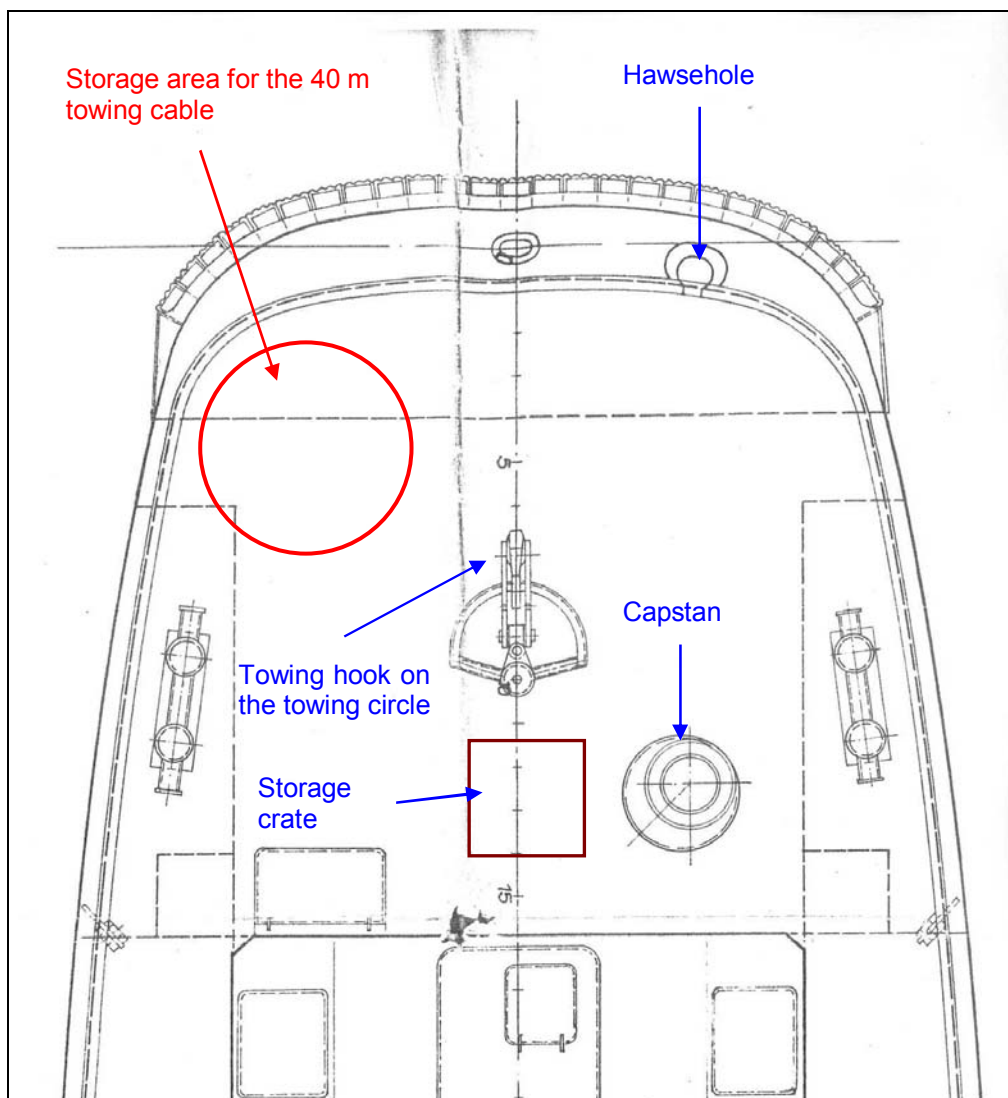
Figure 5: BUGSIER 11, plan view of stern

The BUGSIER 11 is tug boat with hook, that is a tug boat that does not have a variable length towing cable on a towing winch, but uses a towing cable with a preset length on a towing hook.

Handling of the towing cable is supported by a capstan located on the port side. The capstan stands on a small platform and has a height of 0.94 m above the deck. The capstan only turns clockwise. It can be operated using a mobile foot switch. After being switched on, it turns a half rotation slowly, then switches automatically to a higher speed. Approx. 5 s are required for one rotation. This gives a speed of approx. 0.41 m/s.
