Investigation Report 01/08

Serious marine casualty

**Grounding of the LT CORTESIA on
2 January 2008 on the Varne Bank in the
English Channel**

1. April 2009

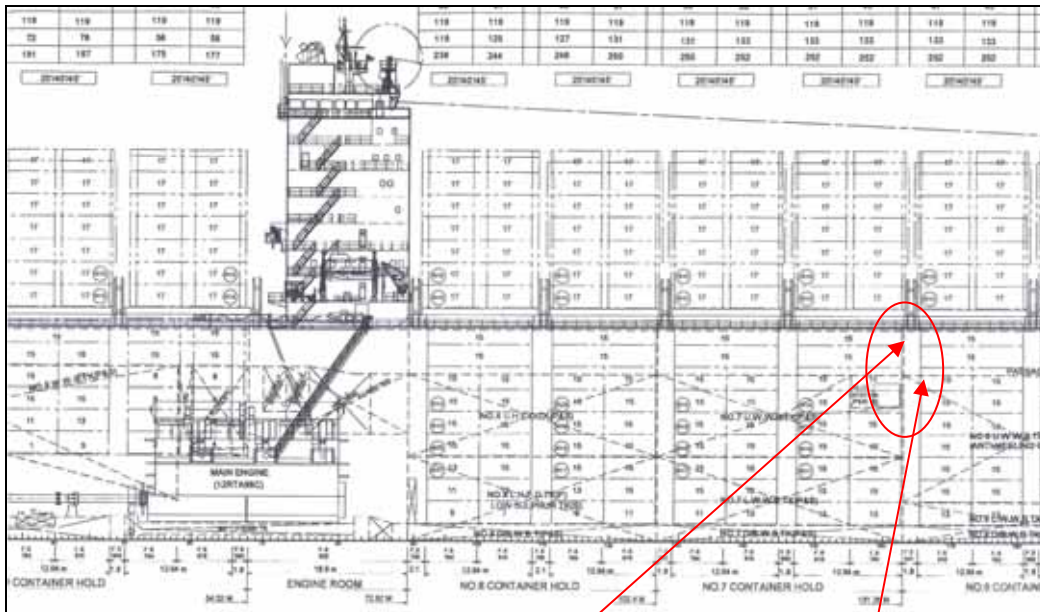
Figure 4: General arrangement plan extract

Neither tanks nor the ship's base were damaged when the vessel ran aground. The only identifiable damage in the form of deformation was observed on frame 163 on brace struts and frame bulkheads.

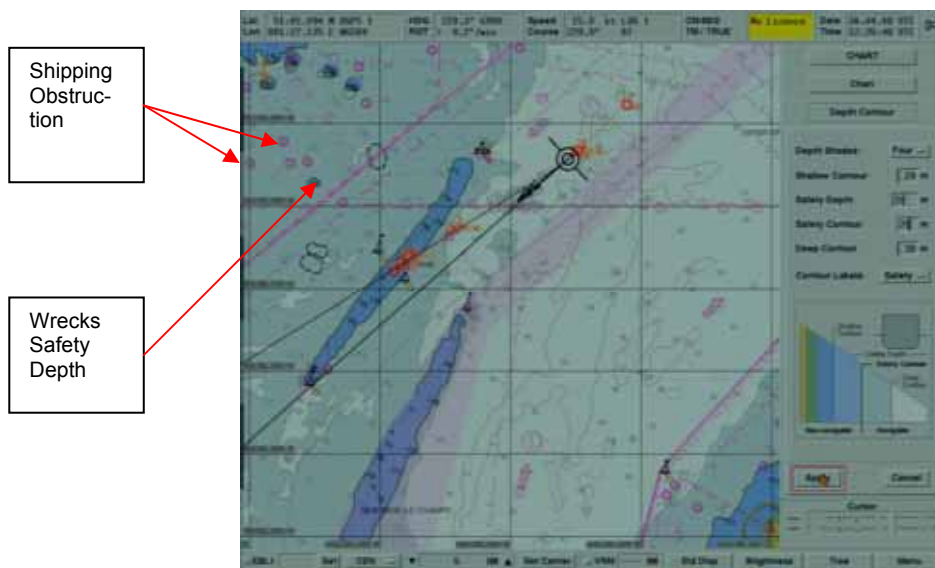
Figure 23: Setting for Safety Depth 20 m

With this display the Varne Bank as well as the buoy symbols in the light blue and grey area stand out. Wrecks and shipping obstructions are highlighted. The display grows even more clear with the setting of the Safety Depth and the Safety Contour on 20 m. The one way waterway is displayed as largely navigable water area. The passage between both sand banks is visible and more shipping obstructions and less wrecks are displayed:
