Bundesstelle für Seeunfalluntersuchung
Federal Bureau of Maritime Casualty Investigation
Federal Higher Authority subordinated to the Ministry of Transport,
Building and Urban Affairs

Investigation Report 107/08

Serious Marine Casualty

**Engine Failures of HOPE BAY and Collision
between HOPE BAY and OCEANIC
on 12 March 2008 and Collision between
OCEANIC and JOSEF MÖBIUS on the Elbe
on 14 March 2008**

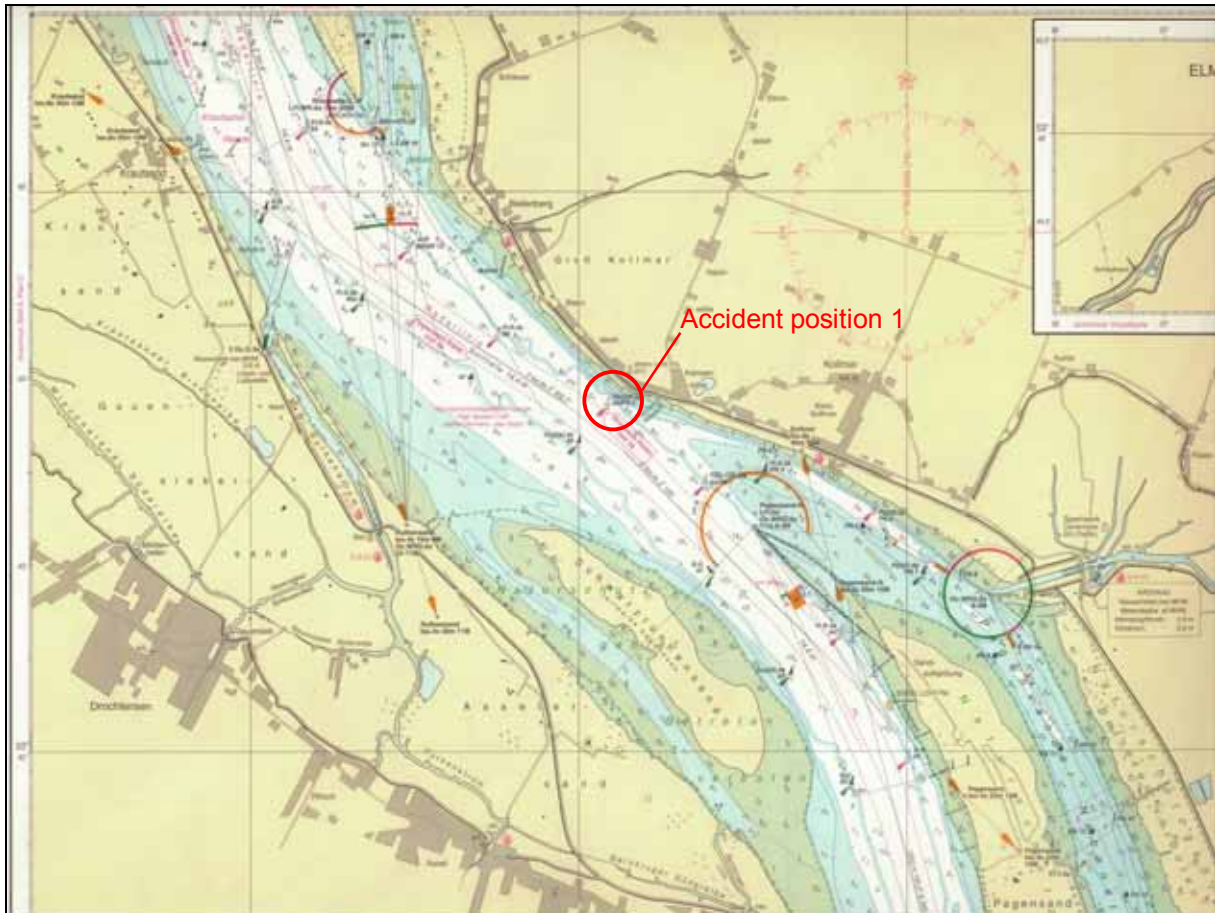
Figure 1: Chart with first accident position

Type of event: Marine casualty, engine failure and collision with buoy
Date/Time: 12 March 2008/0535
Location: Elbe, buoy 90
Latitude/Longitude: φ 53° 43.85'N λ 009° 27.28'E

During HOPE BAY's manoeuvres there was contact with buoy 90. As a result the buoy was moved 120 m towards the middle of the fairway. The vessel itself was not damaged.

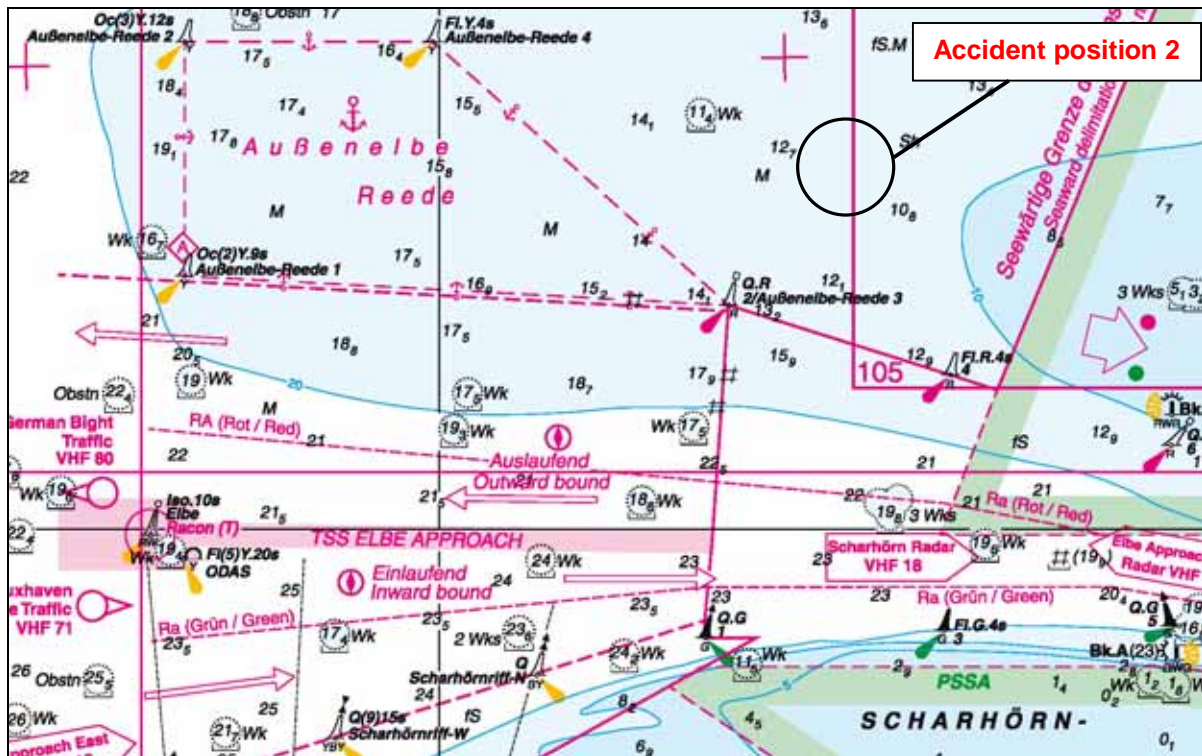
Figure 2: Chart with second accident position

Type of event: Serious marine casualty, engine failures on HOPE BAY and collision between OCEANIC and HOPE BAY, two seriously injured persons on OCEANIC

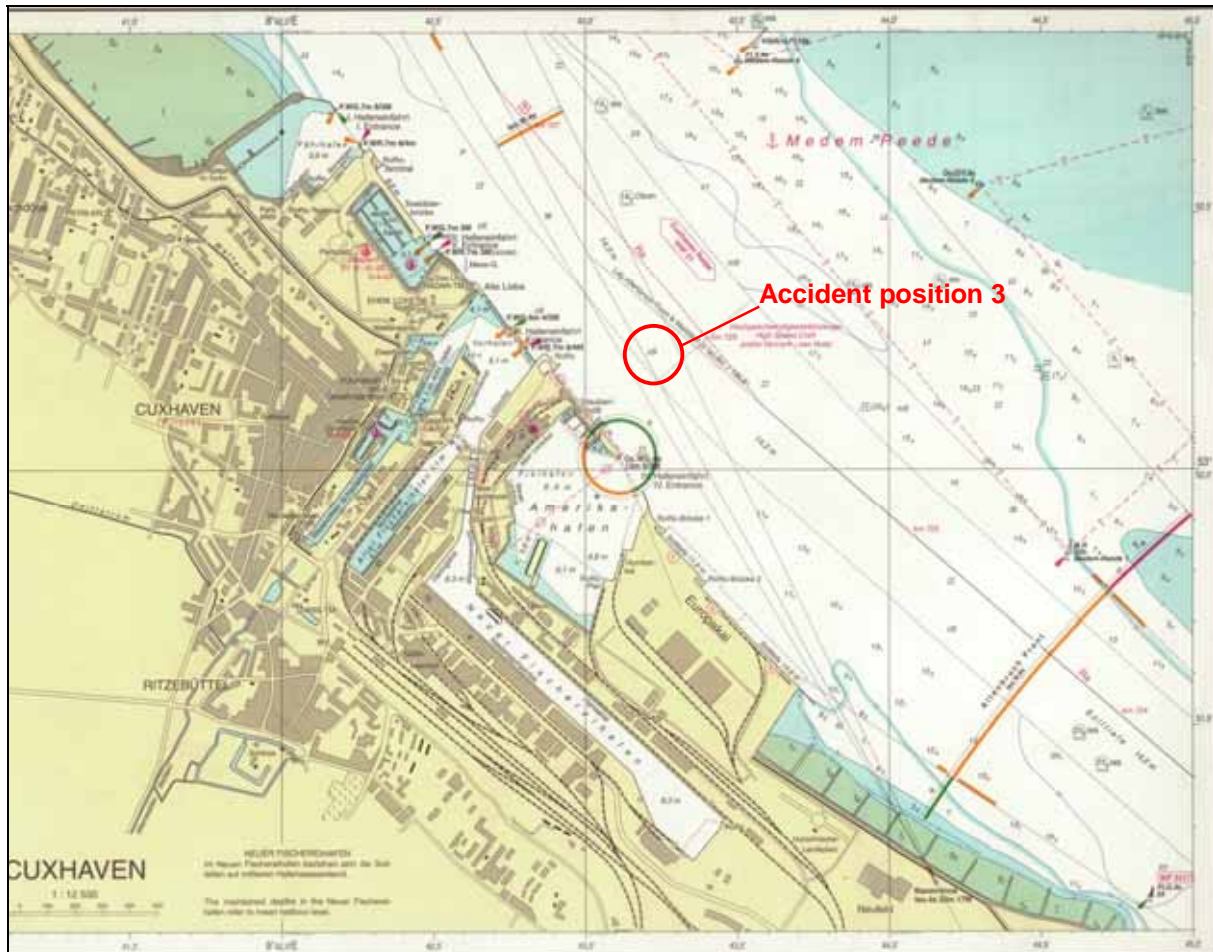
Figure 3: Chart with third accident position

Type of events: Marine casualty, collision between OCEANIC and dredger JOSEF MÖBIUS
Date/Time: 14 March 2008/2057
Location: Cuxhaven, on the river Elbe off Amerikahafen
Latitude/Longitude: ϕ 53° 52.22'N λ 008° 43.22'E

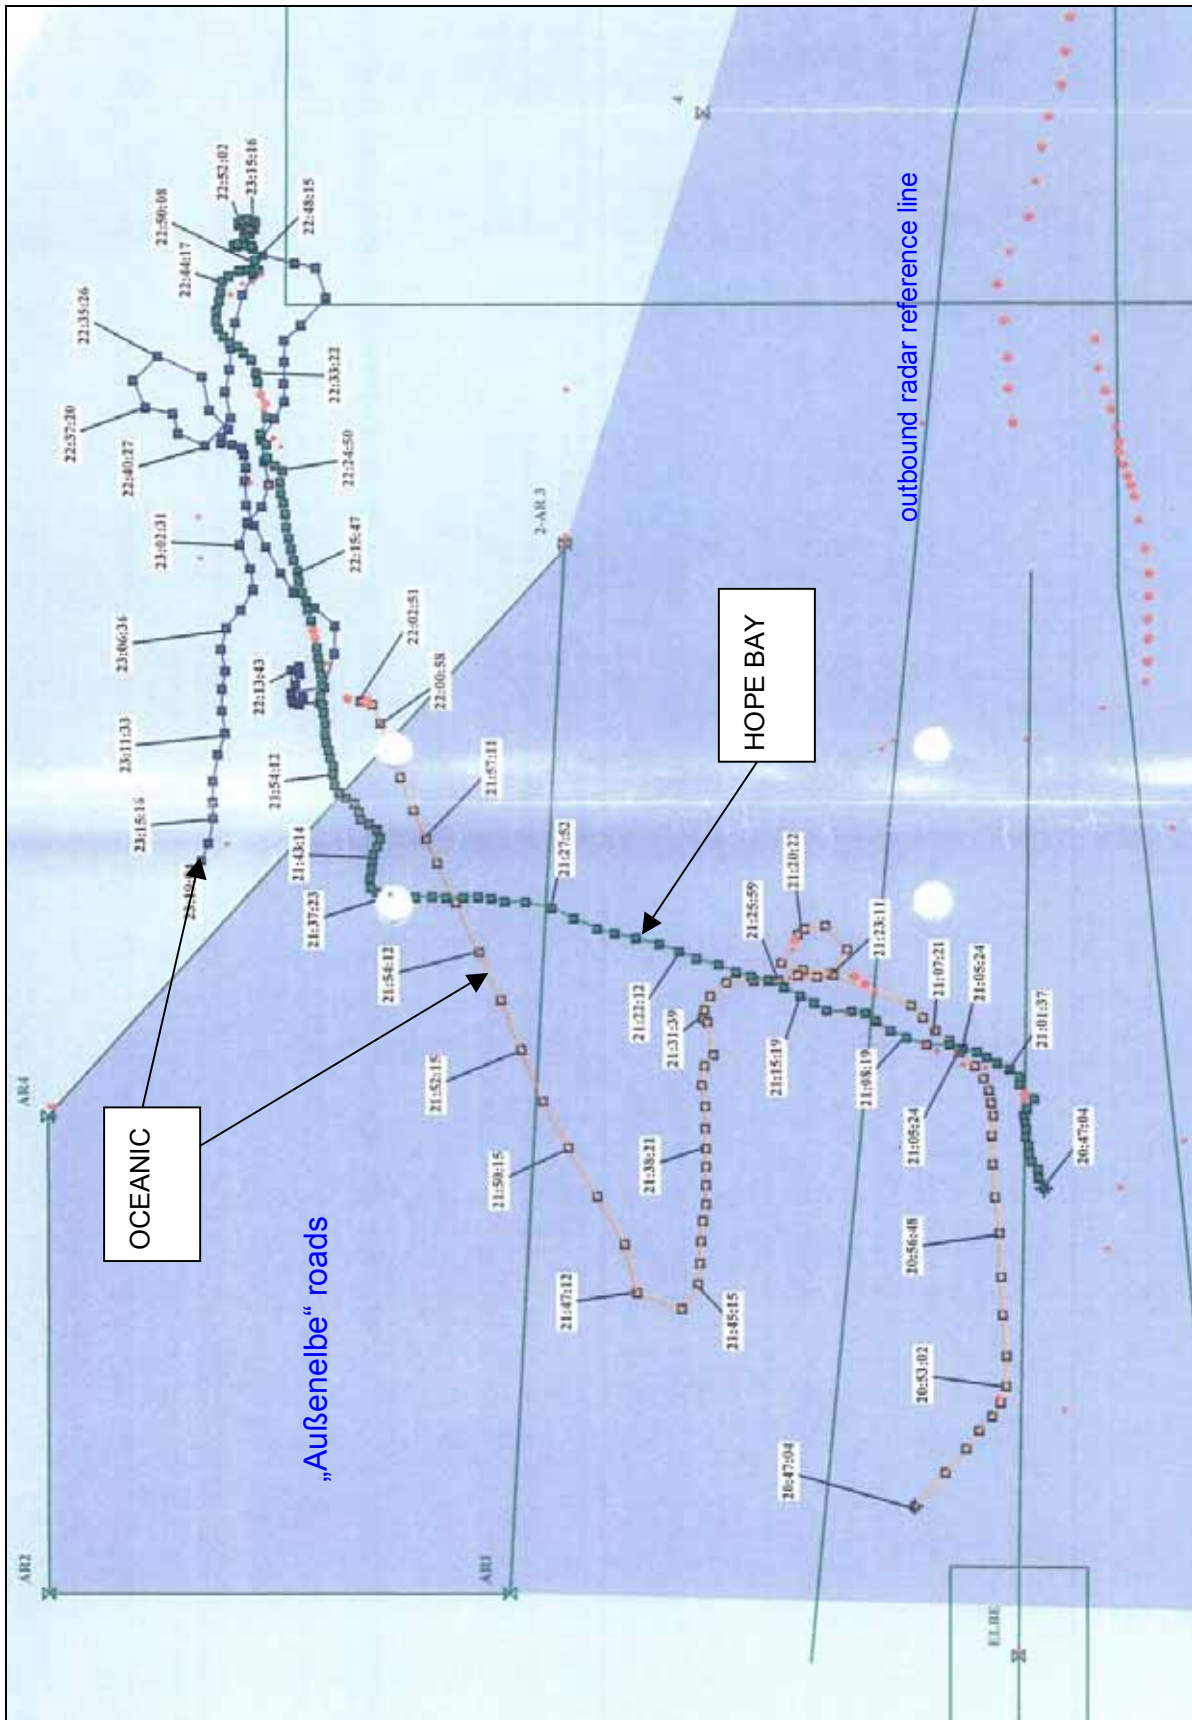
Figure 20: Radar plot HOPE BAY and OCEANIC of VTS Cuxhaven

The data contained in figures 16 to 18 (s. also figure 20 as graphical description) show, that the engine of HOPE BAY apparently ran again since 2101, because the speed increased from this time on.

At 2144 the vessel command of HOPE BAY reported renewed engine failure. In the meantime the vessel had dropped seven lengths of the port anchor chain into the water. EAR again recommended using the main engine, as the drift speed was approx. 2 kts.
