Investigation Report 149/08

**Serious marine casualty**

Forward tug WILHELMINE broaching to in front of MV PAVEL KORCHAGIN on 4 April 2008 in the Port of Hamburg

15 April 2009

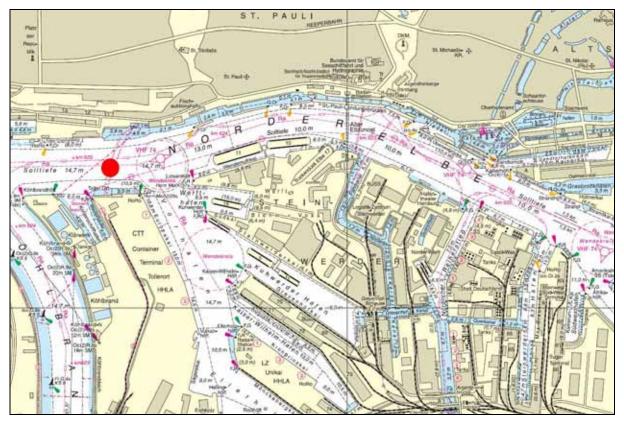
Figure1: Scene of the accident

Date/time: 4 April 2008, at 2026 Location: Tollerort, Port of Hamburg Latitude/longitude:  $\phi$  53°32.5'N  $\lambda$  009°56.7'E

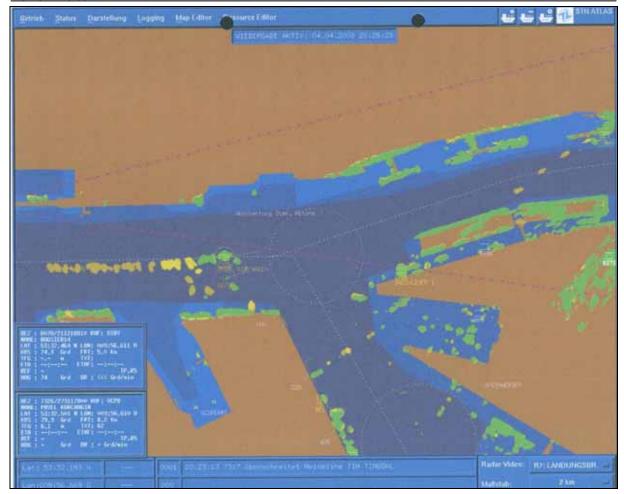
Figure 4: Vessel Traffic Service 2025:29

According to the recordings and photos, the PAVEL KORCHAGIN is a conventional general cargo ship with a length of 130 m without a bulbous bow. The vessel's speed over ground directly prior to the collision at 2025:29 was, according to the radar recordings, 8.2 kn on a course of 079.9 degrees (see Fig. 4). The speed then fell suddenly to 4.6 kn (see Fig. 5). The draught of the vessel was 6.1 m. There are no detailed manoeuvre recordings available.

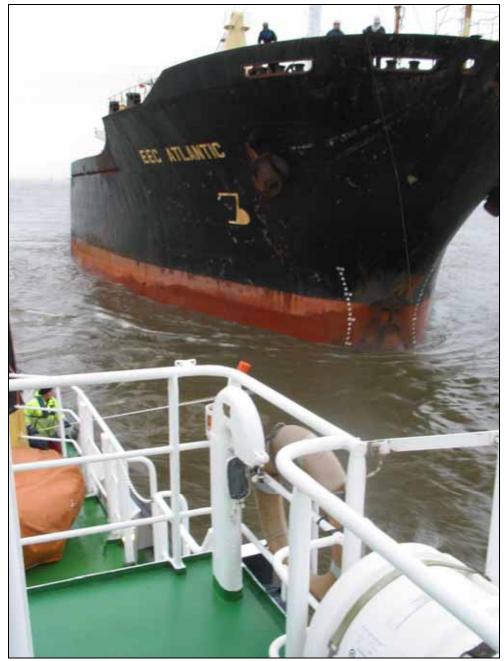
Figure 11: Take-up of heaving line

The master navigated by sight, crossed the fairway off Blankenese and turned in, approaching the front of the ship on her starboard side, coming from astern. When attempting to catch the ship's heaving line, the tug was inevitably forced to operate in the bow-wave zone. On the first attempt, the heaving line fell into the water (see Fig. 11). At a speed over ground of 8 kn, it was possible in the end to catch the heaving line in front of the bow and secure the tripping line. Once the tripping line had been made fast through the central hawse on the ship's forecastle, the hawser could be fastened. For this, the winch was operated by the engineer on the after edge of the bridge. While pulling the line in tightly, the deckhand determined that the shackle on the forerunner was loose. The hawser had to be slackened so that the bolt pin could be tightened with a shackle key. Then approx. 40 m of line were fed out. The procedure took approx. 5 min.

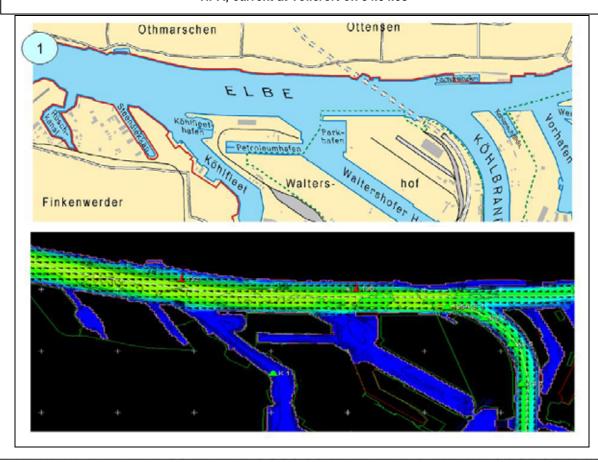
**Figure 1** shows the localised connection between Tollerort and Teufelsbrück and the flow rate from the model calculation for the area under consideration. The mapped current shows that, for the relevant tidal time (approx. two hours to low tide), the currents are fundamentally similar at the two locations.

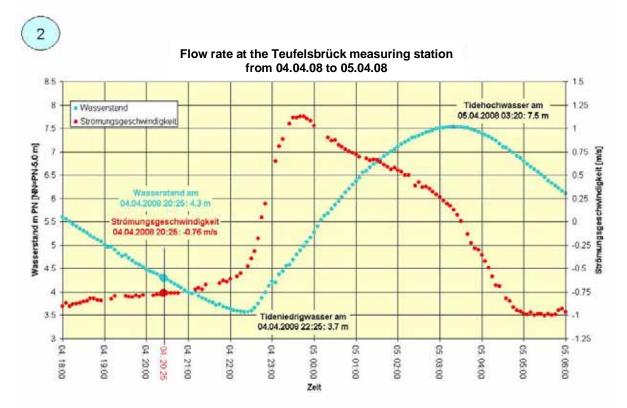
**Figure 2** gives the water level and the flow rate of the current measurement system at Teufelsbrück for 04.04.08, and the time 20:25 is also specifically pinpointed. The prevailing flow rate was 0.76 m/s in a westerly direction (ebb current). Low tide occurred at 22:25, two hours after the time under consideration.

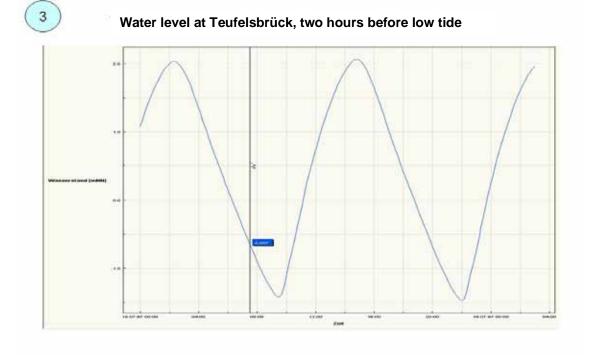
**Figure 3** shows the transfer of tide times on 04.04.08 to the model based on the water level. Two hours before low tide corresponds to a model time of 07:25.

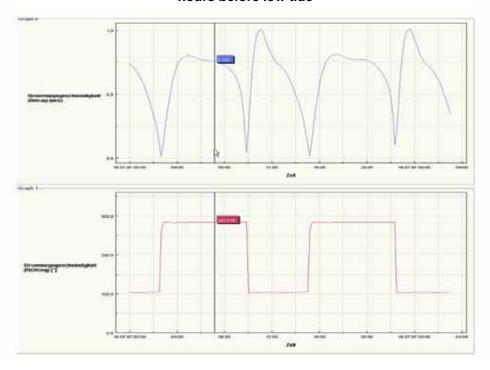
## Model result: flow rate and direction of flow at Teufelsbrück two hours before low tide

**Figure 4** gives the flow rate and the water level for the measuring point Teufelsbrück for the time two hours before low tide. As a comparison of the measured currents and the model result shows, the ratios tally, meaning that the model results can be applied as a good approximation of the flow rate.

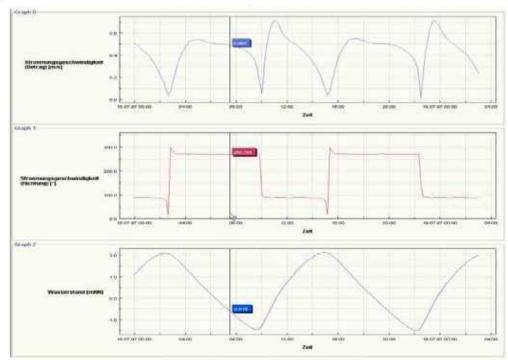
# Model result: flow rate and direction of flow at Tollerort two hours before low tide (averaged across a cross-sectional area)

**Figure 5** shows the current from the current atlas at Tollerort at the time two hours before low tide, which is 0.49 m/s at the time under consideration, flowing in a westerly direction. This is a flow rate calculated across a cross-section of the water. **Figure 6** shows this rate again in the relevant expanse, revealing that, from the centre of the water to the edge, the rate decreases.
