# **Investigation Report 167/08**

**Serious marine casualty**

# **Grounding of the MV PACIFIC CHALLENGER to the east of Oro Bay/Papua New Guinea on 9 April 2008**

2 February 2009

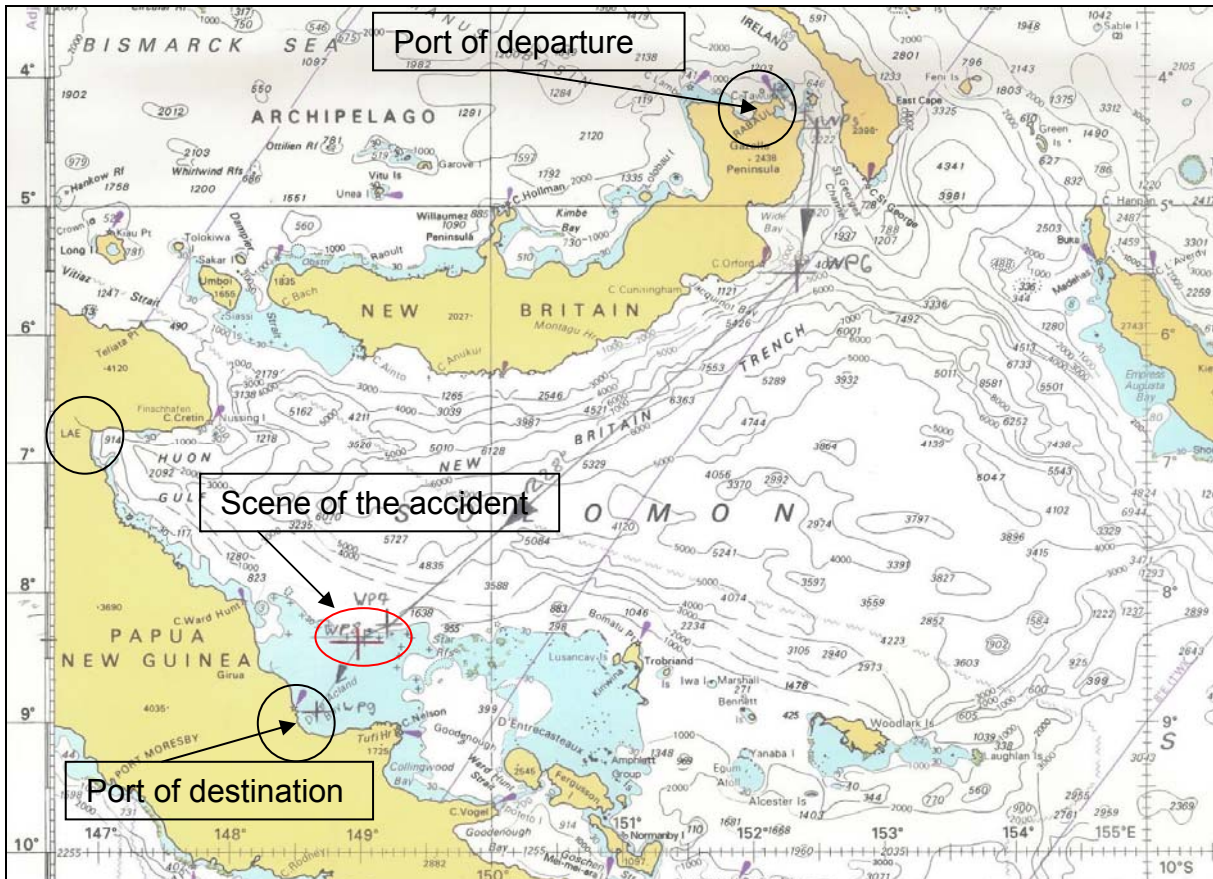
Figure 1: Coral and Solomon Seas nautical chart

Section from nautical chart 4604, Coral and Solomon Seas, British Admiralty Chart
