Bundesstelle für Seeunfalluntersuchung
Federal Bureau of Maritime Casualty Investigation
Federal Higher Authority subordinated to the Ministry
of Transport, Building and Urban Affairs

Investigation report 211/08

**Collision of the RoPax ferry FINNLADY
with the Skandinavienkai
on 16 May 2008
in Travemünde port**

17 August 2009

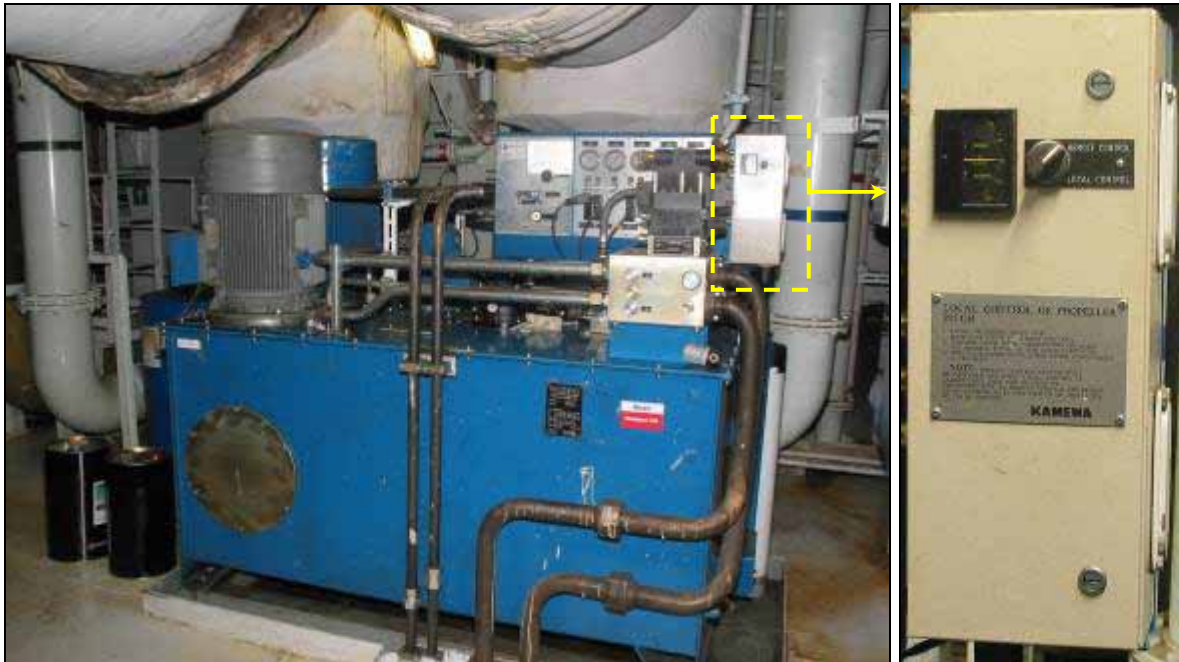
Figure 22: CPP unit in the engine room

In an emergency, the propeller pitch can also be controlled directly from the engine room. For this, a turn-switch on the CPP unit itself must be actuated (see Fig. 22).

Activating engine room control automatically deactivates all other control and safety functions for the CPP (e.g. pitch limitations). The instructions on a sign located directly below the turn-switch describe briefly and clearly in English how the propeller pitch can be altered manually using the push buttons directly at the valves.

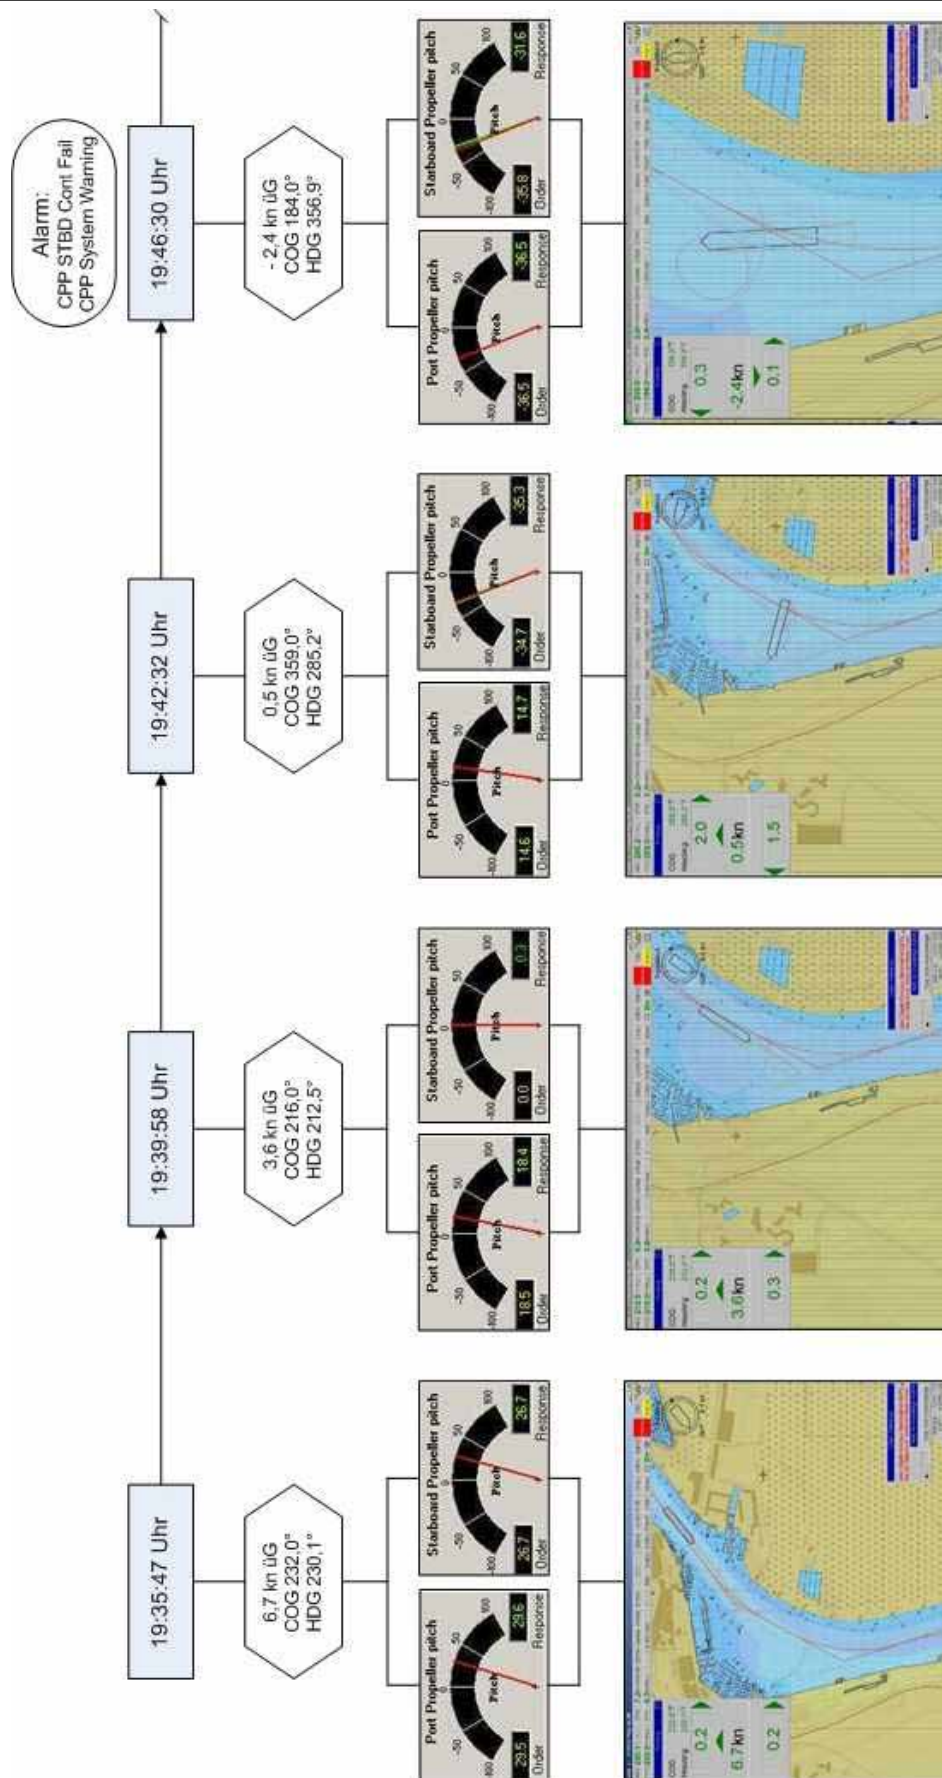
Figure 26: VDR evaluation 1935:47 to 1946:30

The above presentation of the significant VDR information shows that the starboard CPP system failed at 1946 at an actual astern pitch shortly before the completion of the turning manoeuvre, which triggered an alarm (see Fig. 26). This is verified by both the printouts of the fault printer ("CPP STBD Cont Fail"¹¹, "CPP System Warning") and the recorded bridge noise. From that point on, the actual pitch (-31.7) no longer corresponded to the ordered pitch (-35.8). It is important to note here that the above VDR pitch display differs considerably from the analogue pitch display in the overview panels on the bridge: whereas the digital pitch display shows exact numerical values and has two different pitch indicators (red for the ordered value and green for the actual value), the analogue pitch display on the bridge only ever shows the actual value. The Master of the FINNLADY therefore did not have detailed VDR information, but instead had to - as is customary on the bridge - monitor the displayed pitch value using the selected speed level (see Fig. 31).

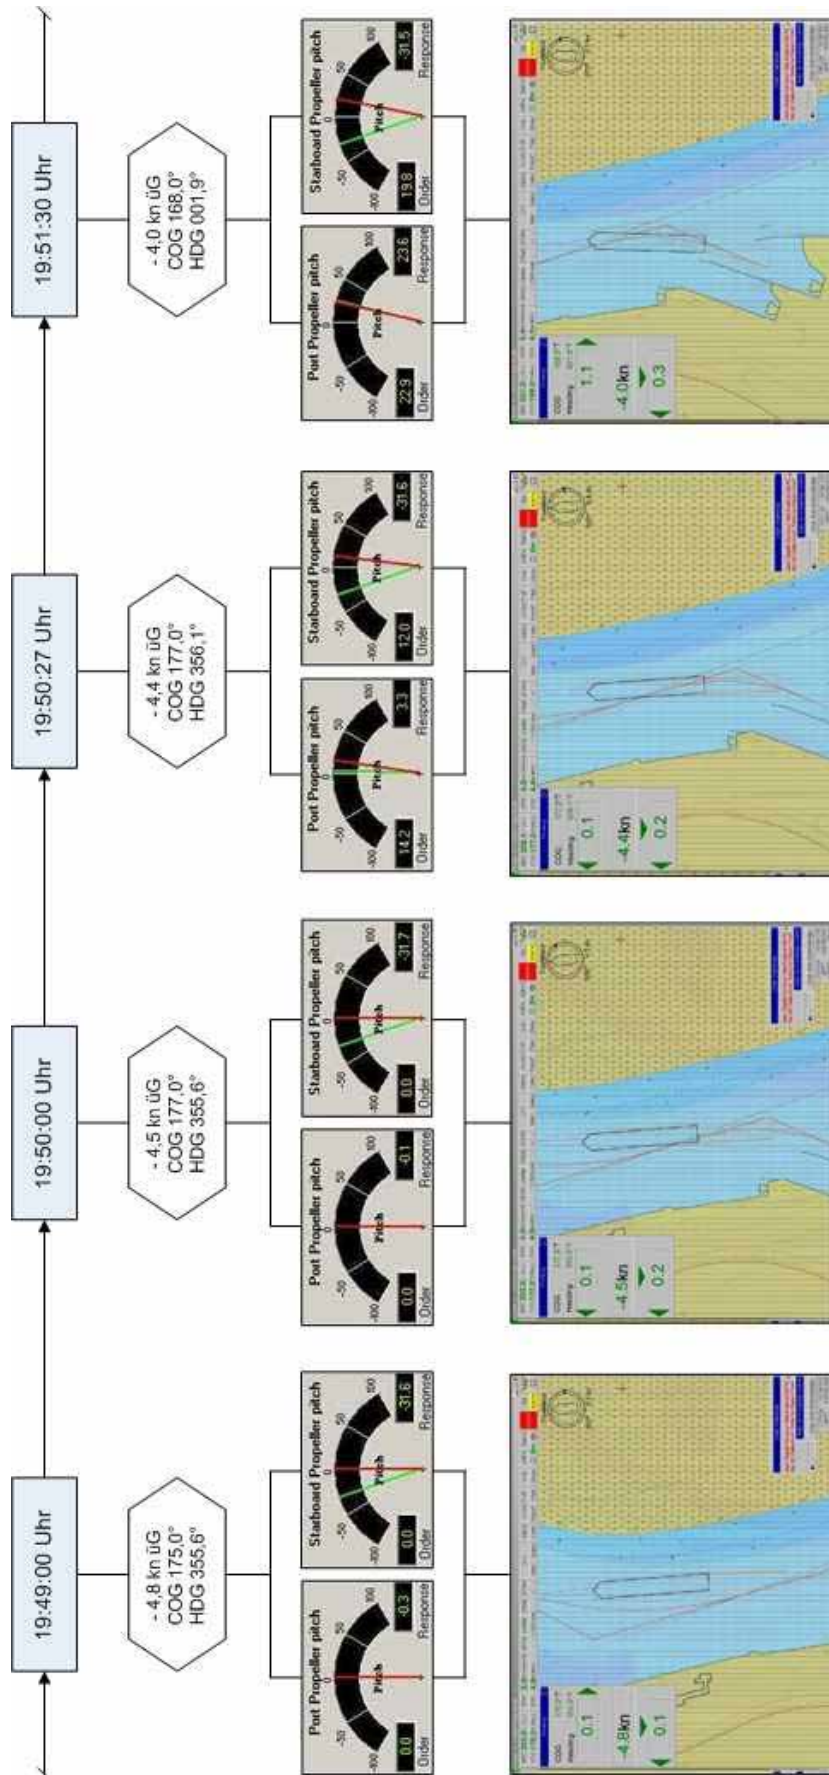
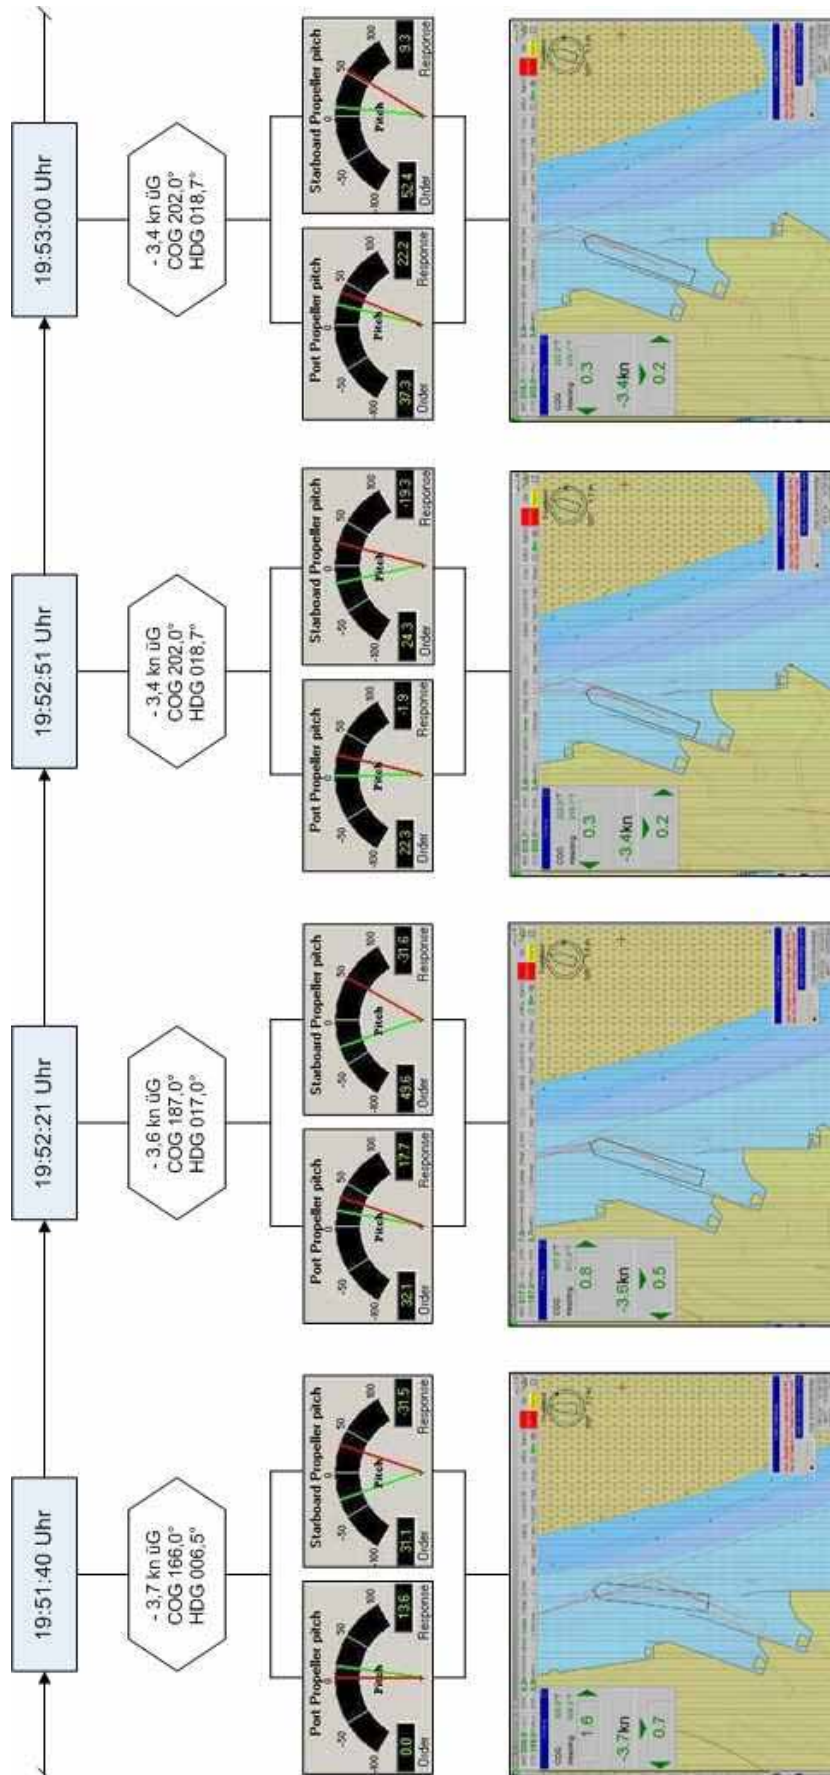
1950:00, the propellers were gradually adjusted to zero pitch, but the starboard pitch remained the same (see Fig. 28 and 29). Irrespective of the alarm issued, the fault relating to the starboard propeller pitch was also clearly identifiable on the analogue pitch display by 1950:00 at the latest, as the zero pitch was not realised.

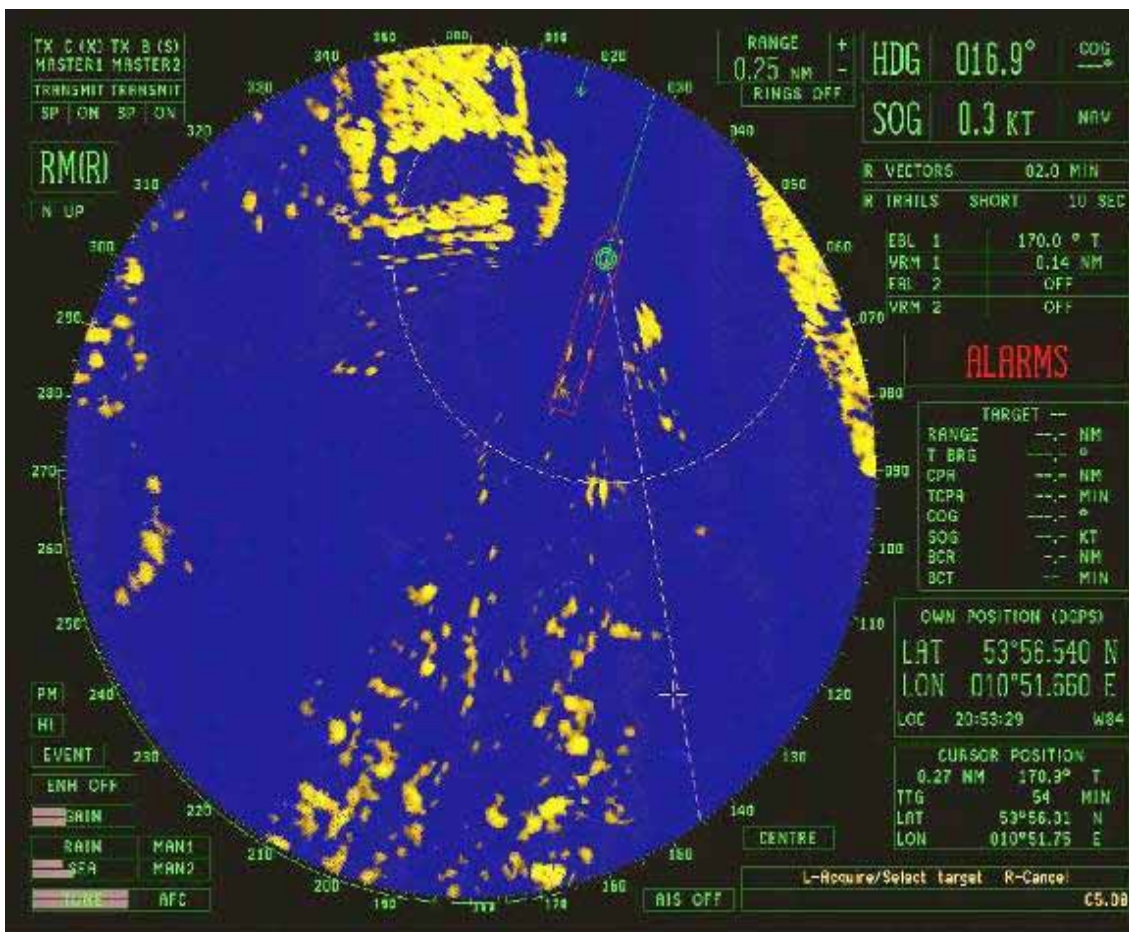
Figure 32: VDR radar image at the time of the collision

During the reconstruction of the course of the voyage, evaluation of the ECDIS recordings was given priority over the recorded radar images. The radar images (radius: 0.25 nm) were not very useful in view of the shadowing caused by the ferry (see Fig. 32).

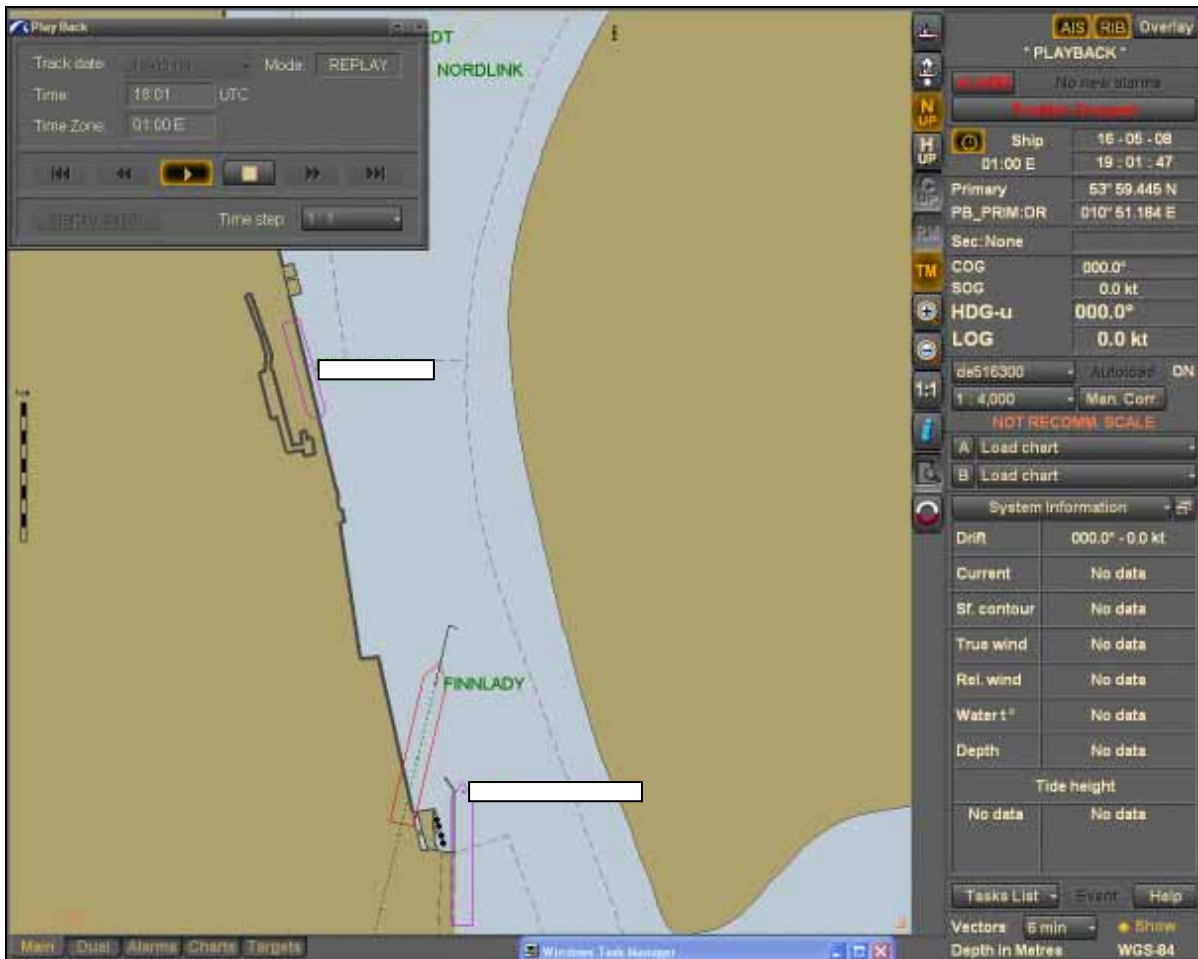
Figure 33: Vessel Traffic Service AIS recording

The AIS recordings were handed over in single-frame format, with a total of eight images for the period between 1950 and 2003. Although the FINNLADY is shown as the selected vessel on these images, no manoeuvres are stored (see Fig. 33).

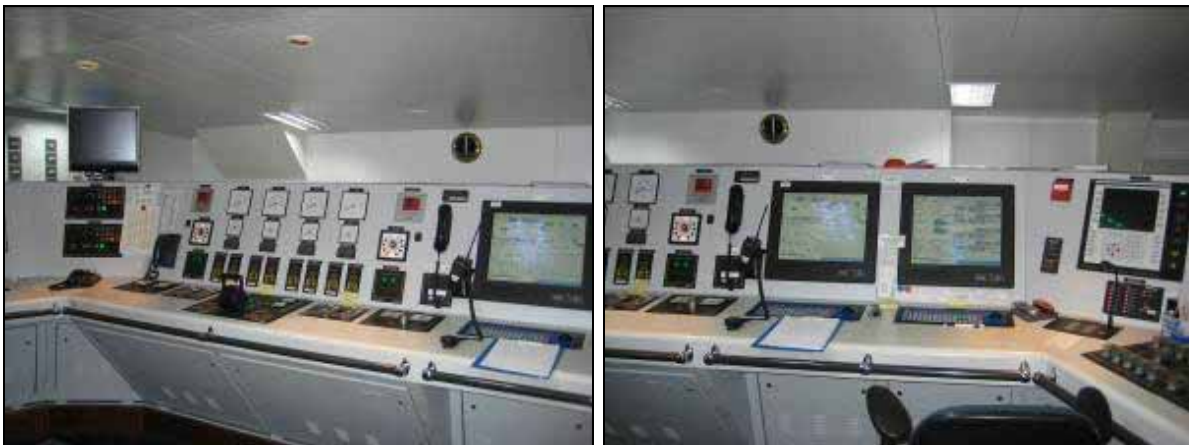
Figure 35: Drive and monitoring panel in the engine control room

The survey of the ECR focussed as well largely on the main propulsion monitoring panel (see Fig. 35).

After manoeuvre responsibility had been transferred from the bridge to the ECR, the same simulation tests as on the bridge were carried out for both main propulsion systems. The results were identical. In addition, the issuing alarm signals were observed on the alarm monitor in the engine control room.

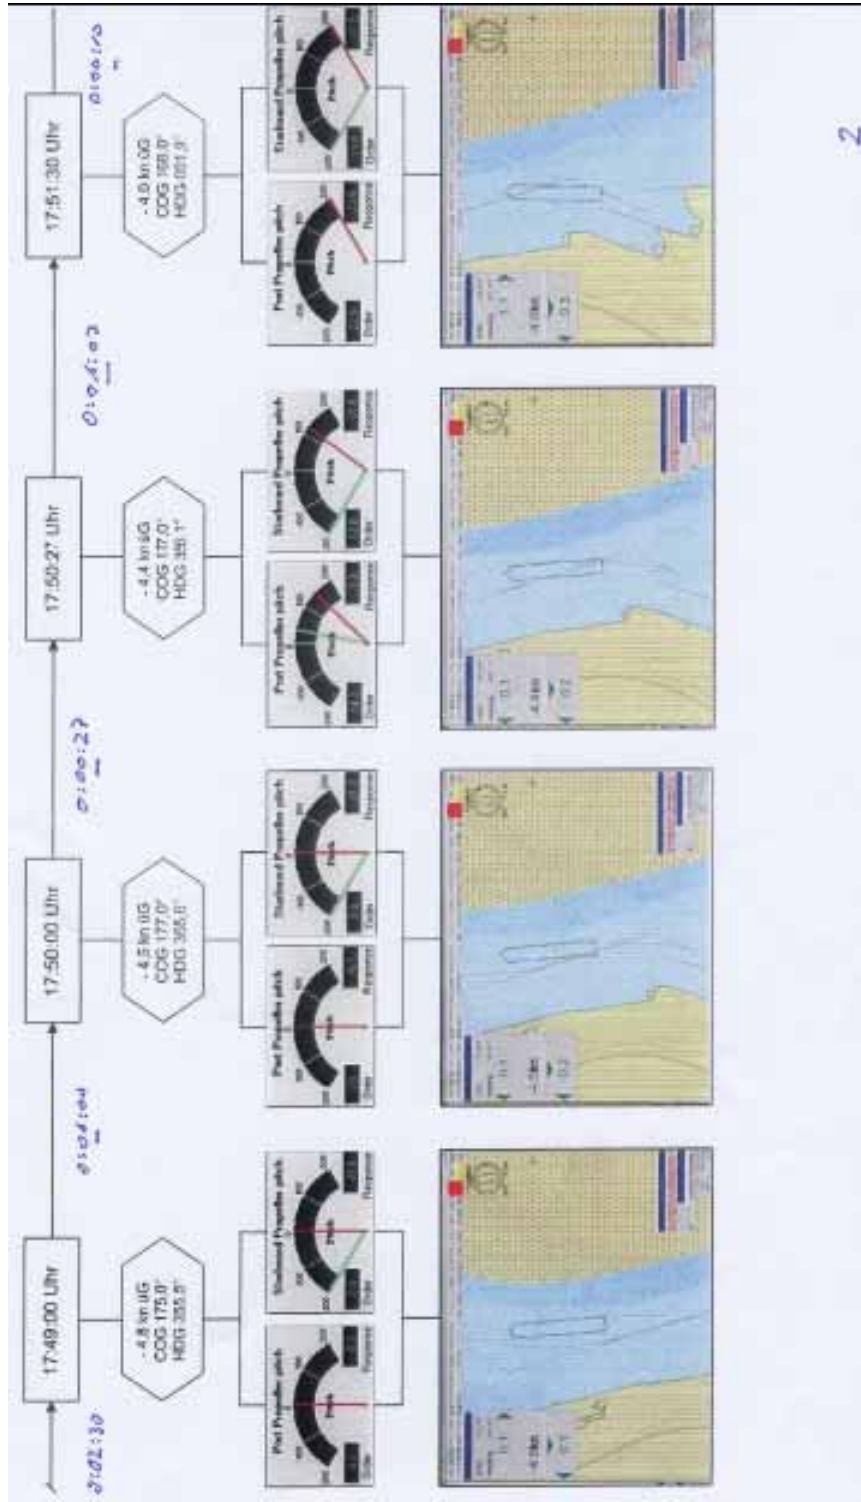
Fault within the starboard propulsion system

Duration of wrong pitch setting of STBD-propeller: minimum 03' 51"

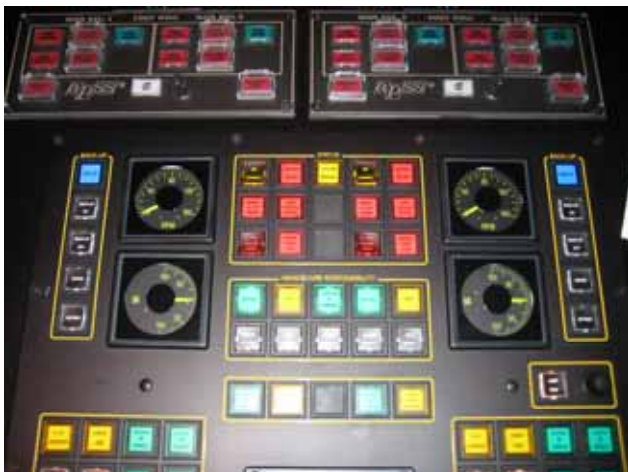
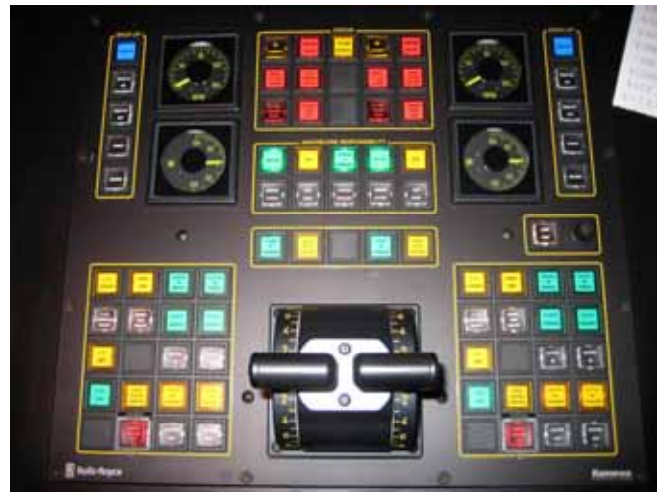
Faults in the control system and resulting influences to the main propeller control system of the main propulsion system can be reset electronically from any active conning position by pressing the "Re-connect" button (1) (arranged on the main propulsion monitoring panel) (Figures 2 and 3). This deactivates the fault and alarm signals.

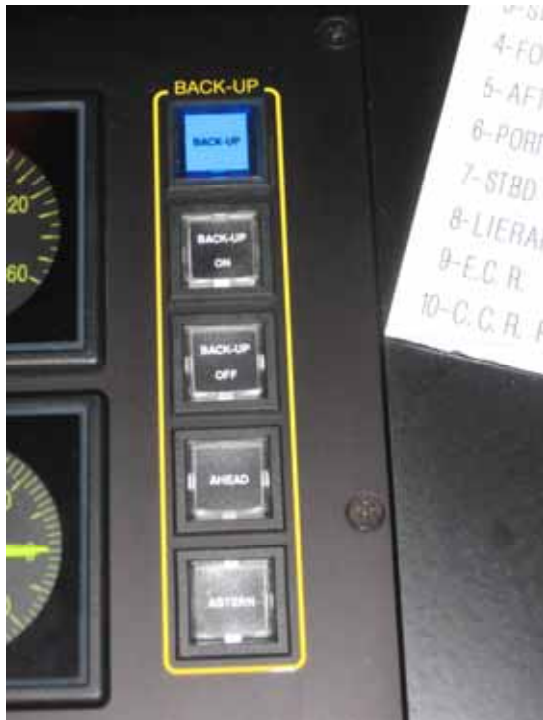
Fig. 5: Bridge wing conning station - „Back-up“ panel

If this is not successful, pressing the "Back-up" button (3) on the main propulsion monitoring panel at the active conning positions enables you to immediately take over the pitch control of the CPP system (Figure 5), also accepting that the function of the "automatic load control" will no longer be active. The status of the automatic mode is reduced to the status of a remote control function of the main propulsion system (non-follow-up type). When an overload situation is reported (alarm signal lights up on the control panel), the operating personnel must intervene manually and carry out an appropriate power reduction (reducing rpm and pitch) (Figure 4). This system has an independent electrical supply and is therefore immediately fully functional even in the event of a real fault in the main propeller control system.

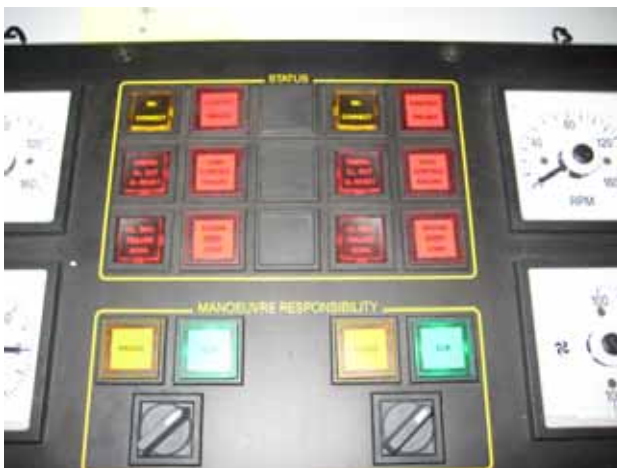
Fig. 11: Main propulsion monitoring panel (details) - ECR

The main propulsion monitoring panels on the bridge and in the ECR (Figures 9 - 11) are largely identical. They generally only differ in the "Manoeuvre Responsibility" (4) field. On the bridge, there are only illuminated displays and cancellation keys, whereas in the ECR (4), there are two selector switches, which are used to activate "manoeuvre responsibility", i.e. the relevant conning positions (Figure 11). Changing the responsibility of a conning position can only be carried out from this panel and leads to a visual (flashing of the corresponding button on the panel) and audible alarm (buzzer) on the main propulsion monitoring panel in the ECR and at the three bridge conning positions (central conning position and port and starboard wing conning positions). As soon as the switchover to one of the three bridge conning positions has been acknowledged by pressing the flashing button, the flashing light becomes a steady light and the buzzer stops.

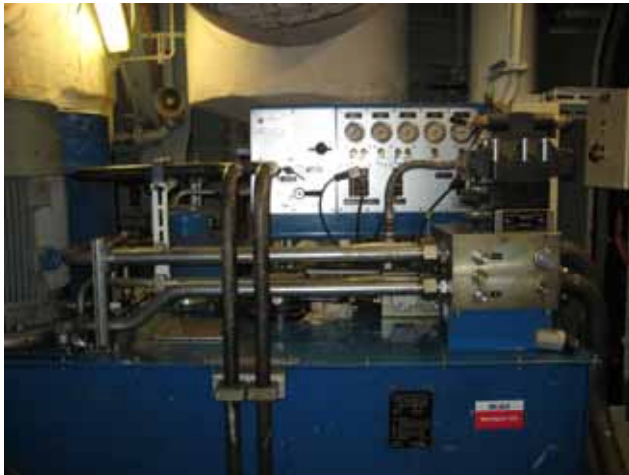
Fig. 13: CPP hydraulic-power pack with emergency operating devices

The CPP system's hydraulic power pack (Figures 13 - 15) was also subjected to a basic visual inspection. Here too, no special findings were determined. The instrument panel, the various controls and the switch devices for emergency operation of the propeller pitch adjustment function were in fault-free condition and clearly labelled.
