Investigation Report 212/08

Serious Marine Casualty

**Accident resulting in severe injuries to 2 people
caused by three broken lines while making fast
CMS RUILOBA
on 18 May 2008 in Bremerhaven**

1 September 2009

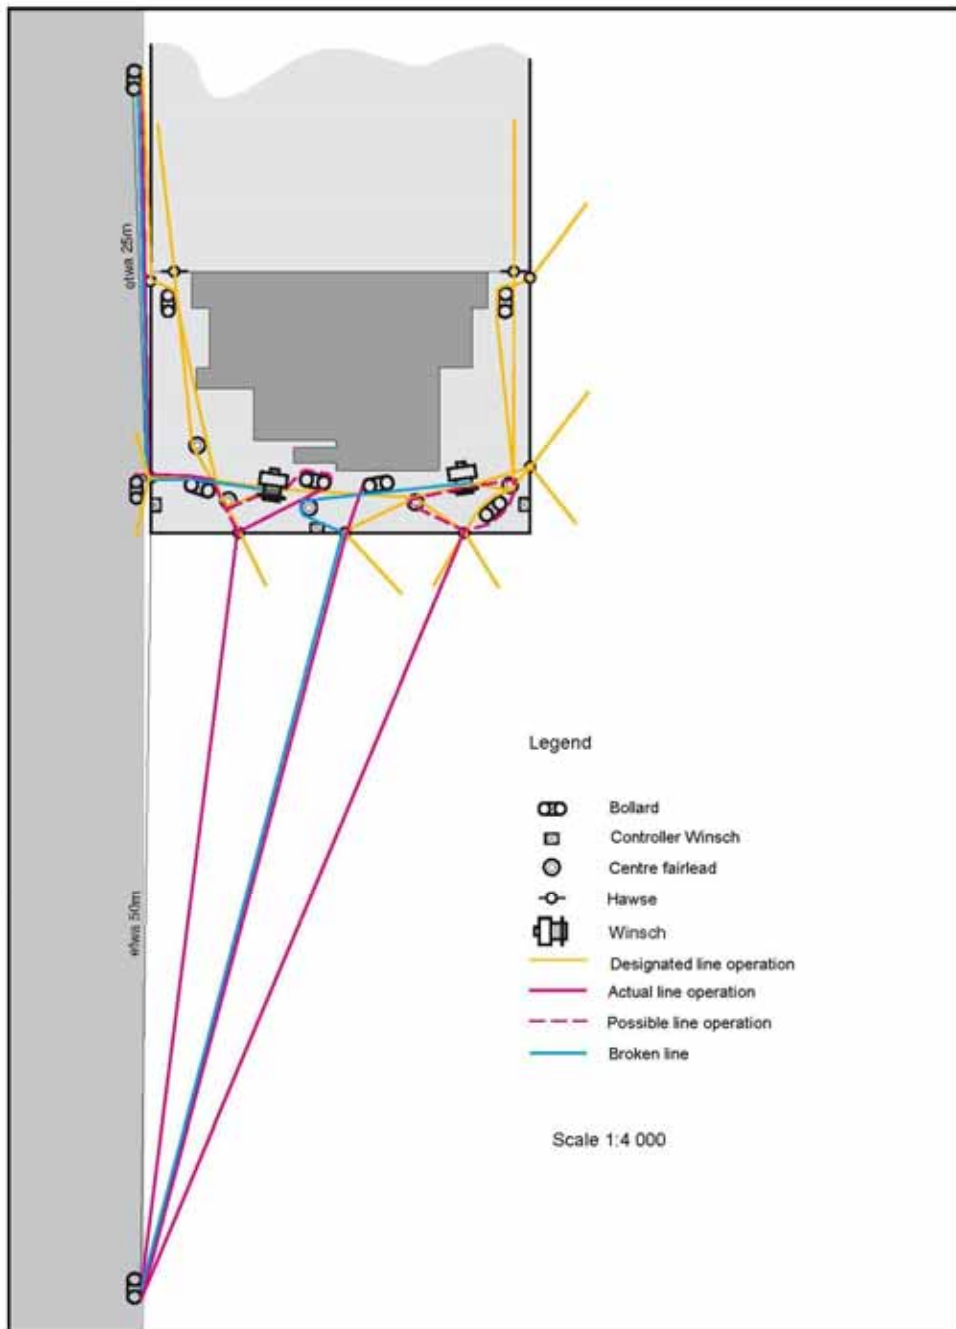
Figure 3: Mooring Plan

Usually at the bow and stern respectively were one spring, one bow line and one stern line with one layer driven on the working drum of the winch, while the rest of the lines remained on the storage part of the winch. The responsible officer at the stern operated the controllers on the winch console (see Figs. 9 and 10), which is situated in the middle of the transom. The broken polypropylene lines were certified and had a breaking strength of 518 kN (50 t, green lines) and respectively 396 kN (40 t, white lines). The broken fore spring was white and the broken stern line and also the aft spring were green (see Figs. 6, 7 and 8). The steel wire rope of the aft spring had, according to analysis of the photos, a diameter of 28 mm, which would correspond to the breaking strength of the green polypropylene rope. The nominal traction force on the stern is specified at the capstan head in 1st gear by the manufacturer Ibercisa as 11 t at a speed of 30 m/min and in 2nd gear as 5.5 t at 60 m/min, as well as in the first layer on the storage drum in 1st gear as 14.0 t and 23 m/min, in 2nd gear as 7.0 t and 46 m/min. After the stern pull came onto the line, the Officer is reported to have warned his second man before the stern line broke, which later had hit the 1st seaman. Afterwards the officer initially standing at the winch, had, according to his own statement, attempted to engage the capstan of the aft spring held by the break in order to provide more slack. Reportedly this did not happen anymore since he himself was hit by the aft spring situated on the storage drum. Engaging would have required to reverse the mechanical lever below the crank handle of the band brake (s. fig. 5 and 8). The investigations of the Waterway Police revealed that, contrary to the mooring sketches displayed above, also lines hauled through were placed on the capstan head and additionally secured on a bollard (s. fig. 4). Hence it is probable that the seaman who was injured first stood in the area of the starboard winch and the injured officer at the port winch in order to be able to work on the capstan heads. The broken stern line and aft spring were lined up in parallel to the capstan heads and were held beyond the breaking strength, respectively, by the mechanical strap brake which is operated with a manual wheel and from the manufacturer is specified for a load of 360 kN (36 t). From viewing the photos, the breaking points were most likely all outside the ship. The impact through overstretching and breaking of the ropes was sufficient to let the long forerunners spring back and hit the seamen on their legs. Depending on the condition of the polypropylene rope the maximum stretching that can be achieved with a length of 50 m is easily 6-9 m, where a total lashing/rigging of approx 18 % and a tolerance of 5 % are assumed. On the working part or storage part of the winch the following rope lengths would fit: green line 37 m, white line 46 m and steel wire 301 m and respectively at half drum occupancy 15 m for the green line, 18 for the white line or 120 m for the steel wire⁴.

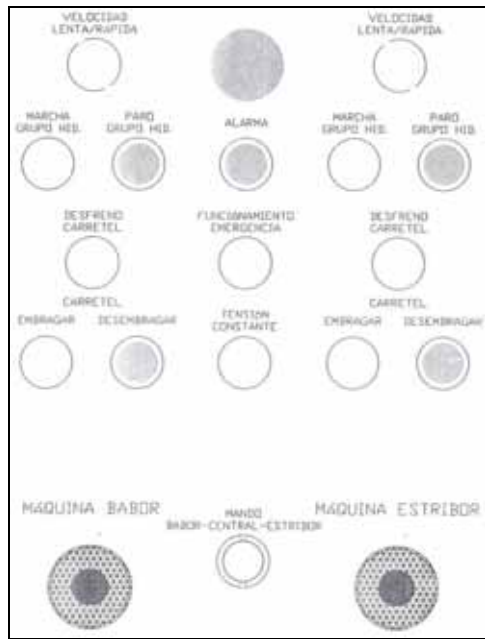
Figure 9: Operation Station for Winches amidships at the transom

⁵ At the control station two speeds (Velocidad Lenta/Rapida) can be selected. Via the switch Grupo Hidraulica the hydraulic pumps are turned on or off. The switch Desfreno Carretel vacates the function of the joystick for starting the driveshaft, which activates the screw brake. The switches Embragar / Desembragar decouple the storage drum so that the capstan head can be worked on. Automated operation with constant load is set via the switch Tension Constante. Further, the switch Funcionamiento Emergencia allows for operation of the emergency off function. The Lampe Alarma lights up during malfunction of the winch system, for instance when the hydraulics do not function properly. With the bottom switches, transfer can be made to the lateral operator stations at the stern and the winches can be started up.

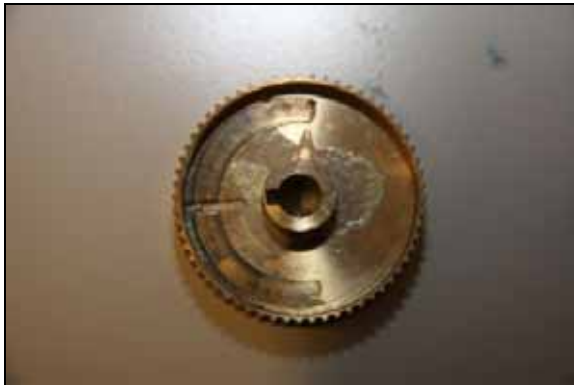
Figure 15: Cog Wheel with groove

At the BSU the control lever of the type LF 120, from the manufacturer Lilaas, was disassembled and photographed (see Fig. 13 ff). With an inbus key (see Fig. 14), a leaf spring fixed to one side can be moved. The opening in the casing for the inbus key is nondescript at first glance. An instruction manual could not be shown to the BSU. The company Lilaas did not want to make a statement to the BSU. On the leaf spring there is a 90° offset roller, which through the tension of the spring presses against a cogwheel (see Fig. 16). On the cogwheel there is a groove (see Fig. 15), which sets the zero position and locks the lever. The smoothness of running of the cogwheel is set with the leaf spring. The leaf spring can be set with a 1.5 mm inbus key so that the zero position is hardly noticeable. The cogwheel is connected via a toothed belt to a potentiometer, which conducts the current to a regulator (see Fig. 13).

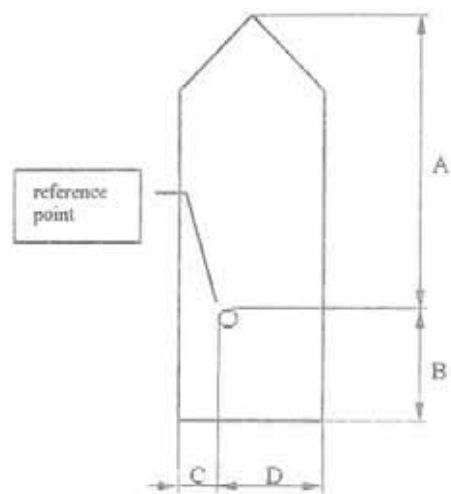
Figure 17: AIS-Configuration RUILOBA

```
AIS Equipment: Class A
Port State: Spain
Call Sign: EBWJ
IMO Number: 9348625
Destination: BREMERHAVEN
ETA: 15/05 15:00 utc
Type of Nav.: GPS
Type of Ship: Cargo ship
Carrying DG,HS, or MP, IMO hazard pollutant category A
Dimensions: length=160 m, width=25 m
Ref. Pos: A=160,B=0,C=0,D=25
Draught: 9.5 m
```

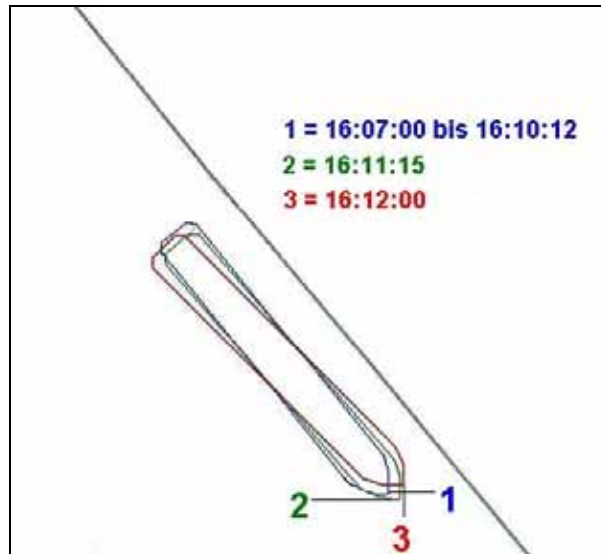
Figure 19: Movement Profile for various times UTC

At 1807 the RUILOBA lay quietly in position parallel to the pier and the propeller pitch was "zero" (see Fig. 18). At around 1809 the propeller rotations changed and the propeller pitch too. From 1810 the RUILOBA started to move causing a stern line and a forward spring to break. At around 1812 it reached its maximum forward speed. In the process the stern moved away from the pier and the aft spring broke. At 1810:34 the propeller pitch altered with a change of direction. It is likely that the Master had tried to stop the RUILOBA with an astern manoeuvre. In doing so the spring line aft had broken. At 1814 the RUILOBA lay again parallel to the pier. The deviation of approx. 5-6 m south from the original position, originally declared by the Pilot, could be explained and was confirmed by trend. According to the VDR data a forward movement and rotation towards port could be determined.

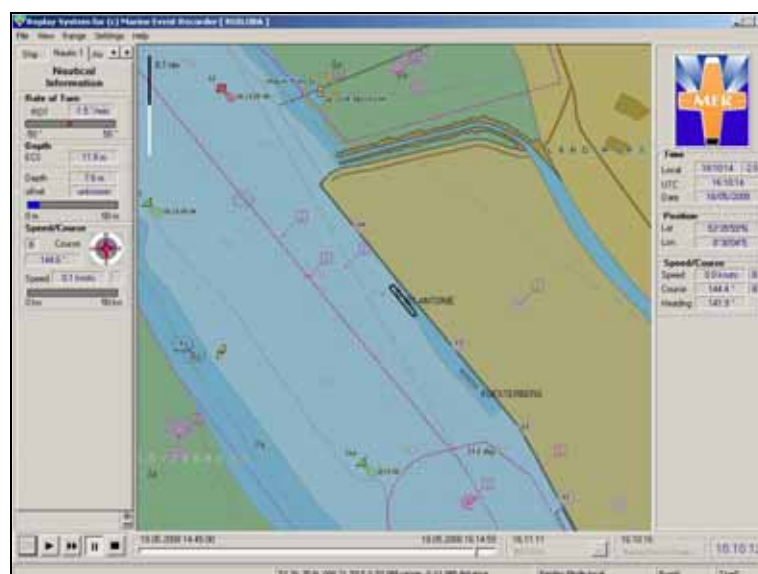
Figure 20: Traffic Situation at 1810

The traffic situation was quiet around 1810. Therefore no swell was generated which could have caused the RUILOBA to move during the mooring procedure.

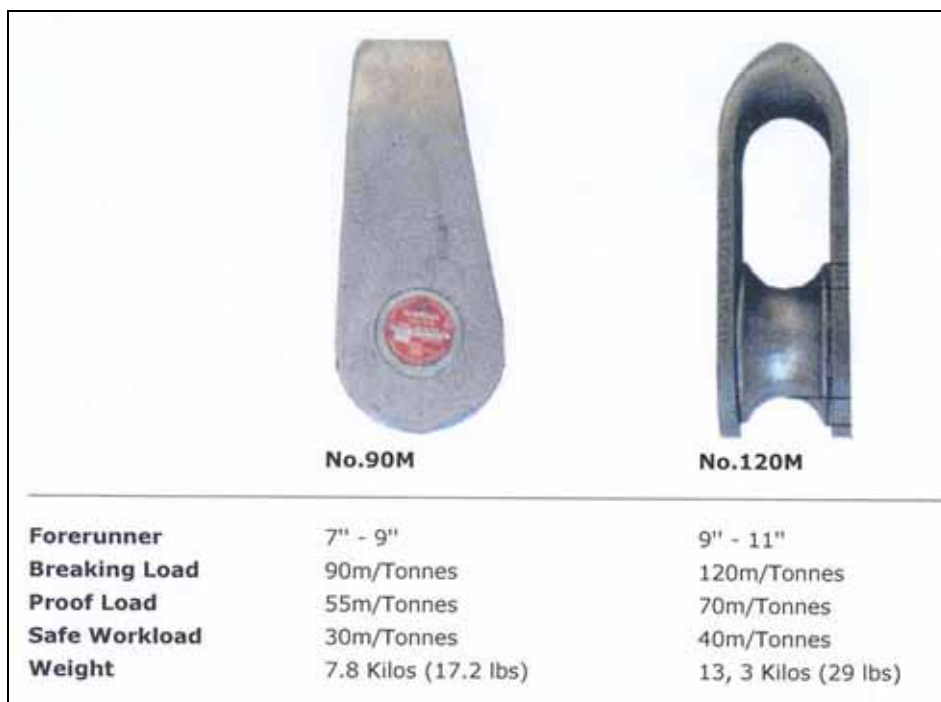
Figure 23: Fairlead Shackle Mandel

According to their technical specifications, the winches of the manufacturer, IBERCISA, are suitable for handling mooring lines of steel wire and chemical fibre. Noticeable were the long forerunners of the wires, each approx 50 m. This combination is unusual and does not correspond to the recommendations of the OCIMF (Oil Companies International Marine Forum). According to this a forerunner should be a maximum of 11 m (6 fathoms) long and have a 35 % higher breaking strength than the wire, because synthetic fibers wear out faster than wire. Further, the rope ends should be connected with a fairlead shackle (see Figs. 22 and 23). For this, the eye of the synthetic rope should be covered, for example with a leather protection. Due to the different expansion characteristics of the materials, steel wires with forerunners are recommended as springs and brest ropes, while fore and aft lines should be from synthetic fiber. The mixing together of the different materials in both spring lines and fore and aft lines should be avoided so that the load is evenly distributed.

The Marine Insurance and Safety Association recommends in its bulletins F5 and G3, on the basis of good experiences with polyamide, to use this as the material for forerunner. In addition for the winch operation there should always be one person available. Locking the winch lever is prohibited. The so-called slippage⁷ on the capstan heads is to be avoided and the cables are not to be left constantly on the capstan heads. They are to be put on bollards and secured. Instead of slippage on the capstan head, the winch is to be used for slackening the line. For synthetic fibre ropes there is the danger of sticking and uncontrolled sweating. Through this the surface becomes smooth so that there is the danger of accidents because of sudden slipping. Any chafing is to be avoided which means the ropes must not be led over/across sharp edges/corners, in order to avoid abrasion and breakage. When knotting lines a breaking strength loss of 50 % must be reckoned with. A person should never be situated beneath a cable under load. When heaving in, the loose part must immediately be rolled up or stored away behind the person at the capstan head to reduce the danger of stumbling.
