**Bundesstelle für Seeunfalluntersuchung**  
**Federal Bureau of Maritime Casualty Investigation**  
Federal Higher Authority subordinated to the Ministry of Transport,  
Construction and Urban Affairs

**Investigation Report 250/08**

**Collision of M/V RABA with  
Special craft ARTUR BECKER  
on 1 June 2008  
Northwest of the Wittow/Rügen Peninsula**

**2 June 2009**

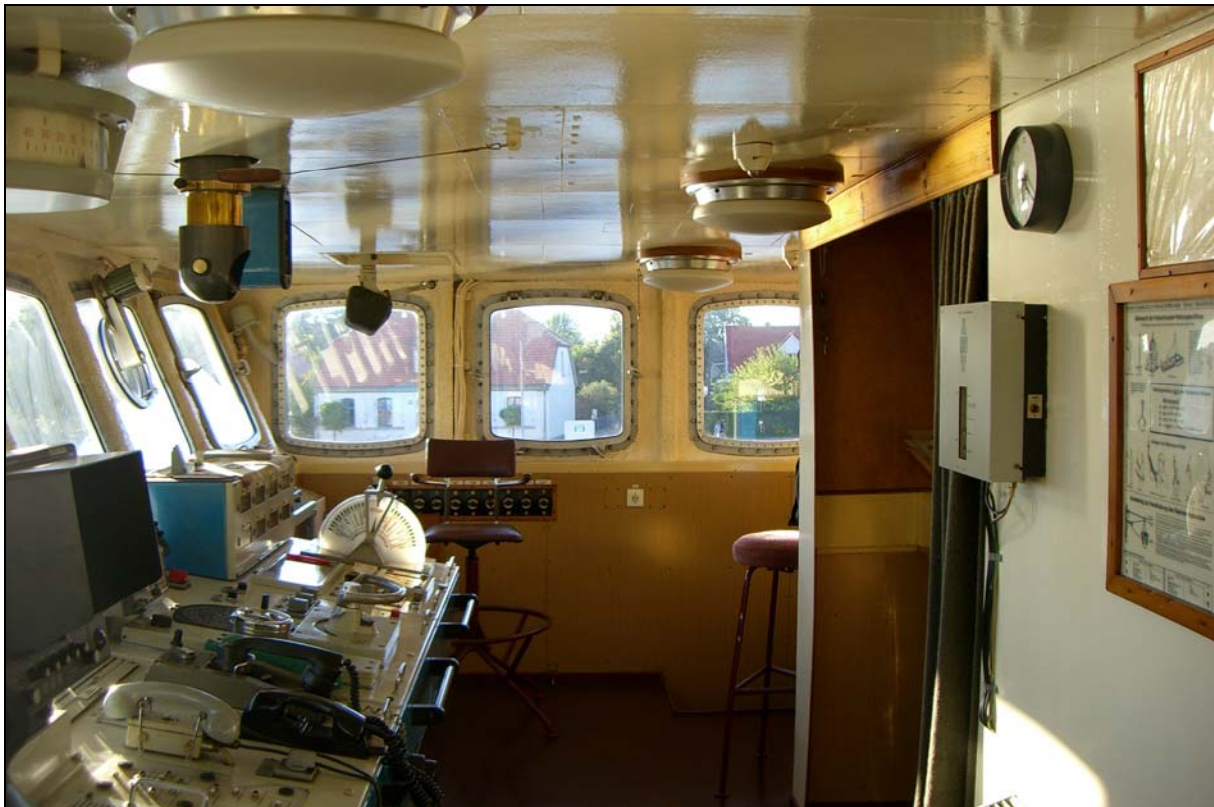
Figure 8: Wheelhouse of the ARTUR BECKER, view to starboard

The damage on board the ARTUR BECKER was documented on the day of the accident by the Sassnitz Water Police with photos. A staff member of the BSU went on board on 10 August 2008 and particularly surveyed the wheelhouse (see Figs. 8 and 9) as well as the visibility from there.

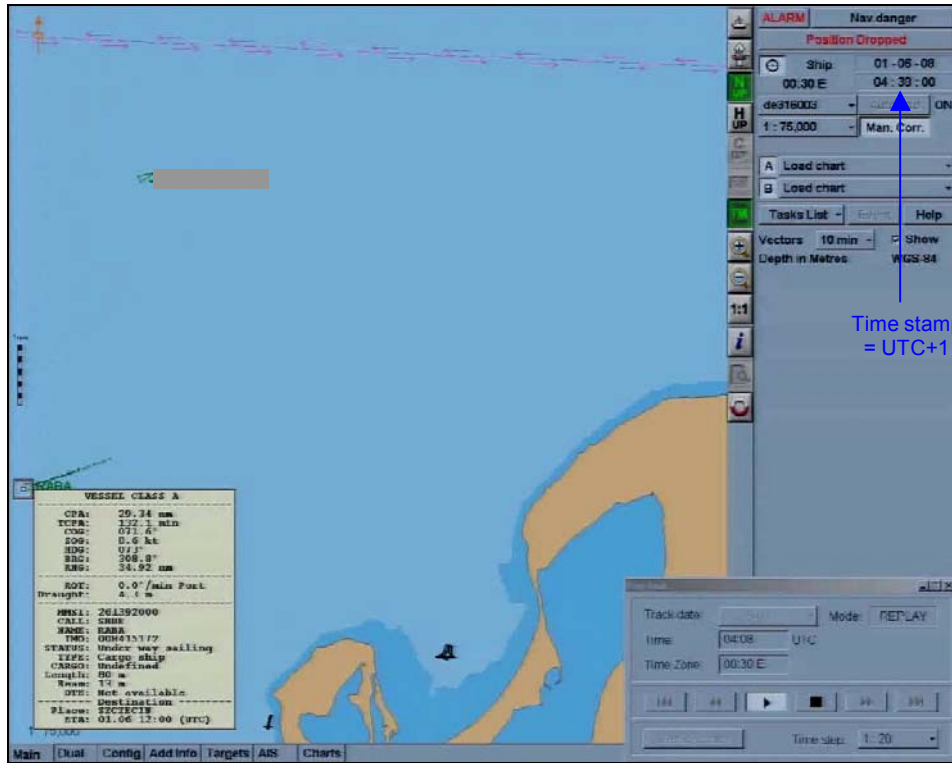
Figure 15: AIS record at 0538:00

The BSU evaluated the recordings for the time period 1 June 2008, 0535 to 0730. The AIS data of the RABA could be extracted from the recordings (see Fig. 15).

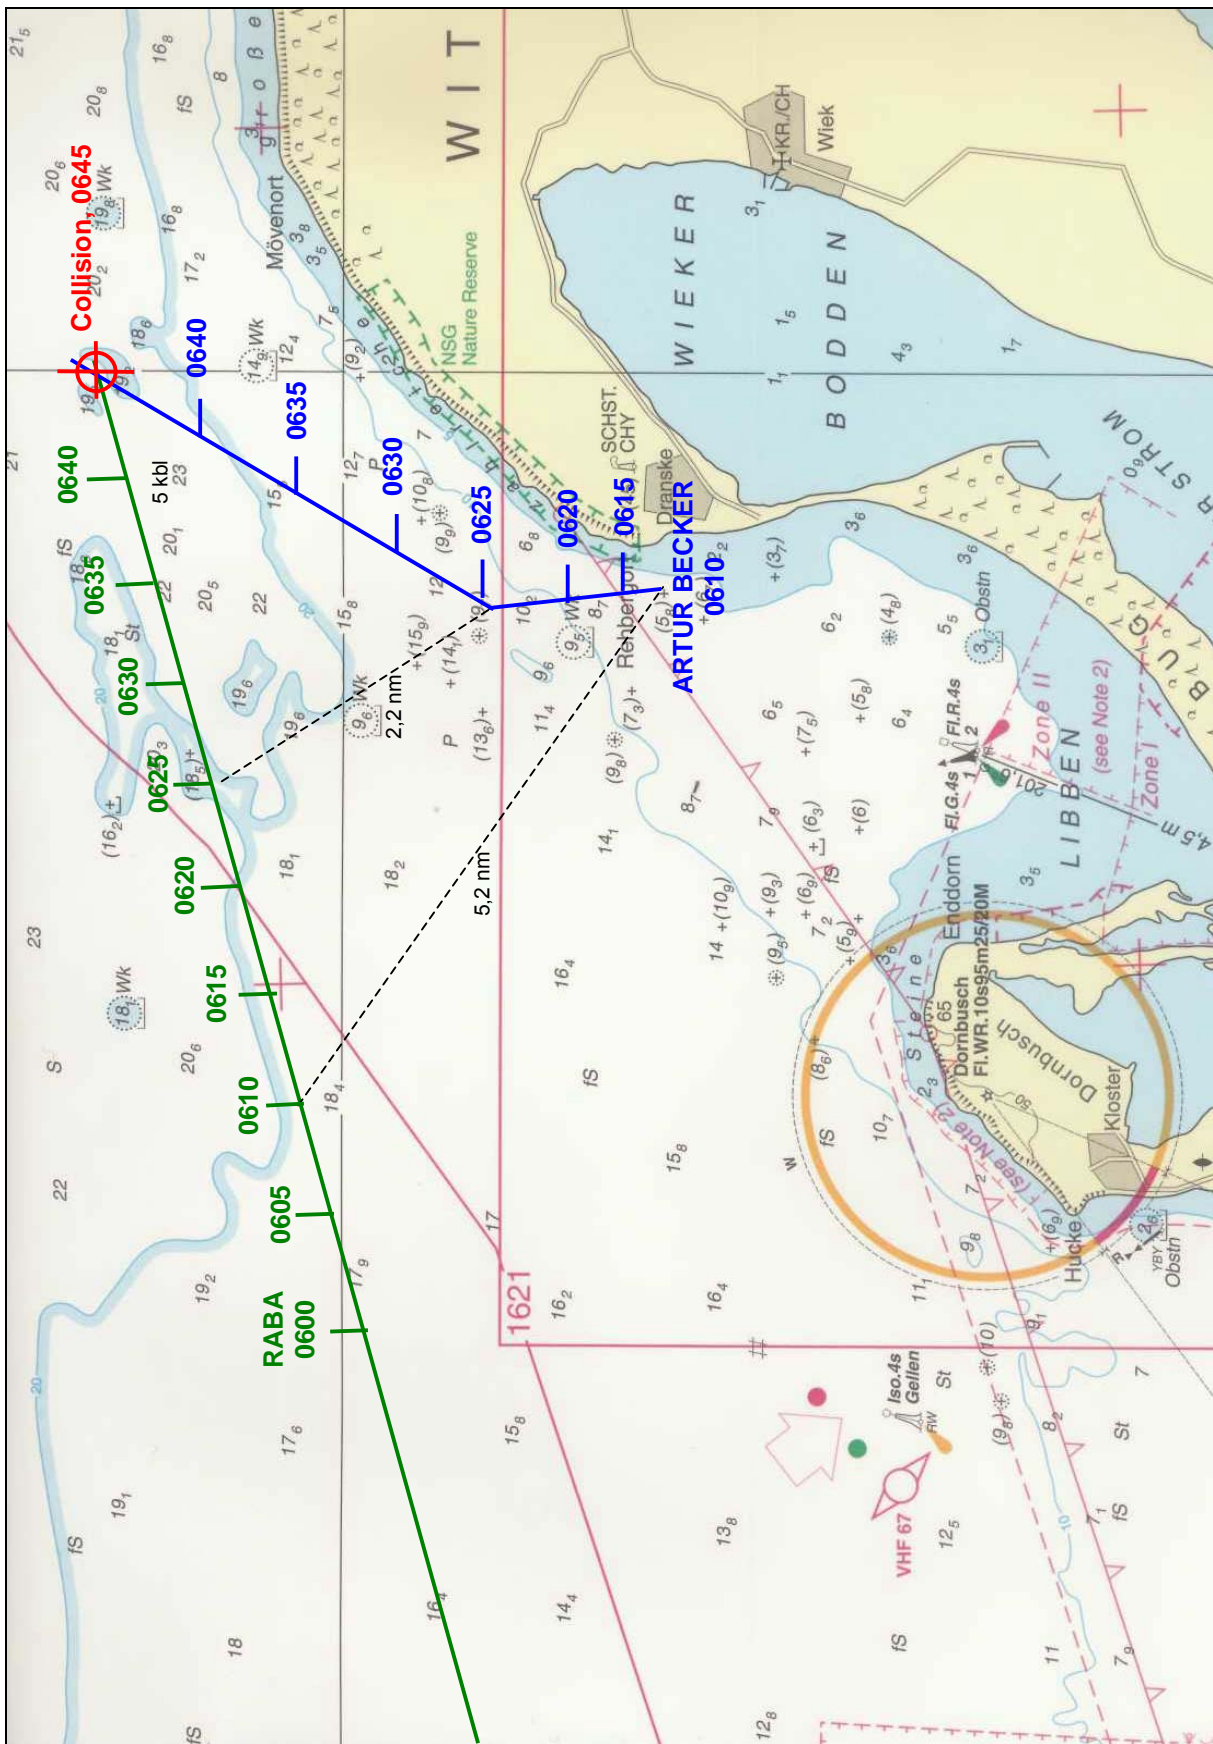
Figure 20: Reconstructed voyage courses, section of nautical chart 162, BSH

In order to reconstruct the course of the vessels involved in the accident, the AIS logs of the Vessel Traffic Service, the bridge and engine logbook entries as well as the journey plans were compared to each other and put together graphically (see Fig. 20). The ship's position of the ARTUR BECKER is subject to estimation, as no voyage plan has been recorded in writing (see section 5.6). The vessel position logged on the RABA for 0600 was replaced with the position recorded by the Vessel Traffic Service (see section 5.5). The time of the accident, which is noted in the RABA bridge logbook for 0655, was assumed in accordance with the VHF and AIS records as well as the statements of the ARTUR BECKER crew as being at 0645.

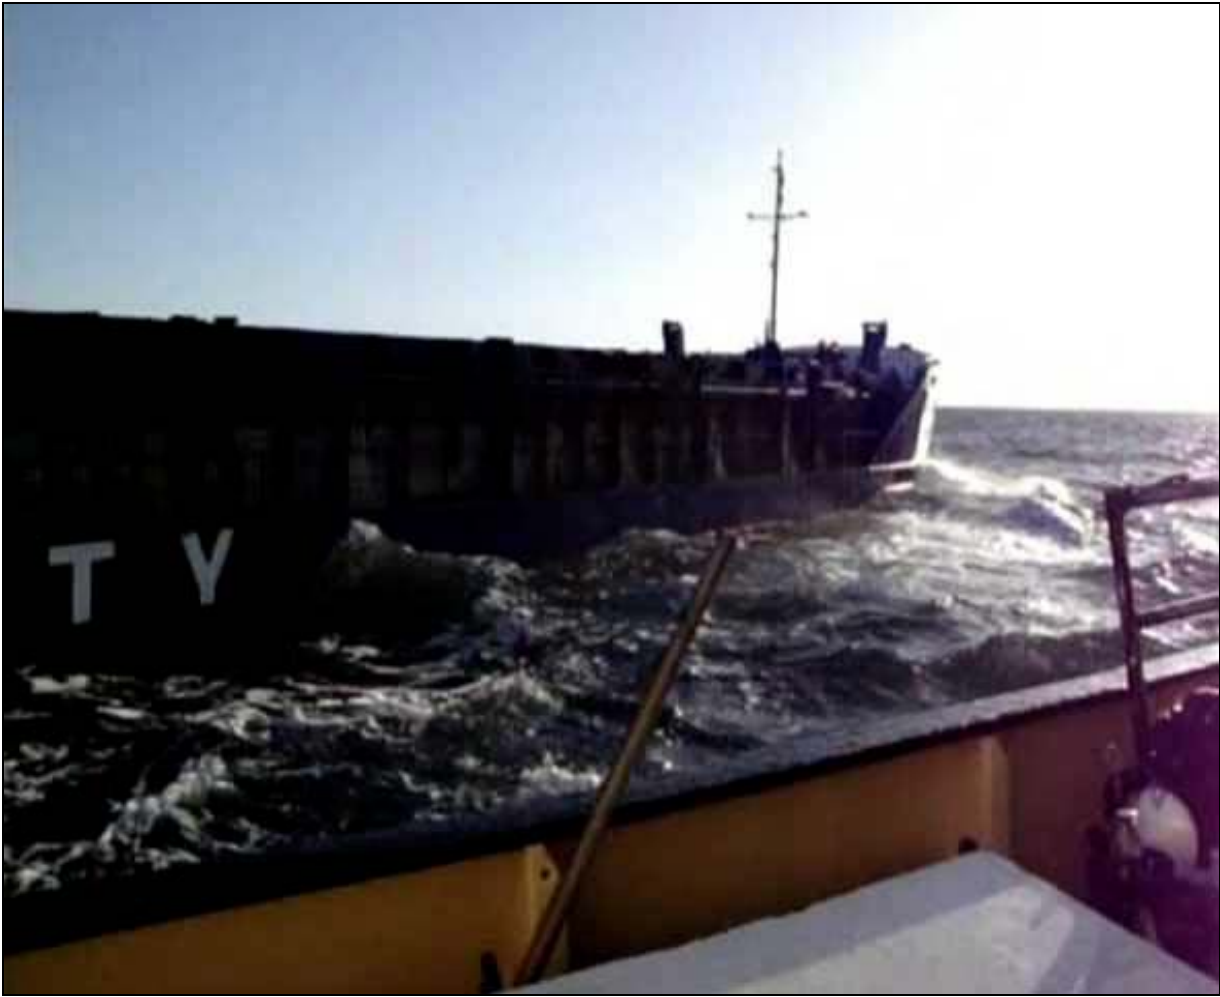
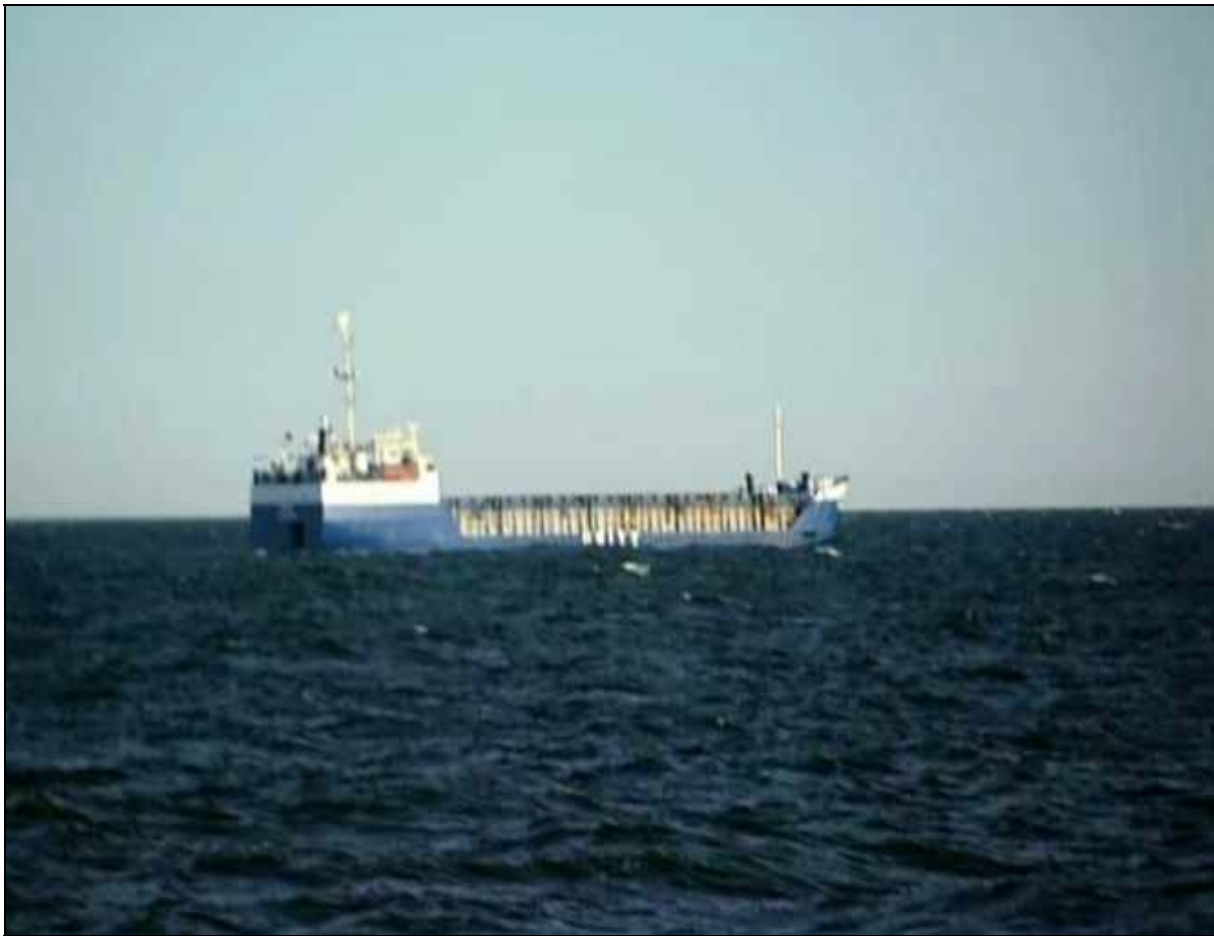
Figure 22: Excerpt from the video recording immediately after the collision

Figure 23: Further excerpt from the video recording immediately after the collision

The estimates made in the DWD opinion about wave heights and good visibility conditions were supported by the images.
