Bundesstelle für Seeunfalluntersuchung
Federal Bureau of Maritime Casualty Investigation
Federal Higher Authority subordinated to the Ministry of Transport,
Building and Urban Affairs

Investigation Report 254/08

Serious Marine Casualty

**Stranding of
CMV NORFOLK EXPRESS
on 30 May 2008
in the Gulf of Suez**

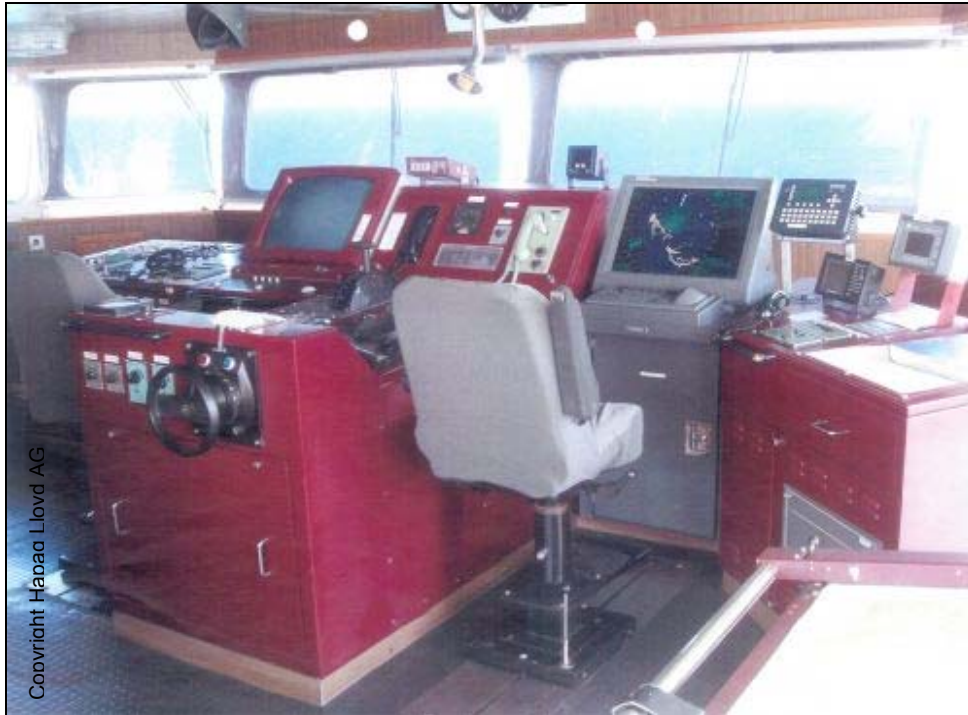
Figure 3: Bridge with paper chart plotter right bottom corner

According to the SMS and the standing orders of the Captain, the Officer on watch would have been obliged to ascertain the position in coastal waters every 20 minutes, ensure a proper lookout and use the available equipment – acoustic, electronic and visual. On NORFOLK EXPRESS the position is displayed continuously on the paper chart through a plotter. The chart plotter is on the right next to the S-band radar set (see Figure 3). That was why the Officer on watch had refrained from making regular entries in the paper chart.

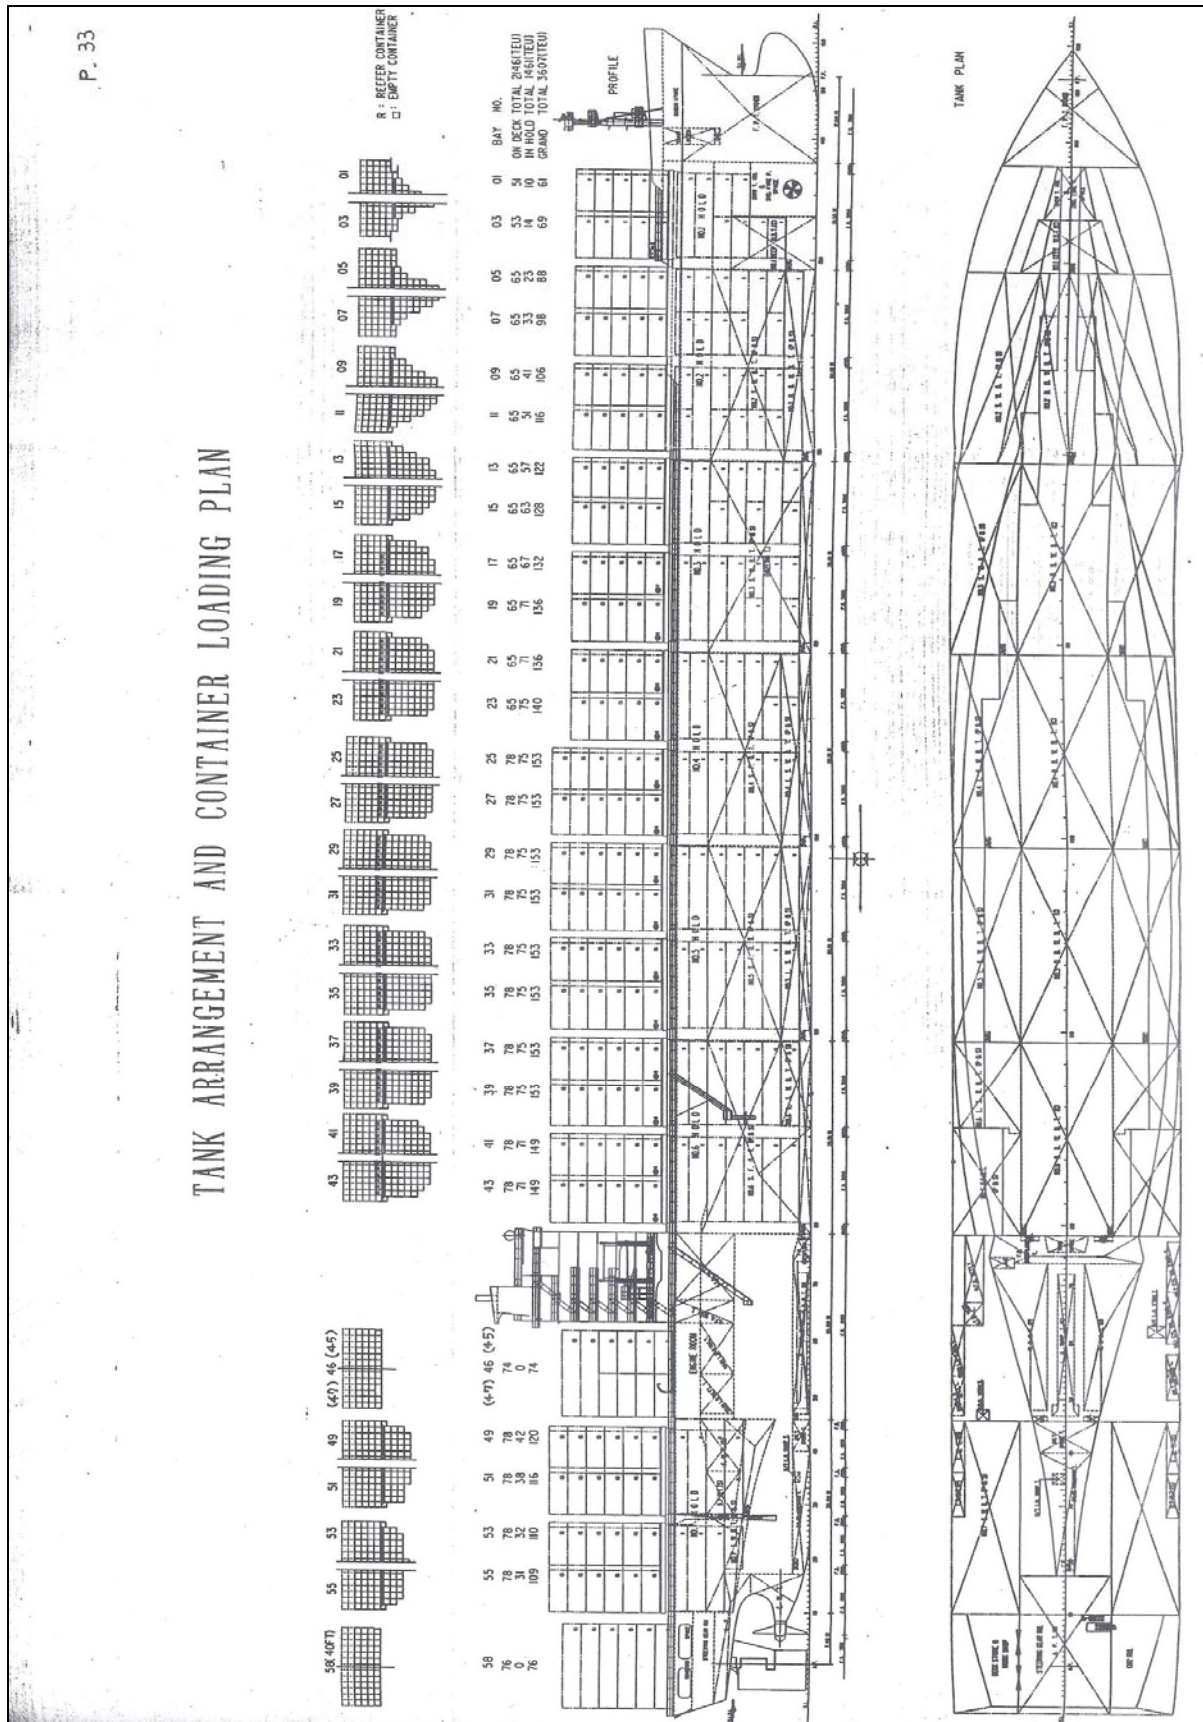
Figure 6: Tank arrangement and container loading plan

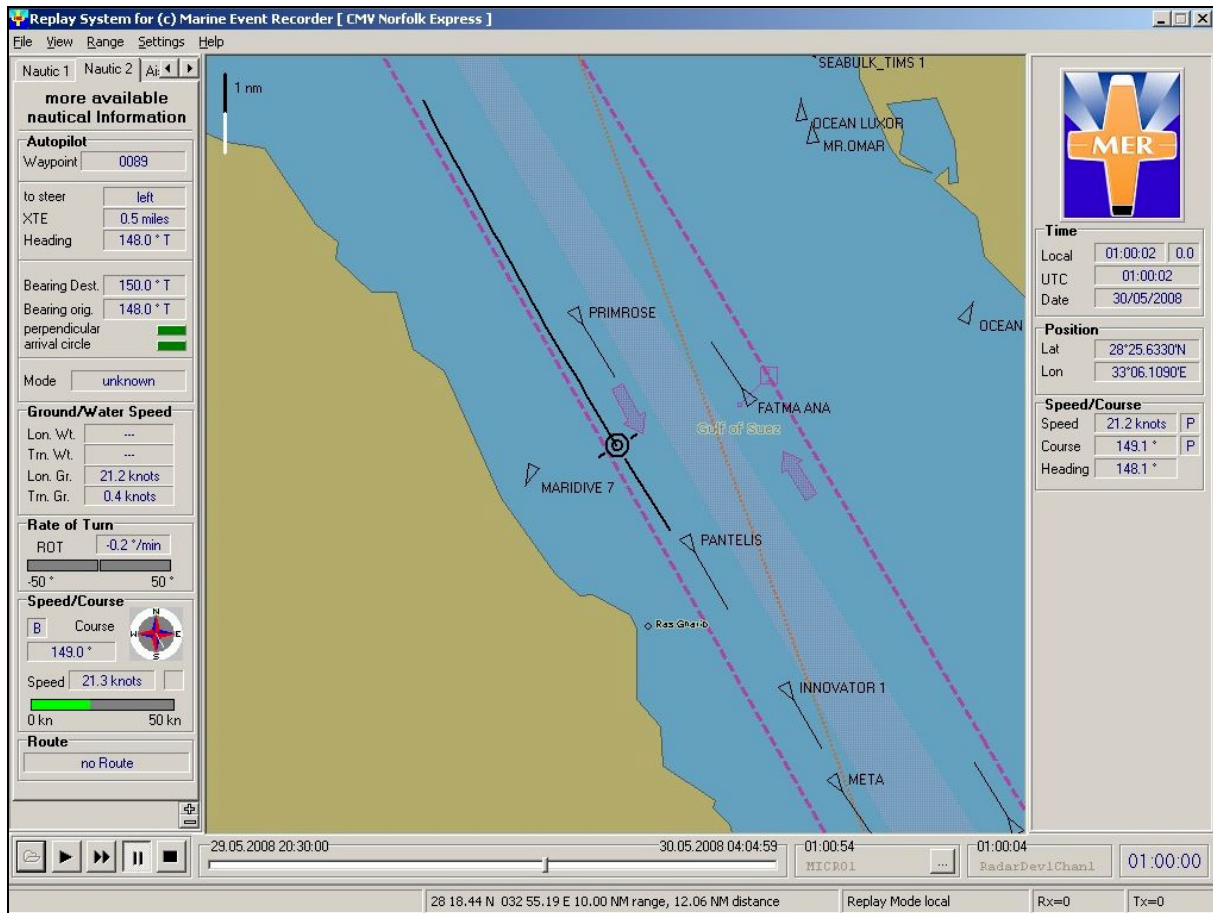
Handing over the watch took about five minutes. The traffic situation, course and speed were explained. This could not be taken from the audio recording. He had checked the position on the paper chart at 0400 and ascertained that initially two other vessels on the same course were ahead of him. However, these had not represented any particular risk (see Figure 8). At 0407 he had sent the lookout away so that the latter could check the temperatures of the reefer containers and then clean the companionways. At this time it had started to become light and the Officer on watch was now alone on the bridge.

Figure 8: Traffic situation 0400 (Chart generalised)

He observed the S-band radar set and switched the ranges from 6 nm to 12 nm and vice versa and saw the PANTELIS at a distance of about 1 nm ahead. He had altered the course 2 – 3° to starboard in order to increase the distance (CPA) on overtaking.
