Investigation Report 302/07

**Very serious marine casualty**

**Personal accident with stern line  
on the MS NORTHERN FAITH  
on 4 July 2007  
in port of Koper**

15. November 2008

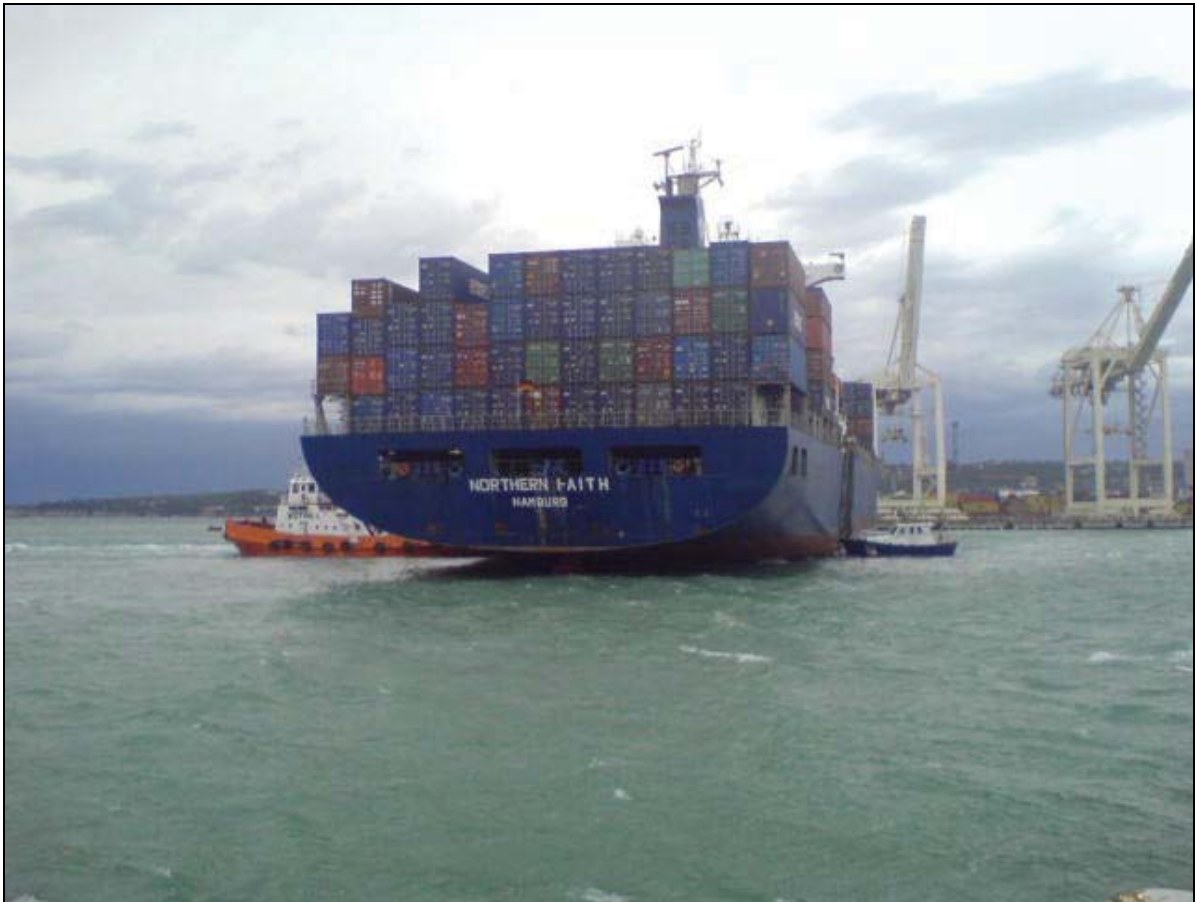
Figure 3: Photo of the turning NORTHERN FAITH (at about 17:23). A tug boat can be seen on the port side and the pilot's boat on the starboard side which had just brought the medical team on board and was waiting to transport the injured person to the pier.

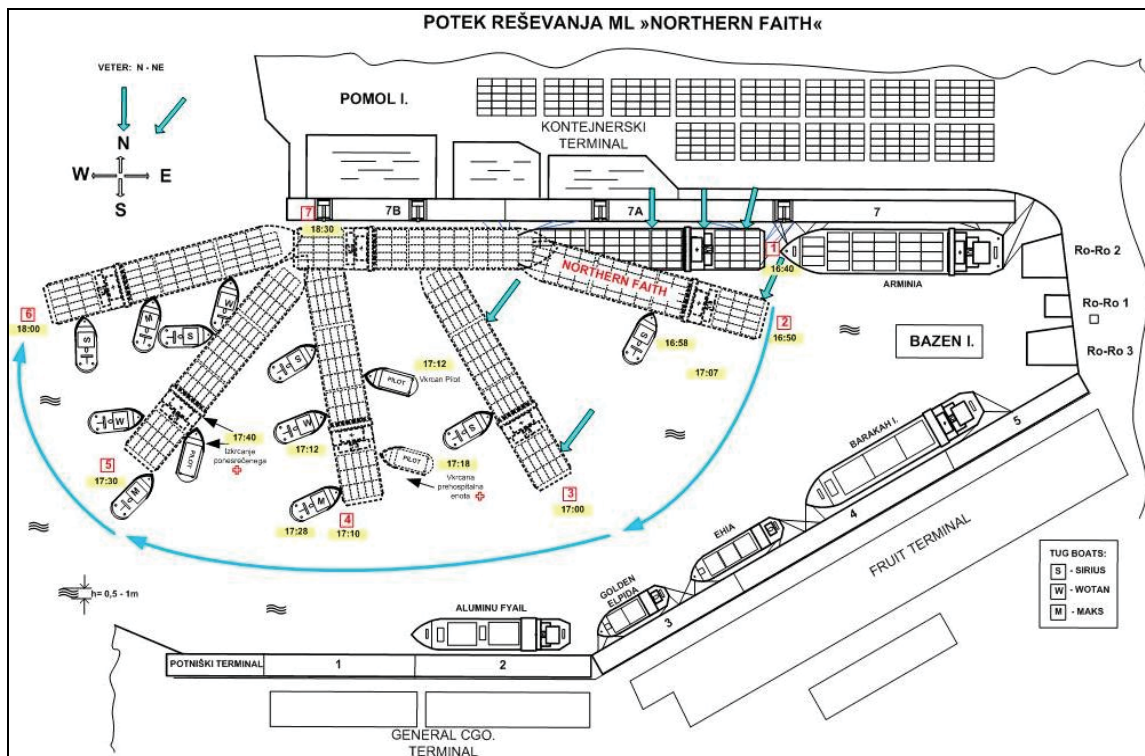
Figure 6: Illustration of the turning movement by the NORTHERN FAITH

The investigating inspector had already arrived at the port during the turning manoeuvre by the NORTHERN FAITH and he documented the event (see Figure 6).

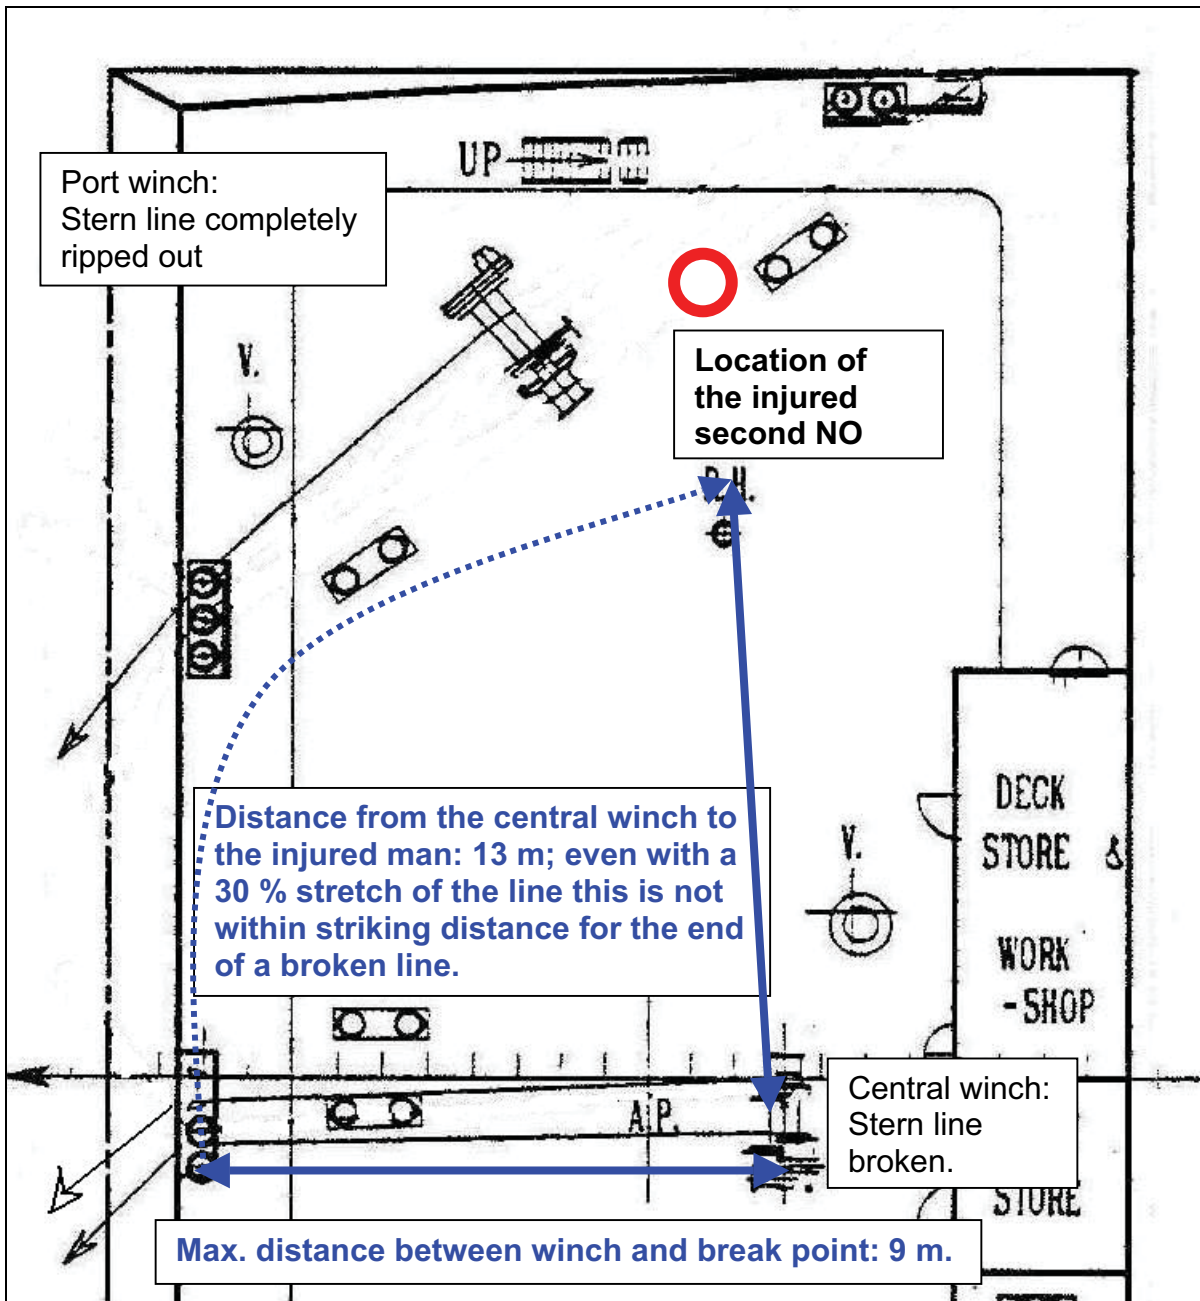
Figure 11: Position of the injured

All those questioned indicated the same position on deck, independently of each other. According to them, the second NO lay about 2 - 3 m away from the port winch with his head towards the bollard. The distance from this position to the central winch was about 14 m. If the central line **on deck** was torn then it could **not** have reached him. If it broke outside the fairlead, then it would have been very unlikely to strike back on deck.

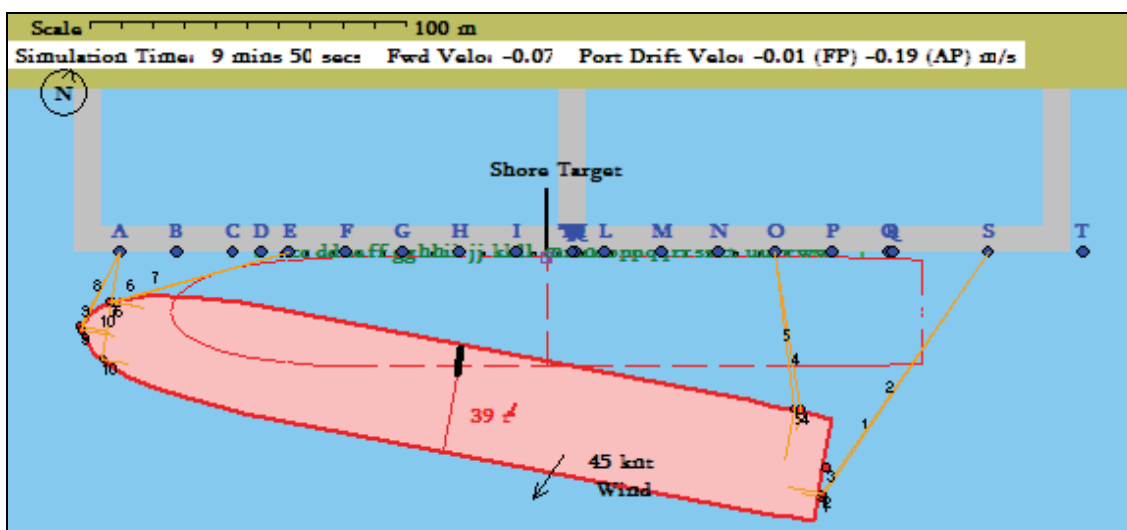
Figure 17: Simulation scenario 4 after 10 mins of wind impact

**In scenario 4 the central stern line would have already broken after 2 to 4 minutes, and the vessel would have been driven very quickly away from the pier, especially the stern of the ship.**

**This last simulation shows a very great similarity to the reality.**

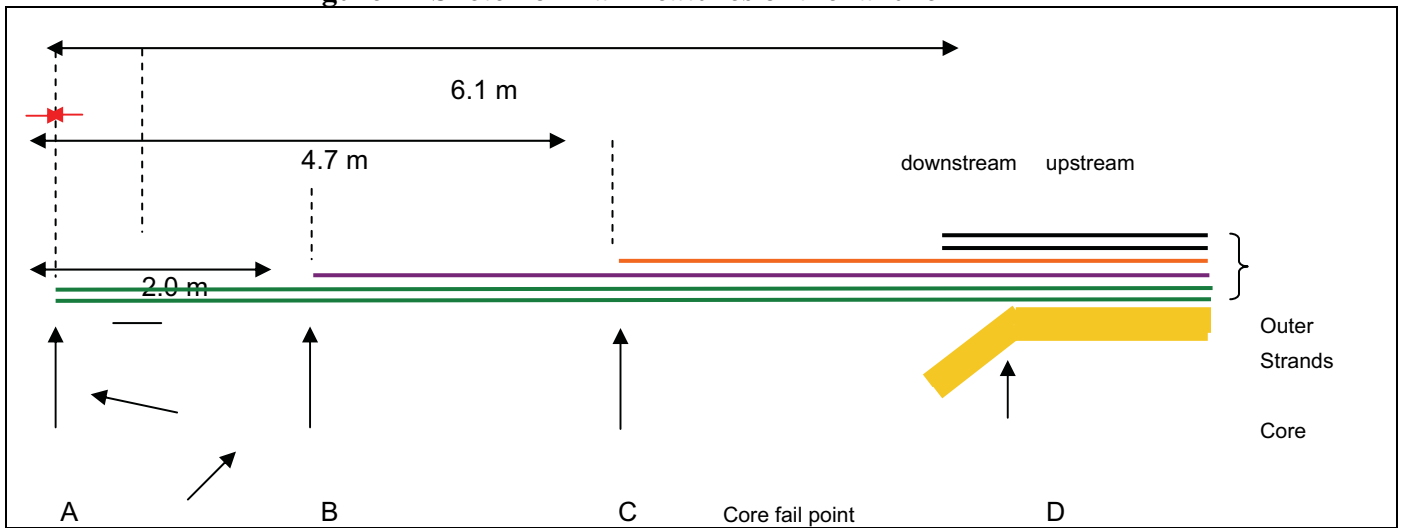
**Figure 1 Sketch of main features of the failure**

The rope yarns of the inner layer are seen at 'b'. They divide into two separate groups 'c' and 'd'. Group 'd' are loose and are in reasonable condition. Group 'c' show evidence of two clusters of localised failure and also melding. The melding is found between the upper and lower clusters of damage, suggesting a short zone where internal structure of the rope had been subjected to excess pressure. These clusters of localised failure are in line with the localised distortion seen at 'a'.

The rope yarn failures found at 'c' are unusual as they have occurred on inner rope yarns whilst their partner outer rope yarns [at 'a'] have only been severely compressed. The damage to both sets of rope yarns has probably been caused by the two strands, black in figure 1. This evidence suggests that at the time of failure, there was excess load and that the load distribution between the elements within the core was poor. The inner rope yarns were strained to a higher extent than the outer rope yarns. The pressure from the outer strands would have resulted in localised restraint of the material lying beneath them, further complicating the load distribution. Due to the excess strain on the inner rope yarns, some have failed whilst the outer rope yarns, under less strain, have been able to withstand the strand pressure more successfully.

4. The two black coloured strands of figure 1 failed initially. During the course of their failure, the strands exerted extreme pressure on the core structure of the rope. This resulted in the damage seen to the rope yarns of the core, photograph 8.

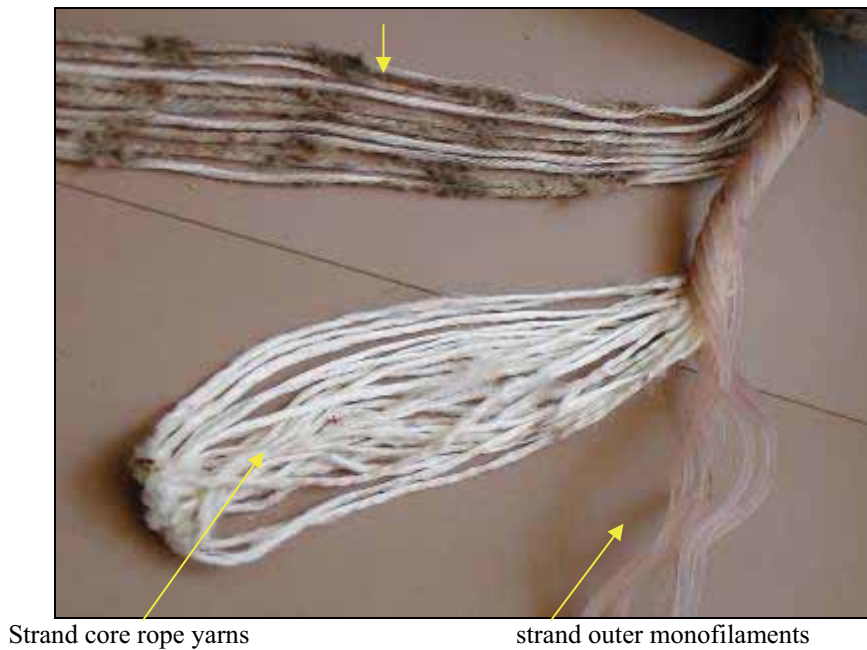
Photograph 10 shows one of the strands upstream of D, unraveled. The outer rope yarns are abraded, but retain some structure. Also, the yarns had a soft 'feel' to the hand, in contrast to the harder 'feel' found on surviving rope yarn material downstream of D. In addition, examination of the monofilaments failed to reveal the same degree of external abrasion as that found on monofilaments downstream of D.

**Photograph 10 Unraveled strand, upstream of D**  
Strand outer rope yarns

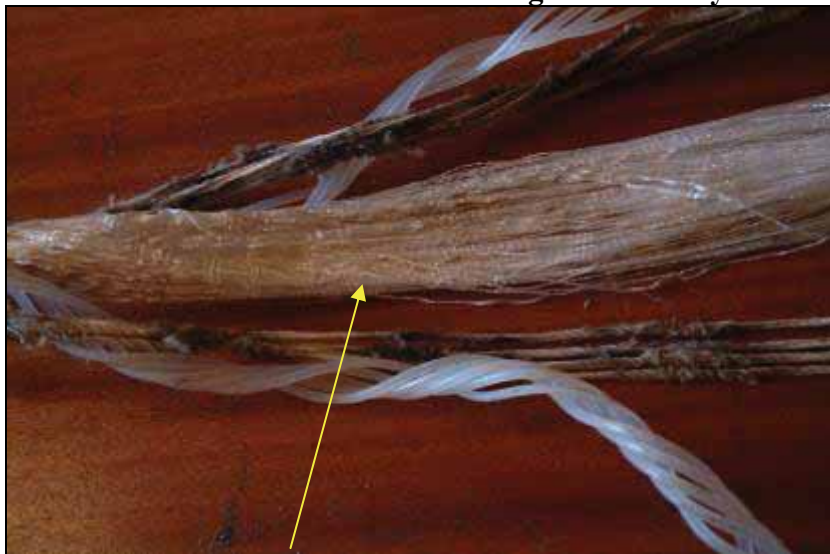
**Photo 13 Unraveled strand showing core textile yarns**

Severe damage was found to some of the rope yarns in the core assembly, photograph 12, but with little evidence of similar damage to the outer strands in the that region. This is similar to damage found in the ‘failure’ sample, upstream of D, where damage to the core was not matched by comparable damage to the outer strands. However, in this case, the cause may have been a previous compression incident, not related to the rope failure. The outer strands, with the tough monofilaments, were able to withstand the compression, whilst the softer core rope yarns could not.

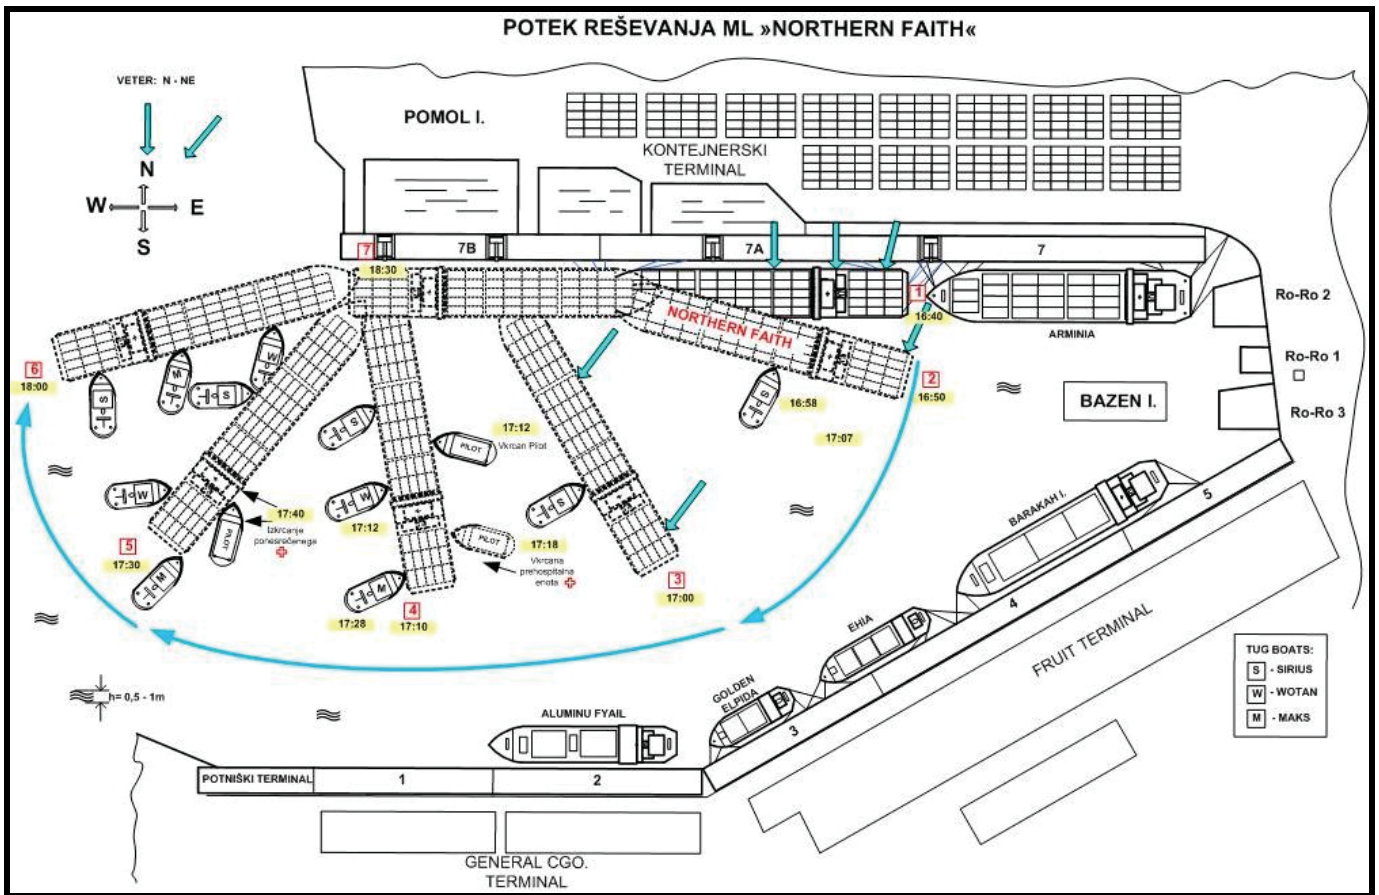
Figure 4: Northern Faith Movement

Figure 4 shows a diagram of the vessel being securely moored at 1640 through to it being controlled by assistant tugs at 1800. As no data was available for the tugs and the initial activity is the most important since this dictates the later excursion of the vessel then the dynamic analysis was conducted from 1640 to 1700.

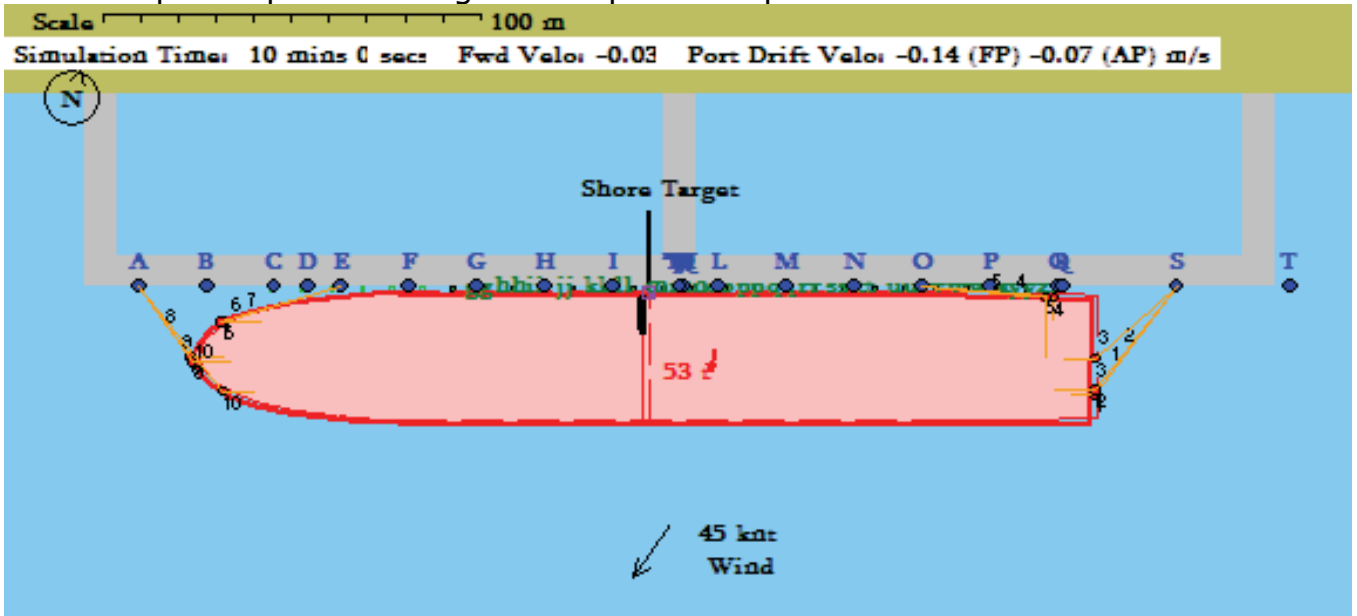
Figure 5: Case 1 After 10 Minutes

Case 1 has all ropes with new certified break load and winch brakes set at 42 tf. After 10 minutes there are no broken lines, acceptable vessel excursion, a highest loaded line of 36% MBL and maximum rendered line of 5.3 m. In the circumstances of a mean wind speed of 45 knots beam on blowing off the jetty this is an acceptable position. Figure 5 depicts this position.

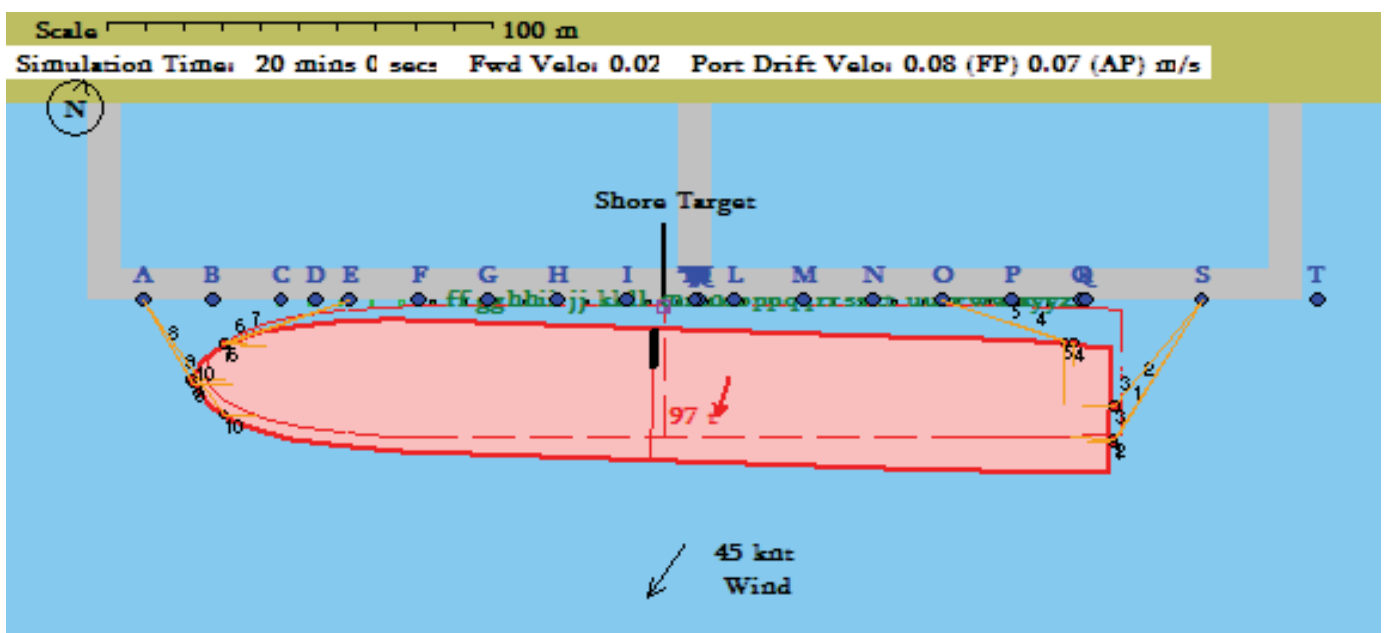
Figure 6: Case 1 After 20 Minutes

After 20 minutes, there are still no broken lines, vessel excursion is high at 2.4 m forward surge and 5.6 m outwards sway. Highest loaded line 32% MBL and maximum rendered line length is 10.9 m. Again in the circumstances of a mean wind speed of 45 knots beam on blowing off the jetty this maybe an expected position but the vessel is not out of control and does not bear resemblance to the Northern Faith's position after the same time interval depicted in figure 4.

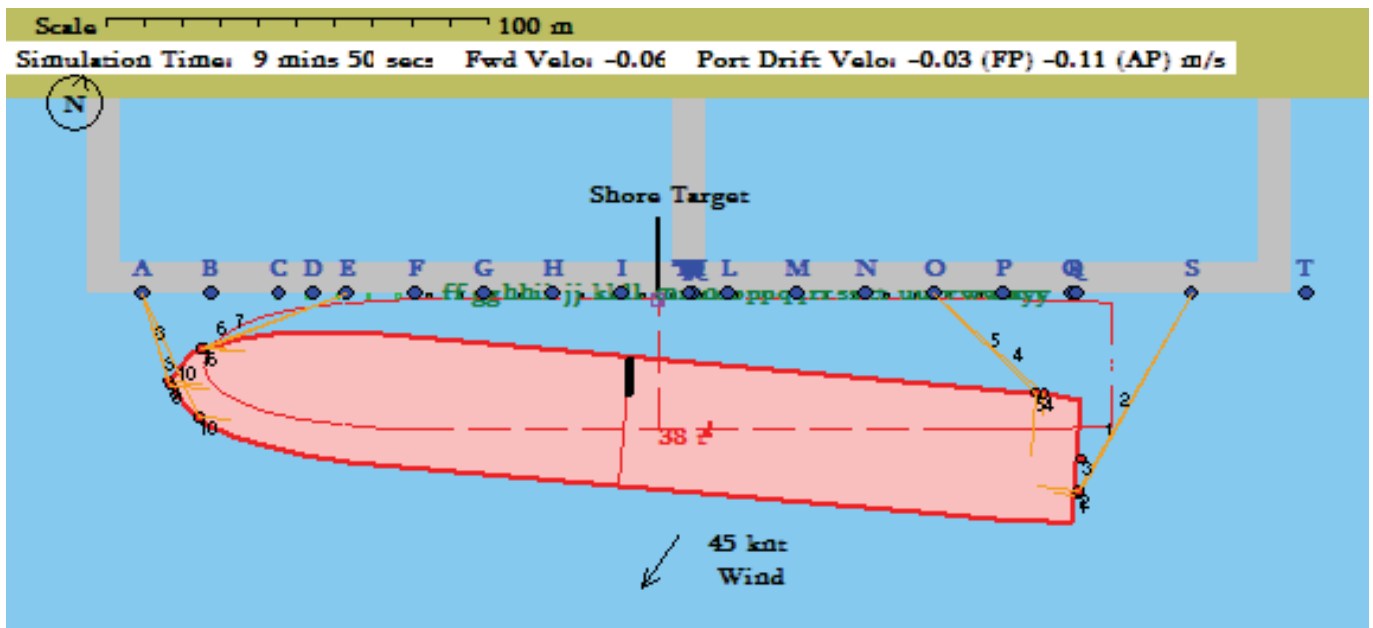
Figure 7: Case 2 After 10 Minutes

Case 2 has all ropes with new certified break load and winch brakes set at 42 tf except line 3 which has a breaking load of 42 tf. Between 3 and 4 minutes line 3 has broken because the line loads were too high. After 10 minutes there is unacceptable vessel excursion of 6.8 m forward surge and 13.4 m outwards sway, a highest loaded line of 34% MBL and maximum rendered line of 26.7 m. In these circumstances of a mean wind speed of 45 knots beam on blowing off the jetty the vessel is no longer securely moored with only one winch stern line and one on bits. Figure 7 depicts this position and it is noted that it is not dissimilar to the actual displacement of the Northern faith shown in figure 4 after 10 minutes.

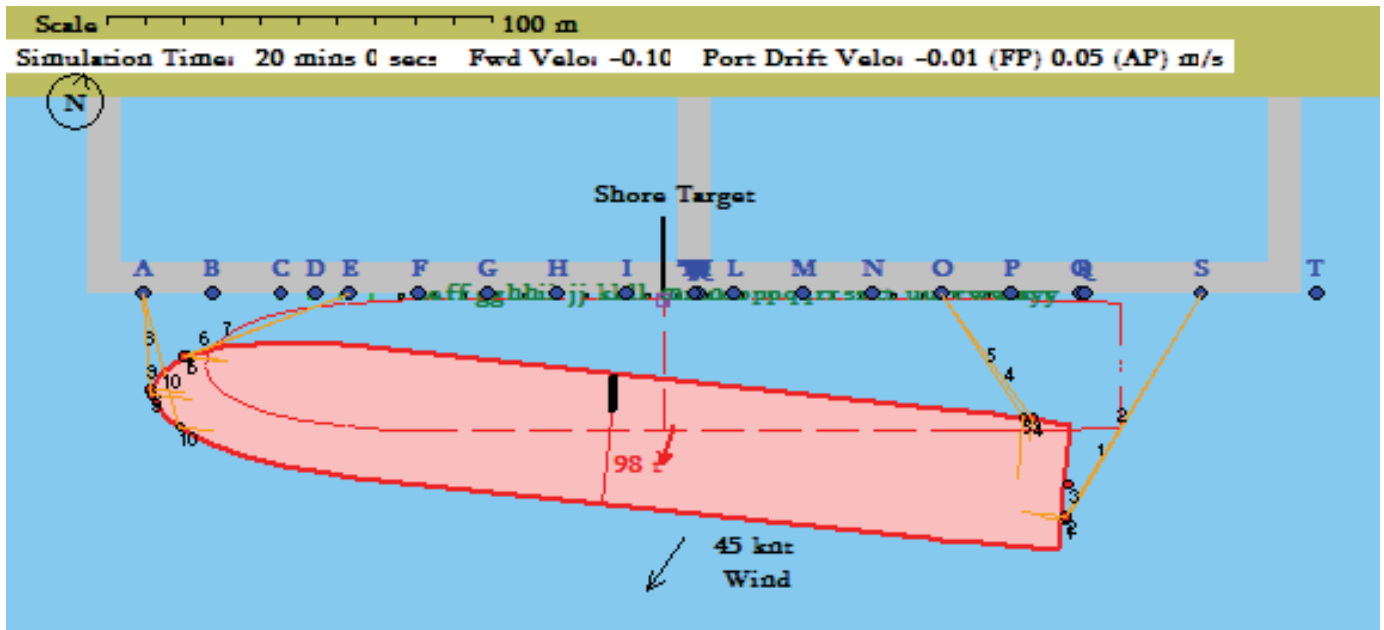
Figure 8: Case 2 After 20 Minutes

After 20 minutes things have got progressively worse with vessel excursion of 12.5 m forward surge and 18.0 m outwards sway, a highest loaded line of 32% MBL and maximum rendered line of 37.2 m. Figure 8 depicts this position. The actual displacement of the Northern Faith shown in figure 4 after 20 minutes is worse than this case 2 simulation after 20 minutes.

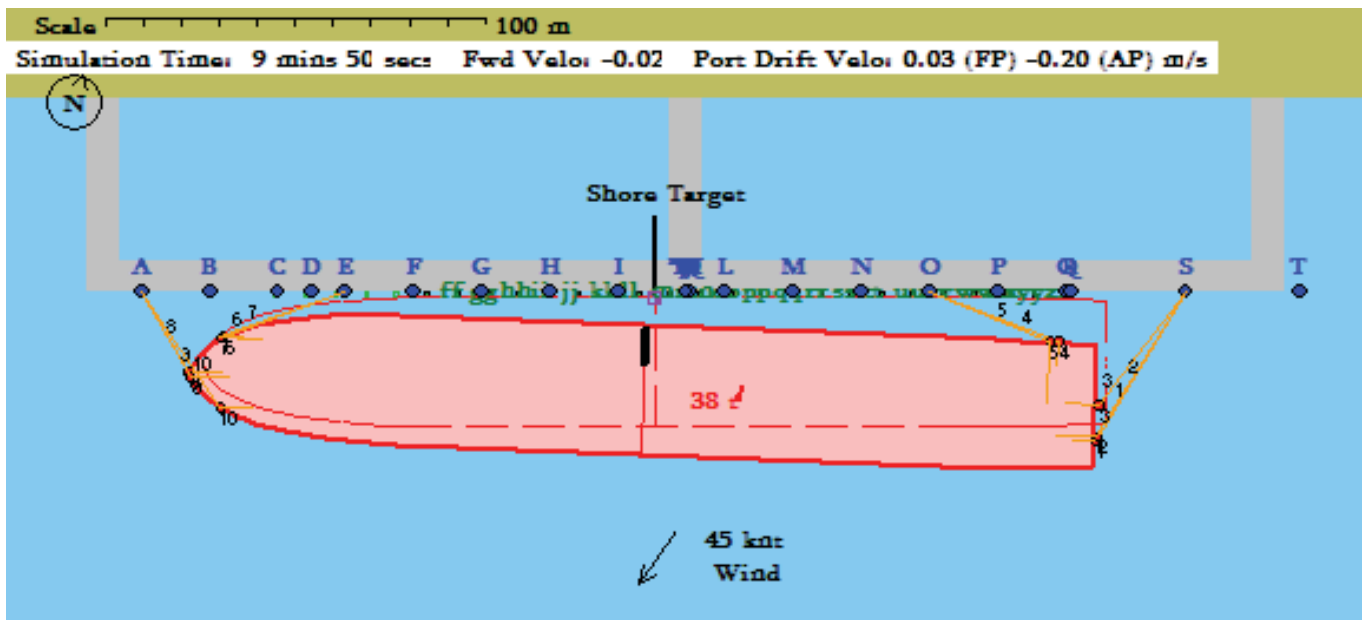
Figure 9: Case 3 After 10 Minutes

Case 3 has all ropes with new certified break load but winch brakes set at 30 tf as an example of brake fade occurring as discussed earlier. After 10 minutes there are no broken lines, 2.4 m forward vessel surge and 6.1 m outwards sway, a highest loaded line of 19% MBL and maximum rendered line of 13.2 m. Case 3 is similar to Case 1 with the exception of lower winch load rendering and therefore the additional vessel excursion is consistent with this. Figure 9 depicts this position.

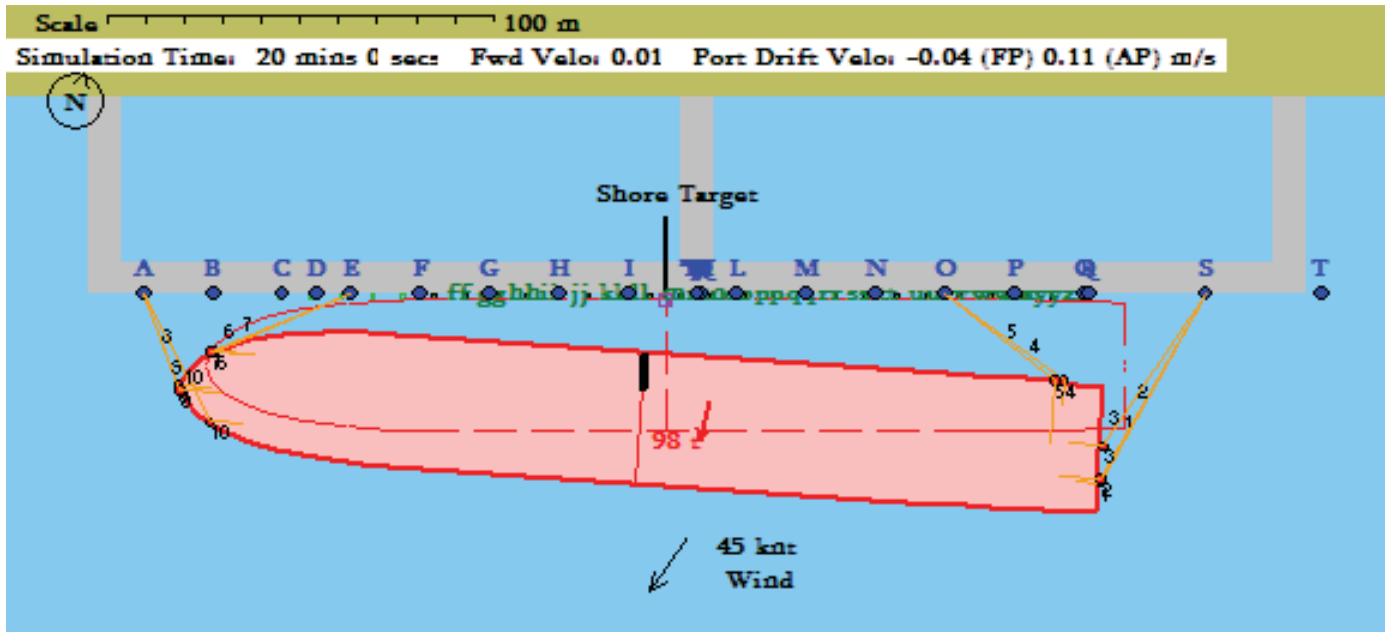
Figure 10: Case 3 After 20 Minutes

After 20 minutes there are still no broken lines but surge and outwards sway have increased to 5.5 and 12.8 m respectively, highest loaded line is 30% MBL and maximum rendered line of 22.0 m. Again with Case 3 being similar to Case 1 bar

the reduced rendering load the additional vessel excursion is consistent with this but the vessel displacement is not as severe as that experienced by the Northern Faith from the figure 4 diagram.

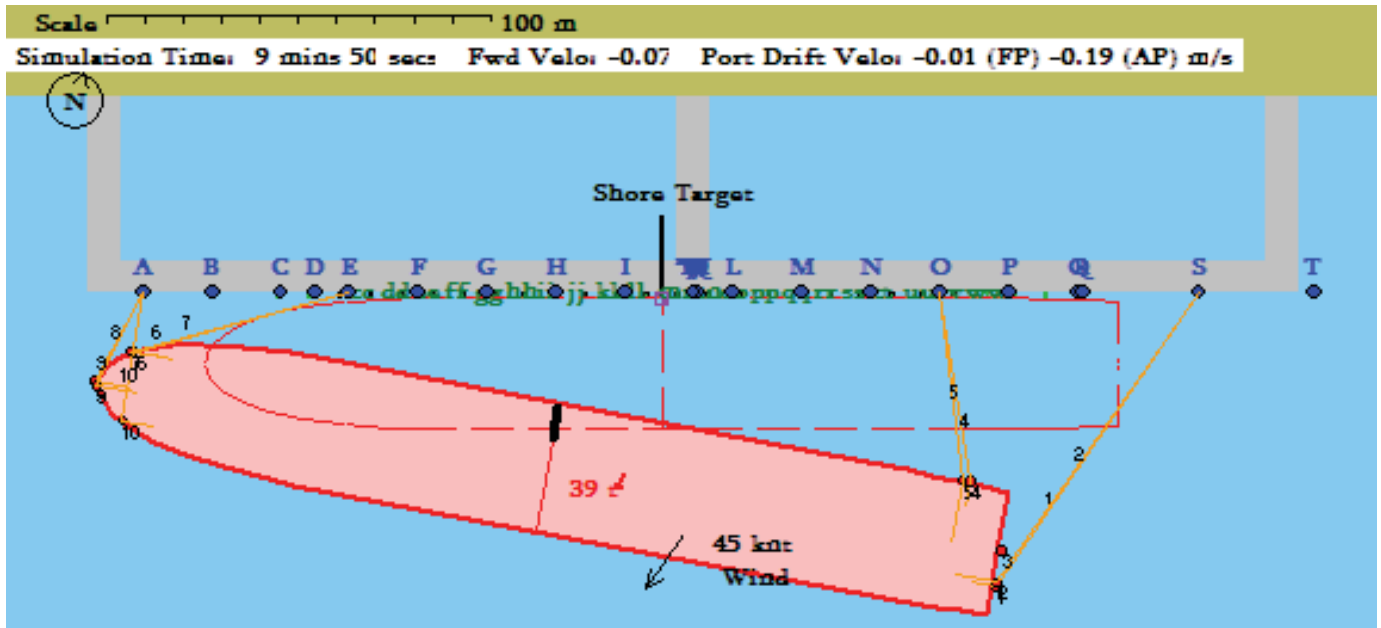
Figure 11: Case 4 After 10 Minutes

Case 4 has all ropes with new certified break load except line 3 which has a breaking load of 42 tf and winch brakes set at 30 tf. Between 3 and 4 minutes line 3 has broken because the line loads were too high. After 10 minutes there is unacceptable vessel excursion of 25.7 m forward surge and 24.7 m outwards sway, a highest loaded line of 31% MBL and maximum rendered line of 58.6 m. Clearly a desperate situation and the worst of the four cases investigated at the 10 minute time interval and very similar to the Northern Faith graphic at the same time interval (see figure 4).

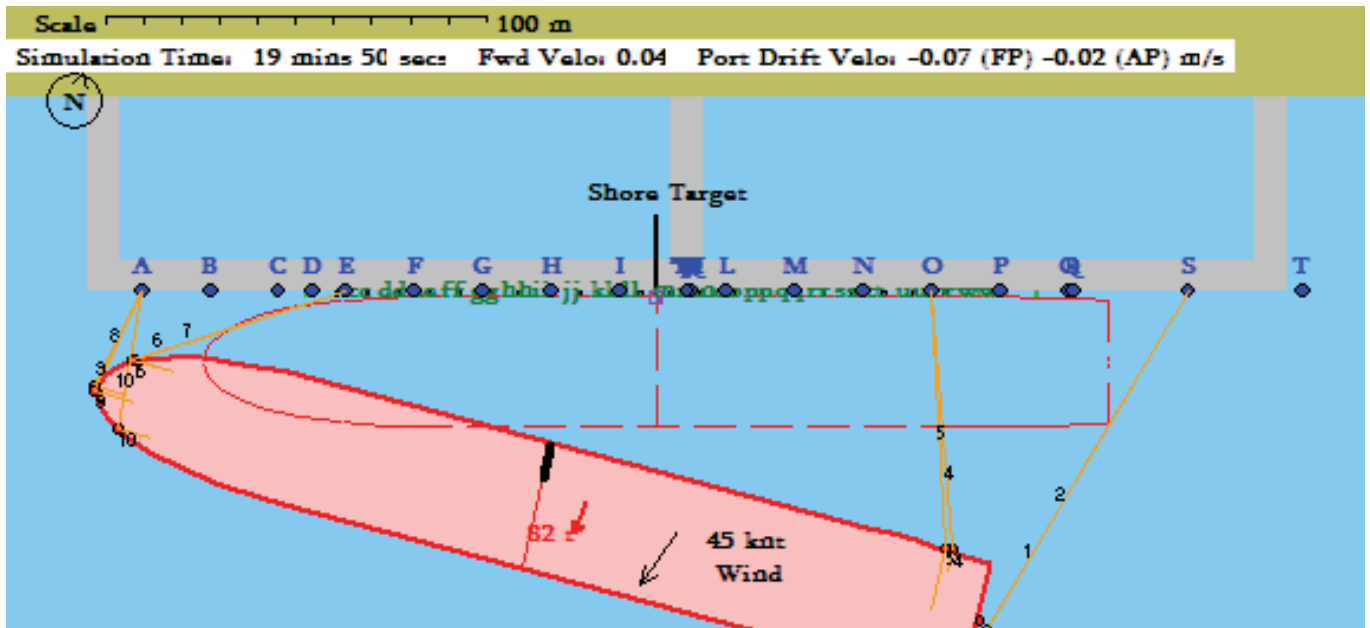
Figure 12: Case 4 After 20 Minutes

After 20 minutes things have got progressively worse with vessel excursion of 27.4 m forward surge and 35.1 m outwards sway, a highest loaded line of 40% MBL and maximum rendered line of 74.1 m. Figure 12 depicts this position. The actual displacement of the Northern Faith (fig. 4) after 20 minutes is similar to this Case 4 after 20 minutes.
