Summary Investigation Report 31/09

Very serious marine casualty

**Accident with subsequent loss of life on board
the fishing vessel TANJA on 6 February 2009 at
the port of Burgstaaken (Fehmarn)**

1 December 2009

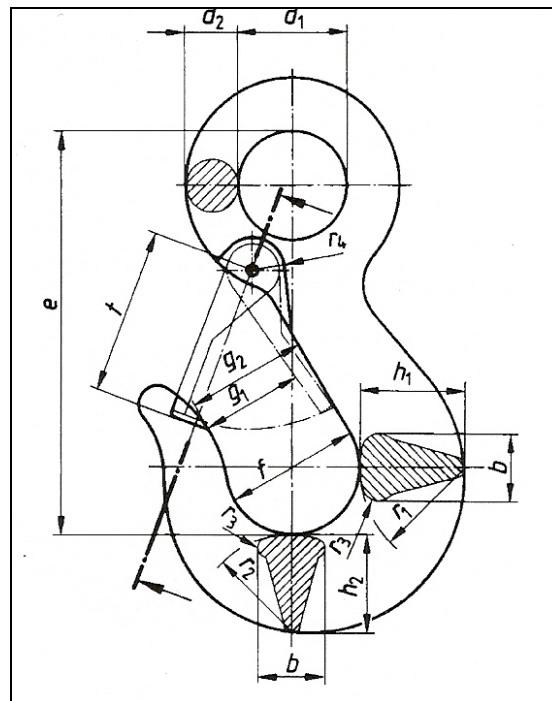
Figure 18: Load hook according to DIN 7541

The geometry does not match that of a standard hook. **Figure 18** shows a diagram of a load hook with a large ring according to DIN 7541. The comparison in the following table shows the differences. Hooks of this size have a load capacity of 12.5 kN.
