**Bundesstelle für Seeunfalluntersuchung**  
**Federal Bureau of Maritime Casualty Investigation**  
Federal Higher Authority subordinated to the Ministry of Transport,  
Building and Urban Affairs

Investigation Report 47/08

**Serious marine casualty**

**Collision**  
**of the MV SCHLESWIG-HOLSTEIN**  
**with the Skanseodde Lighthouse**  
**in Fredericia on 31 January 2008**

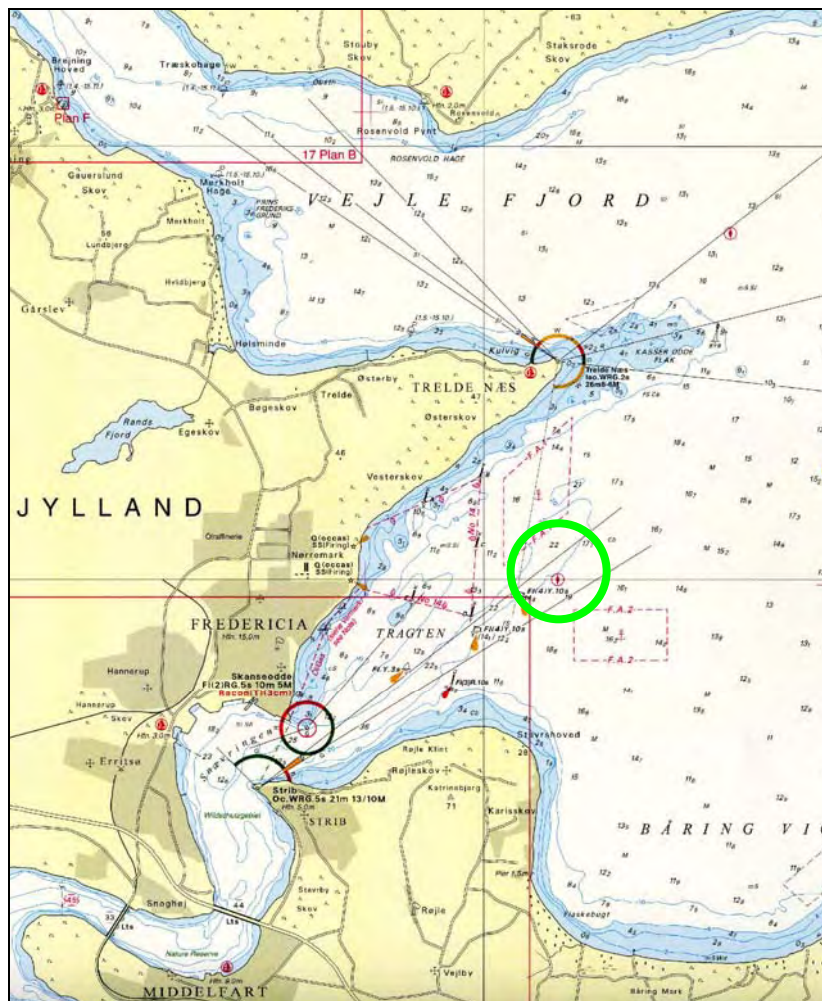
Figure 7: Tragten pilot transfer position

In Danish waters pilots may only embark or disembark either when the ship is in port, by a jetty, in a roasting, etc., or at pilot embarkation points as approved by the Danish Minister of Defence, unless special circumstances apply. The pilot transfer position is marked on the chart as NE of Tragten (see Fig. 7).

In this instance, with the prevailing strong southerly winds, the pilot had decided to transfer west of Skanseodde lighthouse (Snævringen). This decision was conveyed to the master only just before, without any special indication of the risks from wind, current and drift.

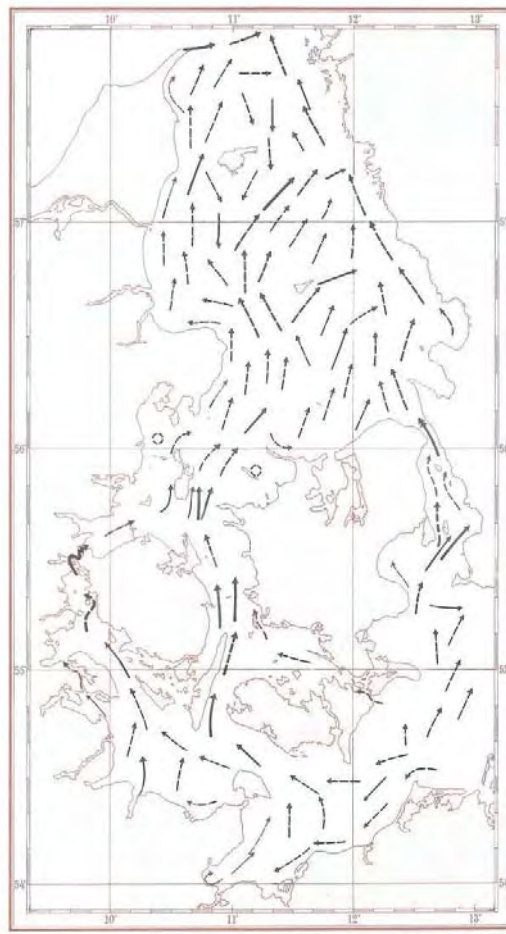
Figure 8: Section showing natural conditions in the Baltic Sea, Federal Maritime and Hydrographic Agency (BSH)

Deviations from the average conditions shown in Fig. 8 (B 5.2 a) must be accepted around the complexly structured coastlines and when the shallows are flooded; there are also eddy currents along the coast.

Surface currents can reach a major force in Lillebælt, specifically in the narrow Snævringen fairway. They do not always set in the direction of the fairway but partially move transverse to it. There is a countercurrent close to shore at individual areas along the coasts which can be used to great advantage by small vessels sailed by local commanders. As a consequence of the windings of the fairway, there are areas of different land protuberances where smaller vessels can anchor outside the current area or where the current is much less forceful than in the fairway. These particular anchorages are stated in the coastal description.

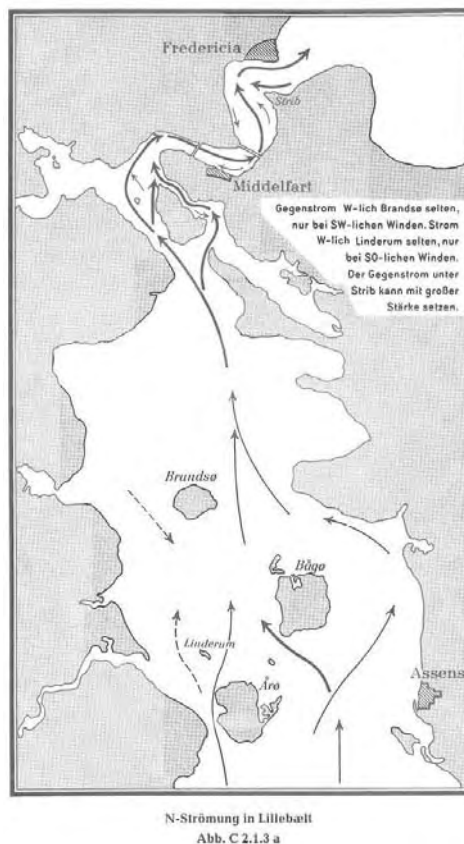
Figure 9: Section from the Kattegat Manual Part I, BSH

In spring, a northerly current predominates; at times it can run in this direction for several days consecutively without being influenced by local wind conditions. Later in the year, both the duration and strength of this current depend more on prevailing winds over the North Sea and Baltic Sea. A southerly current primarily occurs in autumn and then sets with much greater force than the northerly current. The current chart shows the normal progression of currents in the northerly section of Lillebælt (see Fig. 9).

In front of Fredericia port the current almost always sets eastwards even if there is a southerly current predominating in Lillebælt.

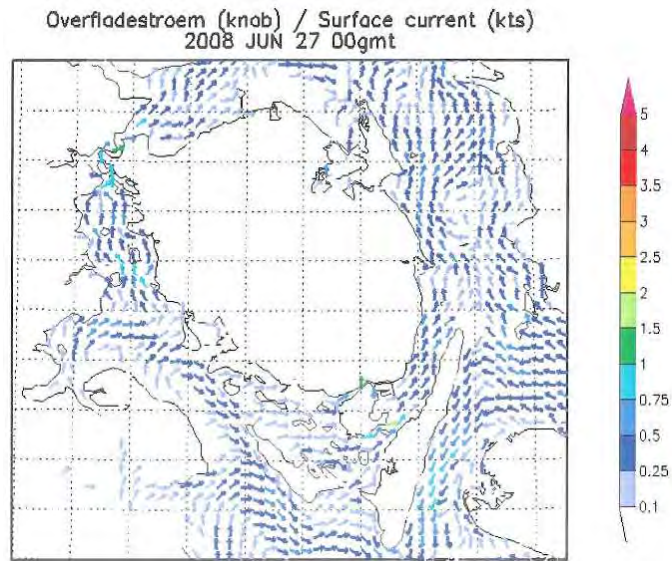
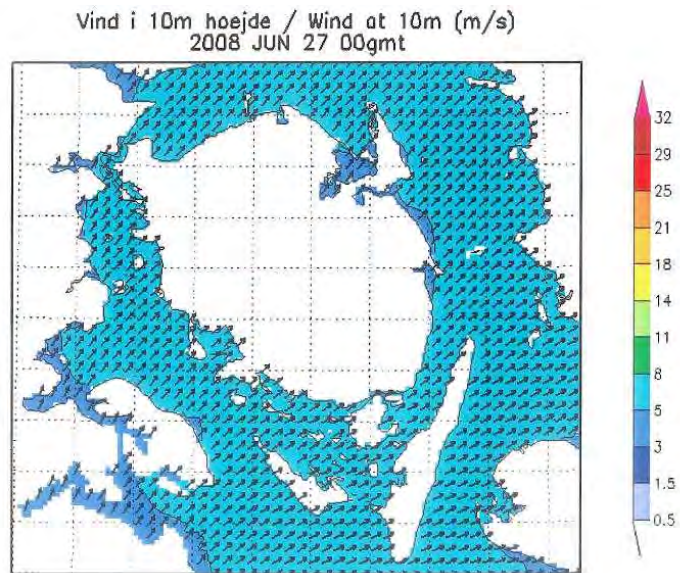
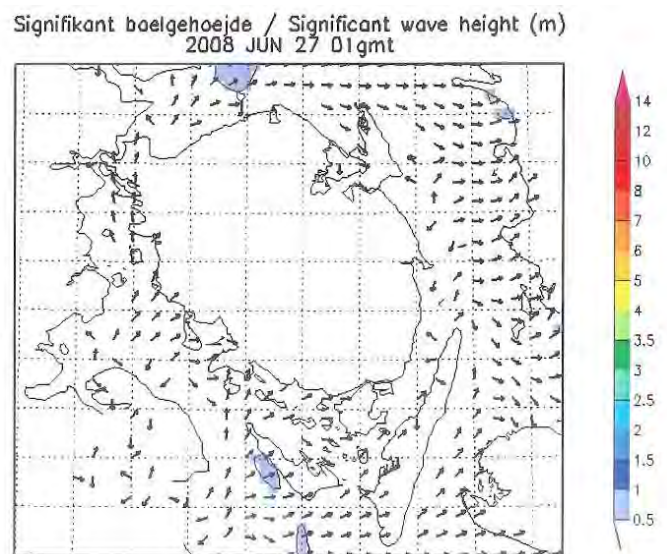
Figure 10: DMI model

The "Danmarks Meteorologiske Institut, Center for Ocean og Is (DMI)" has published daily animations of winds, wave heights and surface currents on its website <http://ocean.dmi.dk>. A northerly setting current at 1.5 kn was forecast on the early afternoon of 31 January 2008. Around 17:00 the current turned and set in a southerly direction until midnight. Subsequently it moved in a northerly direction again. However, the model calculations could not be verified on this day because there were no current measurements for the Lillebaelt from the "Miljoecenter Ribe". Since there is the constantly recurring setting of incoming and outgoing currents in Snaevringen (Fredericia), the model calculations are generally reliable presupposing that the input parameters from the weather model with the predicted gale were correct. A critical factor would be the time when the current turns. Fig. 10 shows a typical animation with a SW weather state from 27 June 2008 which shows the surface current, wind direction and wave height.

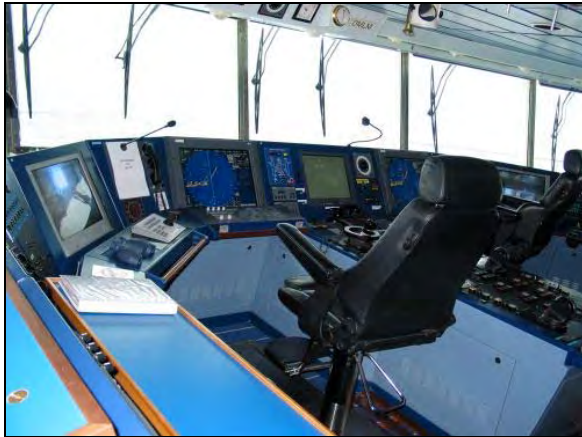
Figure 11: Conning positions

from red to green. Shortly afterwards, the light on the port side came out of sight so it was no longer visible from the starboard conning position. The second master had also lost the light from view; it was now only visible from the bridge wing.

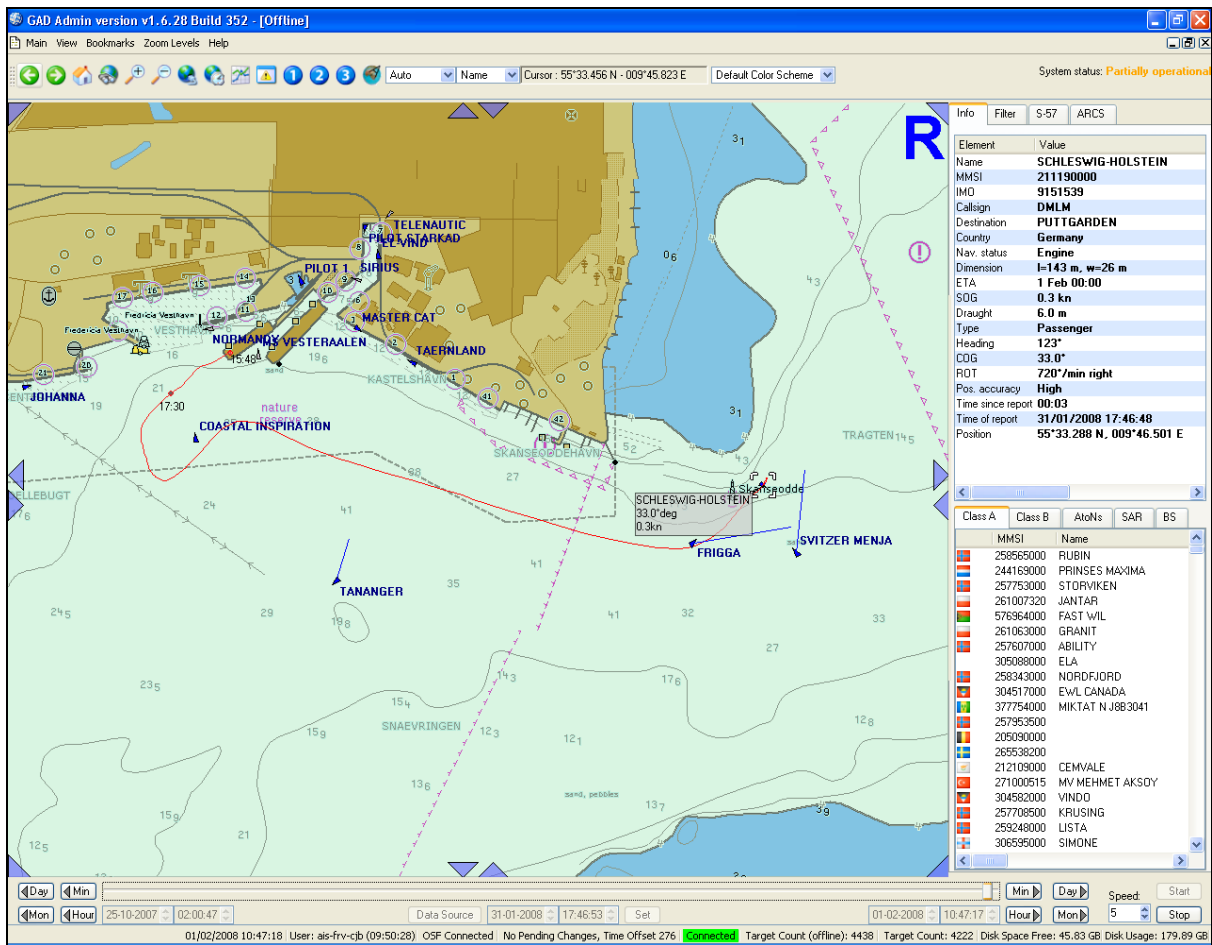
Figure 15: AIS course of voyage

The department for the investigation of marine casualties of the DANISH MARITIME AUTHORITY provided the BSU with extensive data material (AIS, ENC)<sup>6</sup> as well as statements of the tug masters involved and the pilot. The radio communication between the pilot and the tug masters was not available. According to the AIS recordings, at 17:44:11<sup>7</sup> the SCHLESWIG-HOLSTEIN was sailing on a heading of 134°, course over ground (COG) of 042.3°, with speed over ground of 3.5 kn and rate of turn (ROT) of 720°/min to port, which is not plausible (see Fig. 14<sup>8</sup>). The difference of 92° between heading and COG is conspicuous. The tug SVITZER MENJA is located to starboard aft of the SCHLESWIG-HOLSTEIN. Fig. 15 reveals that the vessel drifted immediately to the north after having left the floating dock, without having reached the plotted line of leading lights.

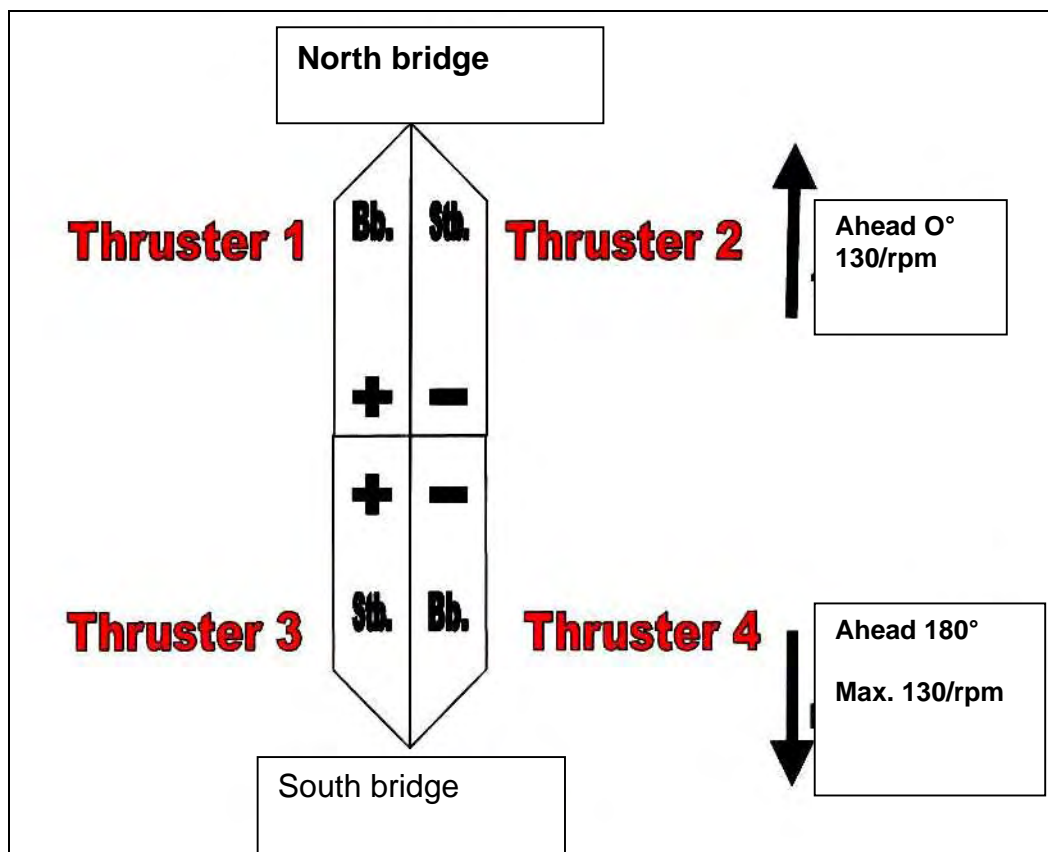
Figure 16: Configuration of the pod drives

Regarding the following VDR recordings, please note that the displays for the pod drives do not correspond to the configuration on the bridge (see Fig. 16) and that pod

drive No. 2 had<sup>9</sup> no response display (R) after the dock stay. The effective directions of the Pod drives thruster 1 and thruster 2 are displayed in the VDR replayer with different prefix in comparison with thruster 3 and thruster 4 in the images 22, 27 and 31, i.e. minus must be interpreted as plus, since the values delivered by the automation are interpreted without prefix-consideration. If the north forecastle makes headway, then forward is zero (0°) with a semicircular numbering system and the direction of rotation to starboard is designated with minus (-) and to port with plus (+). If the south forecastle makes headway, then forward is designated with 180° while the prefix for the semicircular numbering system is maintained. The maximum rotations for the pod drives are 130 rpm each. The thruster-scheme made available for the configuration of the VDR (s. fig. 17) leads in the figures 23, 28 and 32 with regard to the prefix rule to the same effective directions as with the plus/minus display, that means the displayed effective directions in figure 28 are as regards the heading of the complete image with a forward speed of 5,9 kn are not counter-turning.

<sup>9</sup> According to the statement supplied by the VDR manufacturer will be inspected on the next annual maintenance date. An adjustment in the display of the VDR Replayer should be effected if necessary. After ship yard periods and maintenances on systems, which transfer data to the VDR, it should be checked if the VDR is working properly.

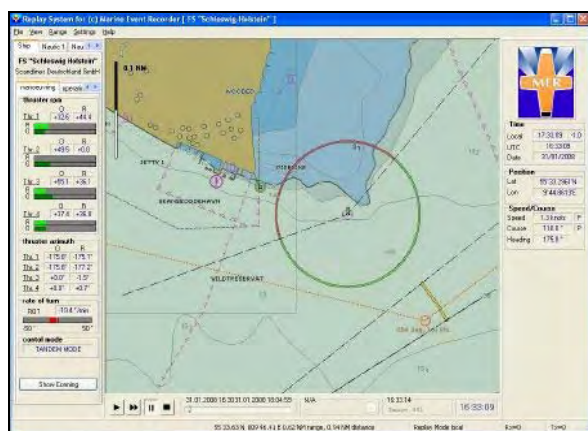
Figure 19: Navionics Chart

With regard to the ENC data: sectors of the Skanseodde lighthouse were not completely shown as a full circle (s. figure 18). However, no entry error was identified in the Danish ENC data following an examination by the BSH. There was a change of scale at those areas where the sectors are invisible. This means there is currently no other way (according to the S-57 standard<sup>10</sup>) to show the sectors differently if larger and smaller detection scales are adjacent to each other at this point. Contour lines are also shown offset. The Navionics company displays the sectors in the electronic chart as a full circle (s. figure 19).

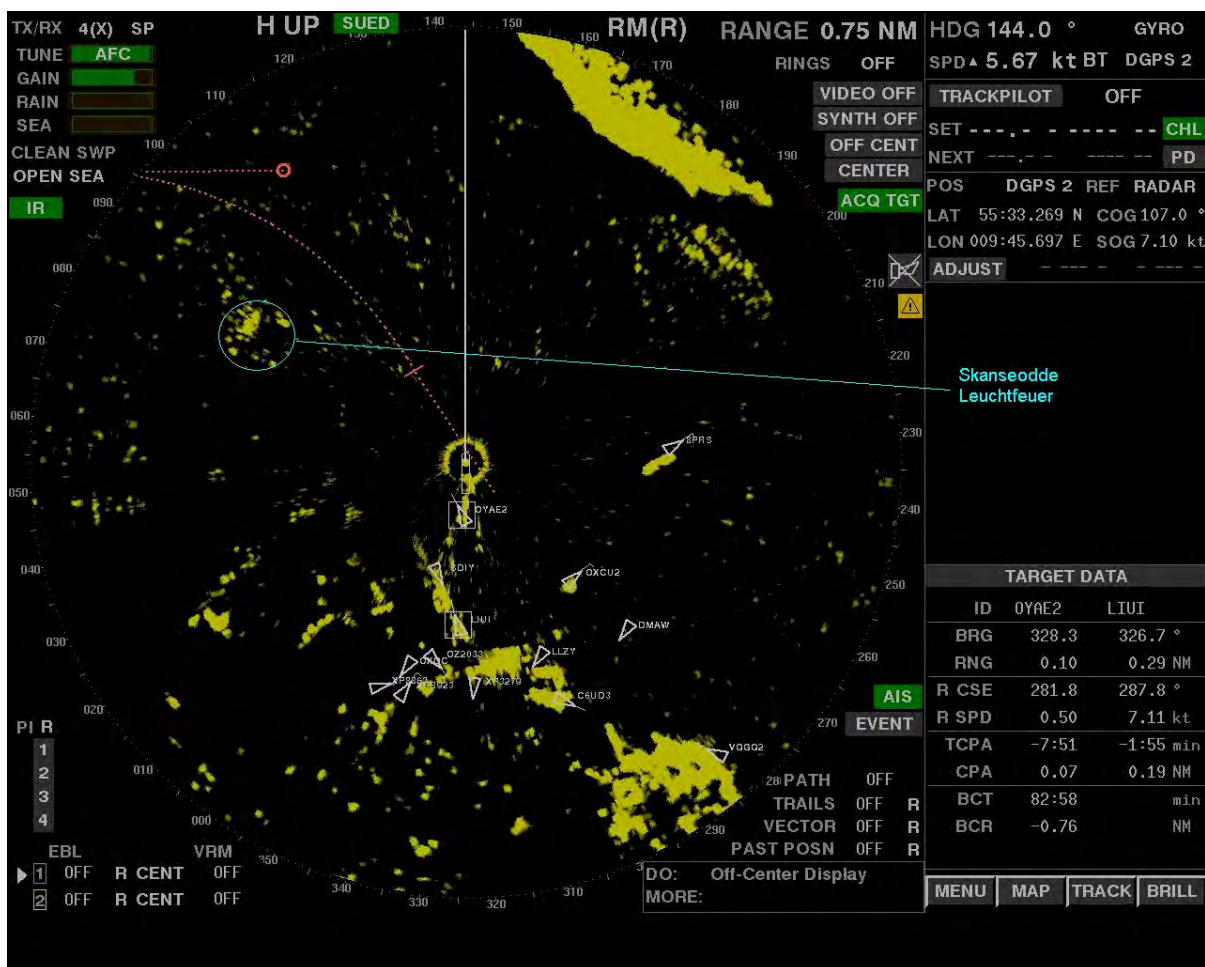
Figure 20: VDR-X band radar 17:40:08 system time

Clutter can occur with poor weather conditions like those on the day of the accident, i.e. showers, snow, rough sea and significant wave heights of 2 m. Without filtering the signal, a circular excentric area pulled in wind direction with differing brightness would form in the centre of the screen. Rain and sleet dampen the radar impulses on the X band radar and lead to echoes in the form of milky areas, whereas there are virtually no damping losses on the S band radar and even targets behind the rain are also detected. Effective targets can be weakened so that they might only be displayed every 3rd or 4th antenna sweep, or even not at all. In this case, the RACON signal was shown distorted (if at all) with characteristic "T" and wave length of 3 cm on the X band radar (see Fig. 17). The S band radar with a wave length of 10 cm was technically unable to display the RACON signal with a 3 cm wave length.

Instead of the ECDIS, the X band radar image was switched on the third monitor available on the left side of the conning position at the time the pilot left the bridge. Consequently, two radar images and the vessel's navigating data were displayed. It must be considered that poor weather conditions with wave heights of 2 m and S winds of 7 Bft, in gusts of 9, prevailed and visibility was reduced due to rain and sleet. Attention also had to be paid to traffic (see Fig. 17 and 18, AIS targets). Under such conditions, radar navigation is only beneficial when the radar images are continuously evaluated. As a result of the filters applied which were used due to the weather conditions, the Skanseodde racon (T) (3 cm) was not identifiable on the X band radar based on the VDR recordings. A clear echo of the frame tower was visible only on the S band radar system. This echo last appeared at 17:40:08 on a bearing of 092° and at a distance of 0.4 nm.

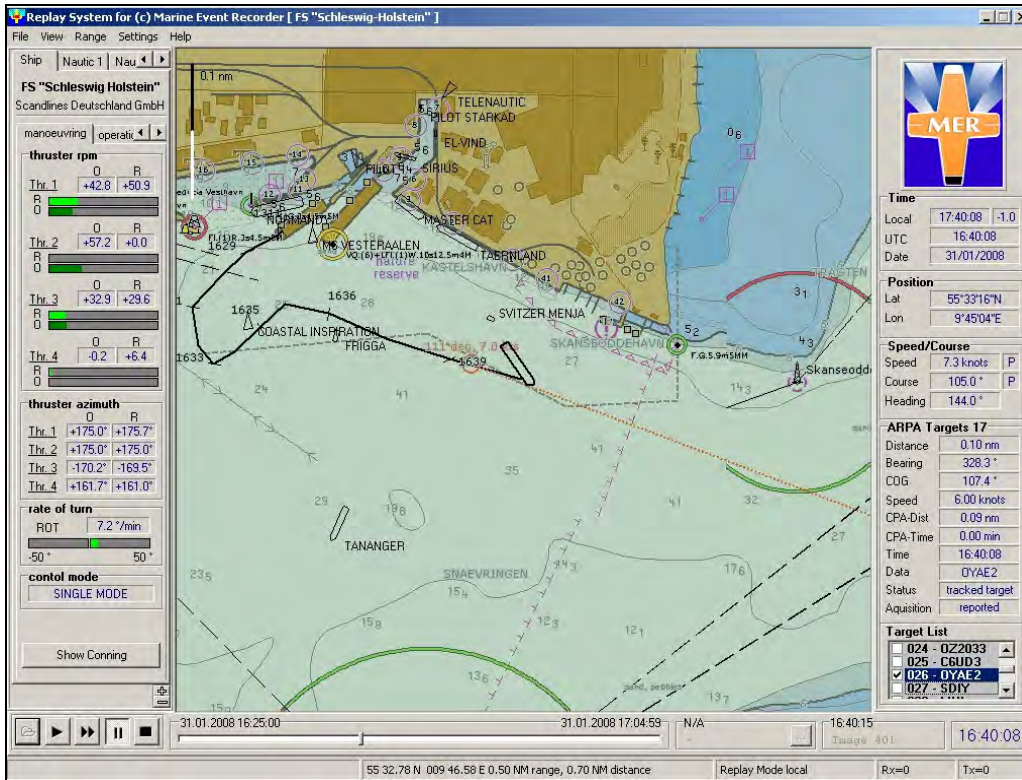
Figure 22: VDR with ECS display 17:40:08

The times shown on the radar images can differ when compared to the times shown with the electronic chart as background by maximum 15 s because the radar images are recorded only at intervals of 15 s according to basic requirements for the VDR. Nevertheless, the difference in the display of geographic positions is too large. The second fraction in length is shown incorrect for the ECDIS display (cf. Fig. 17 to 19). This is obviously a software error by the VDR manufacturer. The ship's symbol is however shown in the correct place<sup>11</sup>

<sup>11</sup> The VDR replay system is able to display the geographic positions in the mode degree/minutes/seconds and in the mode degree/minutes/decimal quota. As regards the longitude the angular second was displaced about 1 position to the right and displayed with prefix of zero. This error was said to have been remedied by now.

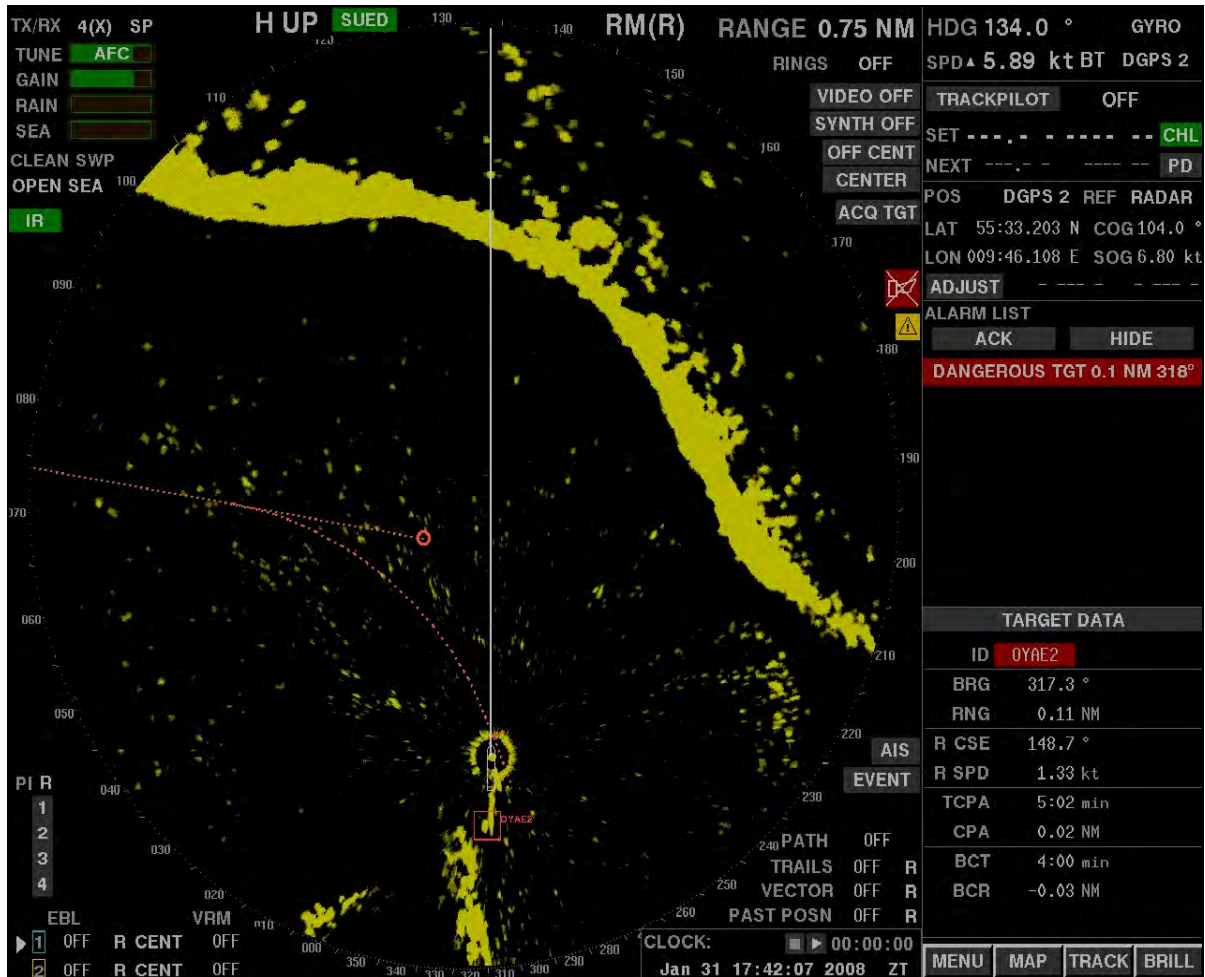
Figure 25: VDR-X band 17:42:00 system time

Two minutes later the echoes of the Skanseodde lighthouse disappear from both radars (see Fig. 21 and 22). The RACON with code "T" is also not clearly apparent at any time on the X band radar system. At 17:42 the values on the X band system show HDG=134.0°, SPD=5.89 kn, COG=104.0°, SOG=6.80 kn. This gives a drift of 044° at 3.3 kn. Due to the position of the pod drives, a resultant rate of turn of 6.4°/min to port is achieved (see Fig. 23).

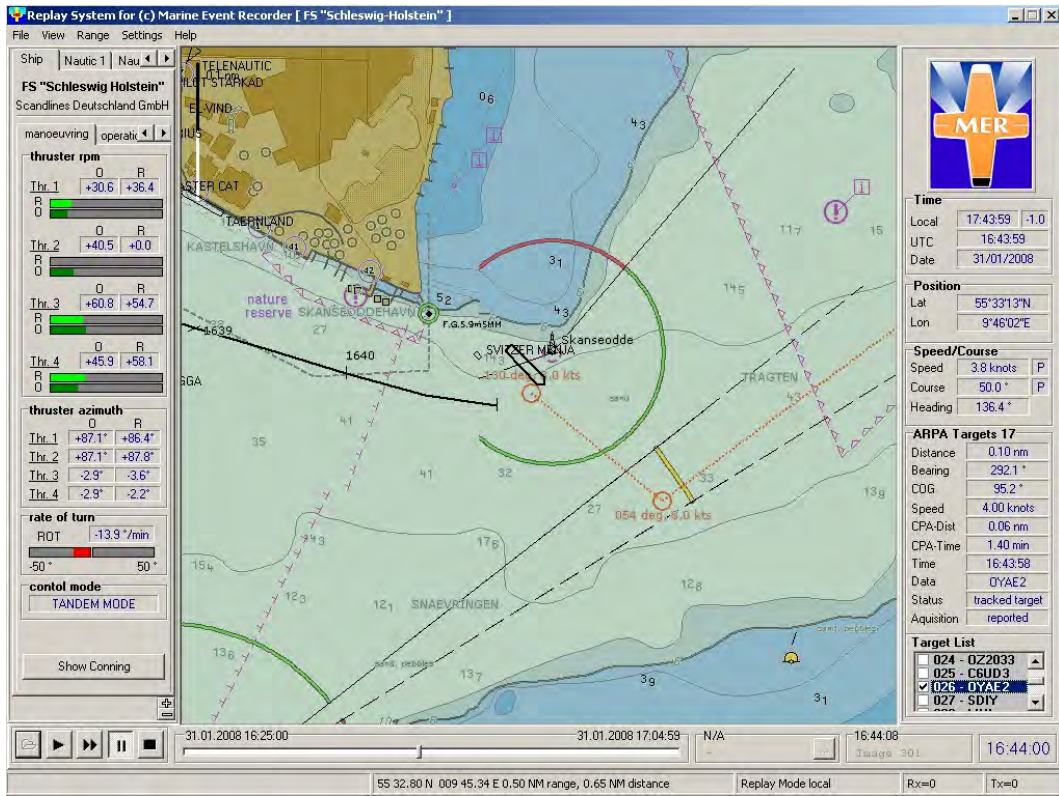
Figure 31: VDR with ECS display 17:44:00

Around 17:44 the SCHLESWIG-HOLSTEIN collided with the Skanseodde lighthouse. Shortly before the collision, the values on the X band system show HDG=134.3°, SPD=0.08 kn astern, COG=43.0°, SOG=3.4 kn (see Fig. 29). This gives a drift calculated by the system, that corresponds approximately to COG and SOG since speed amounts to zero. Due to the position of the pod drives, a resultant rate of turn of 13.9°/min to port is achieved (see Fig. 26). The steel structure of the lighthouse was destroyed by the collision.
