Investigation Report 510/08

Very serious marine casualty

Fatal accident on board the CMV CHICAGO EXPRESS during Typhoon "HAGUPIT" on 24 September 2008 off the coast of Hong Kong

1 November 2009

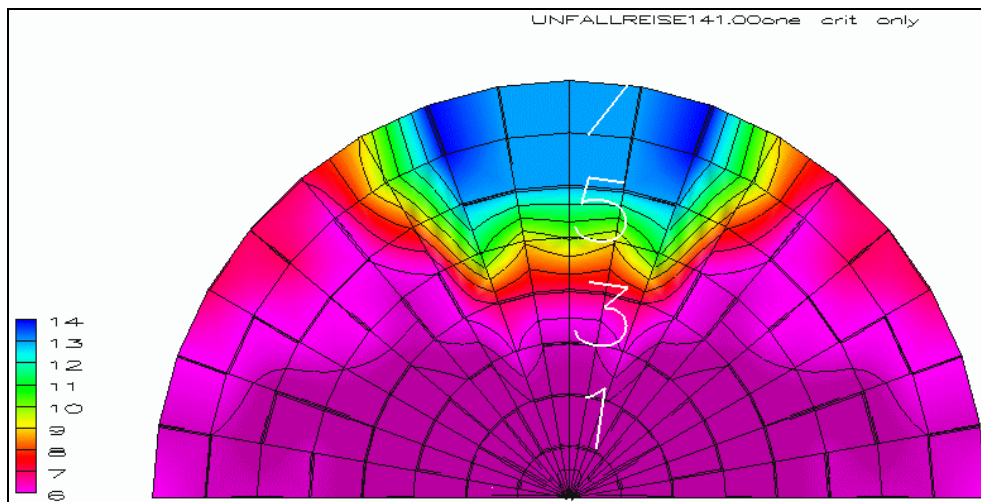
Figure 31: Calculated significant wave heights at a roll angle of 25 degrees

Figure 31 shows a diagram similar to **Figure 30**, but now for a roll angle of 25 degrees. It can be seen immediately that a roll angle of about 25 degrees occurs in virtually every situation below roughly 5 kts. At more than roughly 5 kts, the expected roll angle then decreases slightly if the vessel is steered relatively accurately against the sea. That corresponds very well with the statements of the crew that the vessel ran at speeds of 3-5 kts on various courses and was constantly subjected to rolling of at least 20 degrees, sometimes more violently, sometimes less violently.

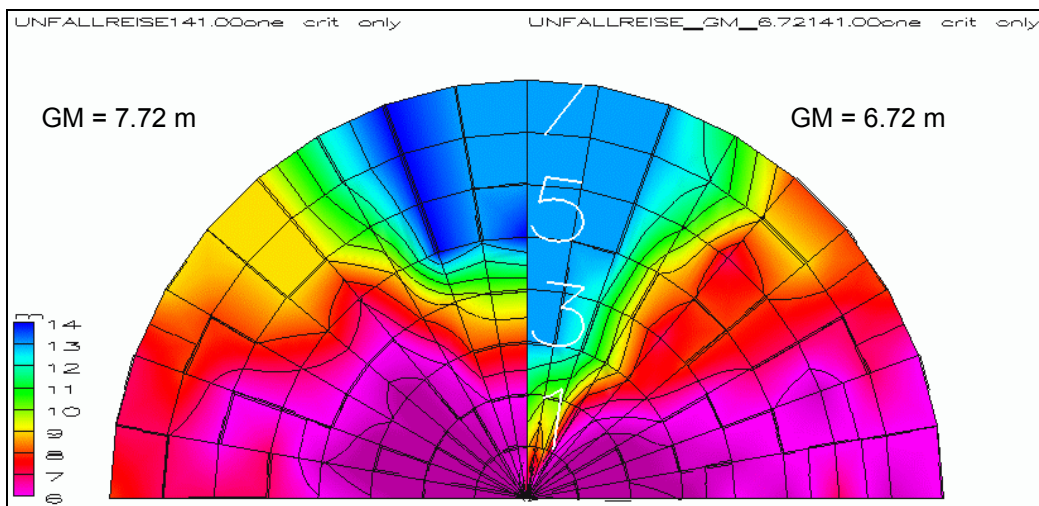
Figure 33: Calculated significant wave heights at a roll angle of 30 degrees

Figure 33 shows the significant wave heights that lead to a maximum roll angle of at least 30 degrees. The left side shows the stability situation of the accident condition and on the right side a GM value reduced by 1 m was applied for the calculation (6.72 m instead of previously 7.72 m). Under the circumstances that led to leaving the port, this GM reduction would have been practically impossible. However, we see that this would not have improved the situation. The risk shifts to a situation in which the sea would have to come from slightly more abeam. This is logical, because it results in the excitation moments increasing. Nevertheless, with parameters similar to those of the accident situation, the vessel would have also been exposed to an extremely large roll angle with these stability factors. Decreased stability thus improves the situation somewhat, but not fundamentally.

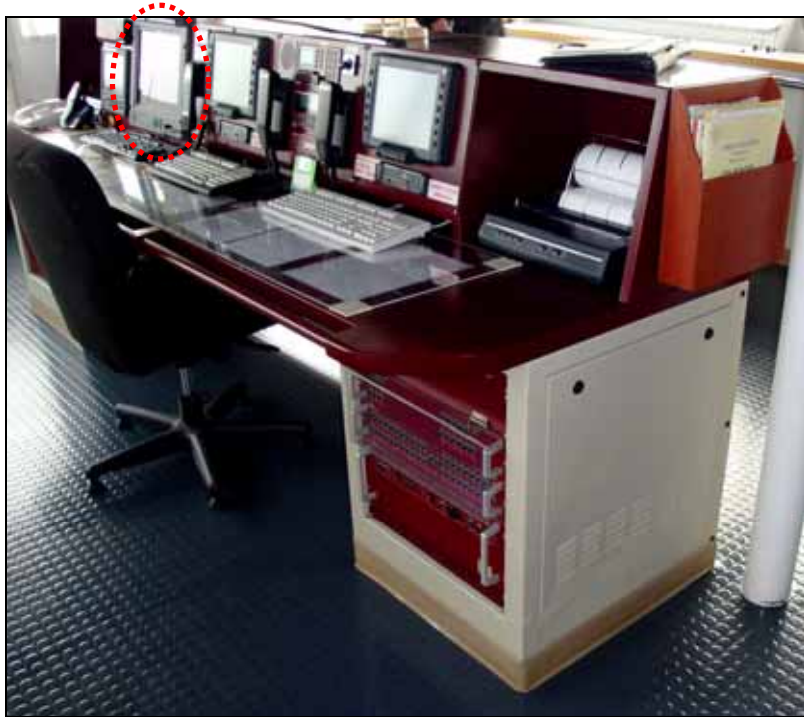
Figure 36: Replay station (integrated in the GMDSS console)

After that, it was evidently the case that the limited functionality of the system described above gradually became apparent when attempting to execute the backup. A telephone call was made to the vessel operator's technical inspection department with the purpose of solving the problem, the cause of which (= hard drive failure) was unknown. Since a backup from the failed hard drive was not possible, an attempt was made to download the data via the system's replay station (see **Fig. 36** and **37**)³⁶ from the FRM to the hard drive of the replay computer. This download should have lasted a little longer than an hour but was aborted shortly before the end of this period. This was probably because after the preceding difficulties and the fact that the download process was perceived as being too slow, the personnel on board erroneously assumed that this data backup method had also failed.

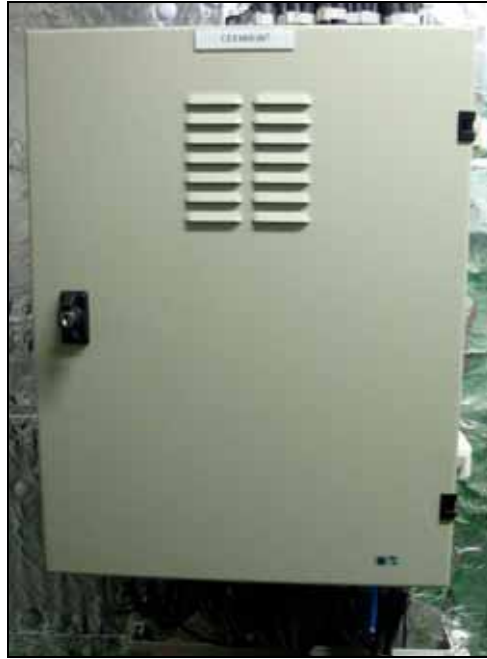
Figure 40: Main Unit VDR (locked)

Finally, although rather improbable, the possible failure of both radar screens after an accident opposes integrating the questionable operator interface in them. However, with the type used here, there is also the possibility of operating the incident backup directly on the VDR's so-called "Main Unit" (Fig. 40 and 41), but this is locked and is in turn located in an area below the bridge deck, which is also locked. Only the Master has access to the key.

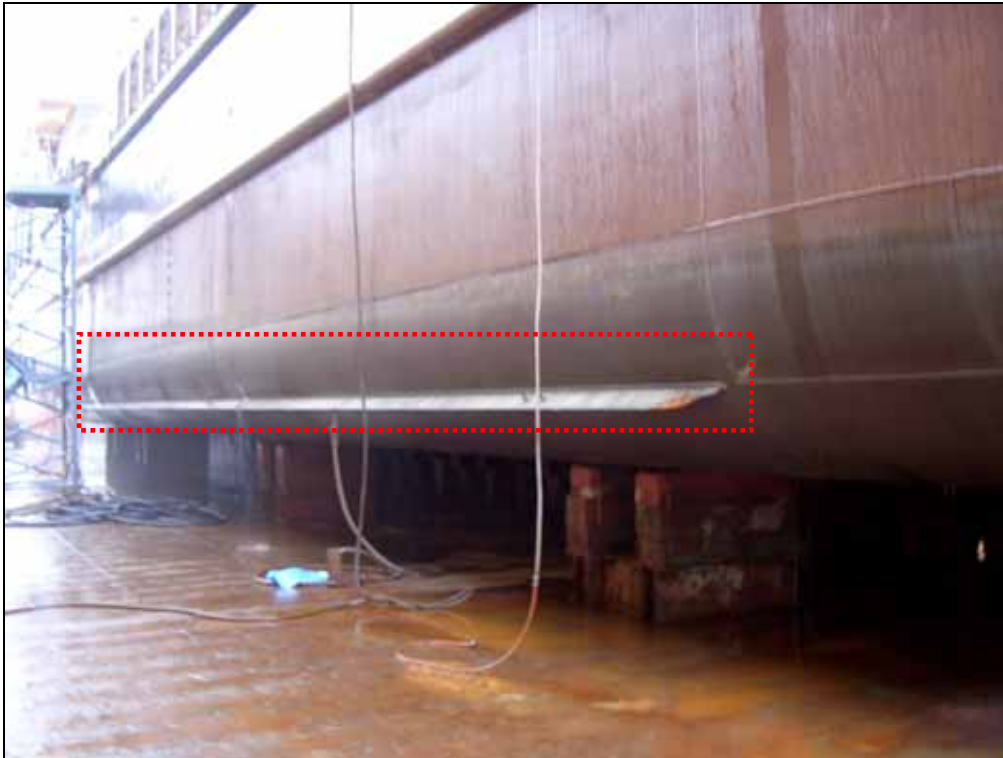
Figure 42: Example of a bilge keel³⁸

The physical effects and phenomena from which the accident resulted that can be used to describe and explain the motions of a vessel in water occur, in principle, regardless of vessel type and size. However, due to the structural characteristics of large and very large container vessels these are particularly prone to absorbing high levels of swell moment because of their large bow flare. In that regard, it proves to be critical that there are no statutory, flag state, or – as far as one can see – class-related requirements for minimum roll damping. Rather, it is the case that, for example, the structural design of bilge keels³⁷ (see **Fig. 42** below), which serve as a proven structural means for influencing roll damping, has seen no significant changes in recent decades. This is astonishing when one considers that the length and breadth of some vessels has doubled in the intervening period.

The cause of the accident therefore clearly shows that accidents of the type investigated here can only be avoided in the future if more emphasis is placed on the swell-related effects when designing and approving such vessels.
