Bundesstelle für Seeunfalluntersuchung
Federal Bureau of Maritime Casualty Investigation
Federal Higher Authority subordinated to the Ministry of Transport,
Building and Urban Development

Investigation Report 548/08

Serious Marine Casualty

**Collision between MV BELUGA SENSATION
and MV JEROME H while moored at the pier
in the Kiel Canal on 26 October 2008**

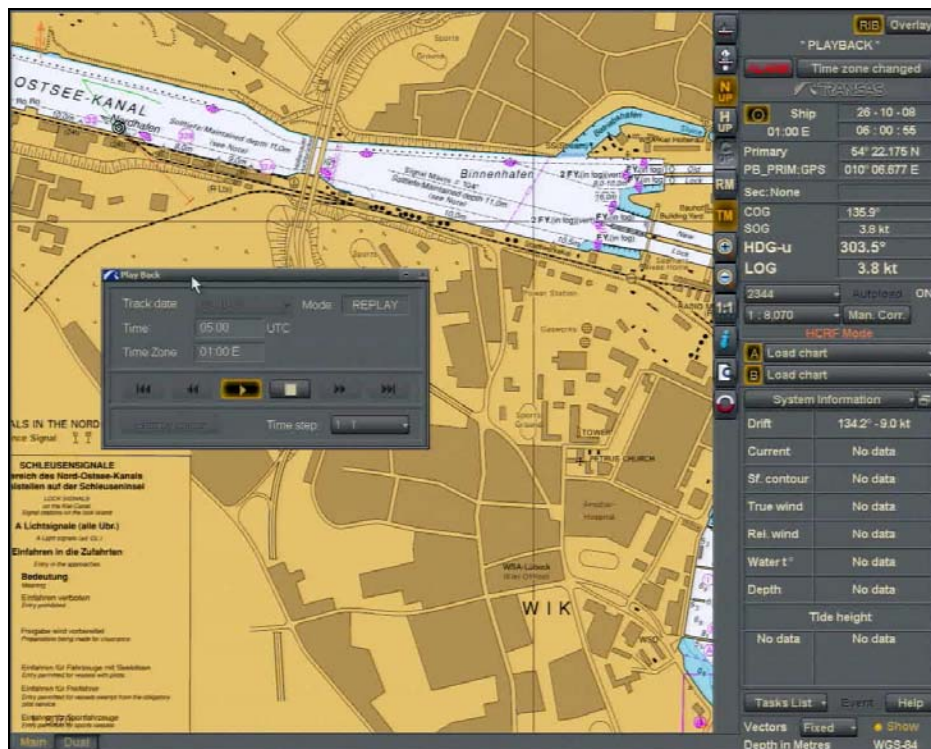
Figure 7: Data from the Electronic Chart System (ECS)

At the time of the collision with the pier at 0601, the speed was approx. 3.8 kts. The course of the voyage is marked green.

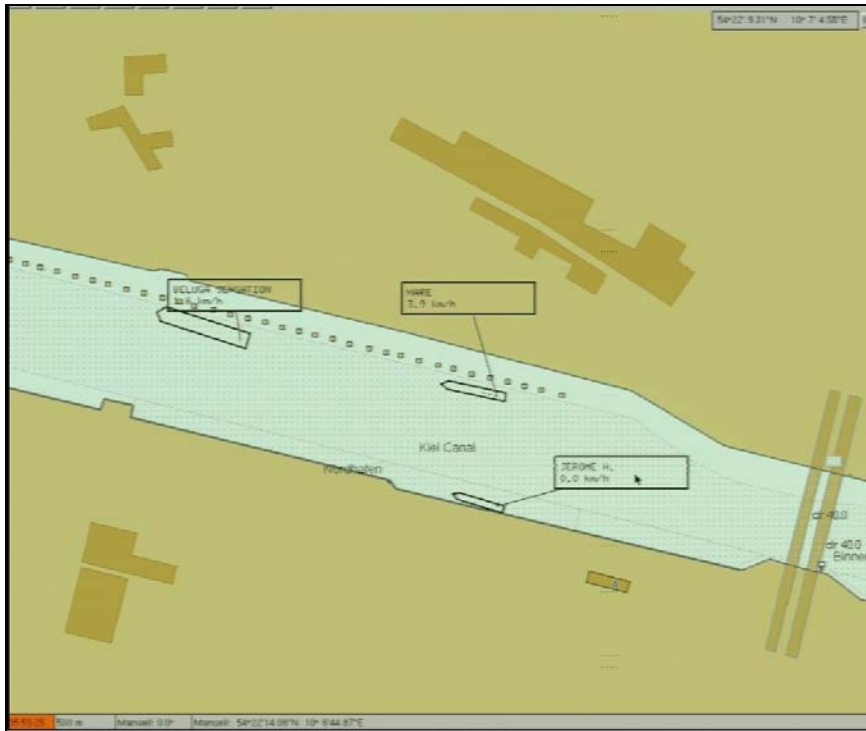
Figure 8: AIS data from 055925

The first recording of the BELUGA SENSATION moving astern was logged at 0559.

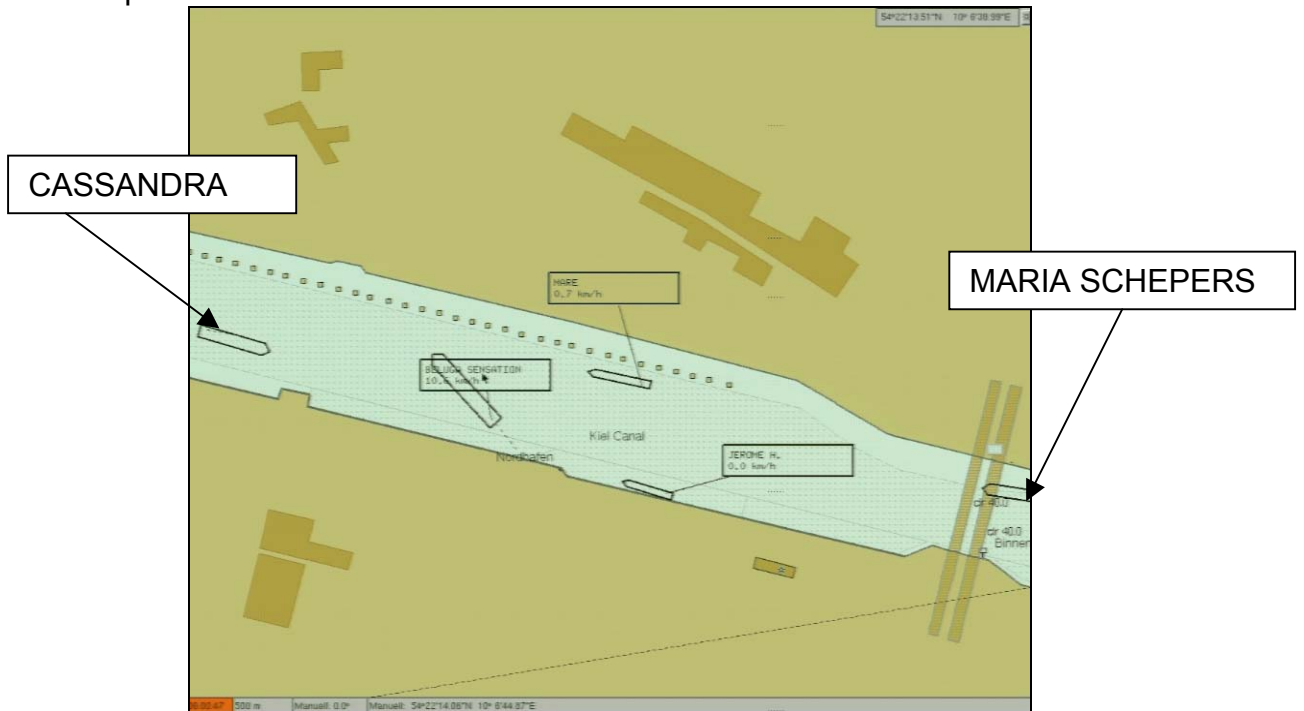
Figure 9: AIS data from 060047

The BELUGA SENSATION continues to move astern unabated. The approaching MV CASSANDRA stops, as does the MV MARIA SCHEPERS, a vessel proceeding in the same direction situated under the bridges in the Kiel inland port. The collision with the pier is recorded at 0601.

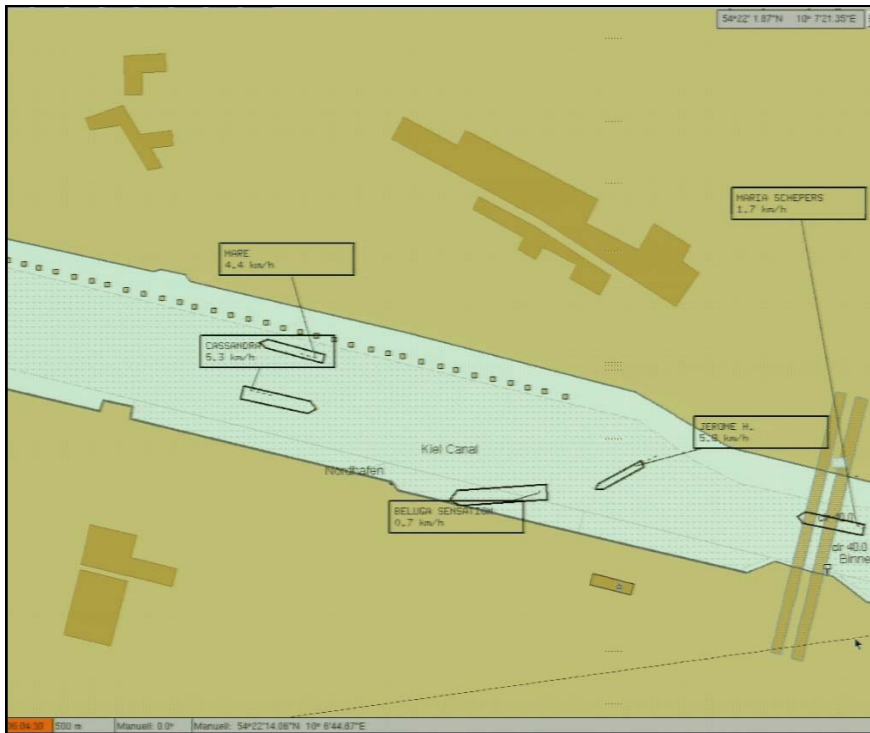
Figure 10: AIS data from 060430

Due to being struck by the BELUGA SENSATION, the MV JEROME H is torn from its mooring and drifts at approx. 3 kts to the northern side.

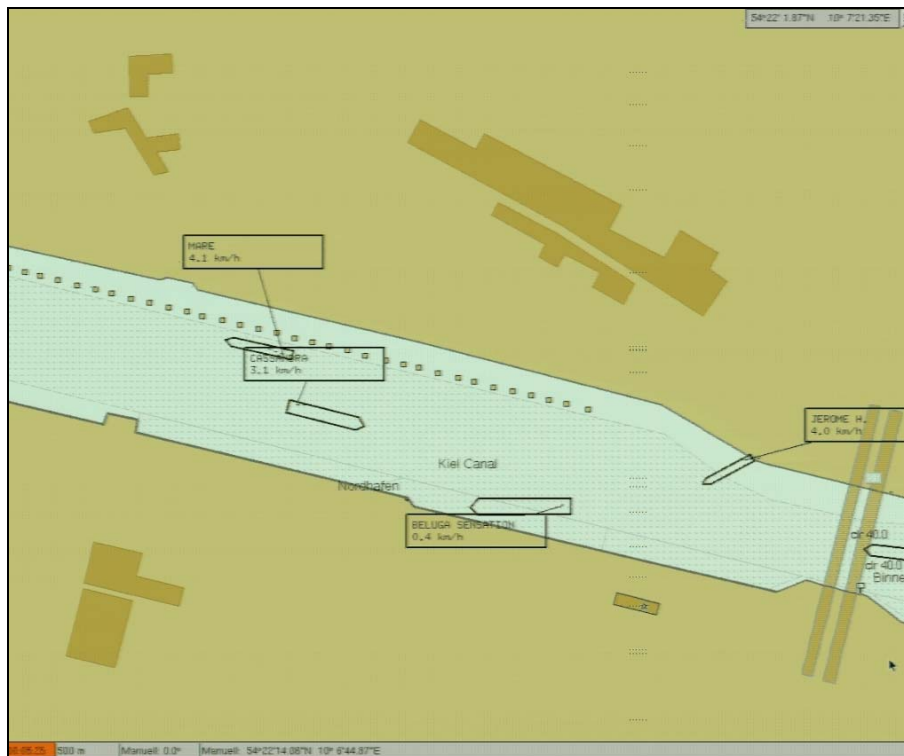
Figure 11: AIS data from 060825

With no one at the helm and no propulsion, the MV JEROME H drifts stern foremost against the sheet piling on the northern side of the canal.

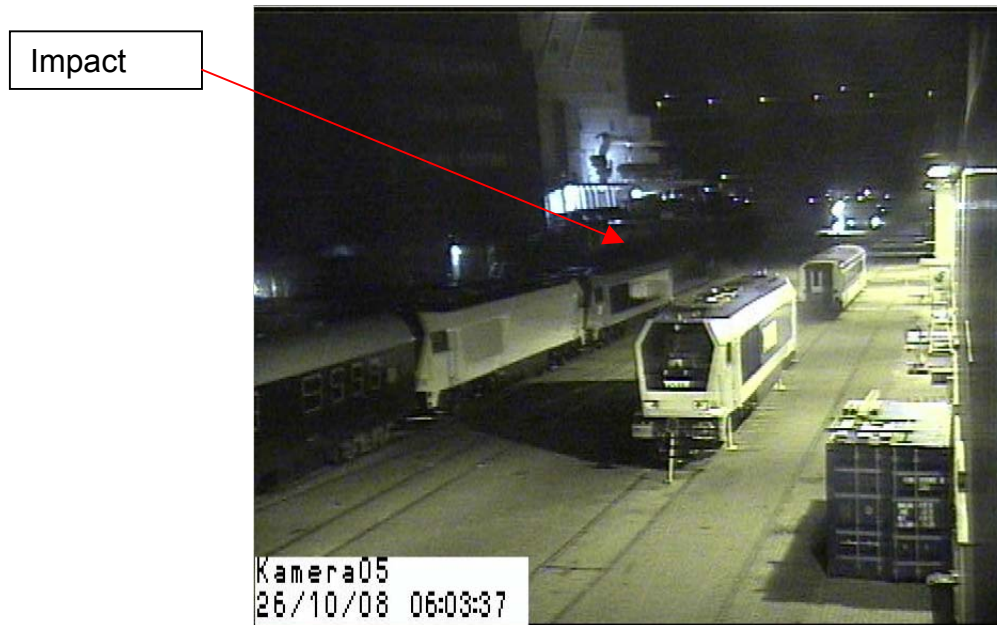
Figure 12: Camera recording

The collision with the pier was recorded by two video cameras at 060340 (time does not coincide with the shipboard GPS time as the time recording of the camera was entered manually and is not modulated).
