**Bundesstelle für Seeunfalluntersuchung**  
**Federal Bureau of Maritime Casualty Investigation**  
Federal Higher Authority subordinated to the Ministry of Transport,  
Building and Urban Development

Investigation Report 015/09

**Very serious marine casualty**

**Capsize of the SY TAUBE with six fatalities  
off the Atlantic coast of Morocco  
on 20 January 2009**

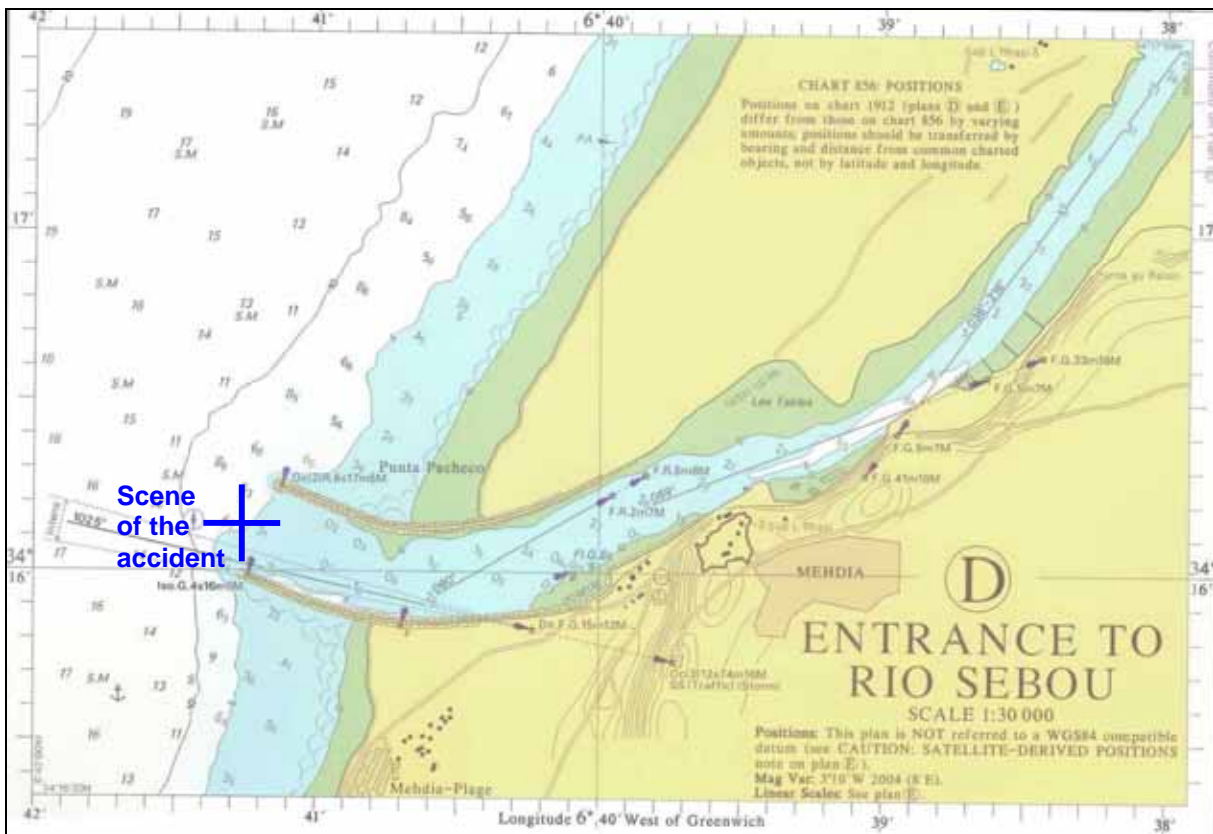
Figure 1: Nautical chart

The approach to the estuary is challenging even in good weather conditions. The water depth of only 3 to 3.5 m between the mole-heads decreases significantly to depths of less than one meter in the estuary (see excerpt of nautical chart at Fig. 1) due to a variable bar<sup>3</sup>. The bar can usually be crossed between two hours before and two hours after high tide (see Handbook for the West Coast of Africa, BSH). The most favourable channel with water depths of between 1.8 and 2.8 m runs through a narrow corridor of about 80 m wide along the southern mole. It is marked on the nautical chart (see Fig. 1) with a leading light beam.

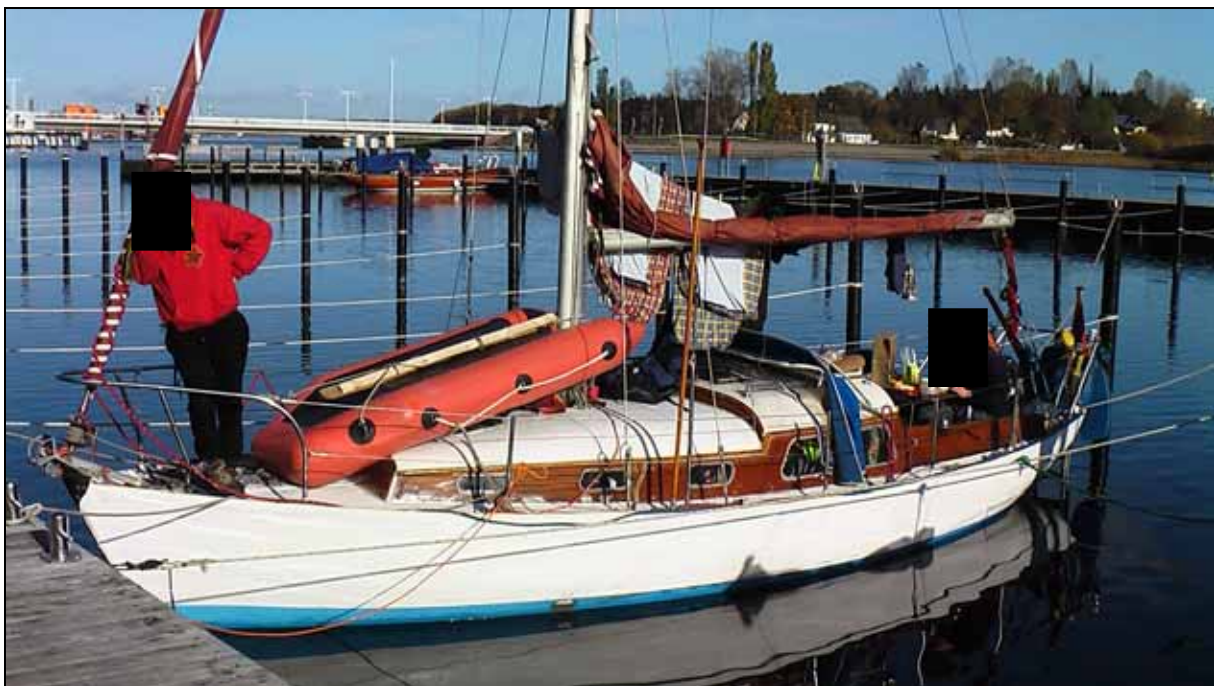
Figure 6: The TAUBE with rubber dinghy, photo taken in autumn 2007

There were no required clearance formalities for leaving the port. On the night of 19 to 20 January 2009, the crew of the TAUBE thus sailed on the high tide out of the port of Larache without giving any notice. Due to the limited space, much of the personal property, including the copy of the port handbook, was stowed on the cabin roof under a rubber dinghy (see Fig. 6).

In the early afternoon, the Austrian and the other member of the operating association alternated at the helm when an oncoming wave washed over the yacht. In the process, it swept away some of the items stowed on the cabin roof. Following that, the crew stowed the remaining items in the cabin and three of the seven automatic life-jackets carried on board were issued to the two helmsmen and the third German male, who was also sitting in the cockpit. Additionally, all three connected to safety lines. The skipper, the survivor, and the Slovenian and Danish females were below deck and did not wear life-jackets.

Safety equipment consisted of seven automatic life-jackets (150 N) including reserve sets for the maintenance of the jackets, seven safety lines, pyrotechnic signal equipment (hand flares and parachute rockets), a rescue line, a lifebuoy and a 406 MHz Type ACR Satellite2 406 beacon (EPIRB), which can be activated manually but also activates automatically when it is placed in water. There was no life raft on board. The rubber dinghy that was carried on board (see Fig. 6) could have accommodated a maximum of two crew members.

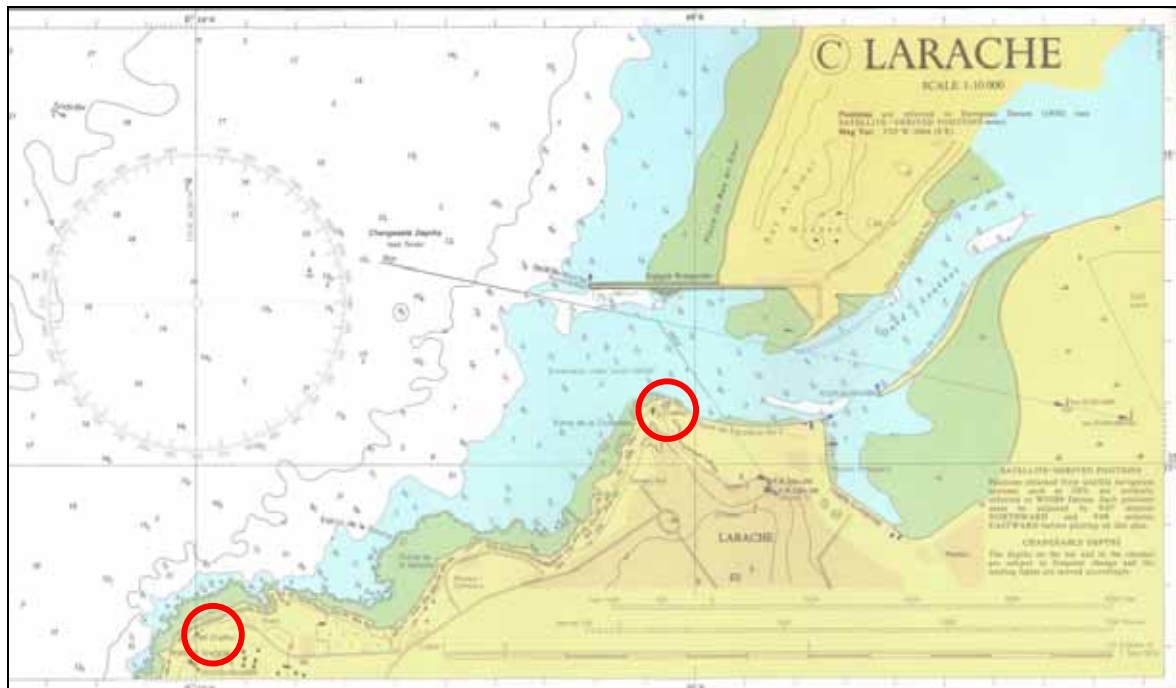
Figure 22: Detailed chart of Larache from nautical chart BA 1912, amended in 2008

The entrance to the port of Larache is similar to that of Mehdia, but is supplemented by a southern mole. In the official nautical chart number BA 1912, as amended in 2008, the original point of entry is still shown (see Fig. 22); in contrast, the new version of 26 February 2009 shows the current layout of the moles (see Fig. 23). Both charts show, inter alia, the site of each port signal point (outlined in red circles in Figs. 22 and 23). Whether the TAUBE possibly carried a copy of the nautical chart from 2008 is not known.

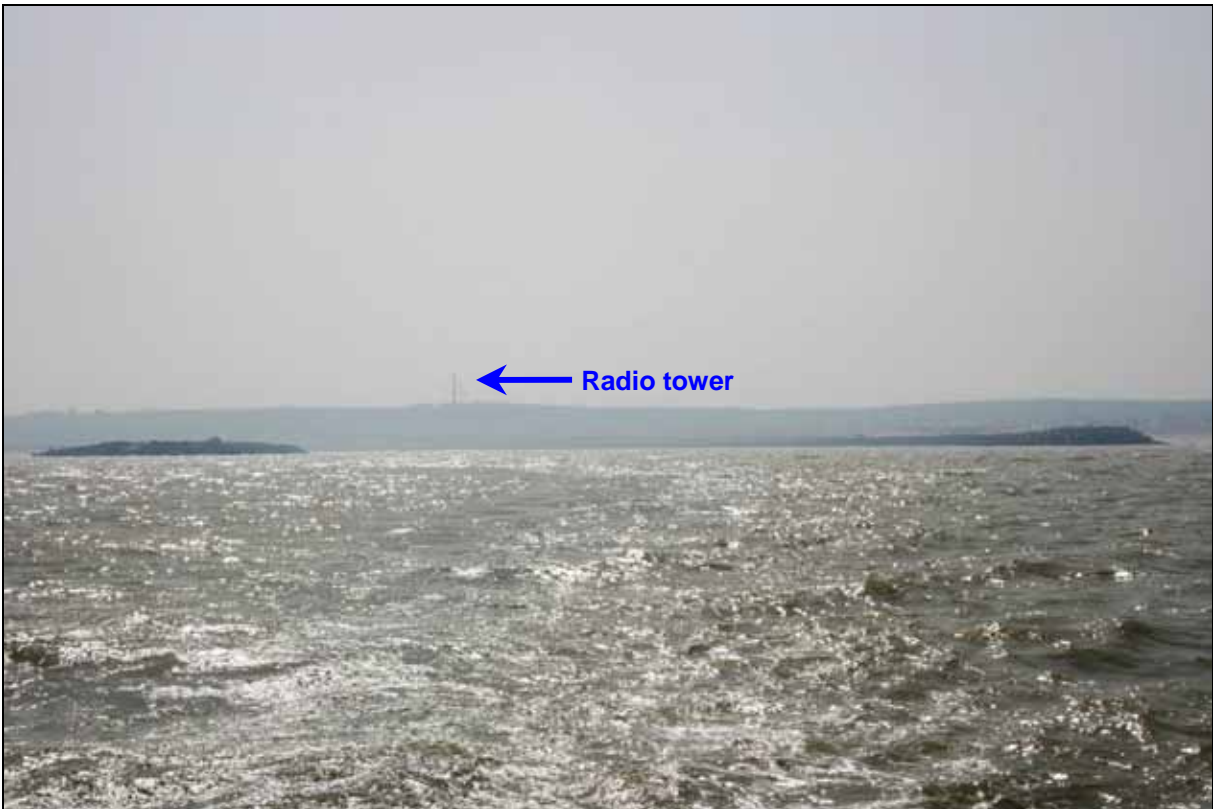
Figure 29: Approach to the Sebou estuary from a distance of 0.5 nm

The skipper, the German female, the Slovenian female and the Danish female were below deck and did not wear life-jackets. The Austrian female in the capacity of coxswain and the two other Germans were in the cockpit with life-jackets and secured by safety lines. The estuary was not seen physically, but located by means of GPS. The following photos (Figs. 27 to 29) illustrate that the entrance is not easy to identify even at low swell and clear visibility.

It was not understood that the port was closed. The corresponding signalling system is located below the radio tower, which stands out from the horizon when the visibility on the estuary is clear (see Figs. 29 till 31).

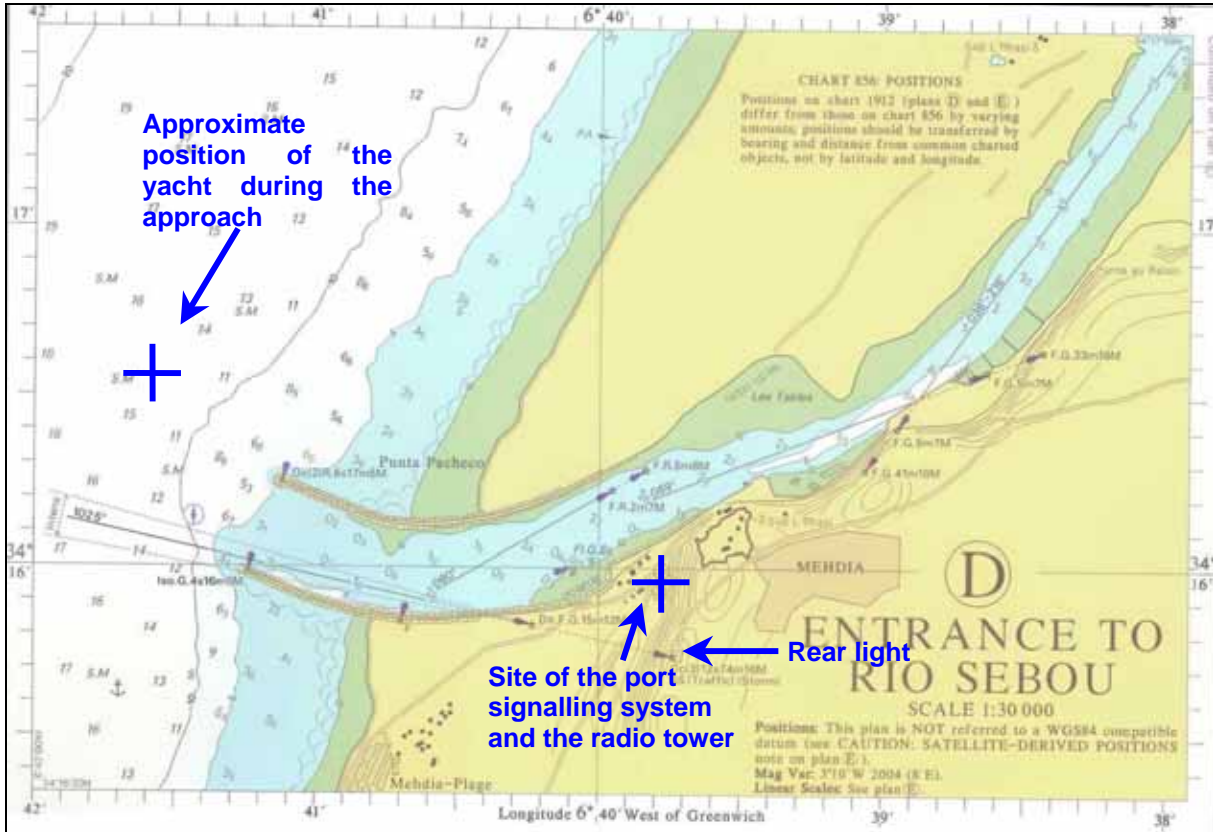
Figure 30: Excerpt from nautical chart BA 1912 with site of the port signalling system

On board the TAUBE, the skipper informed the coxswain of the approach course (presumably 102.5°, see Fig. 30), which he was still able to recall after reading the port handbook. They failed to steer the boat onto this course on the first attempt and therefore turned. At the same time, an attempt was made in the cabin to start the engine, initially without success. The German sailor, who was also a member of the operating association, entered the cabin from the cockpit to assist the skipper in starting the engine. While doing so he removed his life-jacket.
