Summary
Investigation Report 07/10

Very Serious Marine Casualty

Foundering of the FV ORTEGAL UNO
on 13 January 2010
west of Ireland

1 November 2010

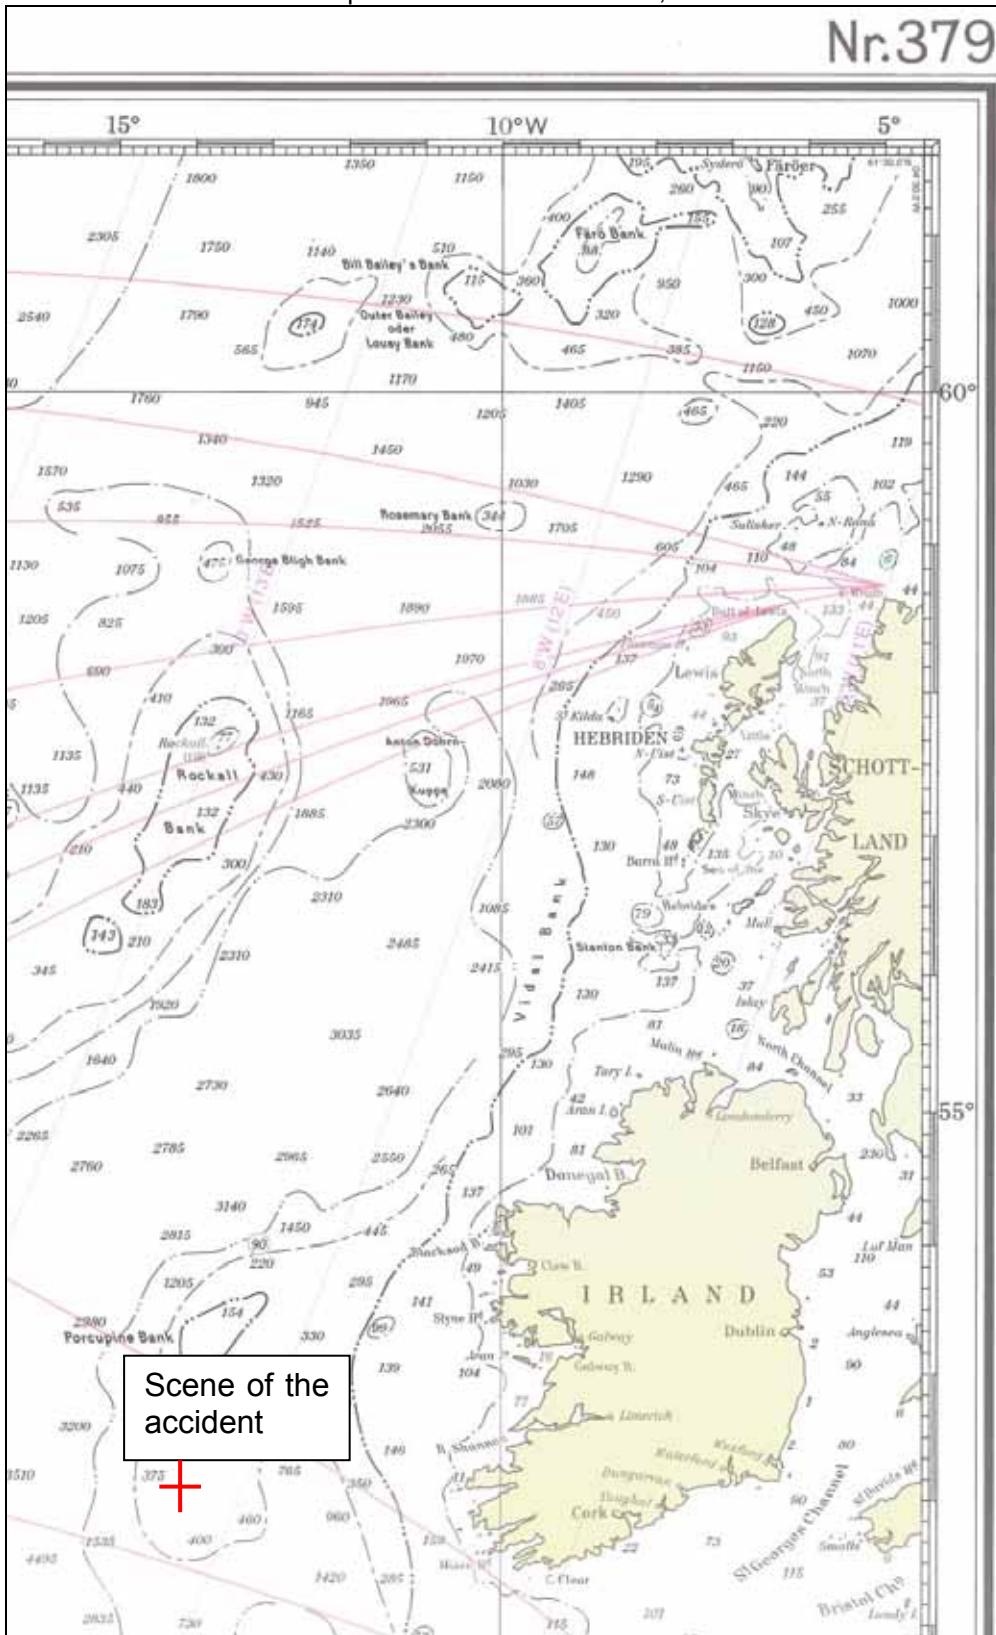
Figure 2: Scene of the accident

Type of marine casualty/incident:	Very serious marine casualty; capsize with foundering of vessel
Date/Time:	12/01/2010/0945
Location:	west of Ireland
Latitude/Longitude:	φ 52°20.4'N λ 014°02.3'W
Ship operation and voyage segment:	High seas Laying the nets
Place on board:	Fore castle
Consequences (for people, vessel, cargo, environment and other):	Total loss of the vessel, no personal injuries

In the skipper's report, the accident position is specified as 52°21'N 014°41'W. This is the position at 0930 on 12 January 2010, when the vessel was hit by large waves and took on a significant amount of water. According to this report, the vessel foundered on 13 January 2010 at the position 52°20'40N 14°02'30W.

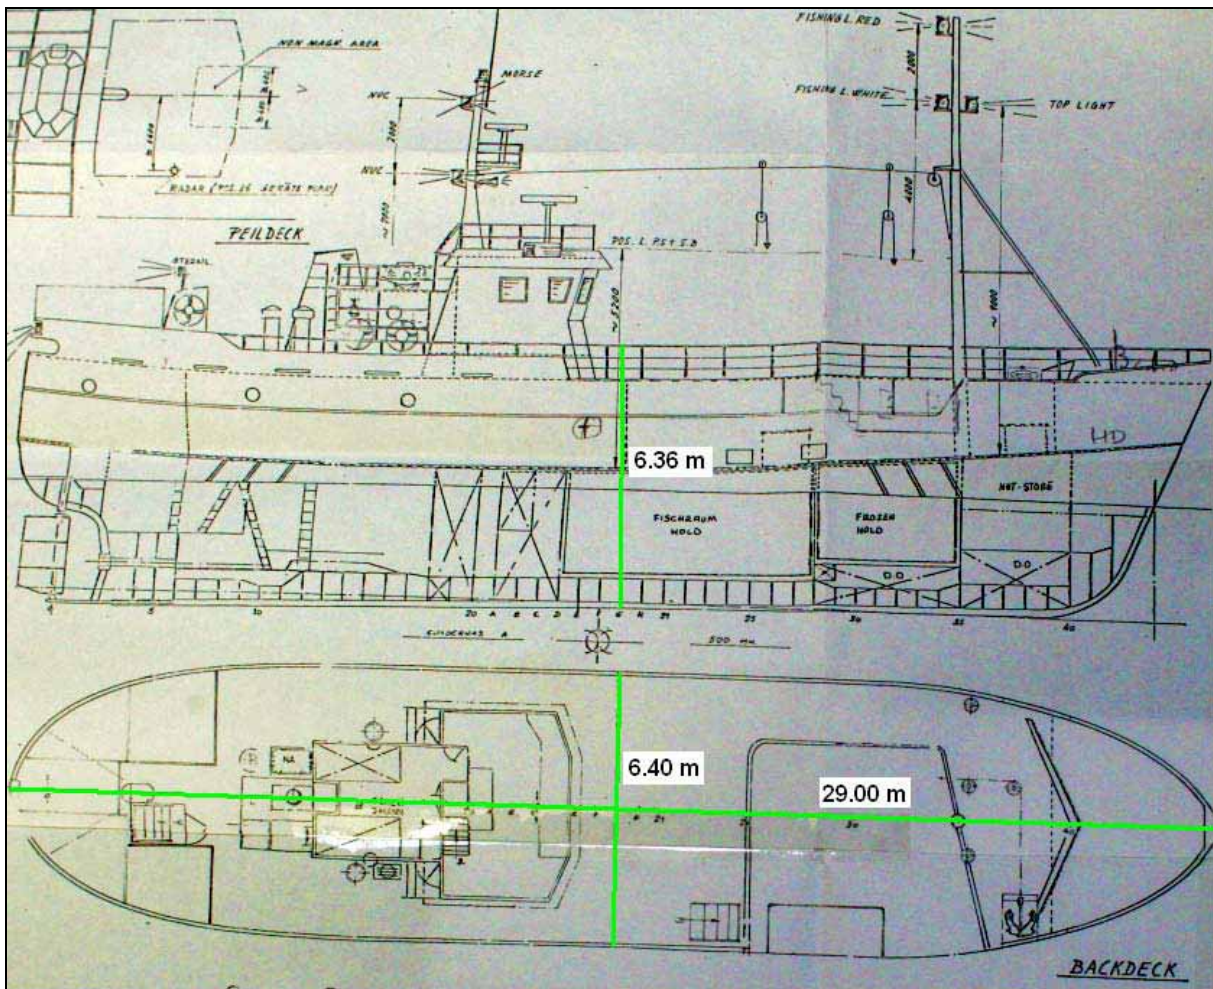
Figure 5: Reference lines used

Necessary reference lines were taken from the general arrangement plan and used to scale the three-dimensional hull form (see Figure 5).

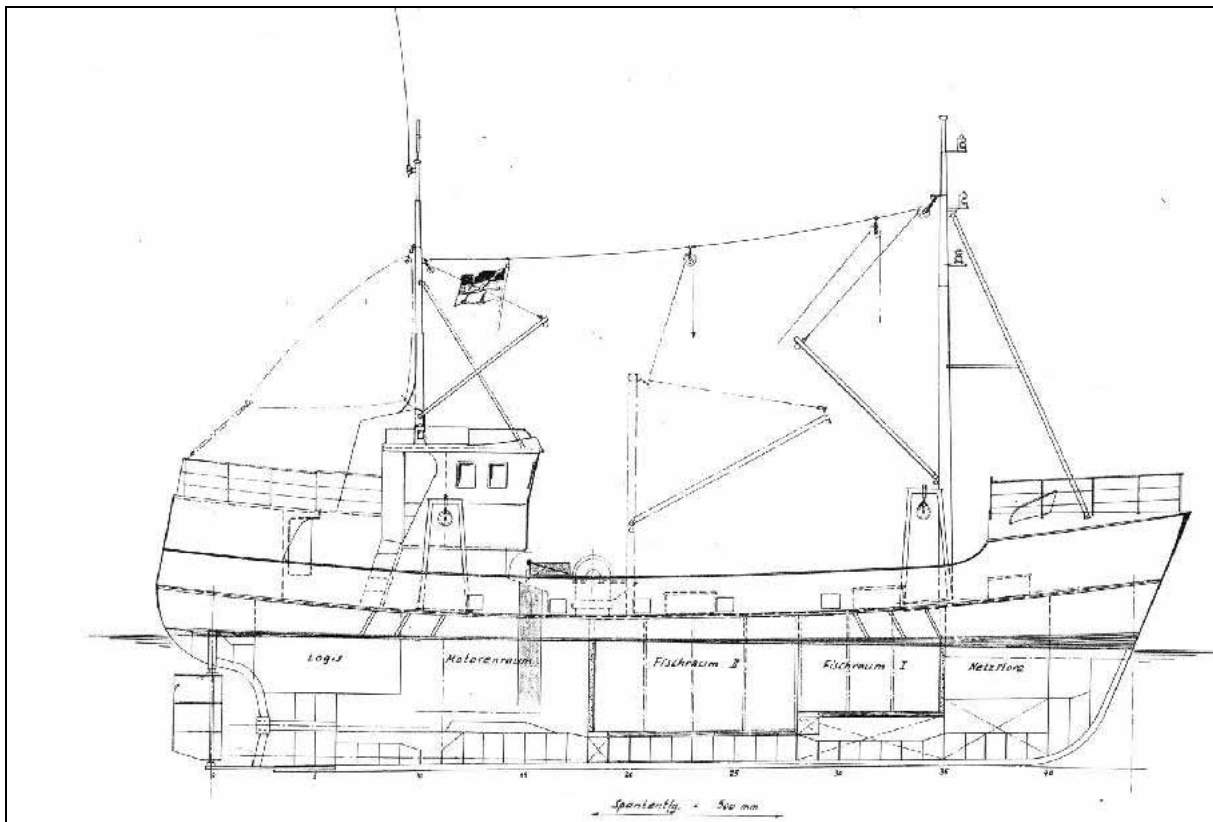
Figure 7: Side view of the vessel in her original state as FV INGRID in 1970

The intact stability of the vessel was significantly impaired as compared to the case documented in the vessel's stability manual; notably, to the extent that the valid and according to the stability manual inspected stability rules were no longer observed. Therefore, the vessel entered poor weather with insufficient intact stability.

It was found that the cause of the accident stems directly from the various structural modifications on the vessel, which are improperly documented. During her last modification, the ORTEGAL UNO was fitted with an ice machine in order to be able to produce the amount of ice required to cool the catch. This also involved the preparation and approval of a new stability manual. Although, according to the statement of the skipper, the vessel did not have ice in the lower fish hold on departure as the ice machine was now available, in the corresponding stability case 25 tons of ice is scheduled for the cargo hold. Furthermore, in the accident situation the fishing gear was carried on the forecastle; however, in the loading condition of the stability manual this is scheduled for the main deck, which is lower. Although the vessel had consumed about a third of her bunker upon arriving at the fishing grounds, the loading condition in the stability manual prescribes a bunker filling of 100%. Therefore, based on the stability documents the vessel's centre of gravity was much higher than indicated, which led to the stability no longer complying with the applicable rules.
