Bundesstelle für Seeunfalluntersuchung
Federal Bureau of Maritime Casualty Investigation
Federal Higher Authority subordinated to the Ministry of Transport,
Building and Urban Development

Investigation Report 161/09

Capsizing of the MB QUINTETT

on 21 May 2009

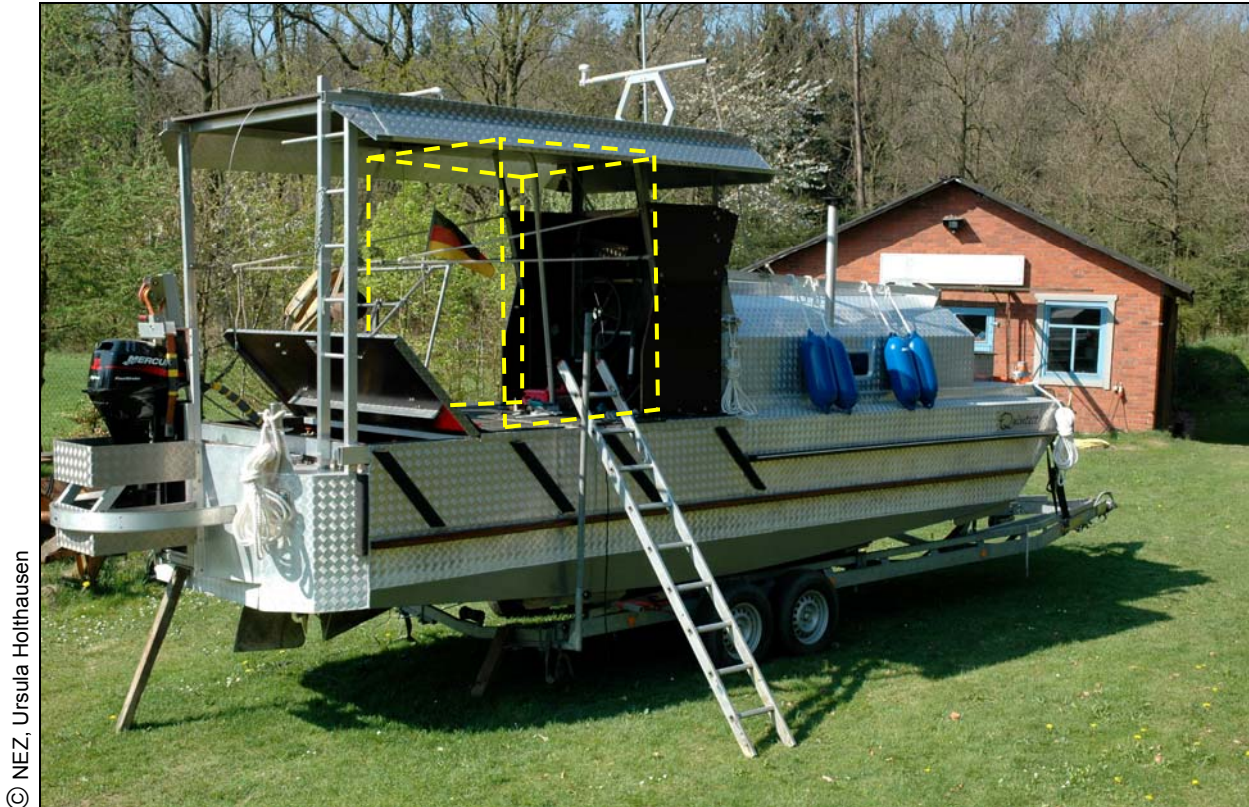
Figure 2: Photo taken in May 2006

(The marked area represents the subsequent position of the wheelhouse, which was enclosed in aluminium panels.)

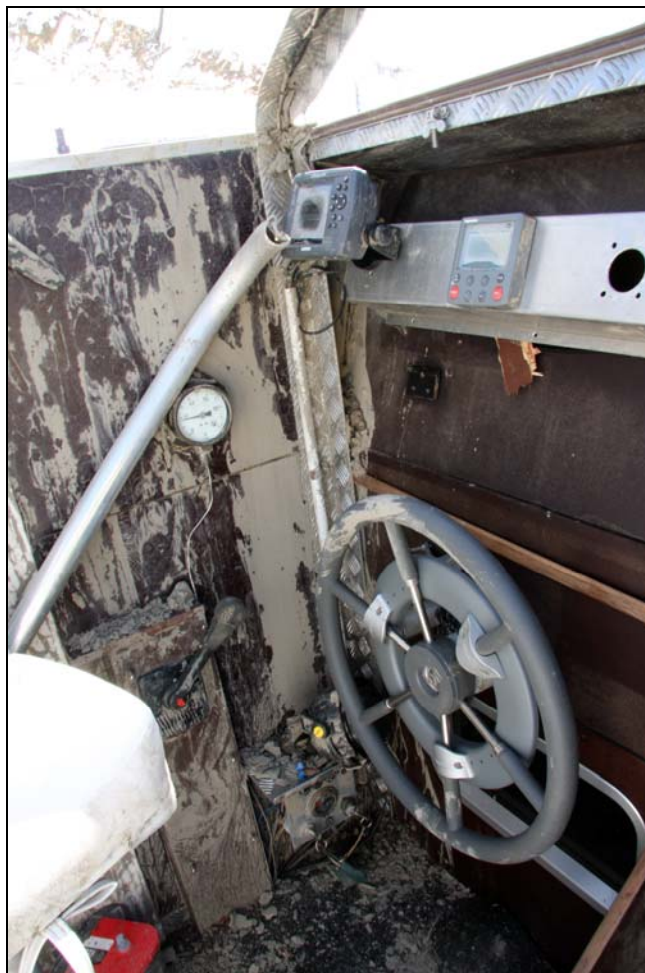
The QUINTETT was equipped with a magnetic compass, a GPS navigation system and an autopilot control panel. Paper nautical charts and sailing directions were not found.

Figure 22: The wheelhouse of the QUINTETT, inside

The BSU was able to export the stored data from the GPS navigation system with the support of the BSH. However, the data gave no indication of the speed of the QUINTETT because no waypoints were set.
