Bundesstelle für Seeunfalluntersuchung
Federal Bureau of Maritime Casualty Investigation
Federal Higher Authority subordinated to the Ministry of Transport,
Building and Urban Development

Investigation Report 255/08

Serious marine casualty

Collision
CMV MARFEEDER
with
CMV APL TURQUOISE
on the Outer Weser
on 1 June 2008

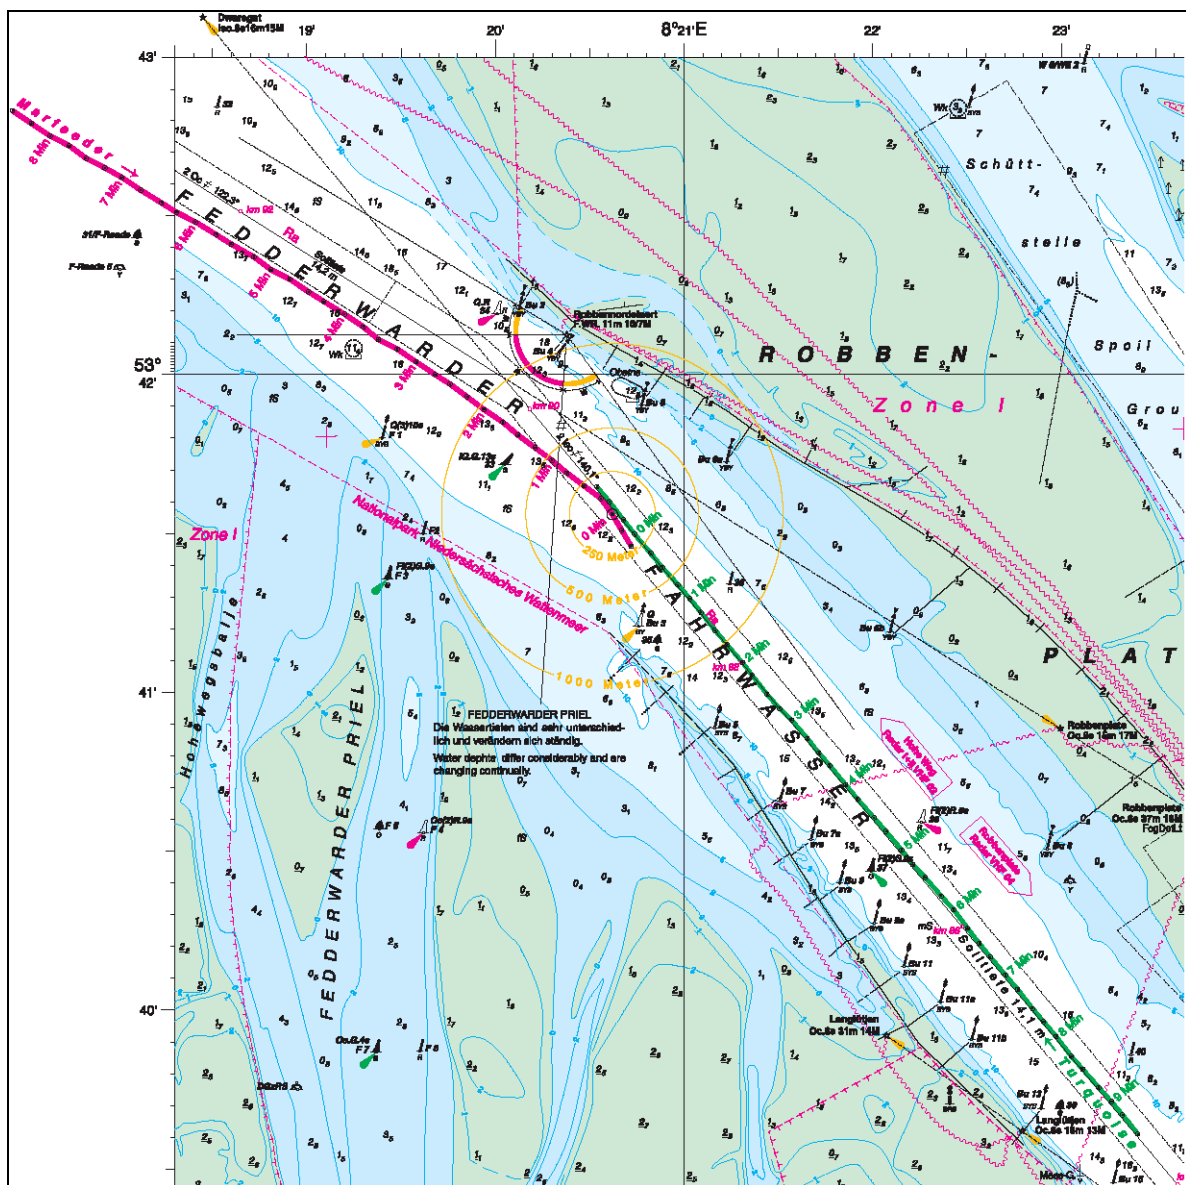
Figure 1: Nautical chart

➔ **MARFEEDER** **Encounter** **←** ➔ **APL TURQUOISE**

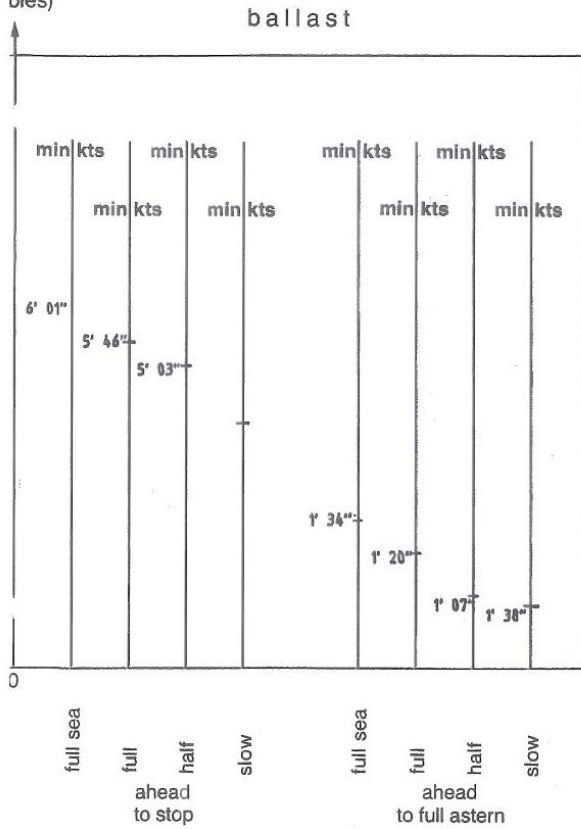
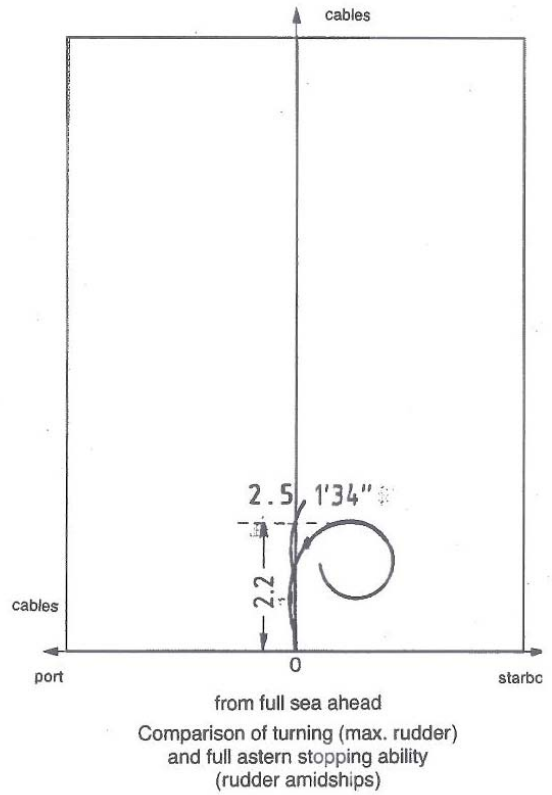
Figure 7: Manoeuvre characteristics MARFEEDER

The manoeuvre characteristics shown in Fig. 7 were measured during a sea trial under ballast and in deep water before the vessel was put into operation in 1996. According to that, the MARFEEDER would have entered a turning circle after 52 s with a 'hard starboard' and 'full astern' manoeuvre after 2.2 cbl at a speed of 8.4 kts. The turning circle diameter would be 1.4 cbl. At 'full astern' and the helm amidships she would have moved slightly off her track to starboard after 1.57 min and 2.5 cbl. The speed would then be approx. 1.2 kts. Controlled manoeuvres would have been possible with the installed left-hand controllable pitch propeller. The risk of an uncontrolled 'running out of rudder' is therefore rather improbable. The MARFEEDER veered to port and turned across the fairway only after the collision. There would have been sufficient room on the river bend for a turning circle through starboard without running aground. The BSU is not in possession of rudder recordings. The shallow water effect and the flow of the rudder were not further investigated. In the hour before the collision, the tide turned from a moderate head current to an aft current.

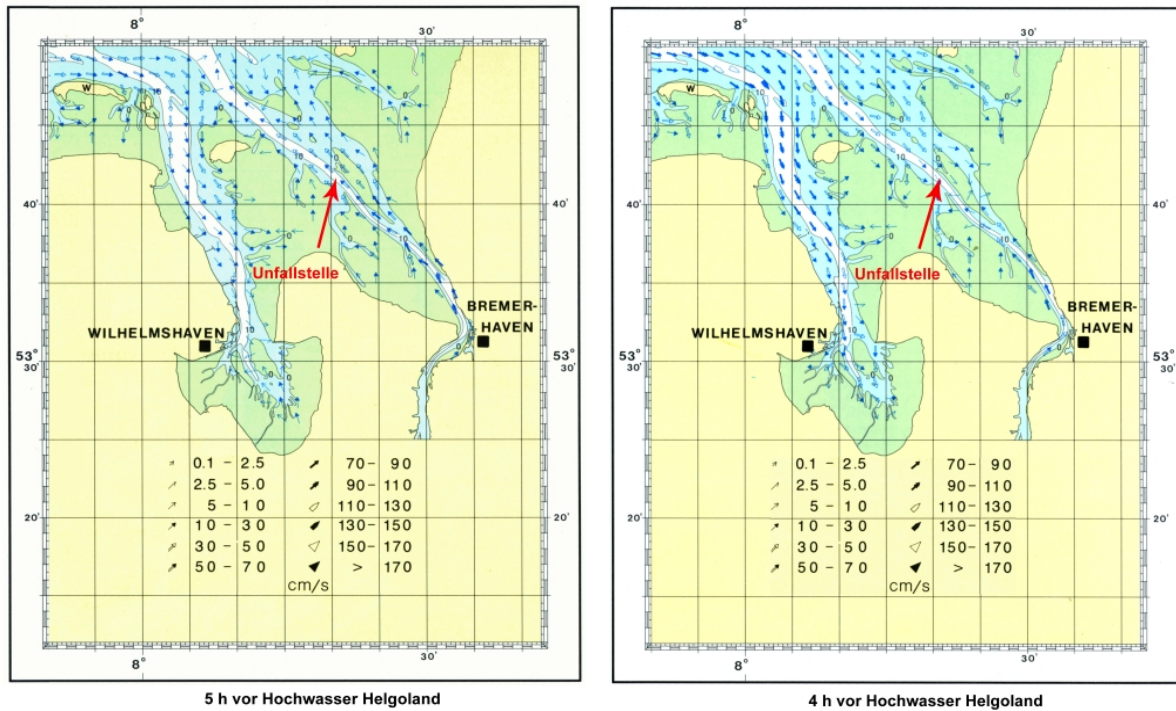
Figure 18: Current conditions at 0500 and 0600

The tide turned between 0500 and 0600 (see Fig. 18). Initially, a moderate head current was detected on the MARFEEDER. According to the tidal stream atlas of the BSH, 0.2-0.6 kts could be expected before and after the tide turned and thus a marginal drift.
