Bundesstelle für Seeunfalluntersuchung
Federal Bureau of Maritime Casualty Investigation
Federal Higher Authority subordinated to the Ministry of Transport,
Building and Urban Development

Summary
Investigation Report 350/09

Serious Marine Casualty

**Collision between MF SCHLESWIG-HOLSTEIN
and SY MAHDI on 24 August 2009
3 nm north-east of the Puttgarden ferry port**

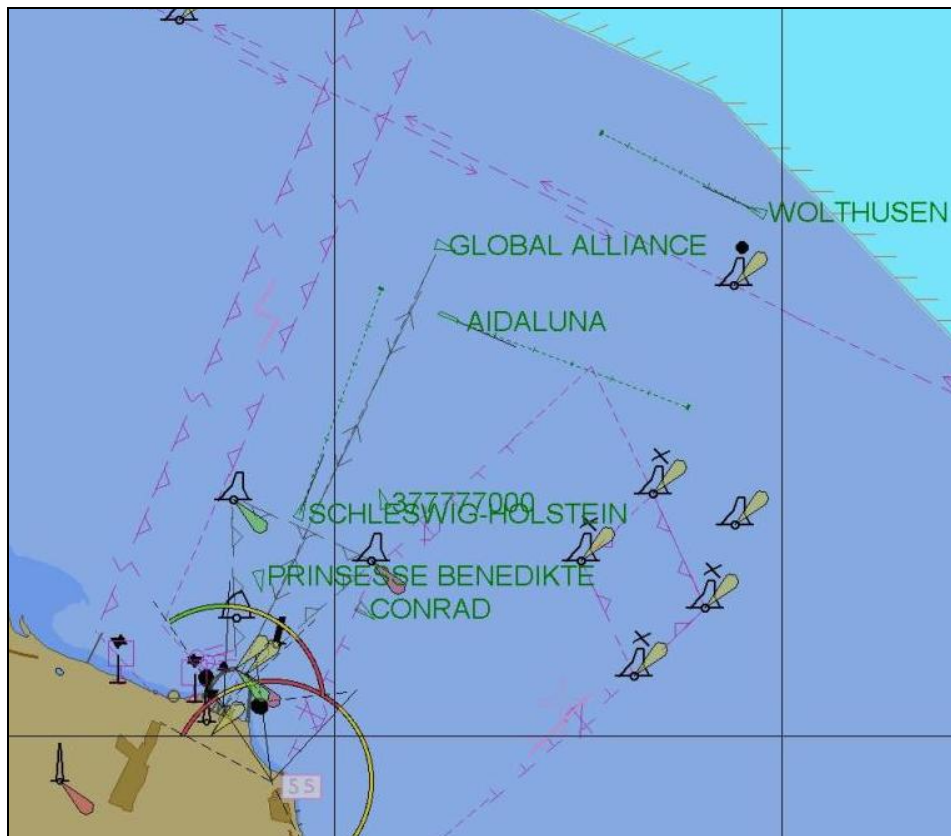
Figure 12: Traffic situation on the AIS of VTS Travemünde at 0353

The following **Figures 12 to 15** illustrate the traffic situation in the area of the accident during the period before the start of the ferry's evasion manoeuvre to starboard in favour of the westbound WOLTHUSEN until the ferry's last-moment action: a change of course to port. In addition to the WOLTHUSEN, the eastbound cruise ship AIDALUNA and the cargo vessel GLOBAL ALLIANCE, which was on a parallel course to the AIDALUNA about 0.4 nm to the north, were of particular significance to the events. It is apparent from the radar recordings (see **sub-para. 3.3.2.1 f.** below) that the MAHDI, which was not shown in the recording of the VTS because she was not equipped with an AIS (not a carriage requirement), was sailing westward between these two vessels and thus temporarily 'in the shadow' of the AIDALUNA. Therefore, at times the yacht was neither identifiable on the radar nor could she be seen from the bridge of the SCHLESWIG-HOLSTEIN.

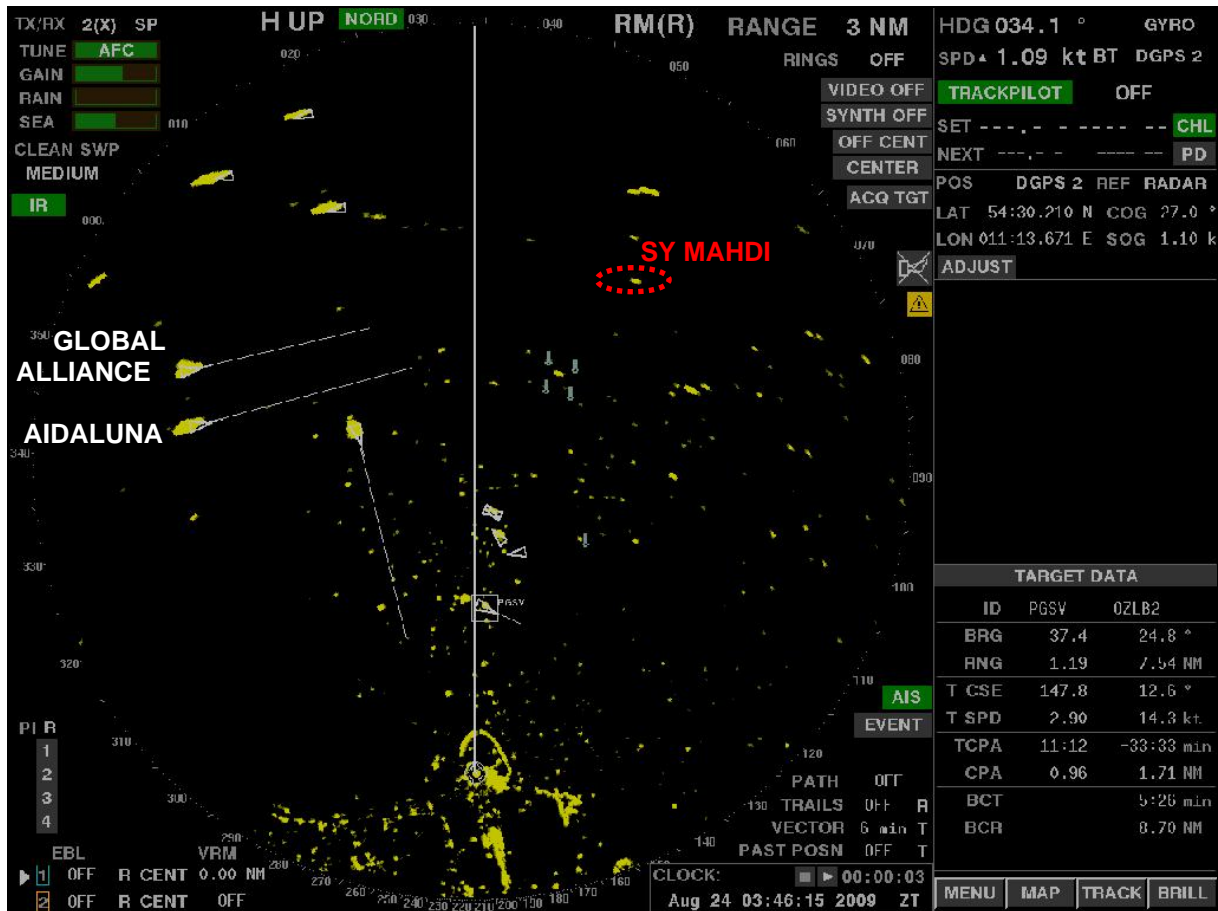
Figure 16: Traffic situation at 034615 (X-band radar)¹⁵

Figure 16 above shows the situation immediately after the ferry cast off. The course steered (HDG) at this point is 34 degrees, the speed is 1.1 kts. The WOLTHUSEN is still not identifiable because she is outside the selected range. Although subsequent evaluation of the following radar images reveals that the echo of the MAHDI is already identifiable, it is not possible to distinguish it from interference, probably caused by the sea, in this image.

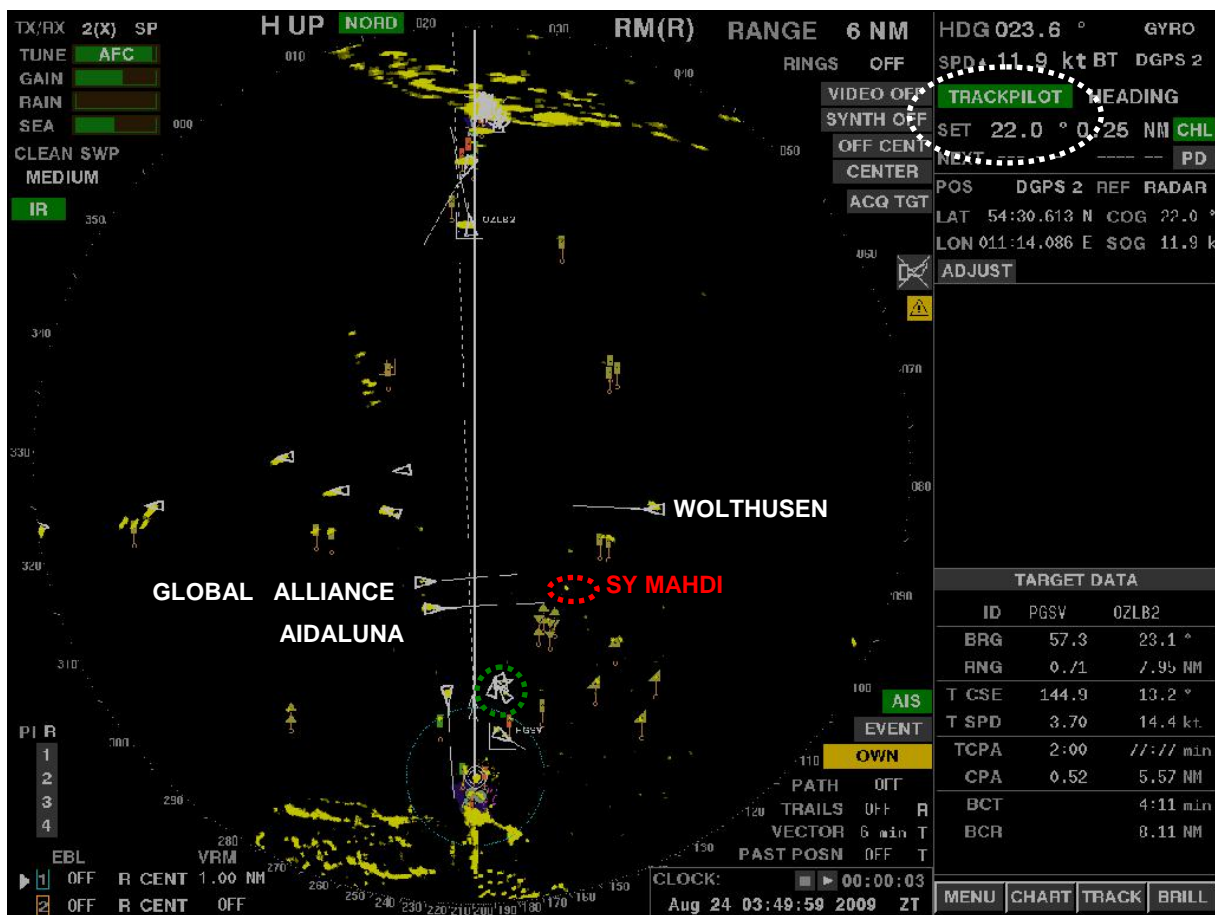
Figure 17: Traffic situation at 034959 (X-band radar)

The WOLTHUSEN is now acquired as an AIS target¹⁷. Due to the off-centred image setting, it is now possible to observe the sea-room about 11 nm ahead; the Danish coastline is already visible at the top edge of the image. The echo of the MAHDI is relatively easy to identify. However, at a distance of nearly 3 nm and on the assumption that the range of the navigation light is not significantly greater than the prescribed minimum standard of 2 nm, it can be assumed that the yacht is still not in sight, in particular, since from this point in time she was increasingly situated 'in the shadow' of an illuminated drilling rig¹⁸, which was made fast by four vessels (see green line in Fig. 17).

In the ensuing minutes, the echo of the MAHDI 'roamed' ever further into the 'shadow' of the platform. Shortly afterwards, it was masked additionally and then later only by the 'shadow' of the eastbound AIDALUNA.

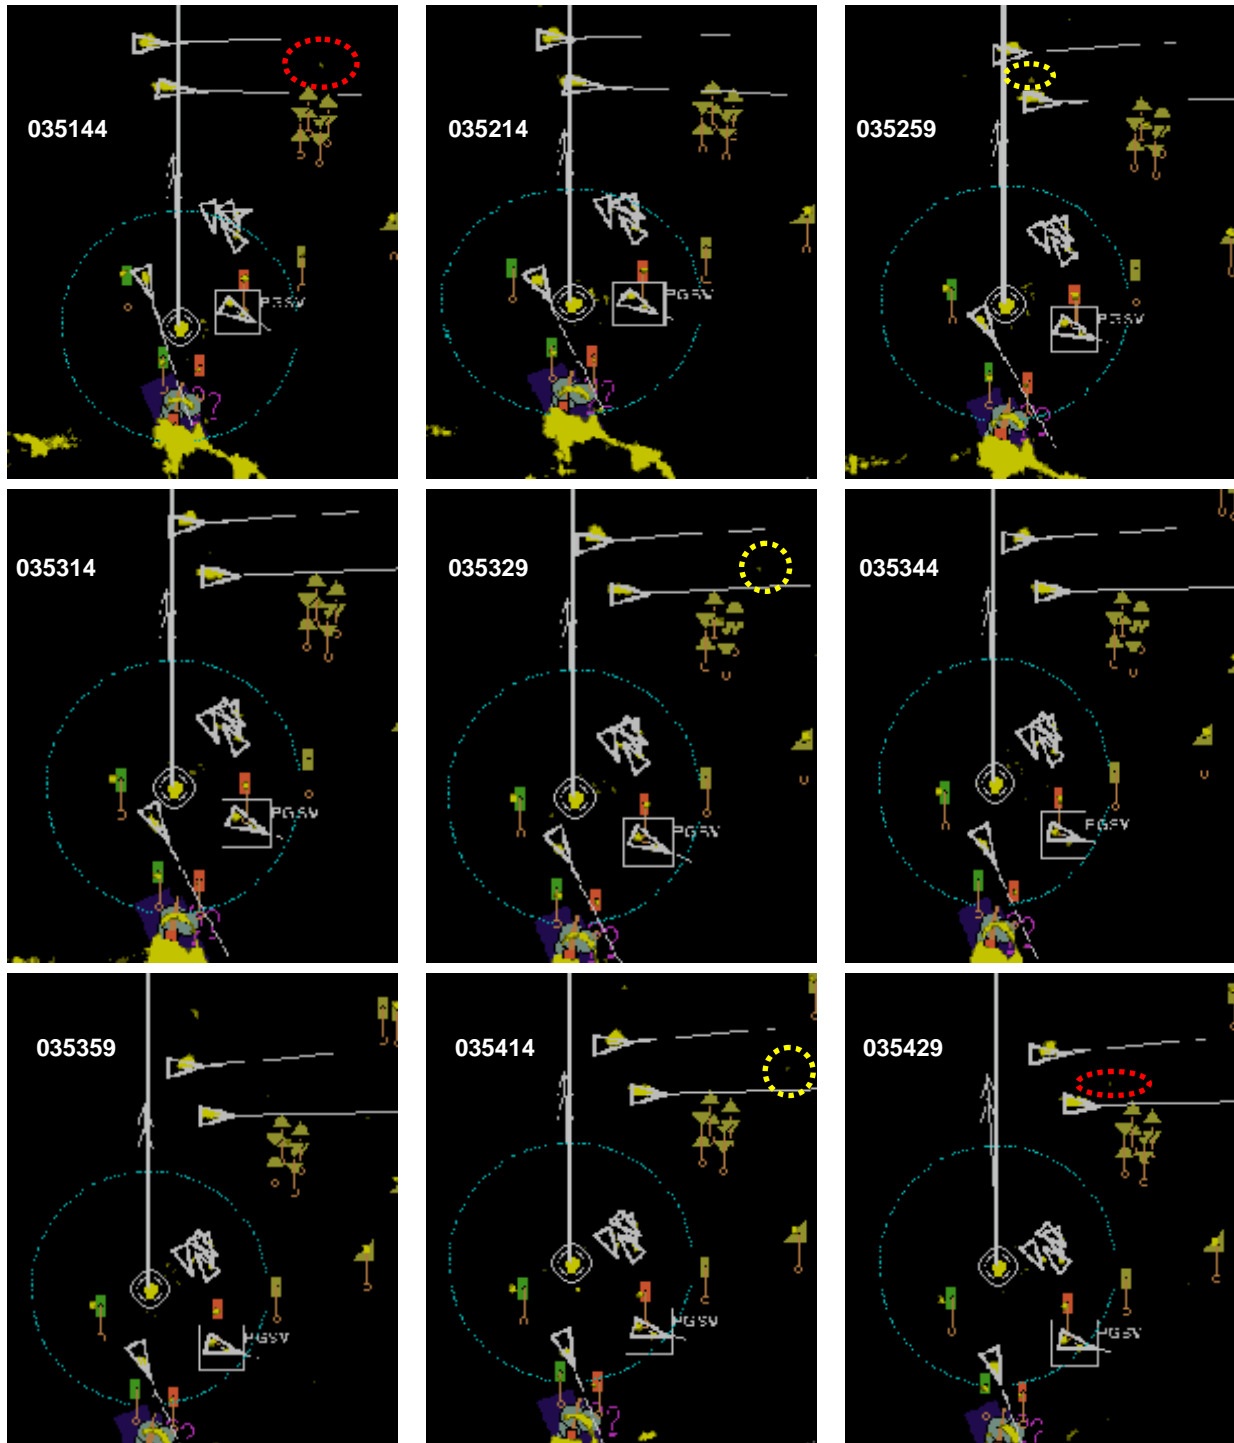
Therefore, during the period 035214 to 035414, the echo of the MAHDI is likely to have been barely¹⁹ visible on the X-band radar (see series of images below).

From the image at 035429 onwards, the echo of the MAHDI is visible in the vicinity of the AIDALUNA; however, a comparison of this echo and the one at 035444 (**Figs. 18 and 19** below), firstly with the apparent echo above the AIDALUNA at 035259, and secondly with the apparent echoes at 035329 and 035414 (see yellow markers at the

top in the series of images), illustrates that it can be difficult to differentiate between interference and an actual object.

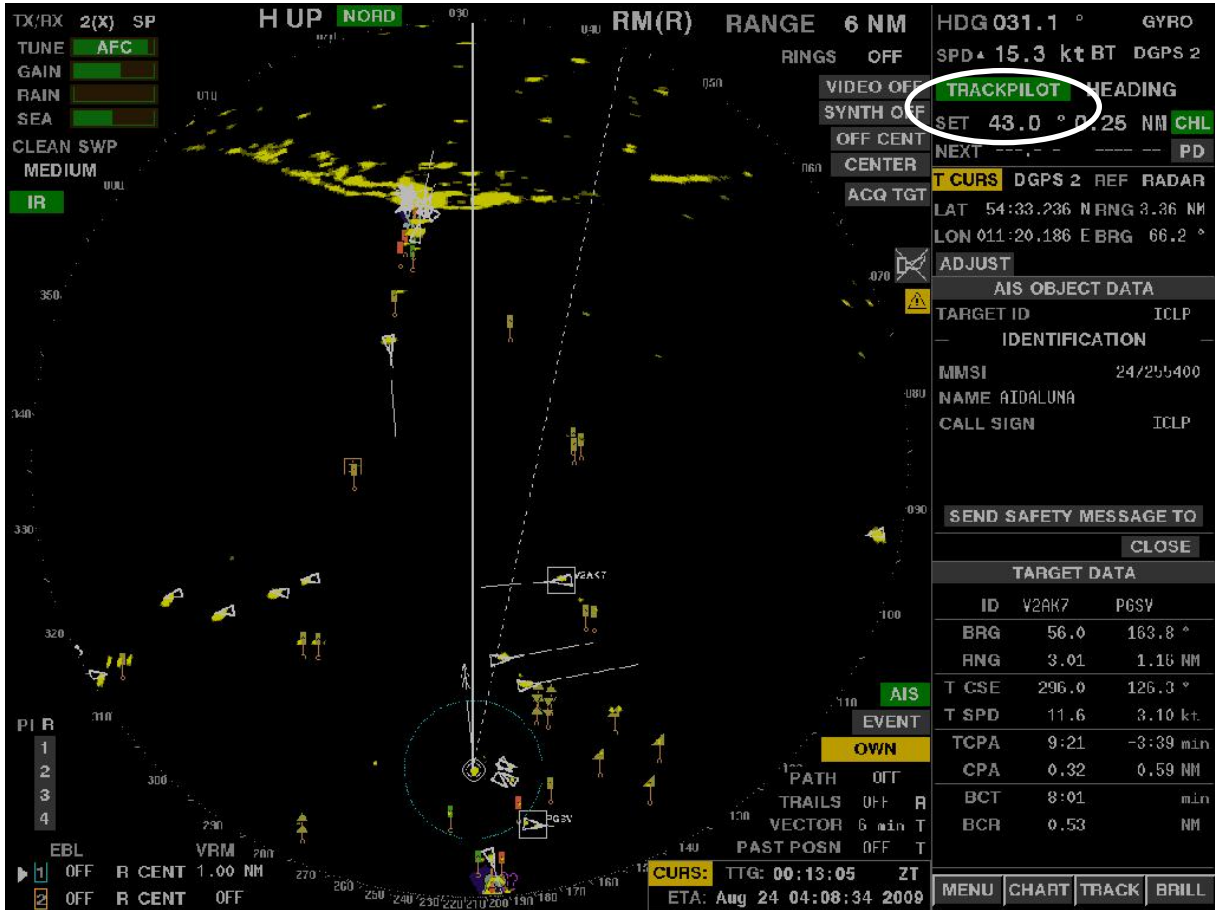
Figure 20: Traffic situation at 035529 (X-band radar)

In **Figures 20** and **21** (035529) below, the SCHLESWIG-HOLSTEIN passes the drilling platform abeam on the starboard side at about 0.4 nm. The trackpilot was set to 43 degrees for the evasion manoeuvre with the WOLTHUSEN.

When looked at very closely, it can be seen that the MAHDI (see Figs. 20 and 21 above) is identifiable as a separate echo astern of the AIDALUNA.

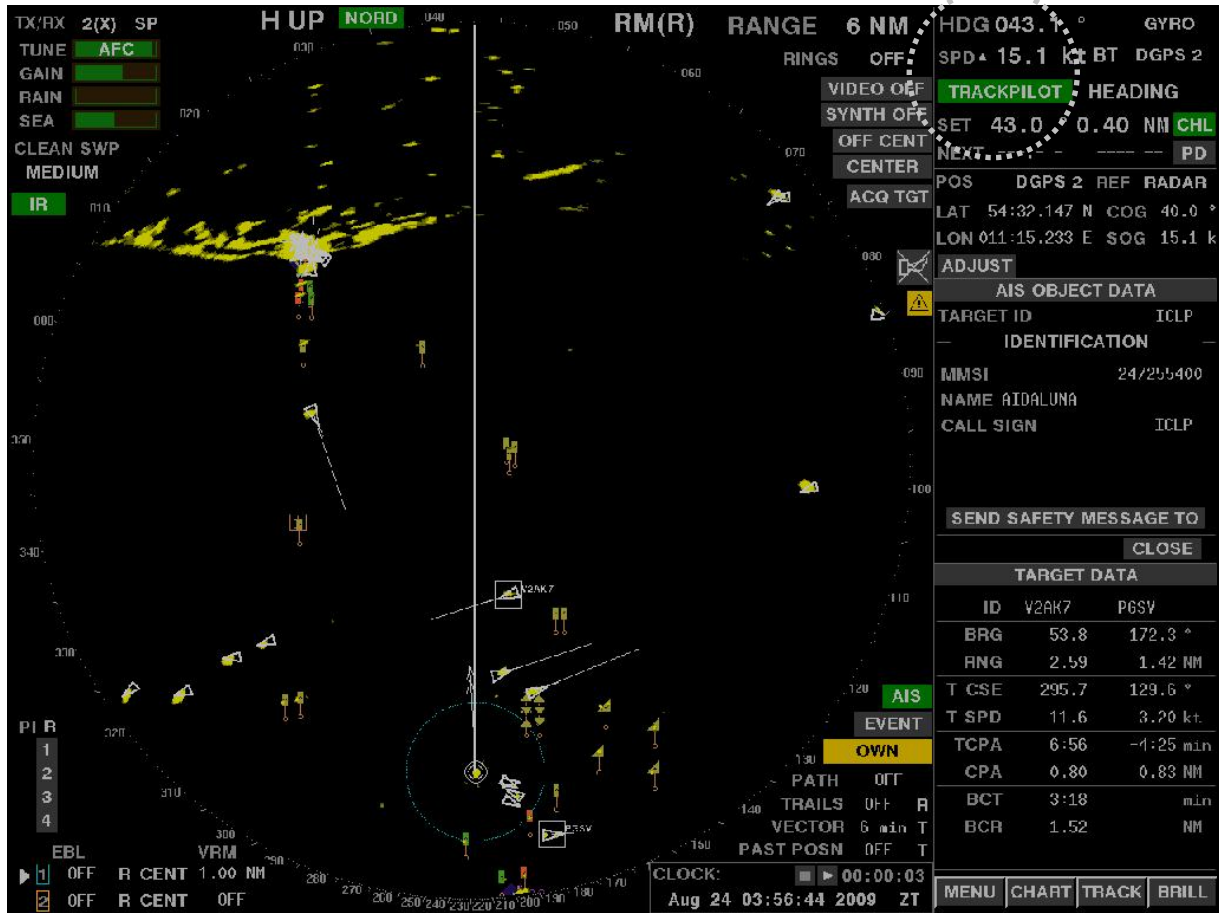
Figure 22: Traffic situation at 035644 (X-band radar)

The ferry completed the course change (see identical values 'HDG' and 'TRACKPILOT SET' at the top right of **Fig. 22**) at 035644 (see **Figs. 22** and **23**). The echo of the MAHDI is in line with the echoes of the GLOBAL ALLIANCE and the WOLTHUSEN 'further above' at a distance of about 1.1 nm. Subsequently (series of images below), the echo of the MAHDI increasingly nears the ferry on a constant bearing and remains in line with the WOLTHUSEN until 035915 (= approximately 50 seconds before the collision). The images at 035714 and 035729 show, that the MAHDI is not permanently detected by the X-band radar even after she left the 'shadow' of the AIDALUNA.

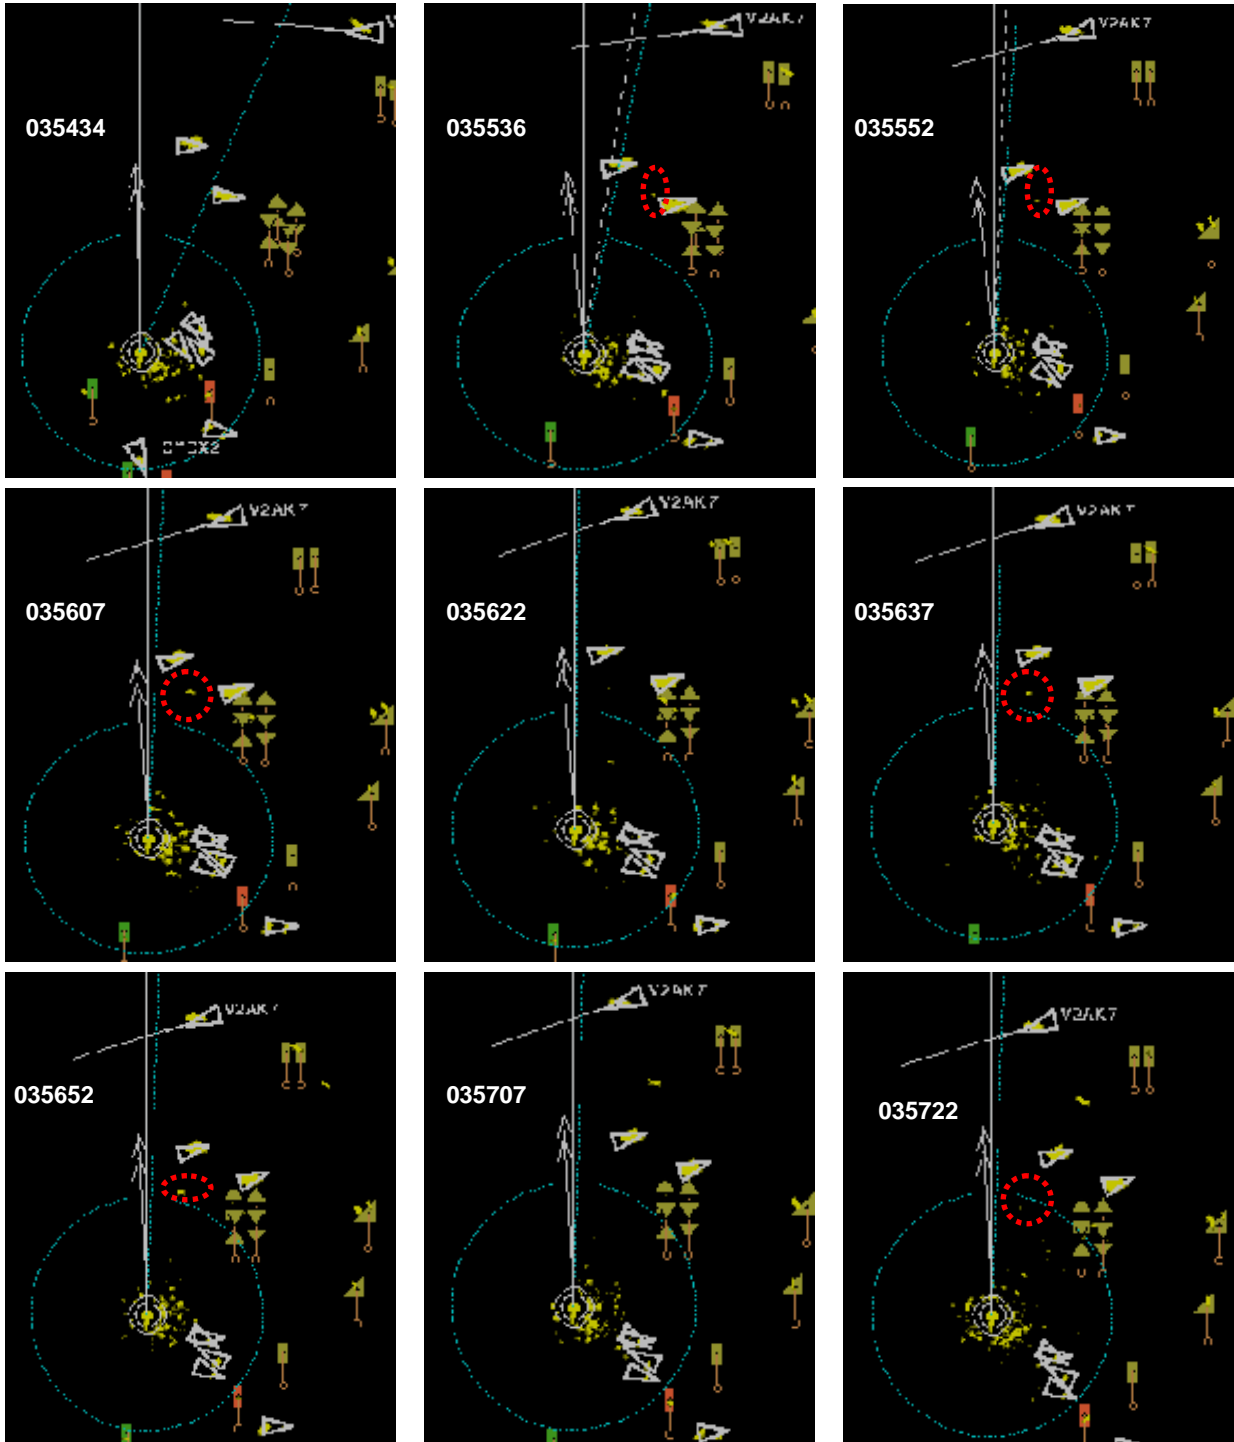
From the screenshot at 035434 onwards (series of images below), the echo of the MAHDI is initially no longer visible on the radar screen. Starting with the image at 035536, the MAHDI leaves the shadow of the AIDALUNA and is then at times clearly and at other times not so clearly visible on the radar image.

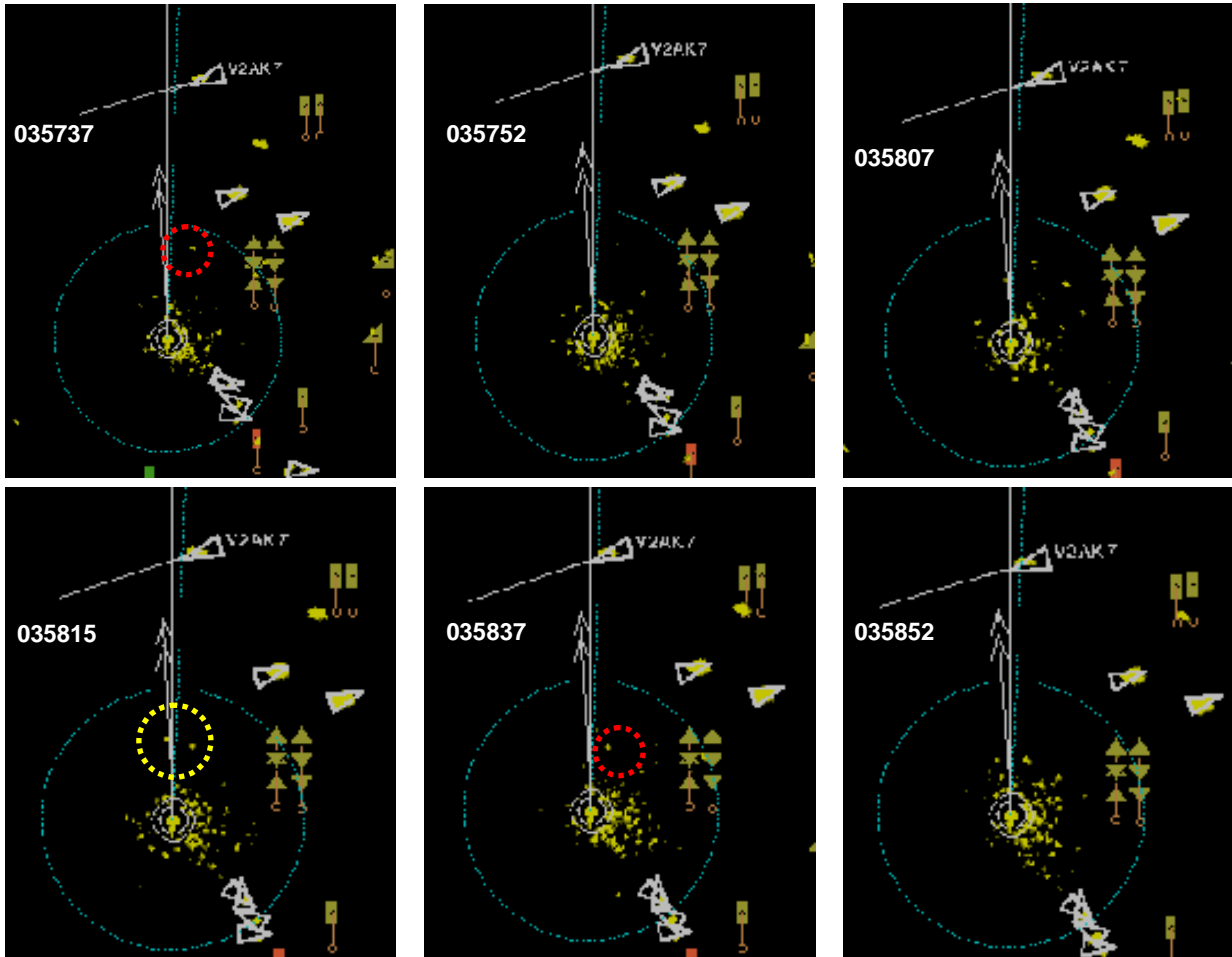
The continuous approach of the MAHDI, which is now within the 1 nm range marker, is evident in the following series of images. The echo is finally lost in the interference on the radar image at short-range at a distance of about 0.5 nm (image at 035852). Even before that, it is virtually impossible to distinguish the echo of the MAHDI from

short-range interference. (By way of example, see image at 035822 – yellow marking. The echo of the MAHDI 15 degrees to starboard at a distance of about 0.7 nm is confusingly similar to the apparent echo just to port at a distance of about 0.75 nm.)

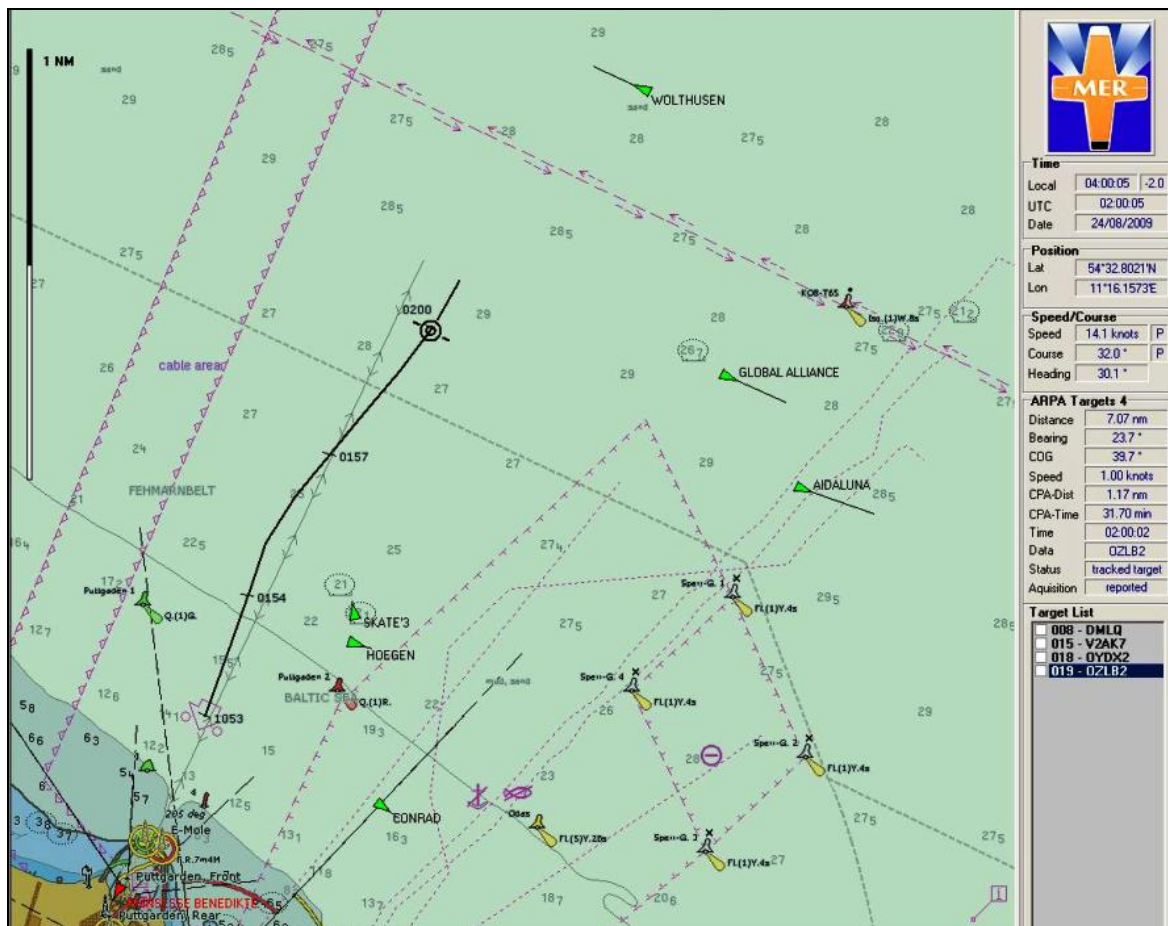
Figure 24: Track of the SCHLESWIG-HOLSTEIN to the scene of the accident

The 'Electronic Nautical Chart' display mode showing the acquired AIS targets WOLTHUSEN, GLOBAL ALLIANCE and AIDALUNA in the VDR of the SCHLESWIG-HOLSTEIN illustrates the ferry's track to the scene of the accident (see Fig. 24).

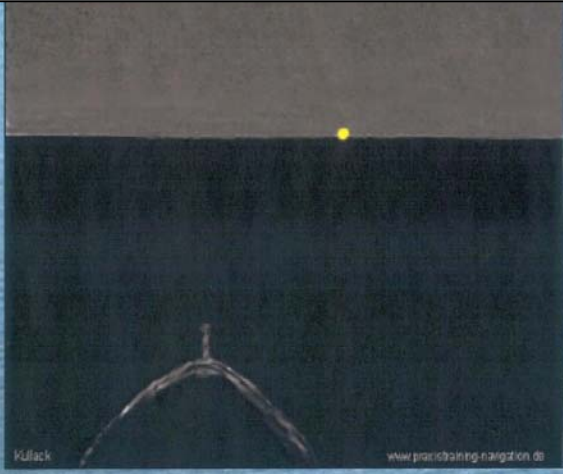
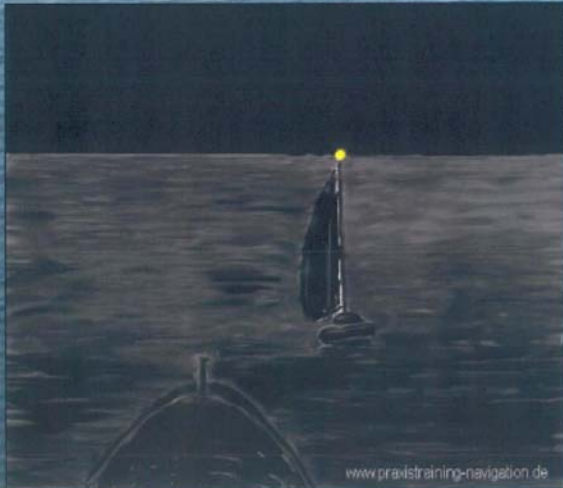
Figure 25: Training document of the Cruiser Section of the DSV 1/2

As an alternative to sidelights and stern light, the COLREGs permit vessels under sail < 20 m to use a tricolour at the top of the mast. That this solution has significant drawbacks and can even be dangerous is illustrated here.

Due to the height of the tricolour light at the top of the mast, this always appears to be roughly on the horizon and thus prevents the navigator on the bridge of a large vessel from visibly assessing the distance to pleasure craft correctly.

A faint light on the horizon?

A very distant vessel!

Wrong!
