**Bundesstelle für Seeunfalluntersuchung**  
**Federal Bureau of Maritime Casualty Investigation**  
Federal Higher Authority subordinated to the Ministry of Transport,  
Building and Urban Development

## **Investigation Report 496/09**

**Very Serious Marine Casualty**

**Grounding with water ingress  
on 21 November 2009  
to the south of São Miguel/Azores and  
constructive total loss of the  
MV S.GABRIEL**

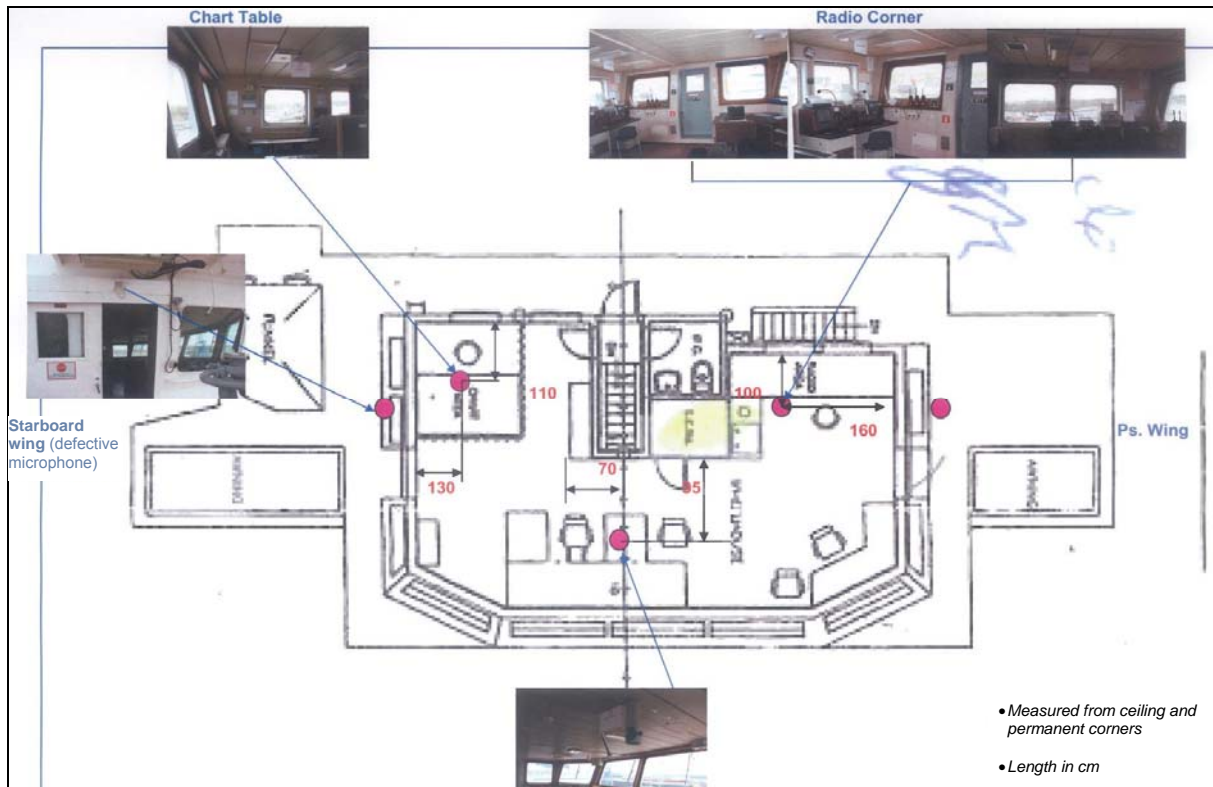
Figure 13: Positioning of the microphones

Testing on the bridge involved the simulation of sounds, such as the opening and closing of doors, loud and normal conversations, movement and other acoustic sounds in order to categorise the audio signals recorded on the day of the accident. The recording quality was quite satisfactory and even quiet sounds were easy to analyse in the subsequent evaluation.
