Bundesstelle für Seeunfalluntersuchung
Federal Bureau of Maritime Casualty Investigation
Federal Higher Authority subordinated to the Ministry of Transport,
Building and Urban Development

Summary Investigation Report 51/09

Collision between the fishing vessel GITTE and the Ferry SKANIA on 17 February 2009 13 nautical miles east of Rügen

1 April 2010

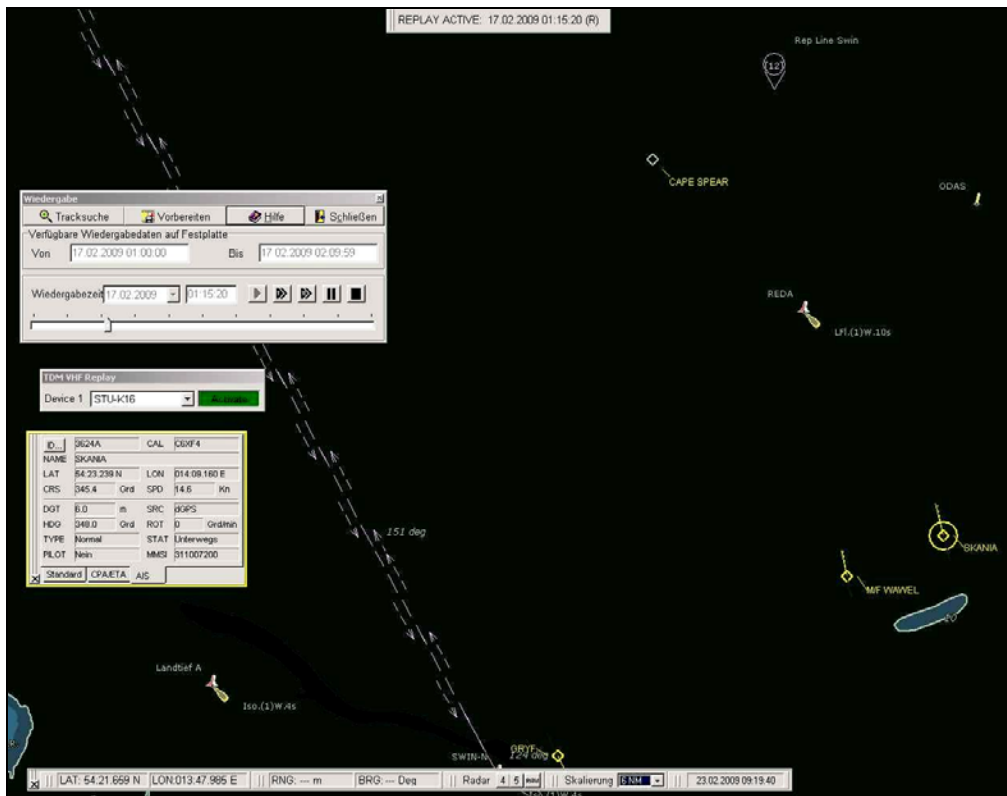
Figure 6: AIS signal of the MF SKANIA at 011520

The analysis of the AIS recording showed that during the thirty minutes under consideration up to the time at which the collision took place and even a few minutes thereafter, the SKANIA was sailing at an almost constant speed over ground of 14.6 kts on a course over ground of approx. 345 degrees towards Ystad (see **Figs. 6 to 11**).
