**Bundesstelle für Seeunfalluntersuchung**  
**Federal Bureau of Maritime Casualty Investigation**  
Federal Higher Authority subordinated to the Ministry of Transport,  
Building and Urban Development

**Investigation Report 557/08**

**Very Serious Marine Casualty**

**Fatal accident caused by a mooring line of the  
TMV COVADONGA breaking on 28 October  
2008 in Brunsbüttel Lock**

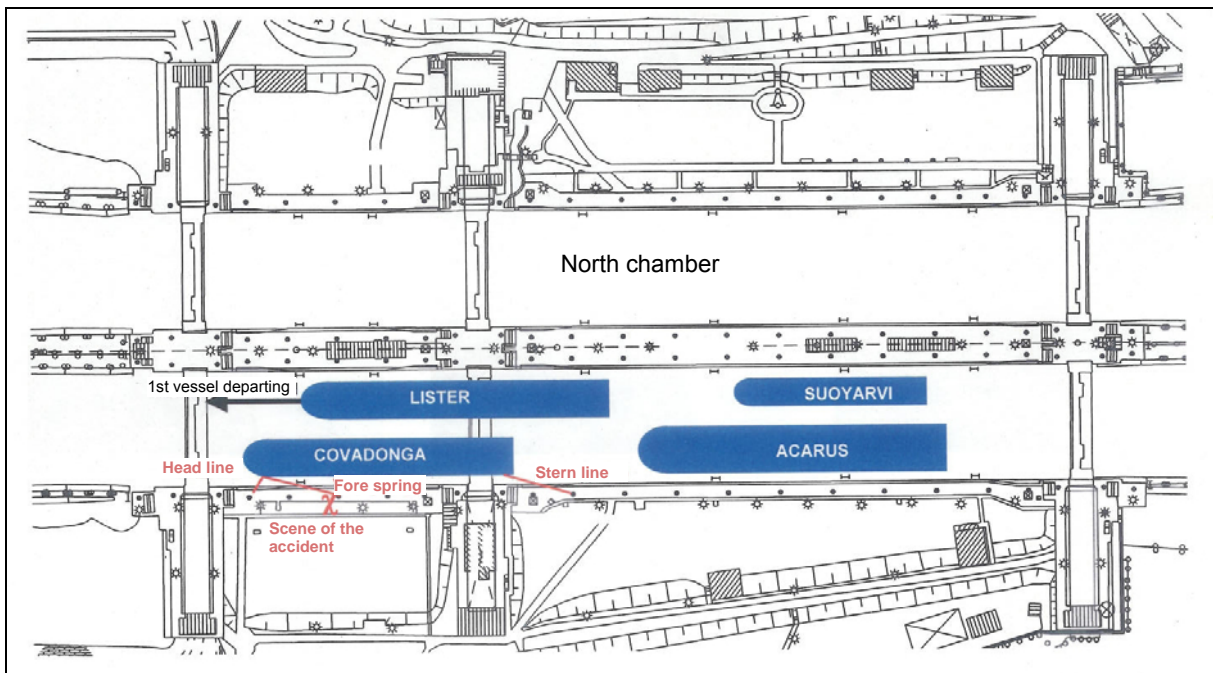
Figure 3: Position of the vessels in the lock

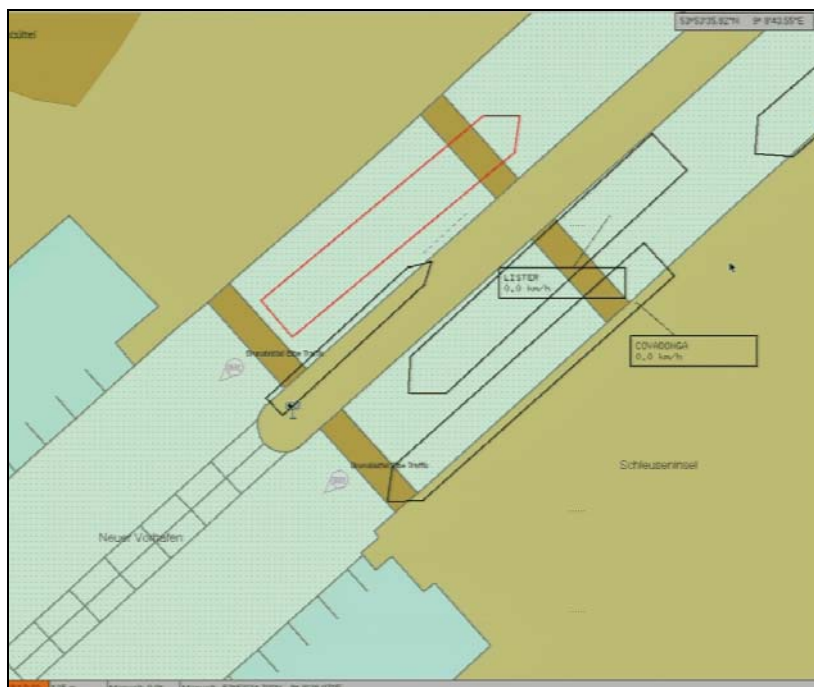
Figure 14: AIS data from 191220

TMV LISTER and TMV COVADONGA are made fast. Speed = 0.0 km/h. The theoretical lateral distance between the moored vessels is approximately 6 m (breadth of lock – (beam of LISTER + beam of COVADONGA + 2 x boom breadth))

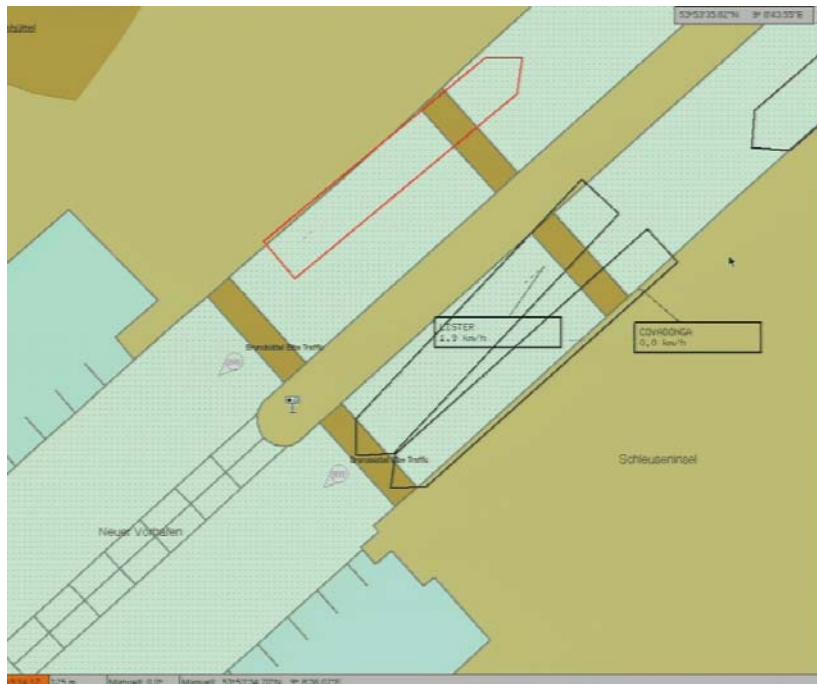
Figure 15: AIS data from 191417

TMV LISTER picked up speed and achieved a manoeuvring speed of 1.9 km/h as she passes stem to stem. The AIS data indicate that the TMV COVADONGA is pulled astern at a non-recorded speed (see position of stem in previous figure).

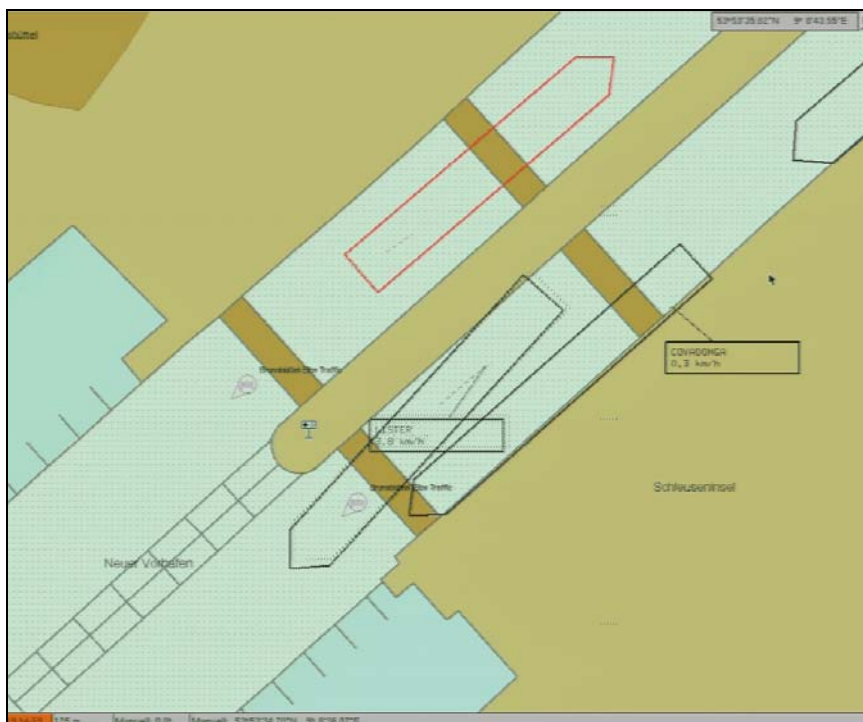
Figure 16: AIS data from 191455

TMV LISTER proceeds at 3.8 km/h. TMV COVADONGA moves ahead, here already at 0.3 km/h.

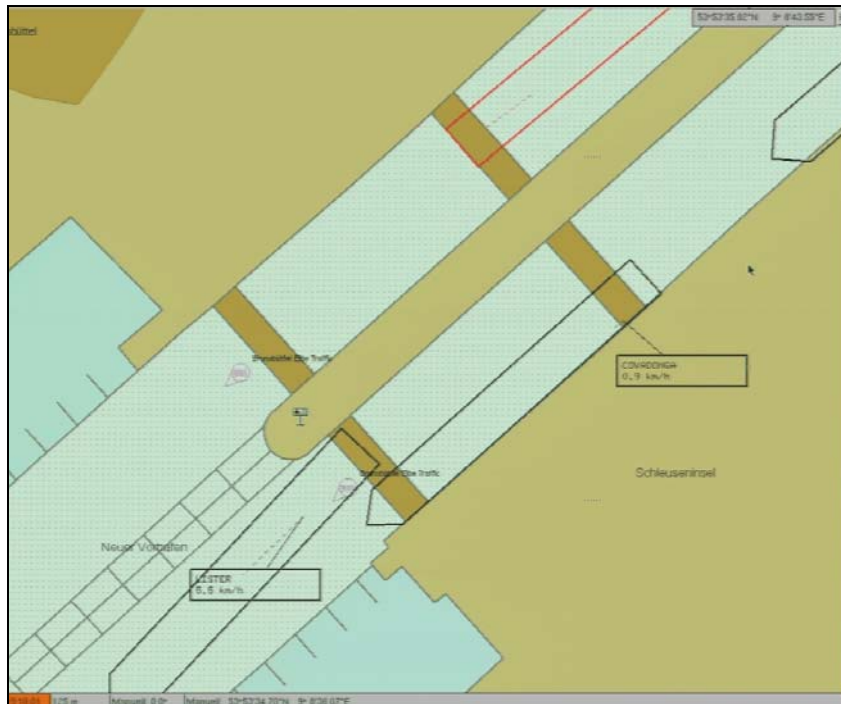
Figure 17: AIS data from 191600

TMV LISTER has a speed of 5.5 km/h and TMV COVADONGA a speed of 0.9 km/h.

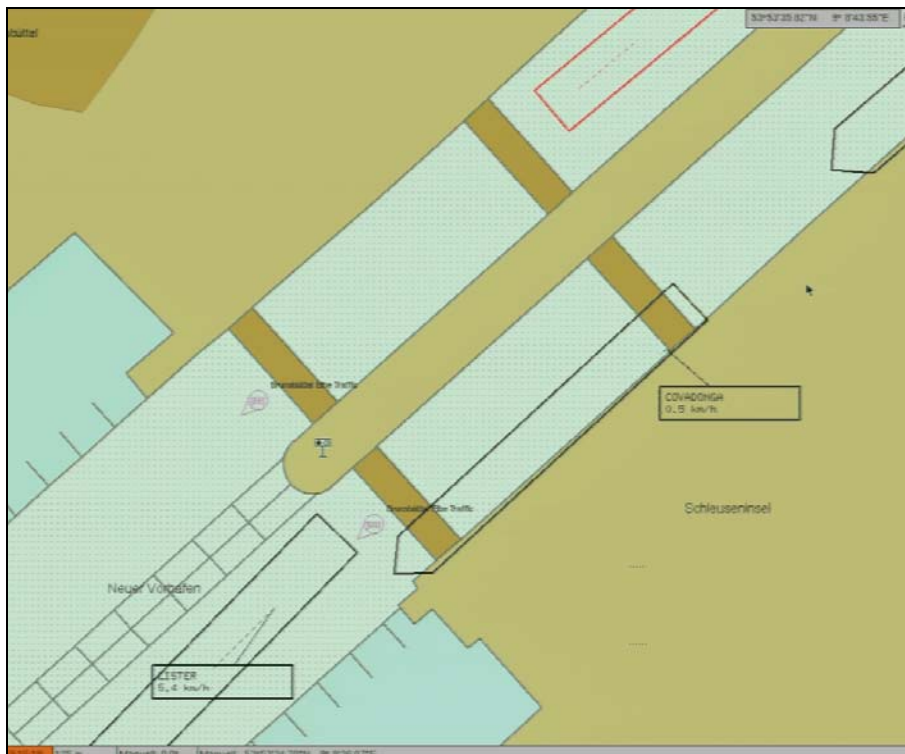
Figure 18: AIS data from 191620

TMV LISTER continues at 5.4 km/h. TMV COVADONGA has a speed of 0.5 km/h, which drops to 0.0 km/h by 191800. The position of the stem resp. the vessel has moved forward considerably.

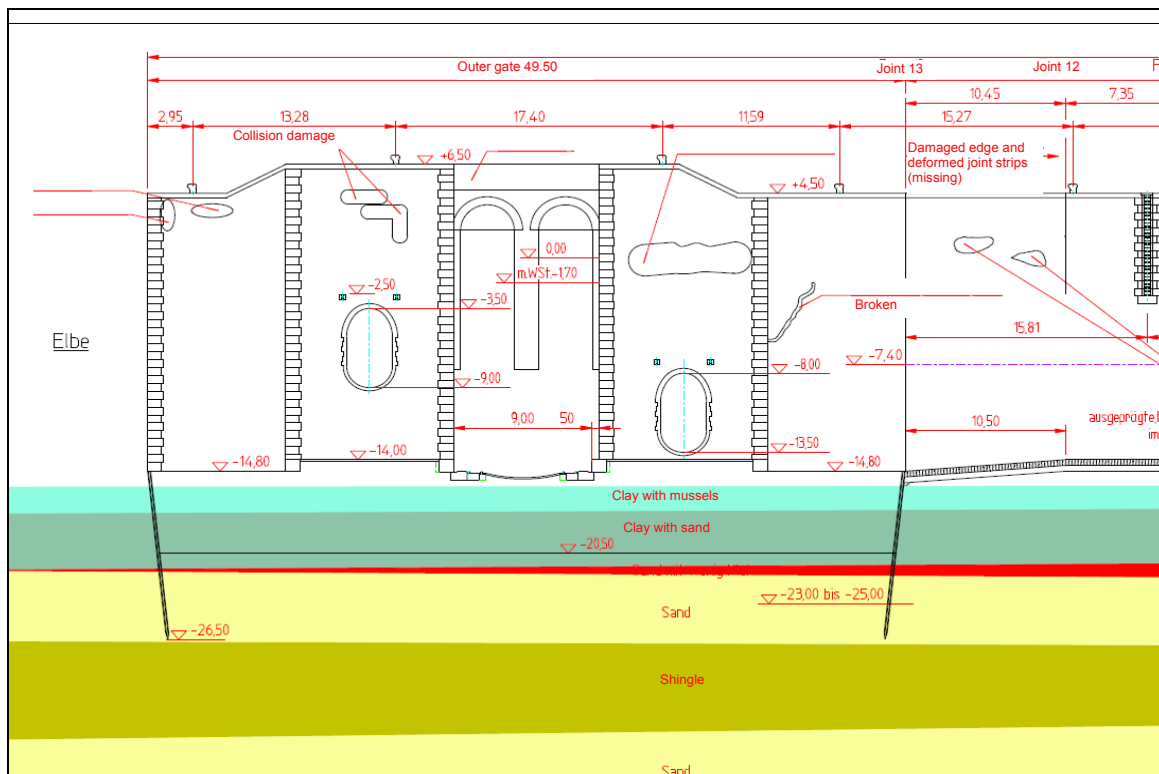
Figure 22: Longitudinal profile of the lock

Control measurements during a local inspection on 30 March 2010 using a 30 m steel tape measure as well as a laser measuring device (Leica Disto) were carried out on the dimensions of the lock wall and compared with the data from the gauge.

It can be concluded that the height from the surface of the water to the upper edge of the lock was between the 5.29 m and 5.33 m on the day of the accident.

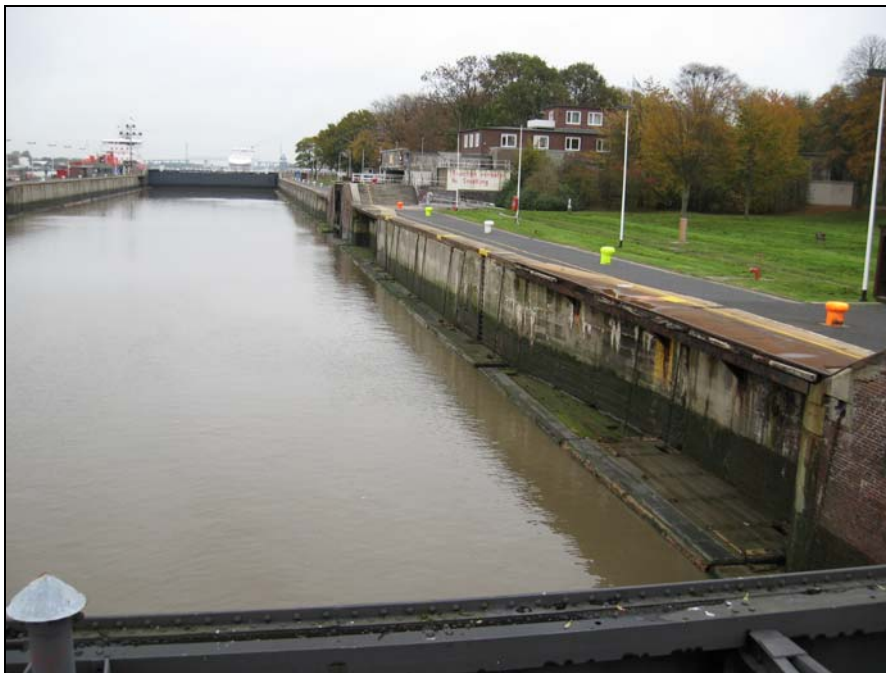
Figure 24: View from the outer wall with bollards, middle gate and safety recess

It was not possible for the linesmen to see one another while carrying out their task due to the raised middle gate.

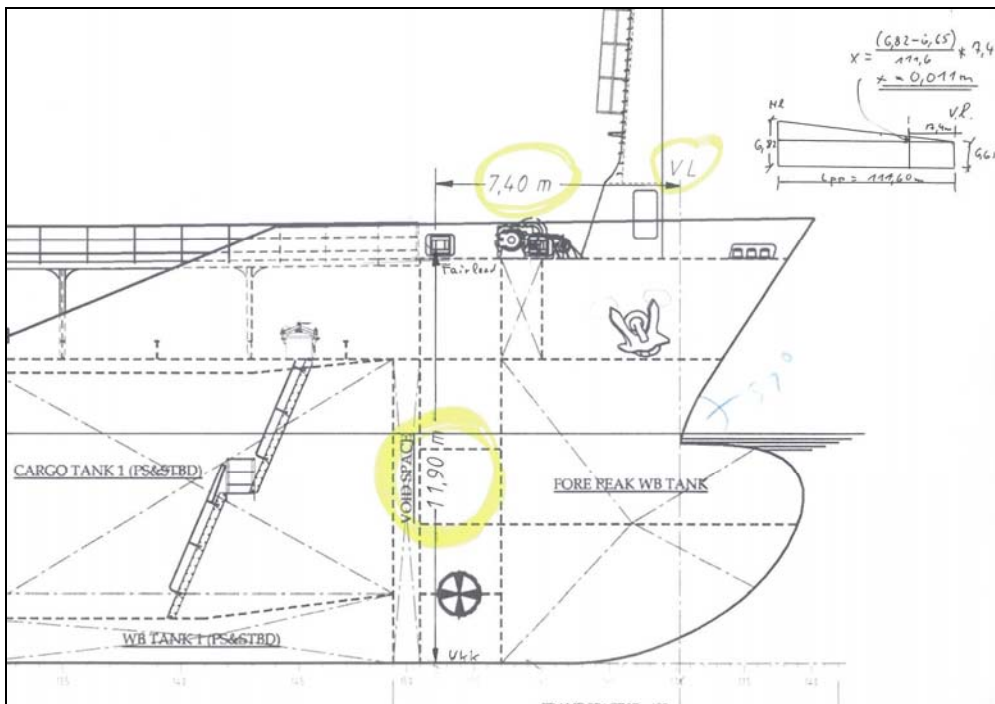
Figure 26: GA Plan, forecastle

Accordingly, the distance from the rear fairlead to the bottom edge of the Kiel (BEK) is 11.90 m (3.60 m + 8.30 m). That corresponds to the value measured by the classification society, Lloyd's Register, according to the General Arrangement Plan (GA Plan).

The rear fairleads are 7.40 m from the forward perpendicular and positioned 11.90 m above the BEK in the GA Plan.

During a survey on board by the BSU on 11 June 2010 in Brunsbüttel, these values determined by the WSP and the values in the GA Plan were confirmed with the current draught. The rollers in the fairleads ran smoothly and no sharp edges were observed.

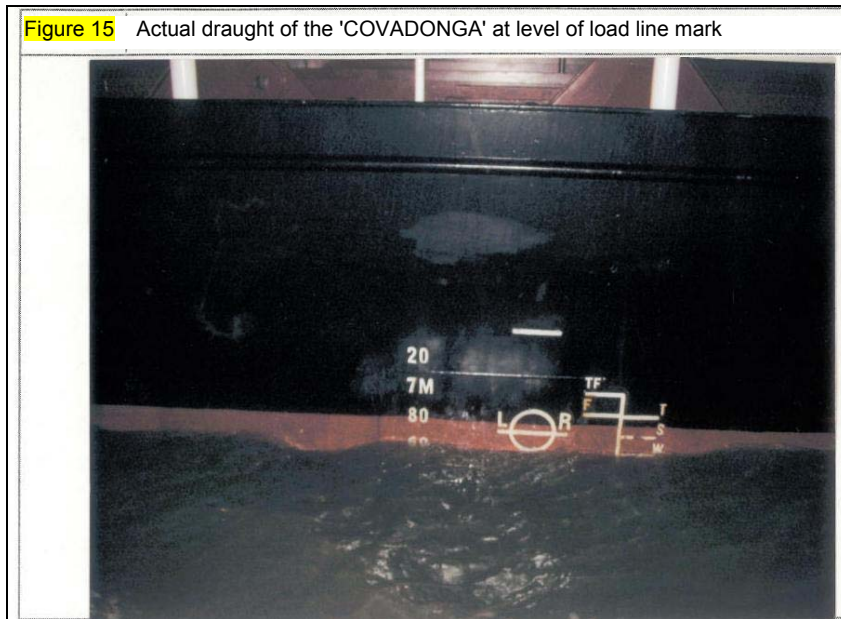
Figure 27: Load line mark at Brunsbüttel roadstead on 28 October 2008

In the forms of the Federal Bureau, which were submitted in February 2010 by the counsel for the vessel operator, the draught is stated as being 6.65 m fore, 6.74 m amidships and 6.82 m aft. These values seem to be more realistic and are confirmed by photos taken in the roadstead off Brunsbüttel on the day of the accident:

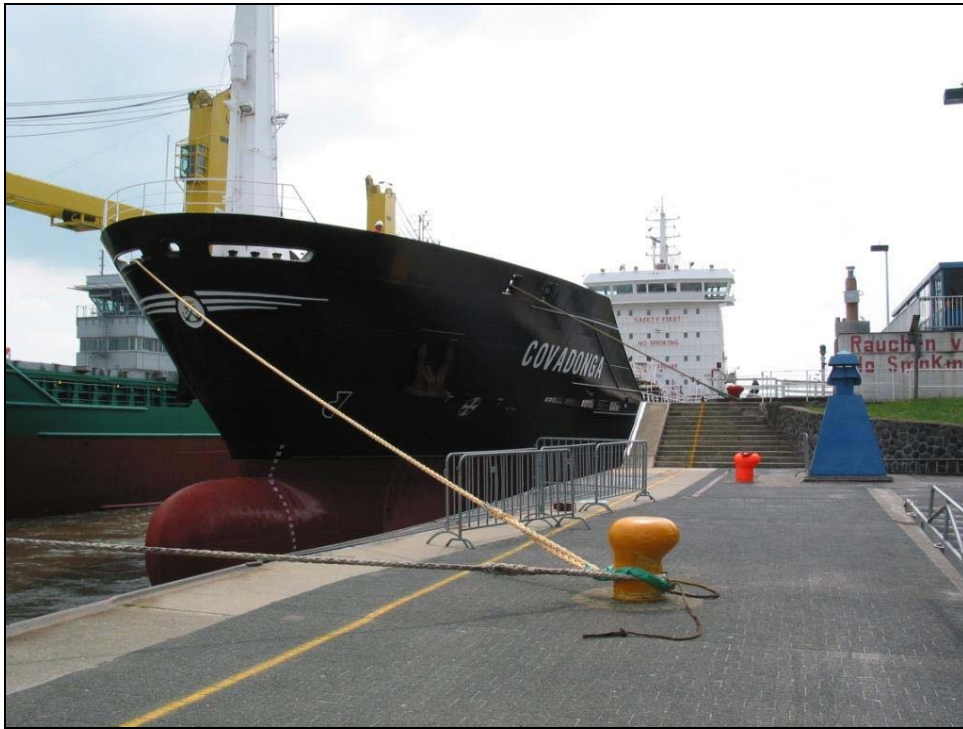
Figure 28: Head line and fore spring on 11 June 2010

As regards line guidance on the forecastle, according to the above photograph the head line ran from the working section of the starboard winch over warping rollers on the deck and through the forward starboard warping rollers and the fore spring ran directly from the working section through the forward port fairlead.

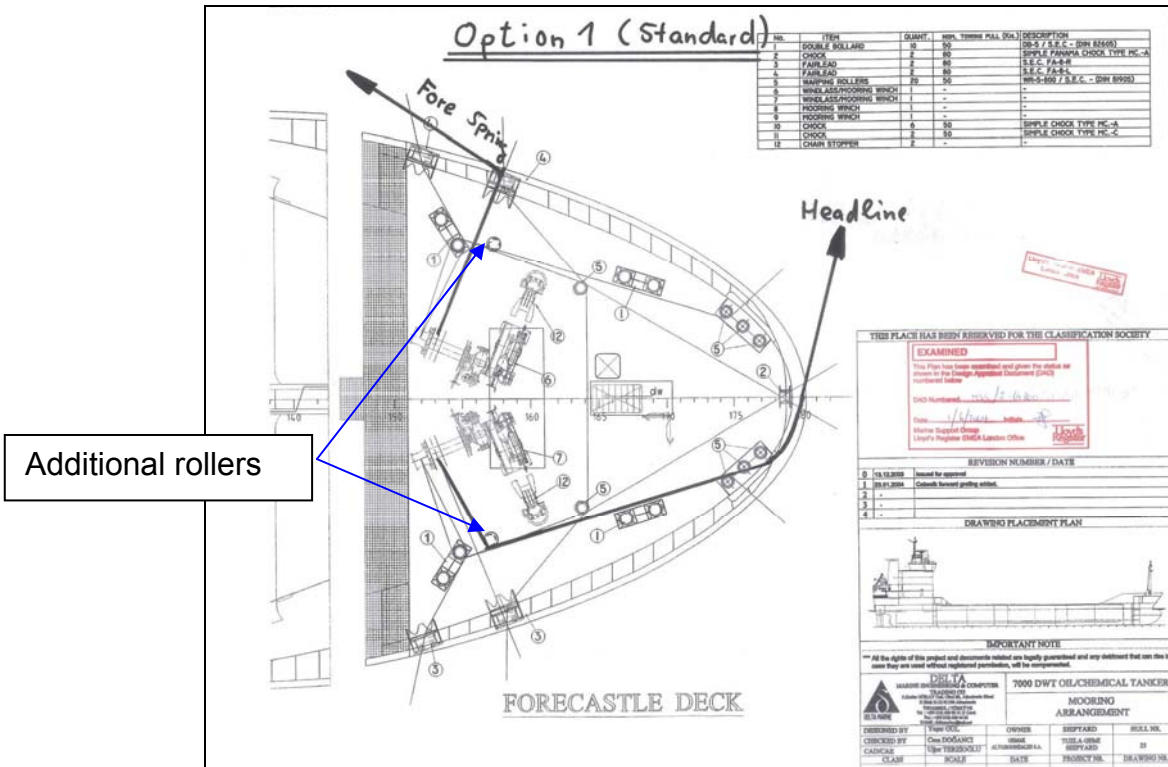
Figure 29: Standard line guidance

It was confirmed in a letter from the vessel operator's legal counsel dated 7 September 2010 that the line guidance shown above in Fig. 29 was that used on the day of the accident. It is noted in the letter that in their first statements the crew members are referring to the guidance of the fore spring on the fairlead, which is located in extension of the relevant winch. The aft fairlead was not used and also not mentioned in the statements. The account of the written testimony of 28 October 2008 (*"The fore spring went through the aft port fairlead, the head line went through the forward port fairlead"*) in the BSU report regarding the used fairleads is misleading. The witnesses did not indicate that of the two port fairleads it was reportedly the rear one which was used for the fore spring. The witnesses indicated that the fairlead used is located in the aft ship of the bulwark on the port side with their statement: *"the fore spring went through the aft port fairlead."*<sup>3</sup>

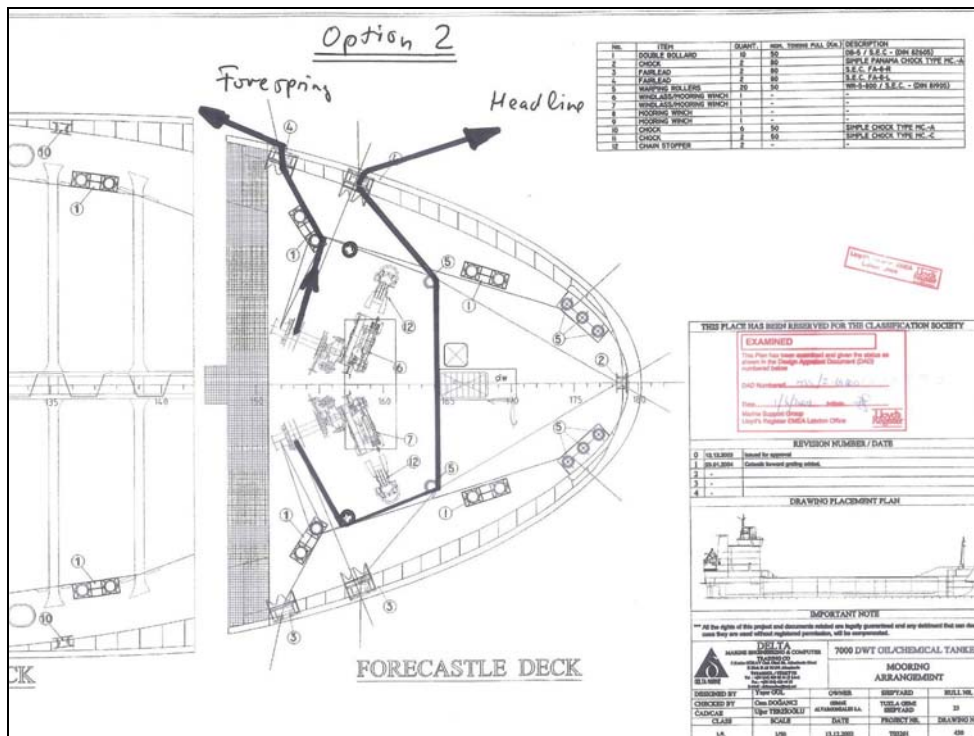
Figure 32: Line guidance option 2

In the case of the second option, the head line would be deflected twice; this would inevitably lead to friction losses and is not ideal in terms of safety. Moreover, a life raft is positioned midships on the aft edge of the companionway/foremast, which can chafe the mooring line.

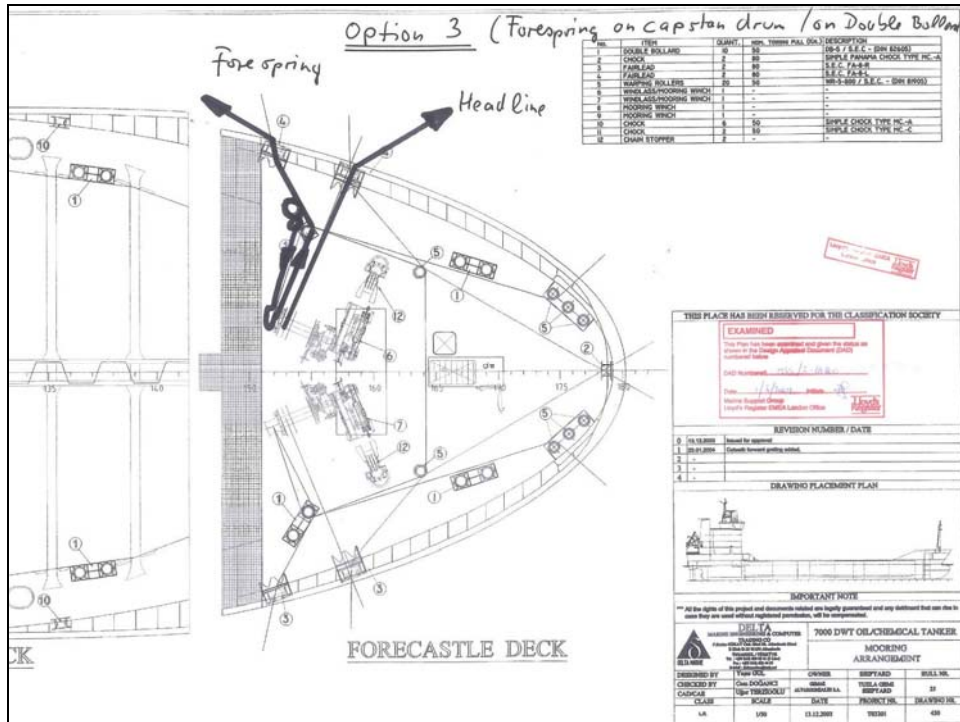
Figure 33: Line guidance option 3

In the case of the third line guidance option, an additional line, which is not used on the capstan drum, would have been necessary for the fore spring. This line is passed over the warping head and placed on the twin bollard. Automatic slackening of the line under load is then not possible. The possibility of a third line being used for the fore spring is opposed by the fact that the police report does not contain any corresponding remarks and the photos of the line wind up on the capstan drum taken on board on the day of the accident show the same blue coloured strands.

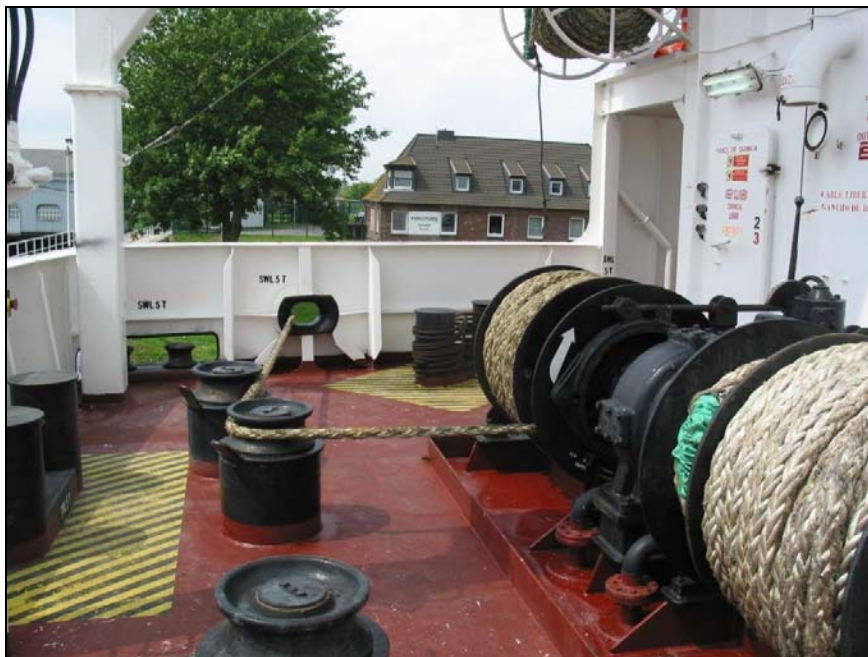
Figure 35: Line guidance on the stern

The COVADONGA has two Panama fairleads on each side of the aft deck. During the survey on 11 June 2010, the stern line was passed over a warping roller through the rear Panama fairlead. These Panama fairleads are level with the warping rollers and used for guiding the aft spring or stern line.

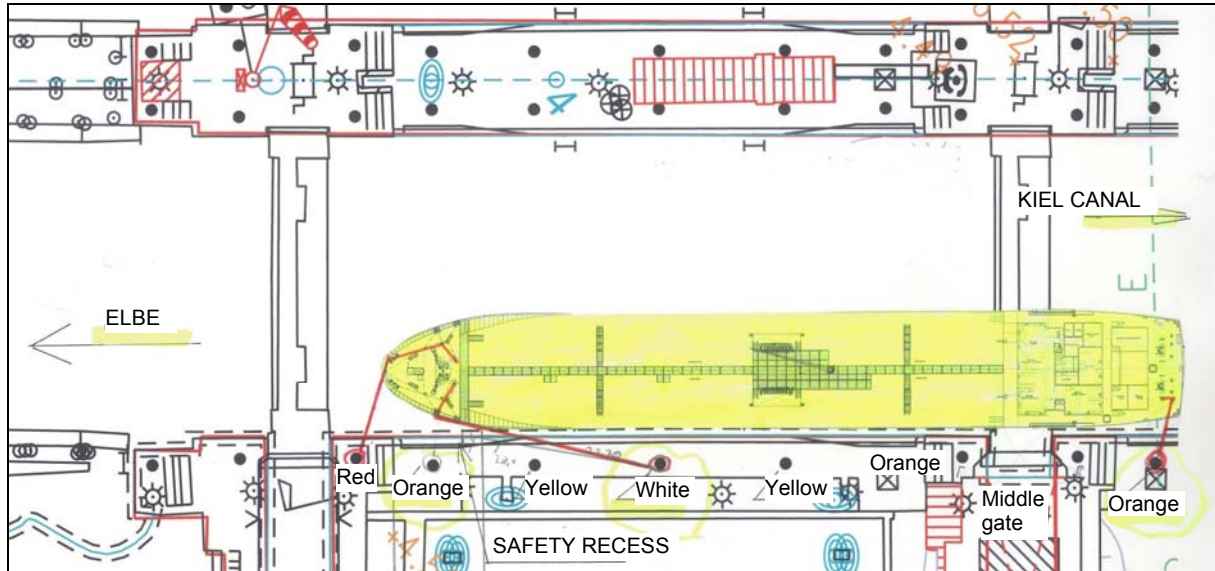
Figure 36: Mooring position on the day of the accident

Based on the statements and AIS recordings, the position of the vessel in relation to the bollards is shown below. In this position, the vessel is made fast with two short breast lines and a spring.

According to the above drawing, the line guidance of the head line led it through the starboard warping rollers at the stem and is consistent with common practise on board. There are no clear statements as to arrangement of the head line on shore. In all likelihood, it was placed on the red bollard on the outer gate. With the vessel in this position, the head line is deployed as a short breast line.

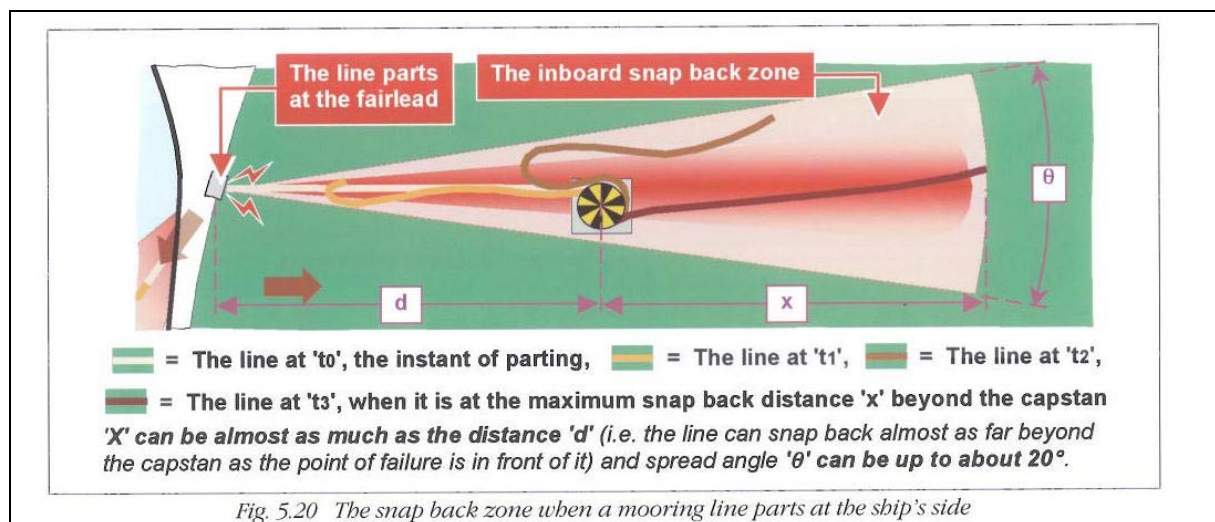
Figure 38: Danger area when a line breaks

Seen from the position of failure, the literature indicates that the angle can be up to 20° and the line snaps back beyond the winch in its length from winch to position of failure ( $x=d$ ).
