**Bundesstelle für Seeunfalluntersuchung**  
**Federal Bureau of Maritime Casualty Investigation**  
Federal Higher Authority subordinated to the Ministry of Transport,  
Building and Urban Development

Investigation Report 168/09

**Serious Marine Casualty**

**Collision between the HÖEGH LONDON and  
three vessels moored on the Weser  
on 26 May 2009**

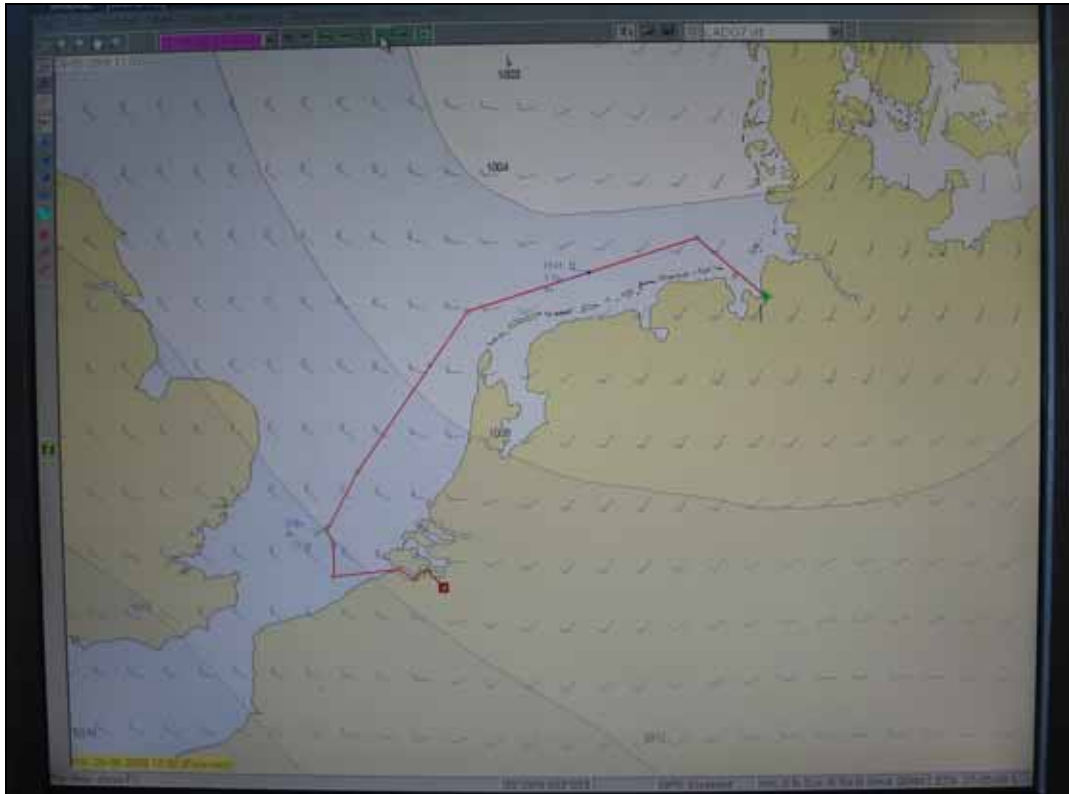
Upon request, the crew submitted a weather forecast in written form and a printout of a wind map to the investigators. This printout came from a computerised system for wind forecasts on board the HÖEGH LONDON, which displayed wind data on a monitor in graphic form. The computer system made it possible to zoom in (see Figures 10 and 11). The displayed wind data only made a broad overview of the situation possible and contained much lower wind forces.

Figure 10: Wind data for 26 May 2009, 1200 UTC – Forecast; photo of the screen display on the bridge of the HÖEGH LONDON

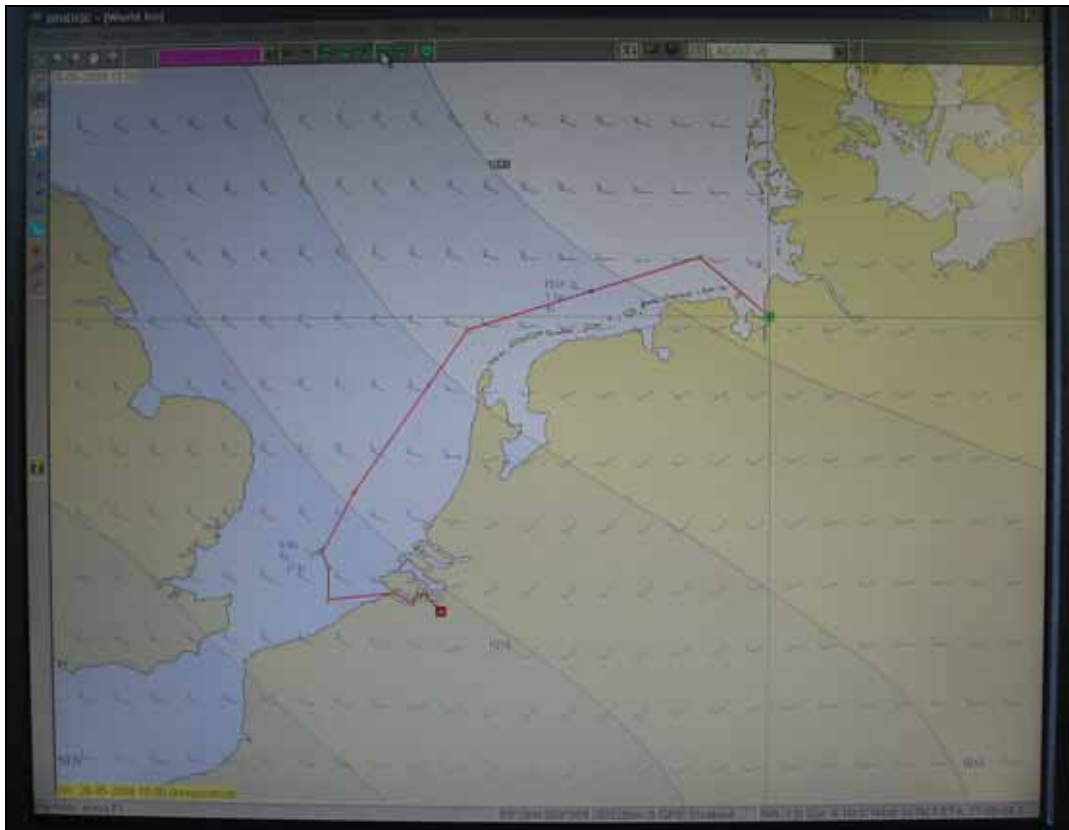
Figure 11: Wind data for 26 May 2009, 1800 UTC – Interpolated; photo of the screen display on the bridge of the HÖEGH LONDON

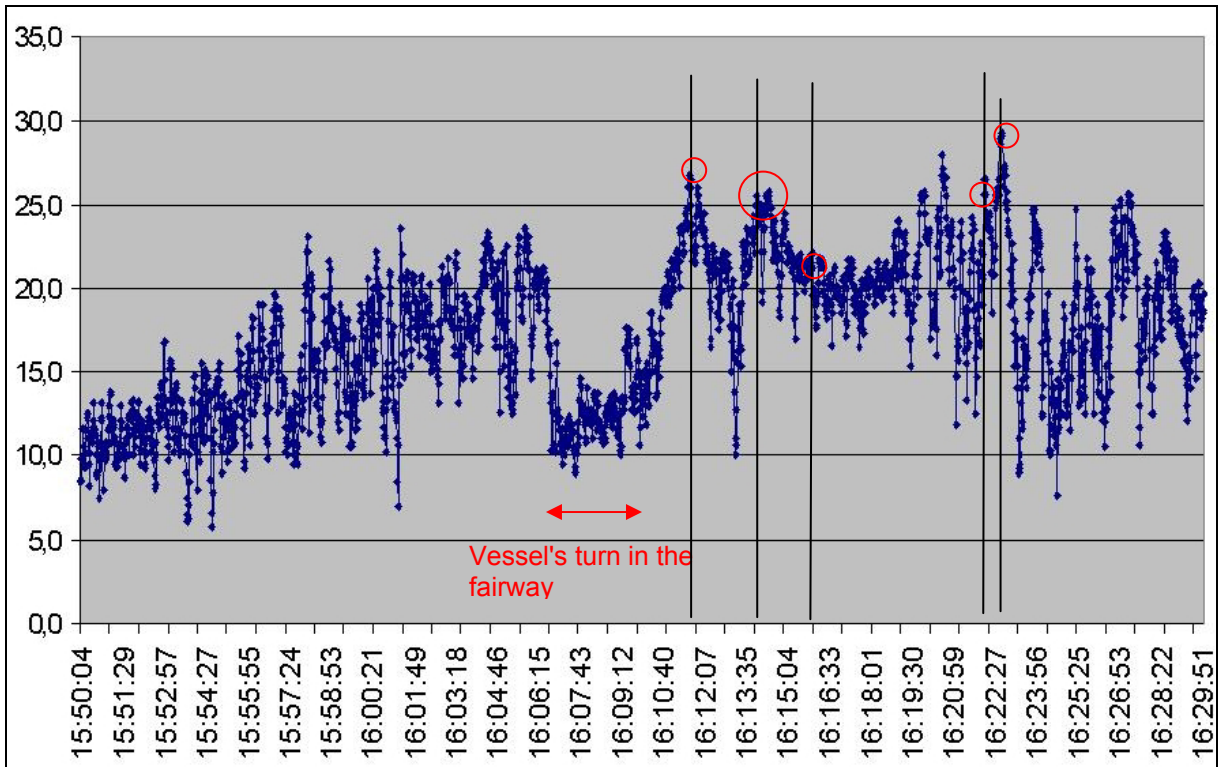
Figure 12: VDR of the HÖEGH LONDON, recording of the wind force of the apparent wind [m/s] over time (VDR system time, equal to UTC)

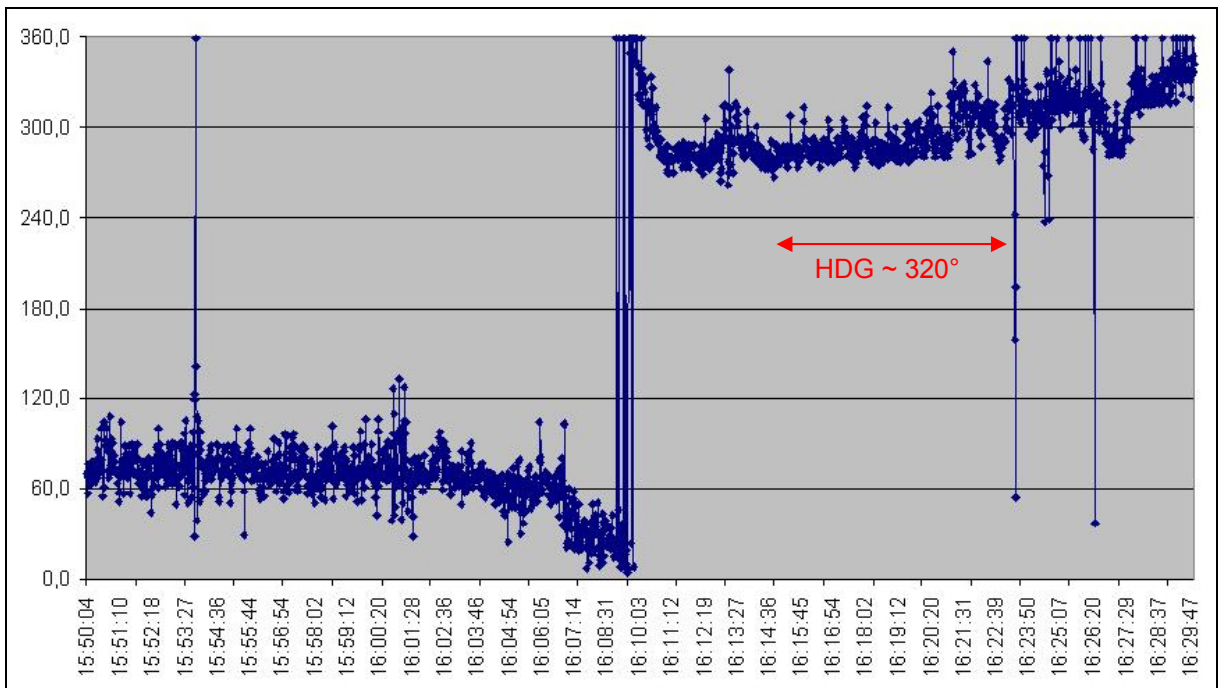
Figure 13: VDR of the HÖEGH LONDON, recording of the wind direction of the apparent wind as a relative bearing [°] over time (VDR system time)

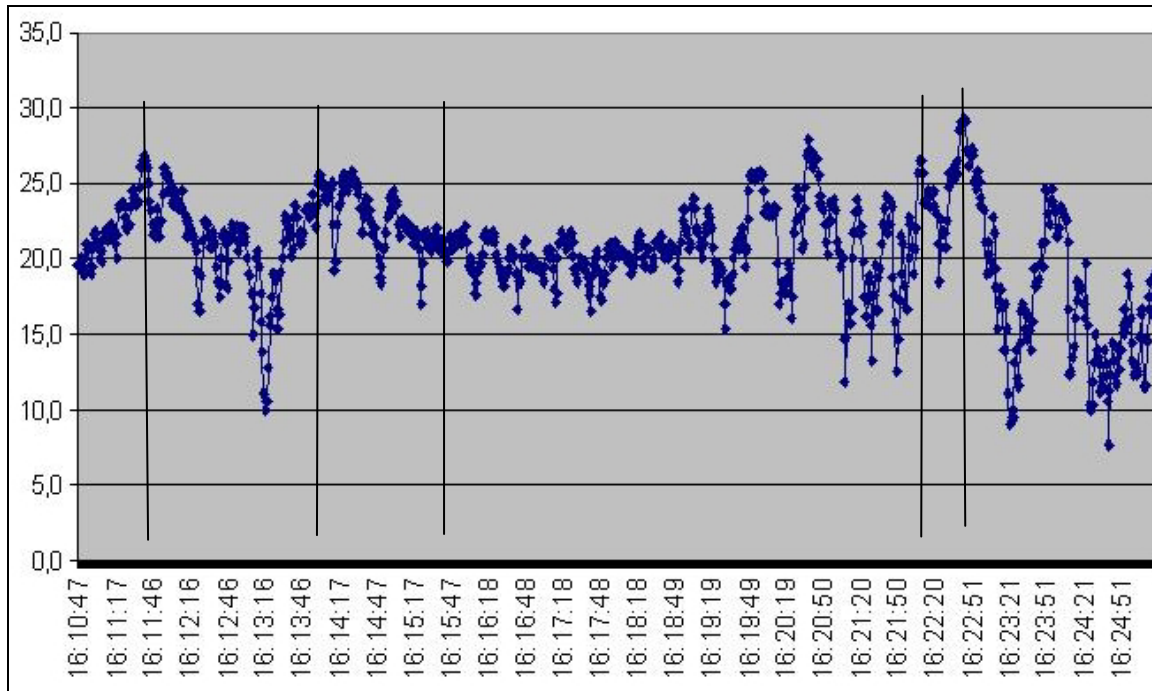
Figure 14 illustrates the wind forces during the period relevant to the accident. Here it is recognisable that the wind was relatively constant and blew with 8 Bft<sup>11</sup> apparent wind between 1815 and 1819.

Figure 14: VDR of the HÖEGH LONDON, excerpt from the recording of the wind force of the apparent wind [m/s] over the time (VDR system time) for the accident period

At 181139, the vessel picked up speed with a drift correction angle of about 13°. At the same moment, the harbour pilots noted that the wind speed was 46 kts (see also figure 14). At that point, the vessel was located at Metre 100<sup>42</sup>, or about 2 cbl away from the MSC MALIN with her bow.

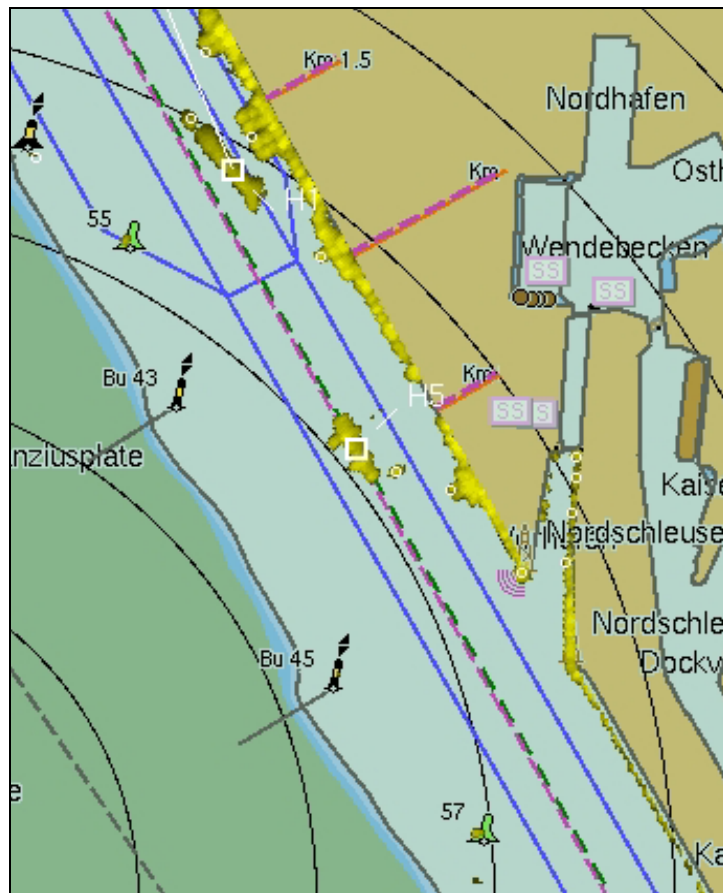
Figure 27: 1817, HÖEGH LONDON, HDG = 316.7°, COG = 333°, SOG = 7.8 kts

The rudder was set to 'starboard 60°' at 181314 (stern at Metre 300) at the moment that they were leeward of the MSC MALIN, which proved successful, the COG dropped to less than 331° and the HÖEGH LONDON was able to gain height to west (1815, see Figure 27, HÖEGH LONDON with her bow on the radar reference line; distance to the pier approx. 170 m).

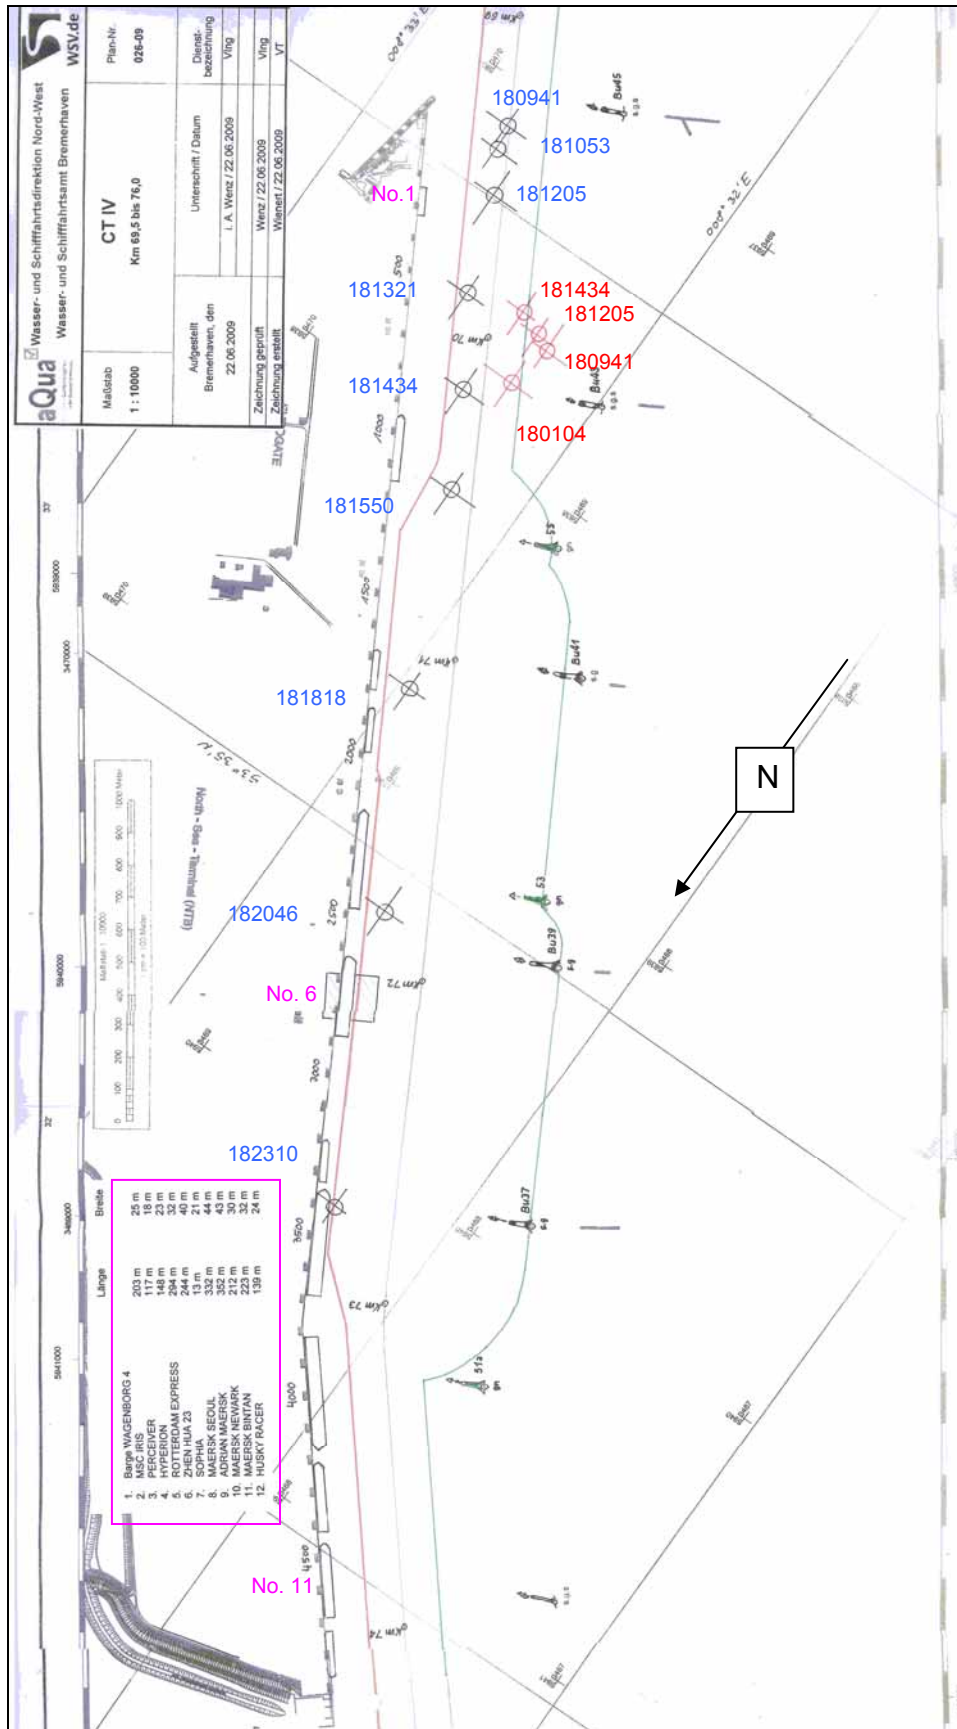
Figure 32: Radar plots for the HÖEGH LONDON and the MSC MALIN from VTS Bremerhaven, transferred to plan drawing of WSA Bremerhaven; with distribution of the vessels on the pier.

MSC MALIN was located outside the western edge of the channel when she was passed by the HÖEGH LONDON. Therefore, the HÖEGH LONDON had about 360 m of water area as room for manoeuvre without safety margins. However, downstream on the Weser this area became smaller because the MSC IRIS was located between Metre 950 and Metre 1,150 and more vessels were moored to the north of that (see Figure 32).

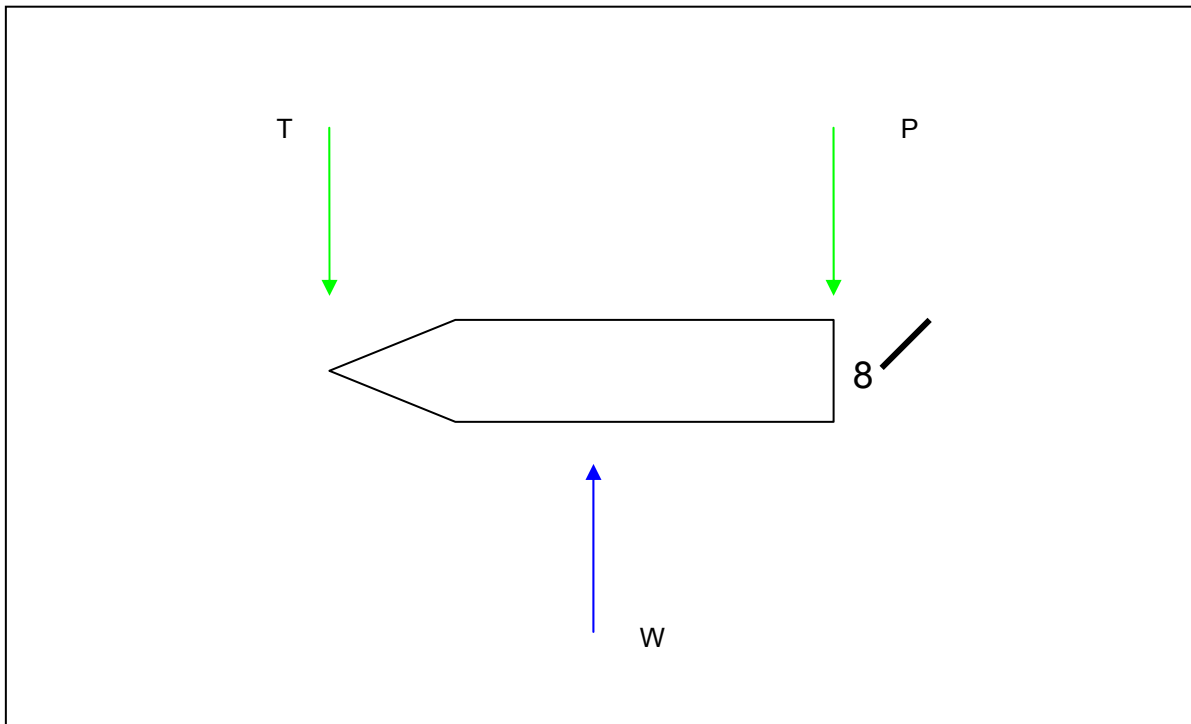
Figure 37: Forces on the vessel in schematic form; W – Wind, T – Tug, P – Propeller

Wind load	In relation to	Propeller + Tug power	Difference
8 Bft (19 m/s)	134 t	↔	79 t + 62 t = 141 t	+ 7 t
9 Bft (22 m/s)	180 t	↔	79 t + 62 t = 141 t	- 39 t
10 Bft (24.5 m/s)	223 t	↔	79 t + 62 t = 141 t	- 82 t
10 Bft (27 m/s)	271 t	↔	79 t + 62 t = 141 t	- 130 t

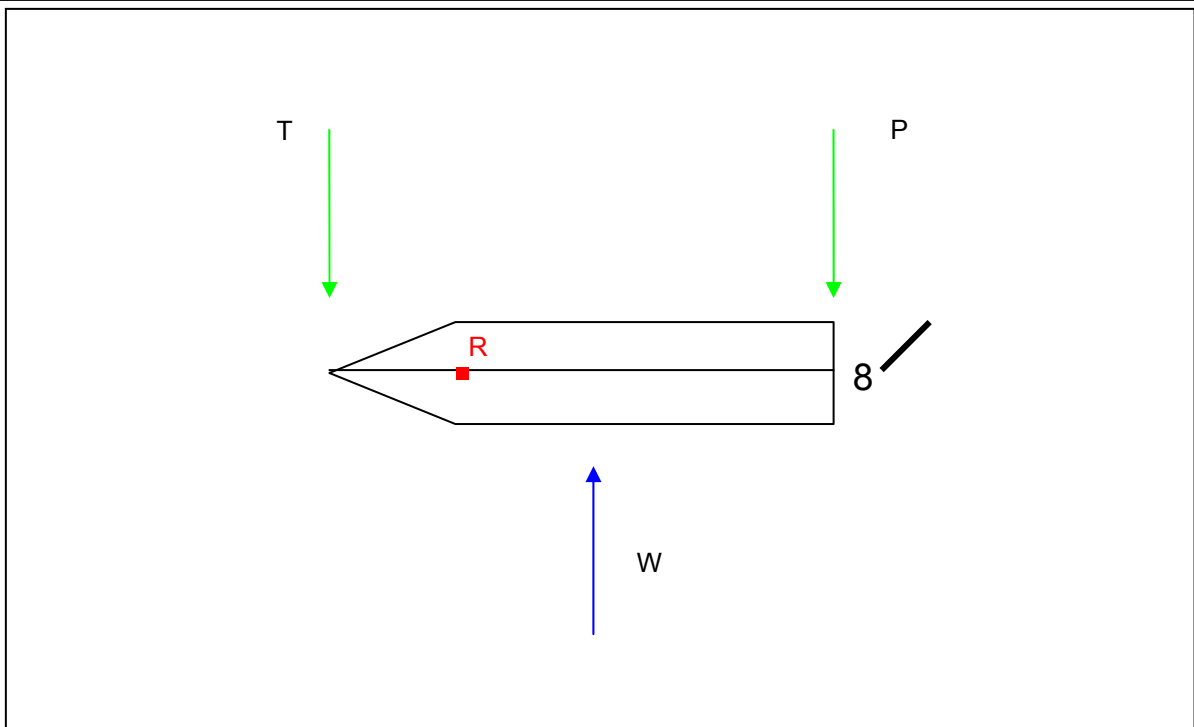
In order to examine a further approach, the torque of the forces applied was then looked at. At the same time, it was assumed that while moving ahead the point of rotation resp. pivot point is  $\frac{1}{4}$  of the total length (see Figure 38). The sometimes very long lever arms can produce large torques.

Figure 38: Torques on the vessel in schematic form; R – Point of rotation, W – Wind, T – Tug, P – Propeller

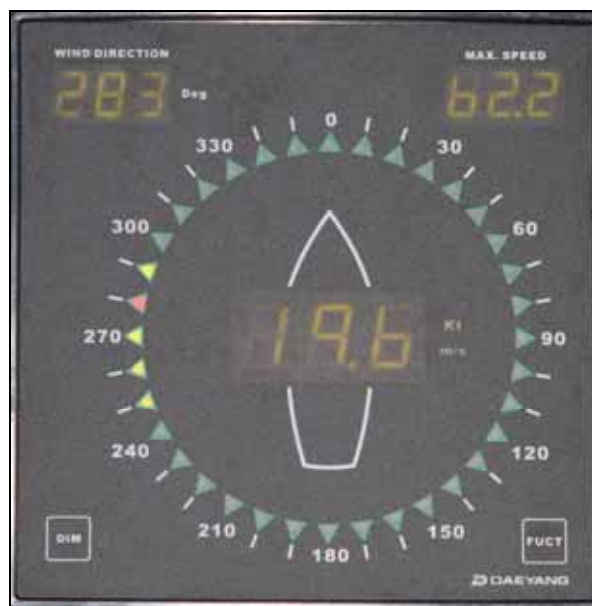
Figure 39: Display of the wind force and direction on the bridge of the HÖEGH LONDON at the time of the survey by the BSU; display of the wind force in knots (slightly backlit)
