Investigation Report 174/10

Serious Marine Casualty

Grounding of the
MV BELUGA REVOLUTION
off ENUS (Tench) Island
in the South Seas
on 30 April 2010

1 August 2011

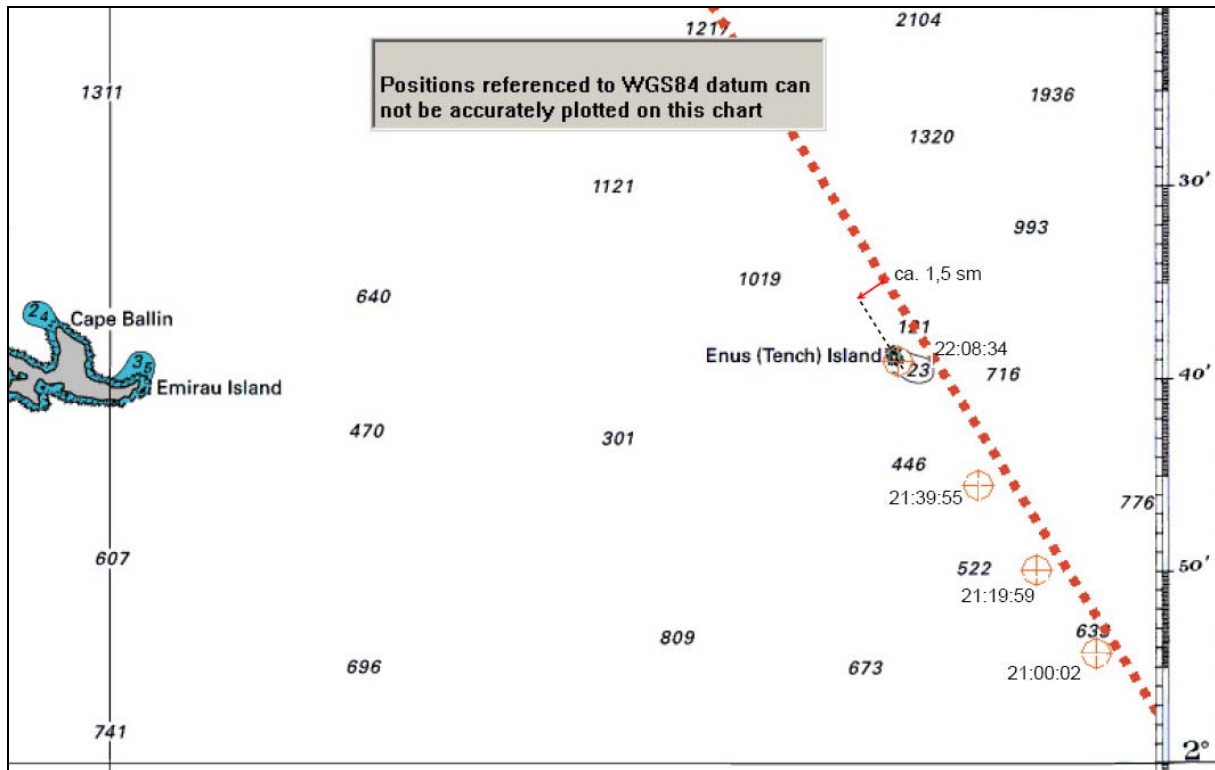
Figure 3: Nautical chart AUS 462 ARCS. Source: BSH

Sailing directions, charts, and the route from Noumea to Pohang, including waypoints, courses and distances, are recorded in the BELUGA REVOLUTION's voyage planning. Routing charts used and sailing directions about ocean tracks were not recorded. The valid routing chart in each case had always been below a transparent sheet covering the chart table. Consequently it was reportedly visible at all times. From waypoint 8 (02°33.8' S, 151° 16.8' E), a rhumb line of 327.4° and 2,301.8 nm was calculated for the track to waypoint 9 (29 ° 44.5 'N, 129 ° 48.1' E). At about 22 nm SE of Tench Island, the chart should have been changed to AUS 462, which was also performed by the ECS. When changing charts with ARCS data, the alarm 'NO OFFICIAL DATA' is triggered on the TRANSAS 2400 ECS. It is no longer possible to establish whether the vessel's position was switched back to after that. At 2100, Chart AUS 462 was already in use (see Fig. 2, vertical magenta line indicates the chart boundary).

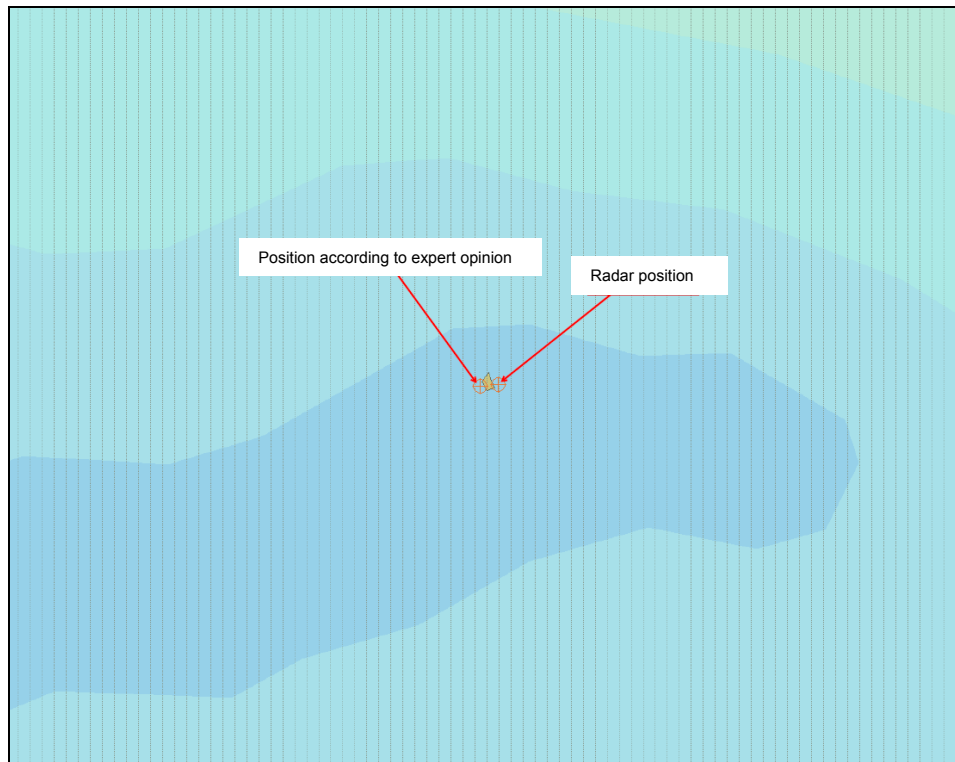
Figure 7: Source: BSH, Chart AUS 462 ARCS, ORCA System

While analysing the data, it became apparent that with regard to the geographical positions, there were inconsistencies between logbook entries, VDR recordings, charts and sailing directions. According to the expert opinion and logbook entry, the scene of the accident did not match the position of the radar recordings made by the VDR (Fig. 7). It is possible that this was on account of the navigation equipment on board or a recording error in the logbook. Therefore, the quality of the received GPS signals was verified. In the case of the GPS signals, there were no irregularities on the day of the accident. In the figure, the error is shown as 4-8 m with a probability of 95% (Fig. 8). Moreover, a comparison of recorded AIS data of the BELUGA REVOLUTION and UNITED TENORIO at 2046, when both vessels passed one another (Fig. 9), revealed no irregularities in terms of the positions.

From a technical perspective, the navigation equipment worked. With a probability of 95%, the GPS error stood at 4-8 m (Fig. 8) and, as demonstrated by a position comparison with another vessel, there was no interference (Fig. 9). It is unclear what led to the position data (see Fig. 7) of the logbook and VDR recordings being inconsistent after the grounding. This was probably due to transcription errors or different sources (GPS receiver). The objective in the SMS of maintaining a track deviation of 0.1 nm can be critical for fully automated track control near the coastline. However, in the case of a conventional heading control with autopilot such as this, it tends to be disturbing because limits can be reached too often and lead to alarms. The X-Band radar system was set according to the manufacturer's recommendations and provided an image with showers and other targets, which was to be expected. It is possible that due to the 10 cm wavelength, the radar image of the S-Band system would not have been affected by the false echoes from rain showers. However, it remains questionable whether the relatively flat island would have been shown as clearly as on the X-Band system with 3 cm wavelength.

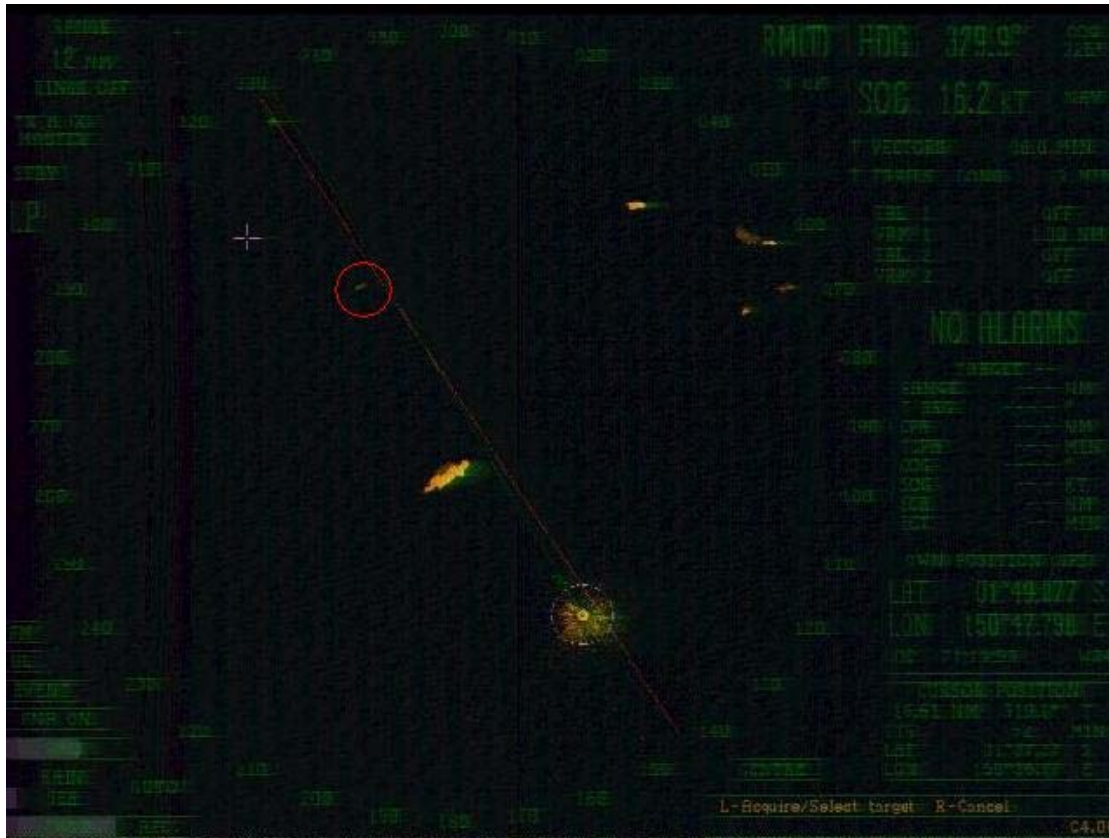
Figure 10: Radar time 211959, HDG 329.9°, COG 326°, SOG 16.2 kts

The VDR recorded the X-Band radar images at 15 s intervals. The settings correspond to the manufacturer's recommendations, i.e. automatic tuning, long pulse length and expanded target display for areas larger than 3 nm as well as automatic anti-clutter for rain and sea. In addition, the system was set to relative motion north up with true vectors (6 min) and true long trails (6 min), the range at 12 nm off-centre and the variable range rings at 1 nm. The red line is the displayed course line between waypoints 8 and 9. The target highlighted with a red circle by the author in Fig. 10 is Tench Island. All other targets are rain showers or, within the variable range ring, sea clutter. At 2204, the echo of Tench Island enters the 1 nm area of the range ring.
