**Bundesstelle für Seeunfalluntersuchung**  
**Federal Bureau of Maritime Casualty Investigation**  
Federal Higher Authority subordinated to the Ministry of Transport,  
Building and Urban Development

Investigation Report 215/10

**Less Serious Marine Casualty**

**Accident involving the shipboard crane on  
board the  
wind turbine installation vessel  
WIND LIFT 1  
on 23 May 2010 at the  
'BARD Offshore 1' wind farm  
about 50 nm north-west of Borkum**

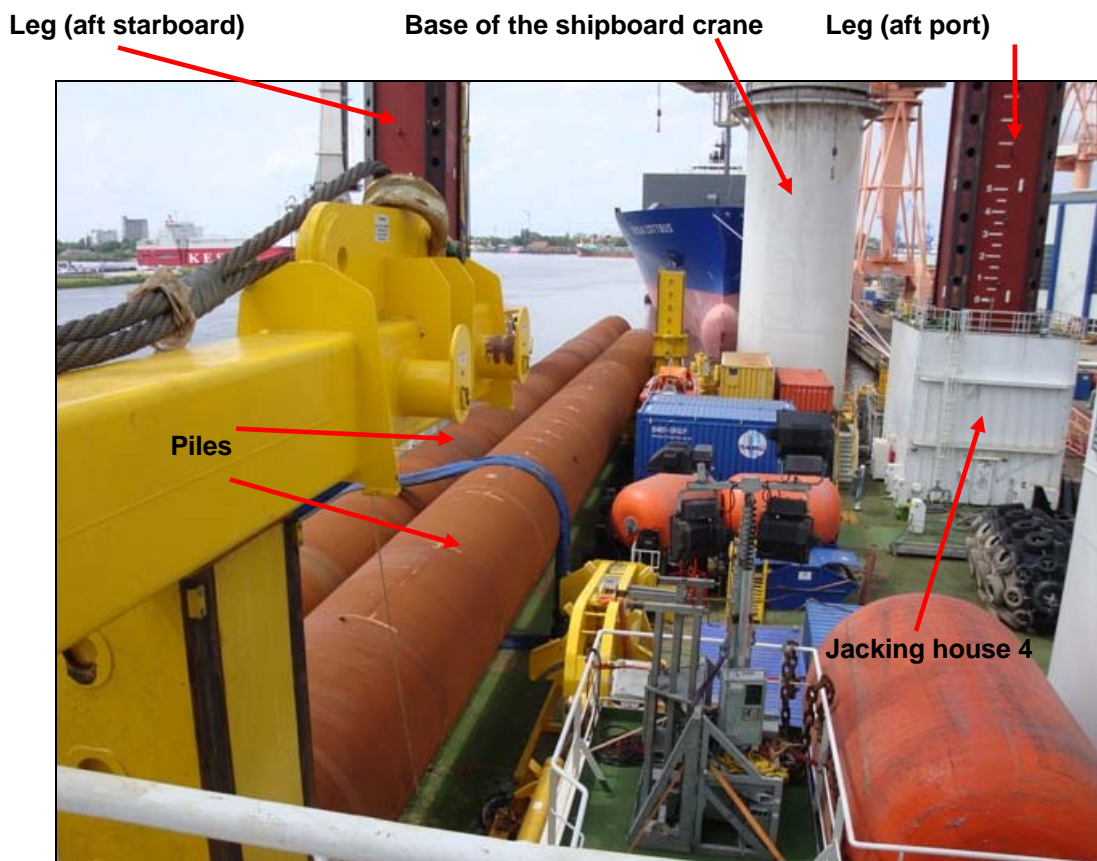
Figure 3: Main deck of the WIND LIFT 1 (1)<sup>5</sup>

<sup>5</sup> Shot from the aft edge of the bridge deck alongside to aft.

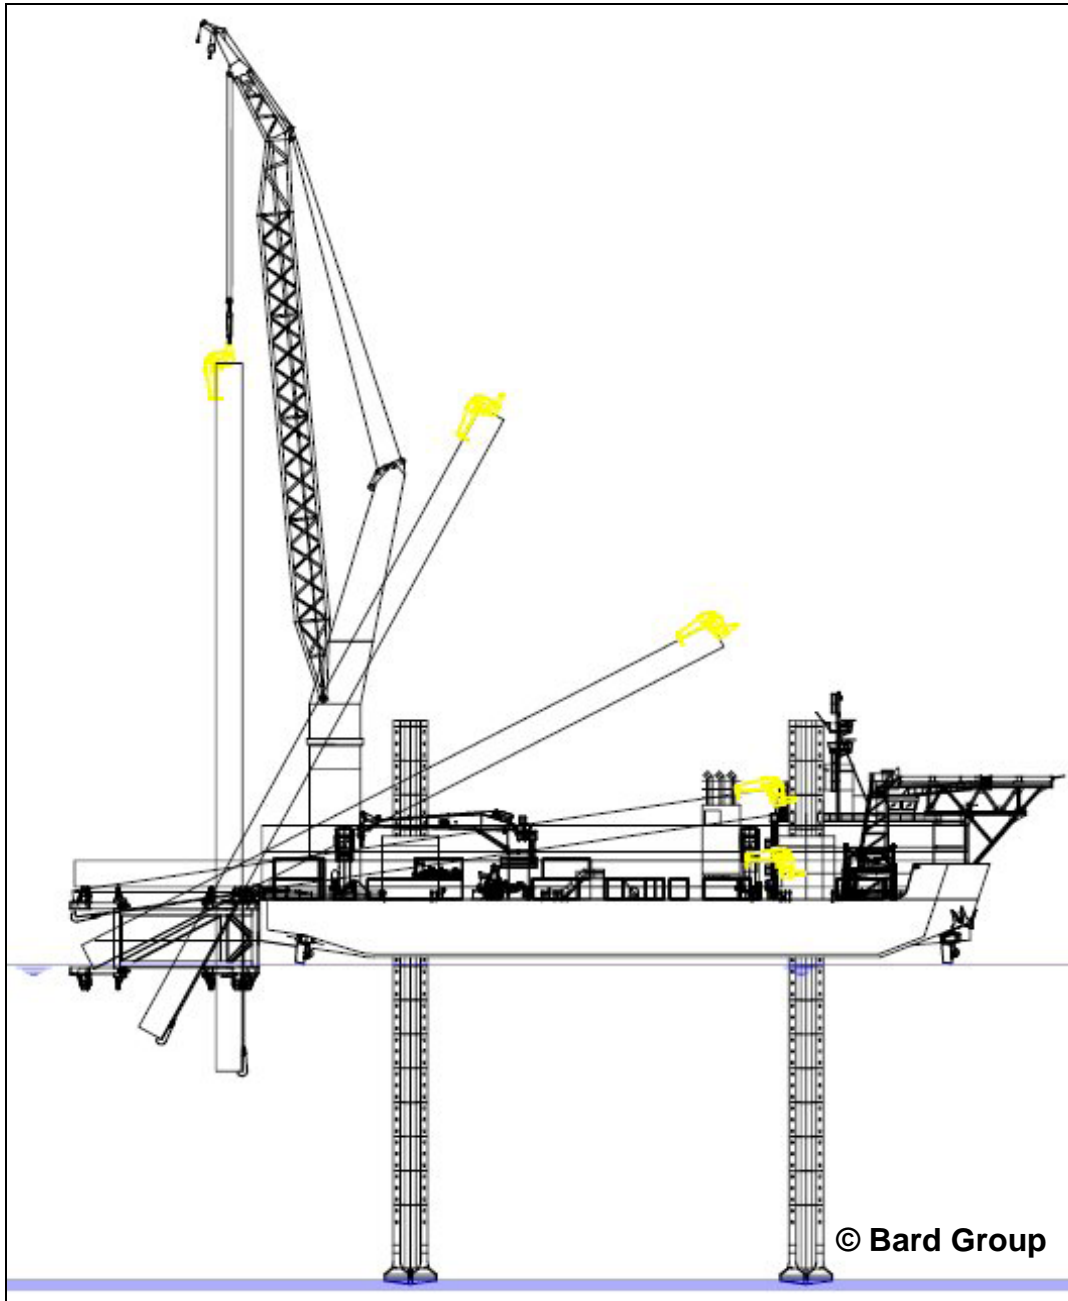
Figure 11: Diagram of a pile being set<sup>28</sup>

The pile is abruptly slid fully into the holding device after reaching an elevation angle of about 35 degrees<sup>27</sup>. The pile is lowered into the water via a so-called upending saddle and gradually put into a vertical position in the course of the lifting process. After the pile is completely upright, it is precisely aligned by means of a so-called template that surrounds it and then driven into the seabed with the vessel's pile driver (see **Fig. 11 et seq. below**).

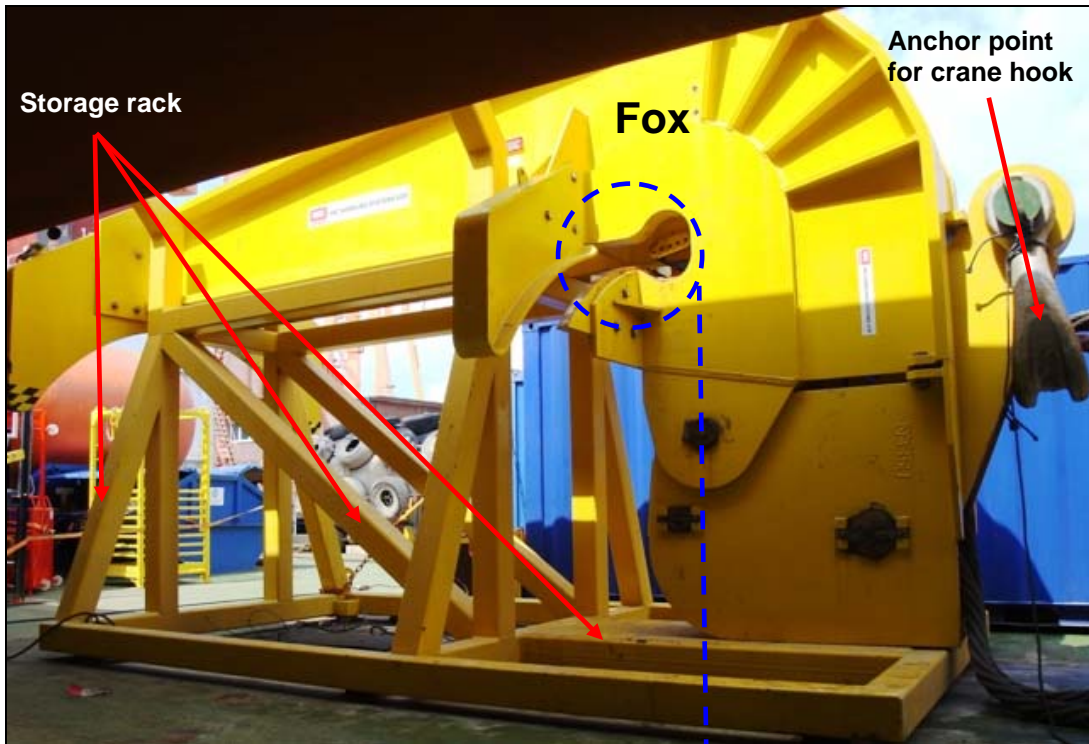
Figure 15: Fox

The gripping device (hereinafter referred to as fox) produced by Dutch manufacturer IHC Merwede is a so-called active lifting device<sup>29</sup>; its main element is two clamping jaws which are pressed together hydraulically (see **Fig. 15 et seq.**). A firm connection between the pile and crane is implemented by the pincer-like fox gripping into the top of the pile with a hydraulic pressure of at least 250 bar.

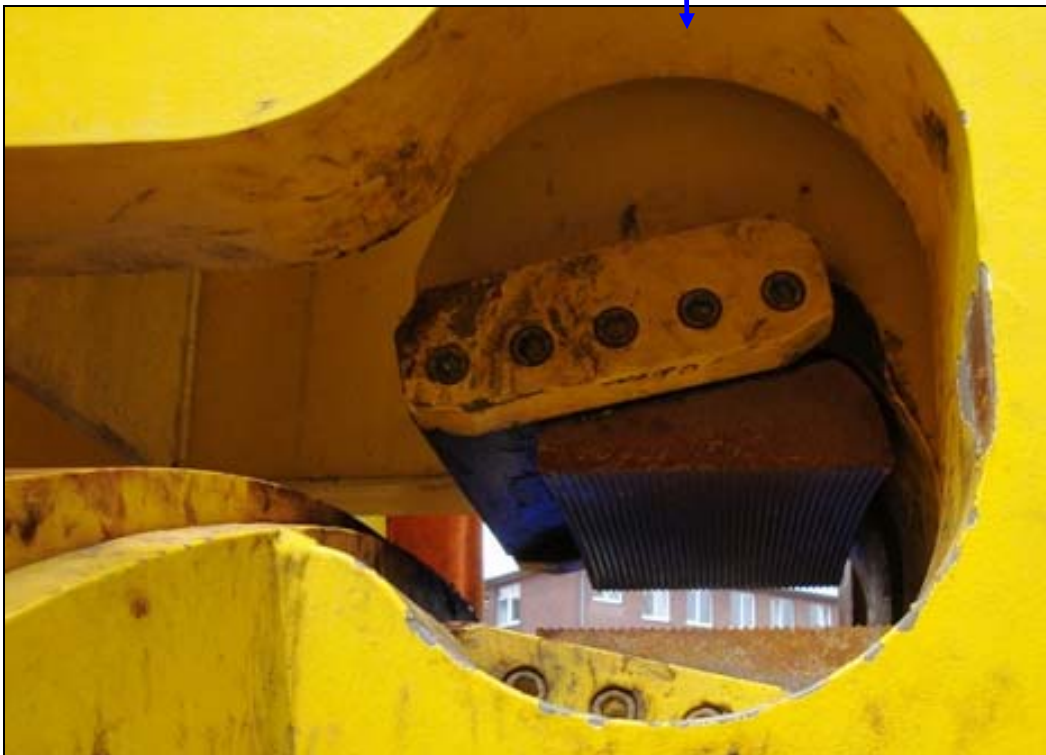
Figure 16: Clamping jaws (close up)<sup>30</sup>

<sup>30</sup> Note: When the proper pressure is applied, the contoured surface of the clamping jaws causes ridges on the contact area of the surface of the pile.

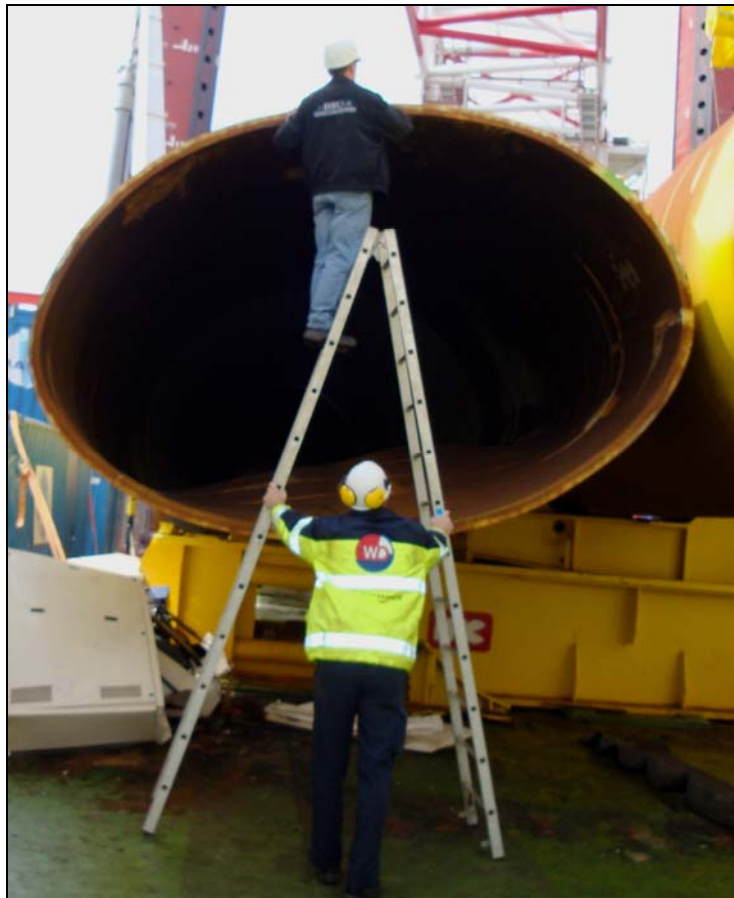
Figure 18: Inspection of the pressure marks<sup>34</sup>

Several witnesses stated that the function test would have also involved a visual inspection, which is not included in the aforementioned checklist, after the fox was fixed to the pile. This would reportedly involve the clamping jaws being re-opened after the initial build-up of pressure and, using a ladder, the surface of the pile being checked for pronounced indentations (ridges). Reconstruction of such an inspection (see **Fig. 18**) proved to be very difficult and hardly practicable due to the size of the ladder available on board. Therefore, it remained unclear whether such an additional visual inspection was actually part of the regular operating procedure.
