Summary
Investigation Report 304/10

Very Serious Marine Casualty

Collision about 25 nm east of Tianjin
between the CMV JULIA S
and the MV ZENITH WINNER on 24 July 2010

15 October 2011

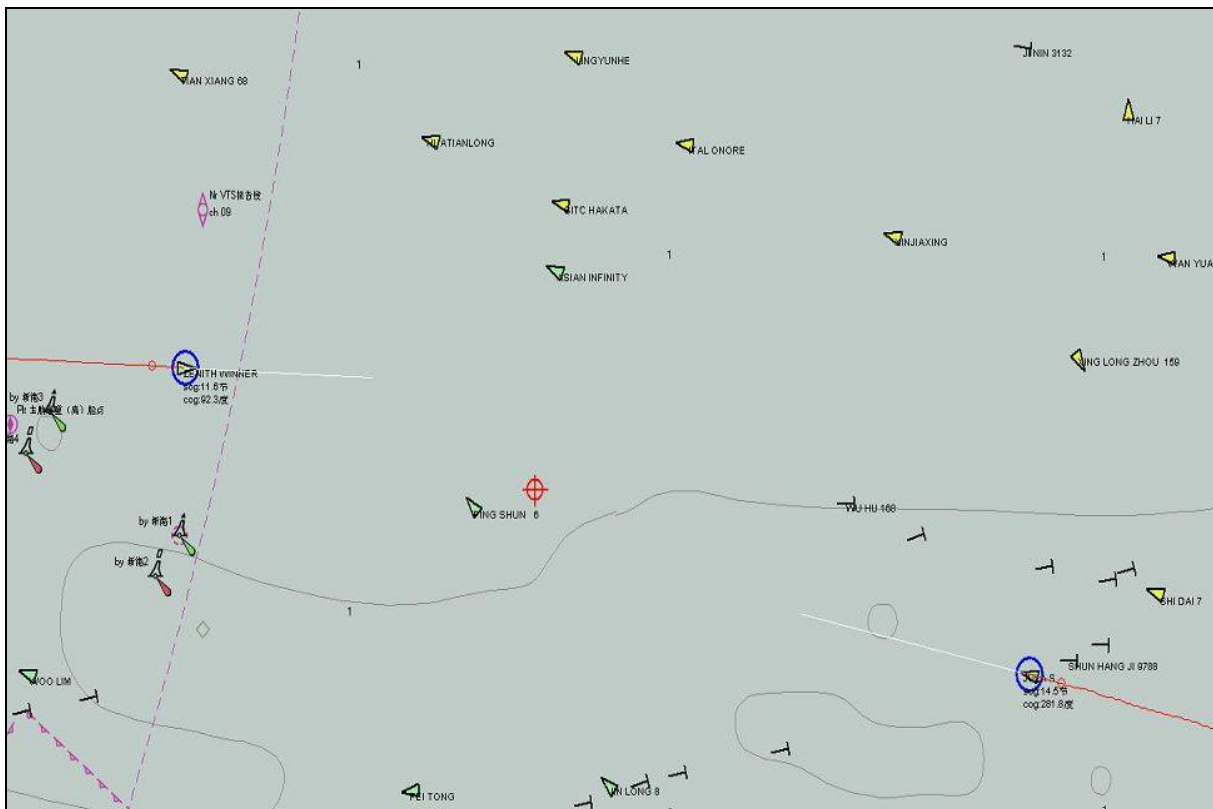
Figure 4: Traffic situation at 0541 (screenshot of the AIS recording of VTS Tianjin)¹¹

In the 30 minutes leading up to the collision, the JULA S, a 2,474 TEU⁹ full container vessel in regular service between the Persian Gulf and China, approached the roads of Tianjin on autopilot. Her course over ground was initially about 282 degrees (see **Fig. 4**) and finished at about 289 degrees (see **Fig. 5**). Her speed stood at a constant 14.7 kts.¹⁰ The sea in the congested area was calm and fog prevailed. Visibility was less than 0.5 nm at times. The vessel was navigated by the master, who was assisted by the chief officer (OOW). Aside from the master and OOW, a rating was also on watch on the bridge.

The ZENITH WINNER left the buoyed fairway of the approach to Tianjin at about **0535** on the day of the accident on its northern side and steered a course over ground of initially about 092 degrees (see **Fig. 4**) followed by about 098 degrees (see **Fig. 5**) up until some 4 minutes before the collision. The speed of the ZENITH WINNER, which was navigated by the chief officer, stood at a constant 11.6 kts.

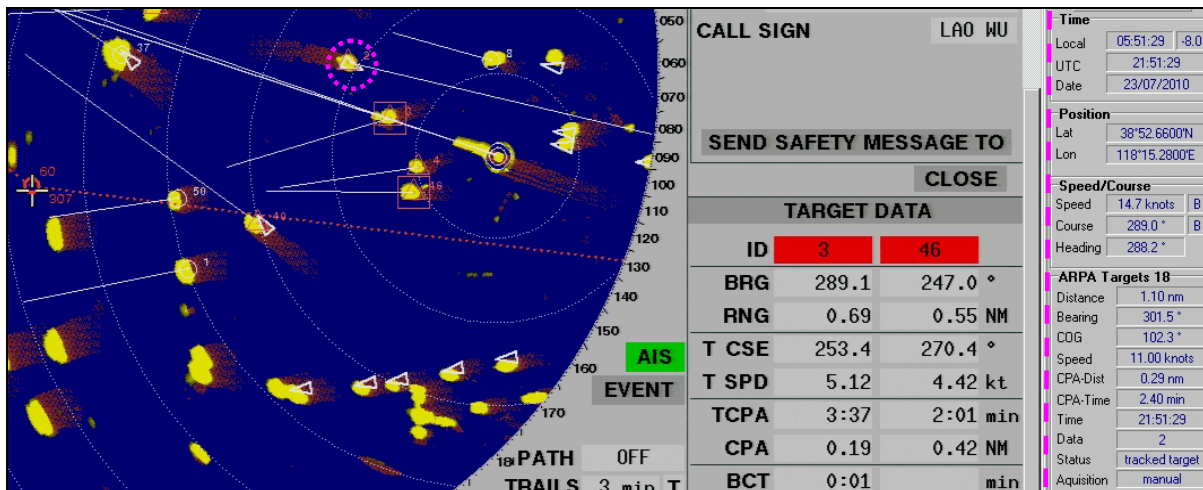
Figure 11: Screenshot of the radar image at 055129 plus VDR replay information window

The fact that the ZENITH WINNER is – as an acquired ARPA target – only shown sporadically with the corresponding symbols in the following screenshots (display of the vector ahead, red triangle to mark the echo identified by the system as being a dangerous target) should not give rise to confusion. The reason for this is that the manufacturer has configured the radar to display flashing symbols for dangerous targets. Accordingly, there is a 50 per cent chance that the vector ahead will be hidden in the respective screenshot when the VDR captures the radar images. Consideration of the following screenshots and the numeric ARPA data for the ZENITH WINNER permits a number of conclusions.

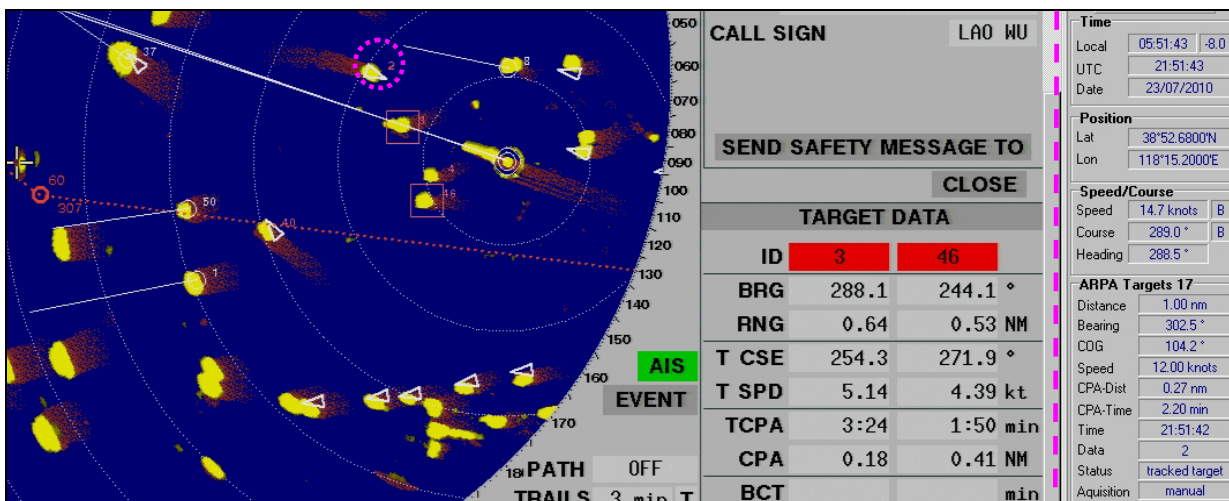
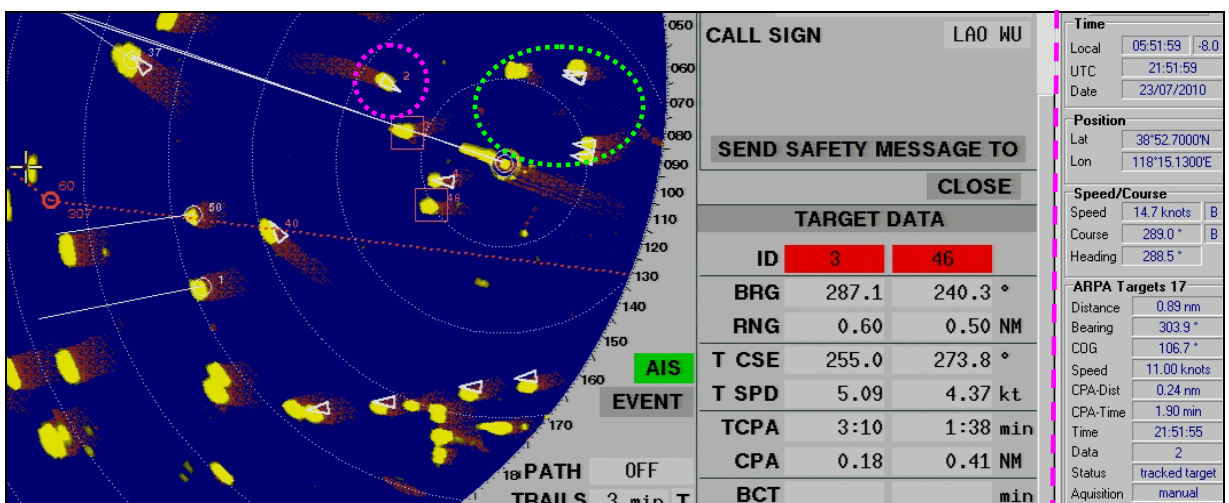
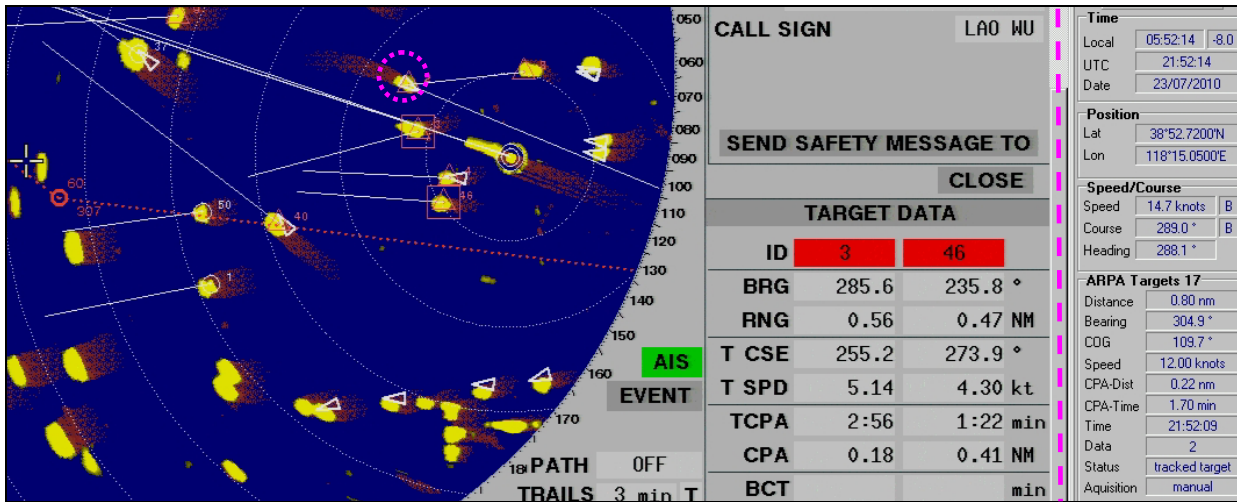
Figure 12: Screenshot of the radar image at 055143 plus VDR replay information window

3. With respect to the echo of the ZENITH WINNER (target number 2), there was initially no heightened need for the JULA S to take action as a 'green - green' passage with a reasonable, albeit fluctuating CPA could be expected (see **Figs. 12 to 14** below).

6. At best, the ZENITH WINNER's continuous turn towards the JULA S can be explained by the fact that the ZENITH WINNER intended to make room for four vessels (three with AIS signal; see green marking added by the author in **Fig. 13**) approaching her from the port side and possibly either

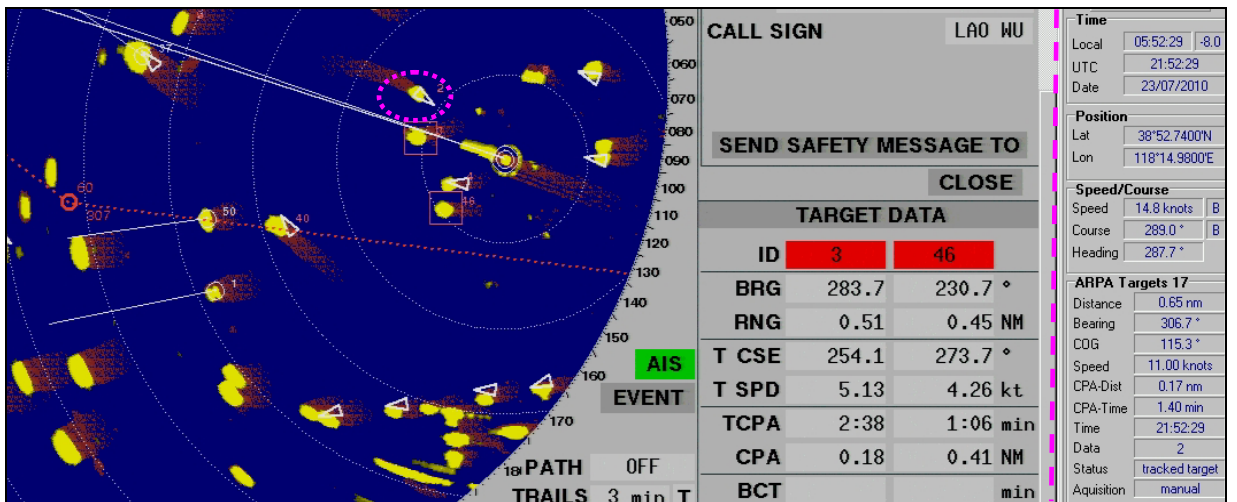
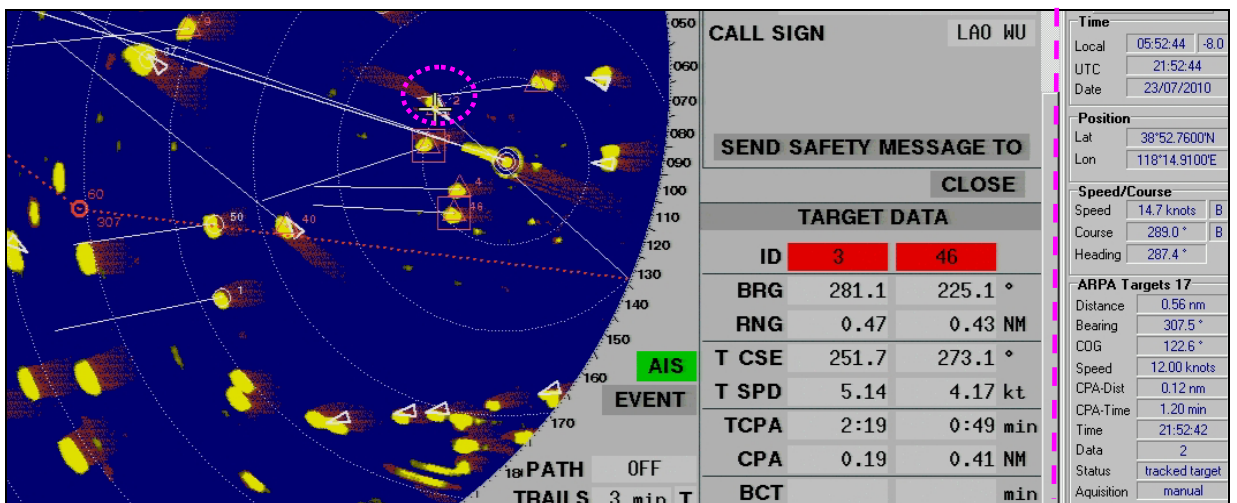
Figure 15: Screenshot of the radar image at 055229 plus VDR replay information window

4. From about **055230** onwards (see **Fig. 15 f.** below), the immediate risk of collision became apparent on the radar image due to the occurrence of the ZENITH WINNER's echo in the close quarters (approx. 0.5 nm), which was continuously converging with the JULA S on her lubber line.

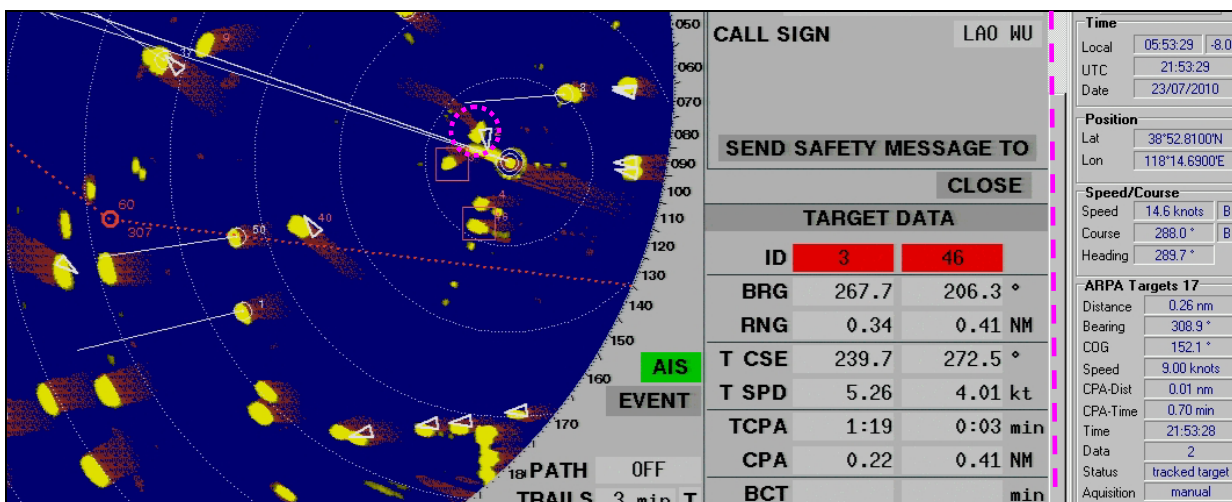
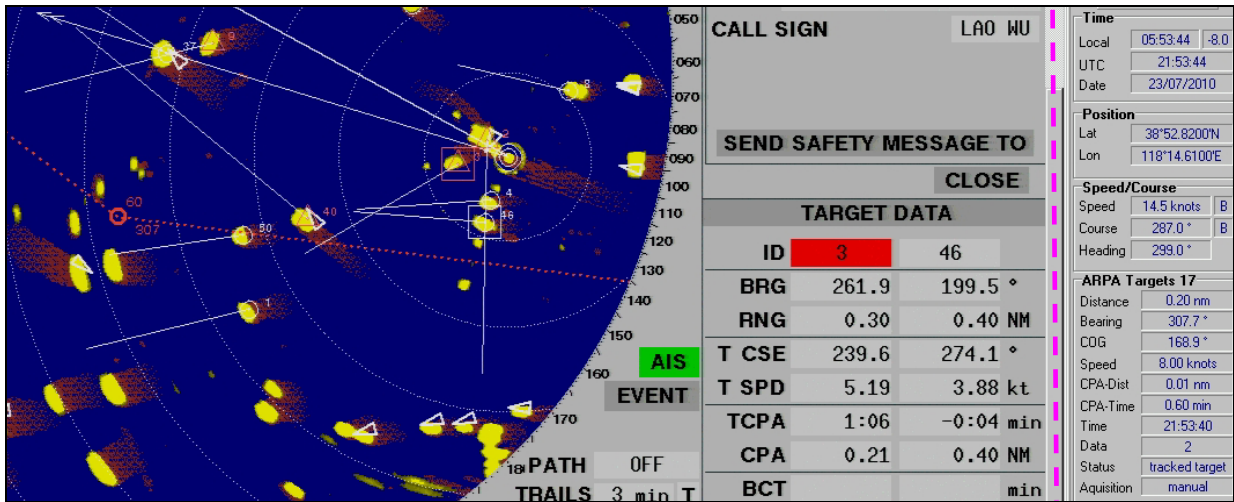
Figure 19: Screenshot of the radar image at 055329 plus VDR replay information window

5. In the period between **055329** and **055344** (see **Fig. 19 f.** below), the ship's command of the JULA S initiated a hard to starboard manoeuvre.

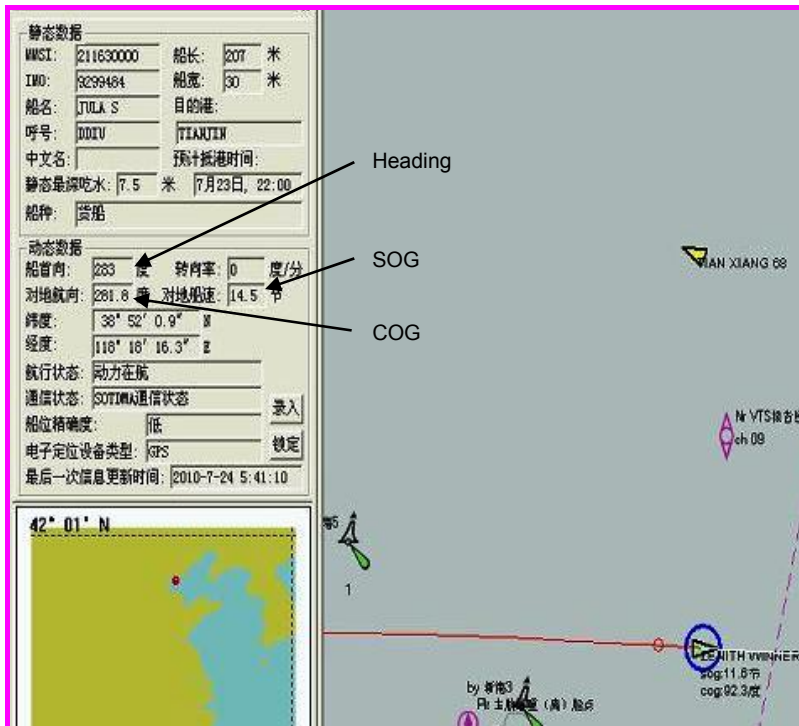
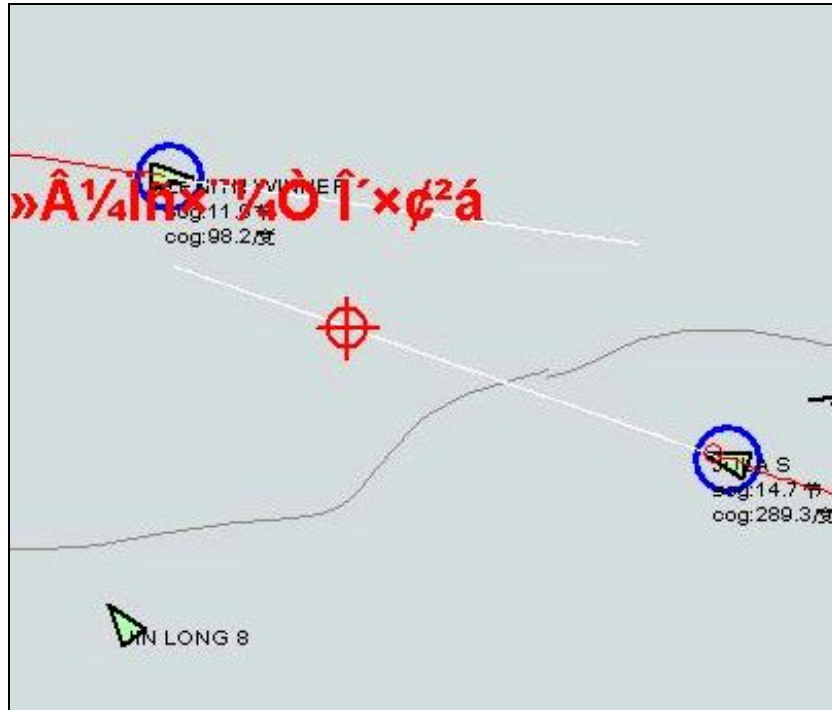
Figure 24: AIS recording at 055010

The AIS recording provided shows the tracks of the JULIA S and ZENITH WINNER. The course and speed over ground (COG and SOG) are shown below the symbol of each vessel.

The data window in the upper left corner of the screenshot contains additional information about the JULIA S (the BSU is not in possession of an alternative representation of the window with information about the ZENITH WINNER).

Figures 24 and 25 show that up until about 3.5 minutes before the accident, it was not possible to predict that the courses would cross.
