Summary
Investigation Report 551/10

Serious Marine Casualty

Collision west of Skagen
between the MV FRISIA ROTTERDAM
and the MV CLEANTEC
on 13 December 2010 at 0518

15 November 2011

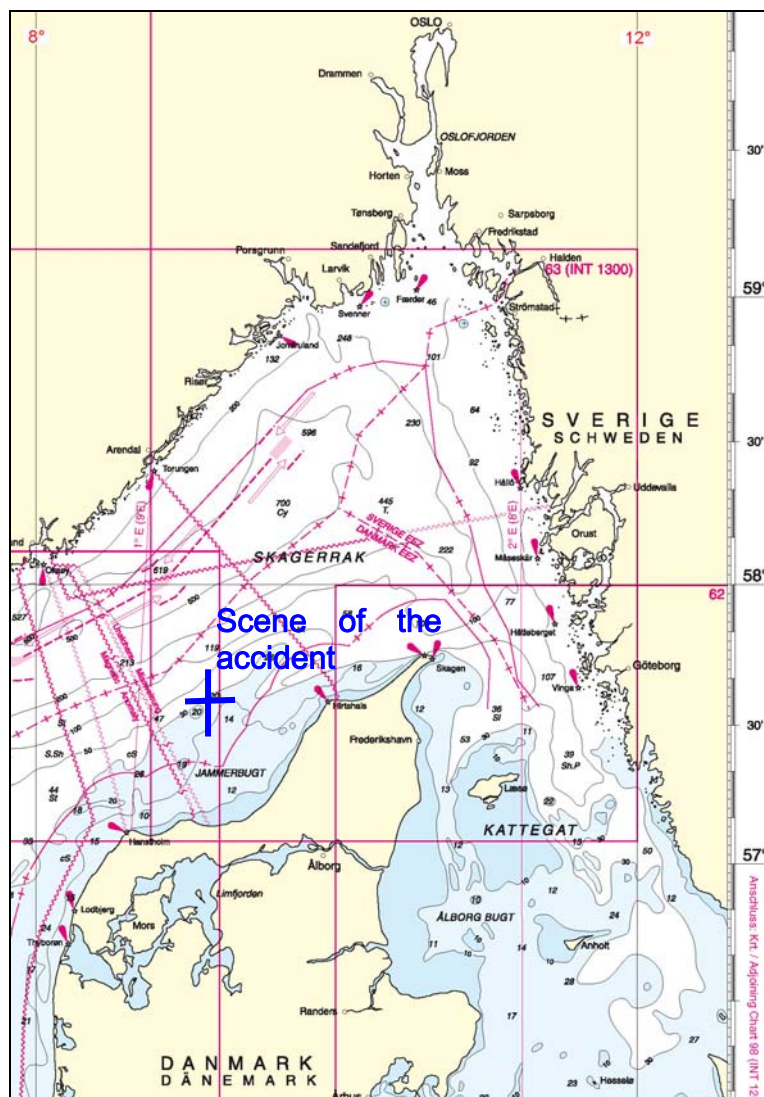
Figure 3: Scene of the accident

Type of marine casualty/incident:	Serious marine casualty, collision
Date, time:	13/12/2010, 0518
Location:	West of Skagen
Latitude/Longitude:	ϕ 57°38'N λ 009°17'E
Ship operation and voyage segment:	Open sea
Place on board:	Forecastle
Human factors:	Yes, human error Yes, violation
Consequences (for people, vessel, cargo, environment and other):	No injuries or damage to the environment, extensive damage to both vessels
