Bundesstelle für Seeunfalluntersuchung
Federal Bureau of Maritime Casualty Investigation
Federal Higher Authority subordinated to the Ministry of Transport,
Building and Urban Development

Investigation Report 286/10

**Collision between the CMV NAVI BALTIC and the
sailing vessel J.R. TOLKIEN on the
Kiel Canal at
Kilometre 90.5 on 12 July 2010**

1 March 2011

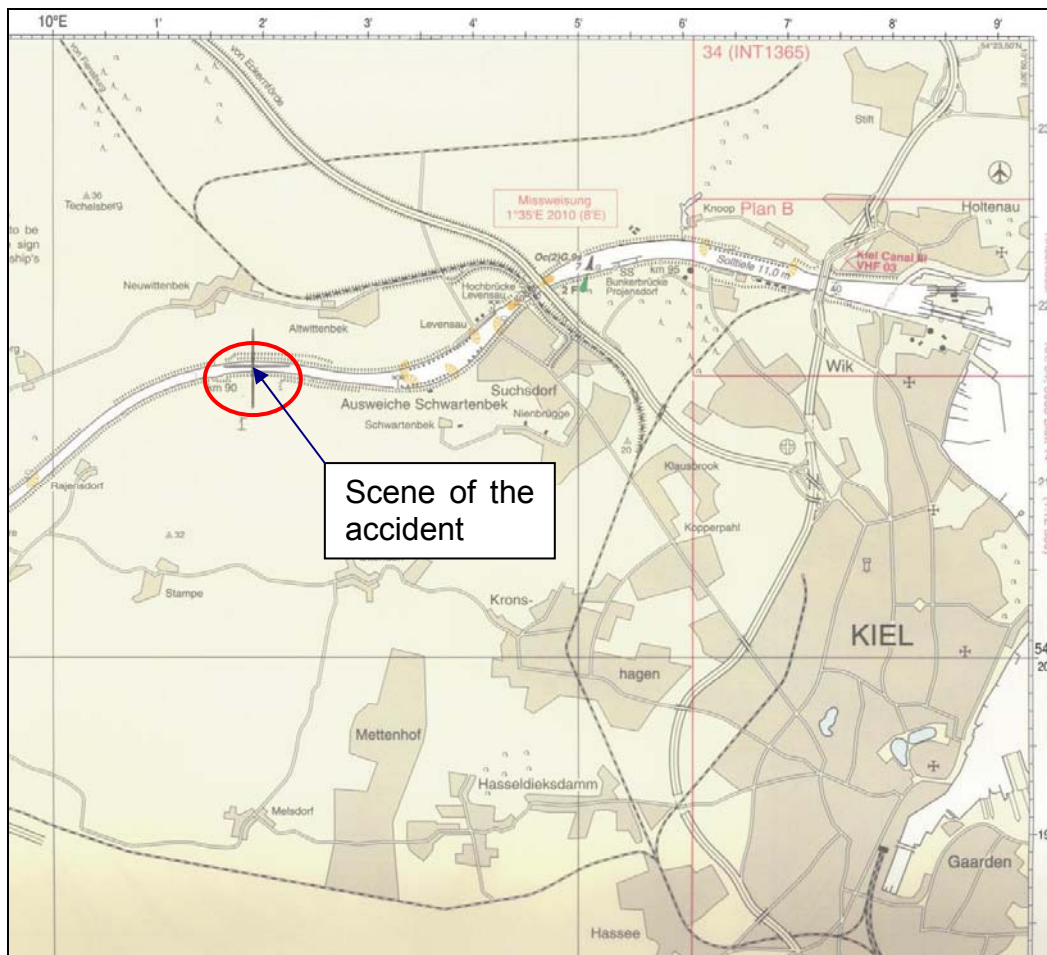
Figure 3: Kiel Canal Chart

Type of marine casualty:	Serious marine casualty, collision
Date/time:	12 July 2010/1608
Location:	Kiel Canal, Kilometre 90.5
Latitude/Longitude:	ϕ 54°21.6'N λ 010°01.8'E
Ship operation and voyage segment:	Harbour mode
Place on board:	Damage to the forecastle and port side of the J.R. TOLKIEN
Human factors:	Yes, human error

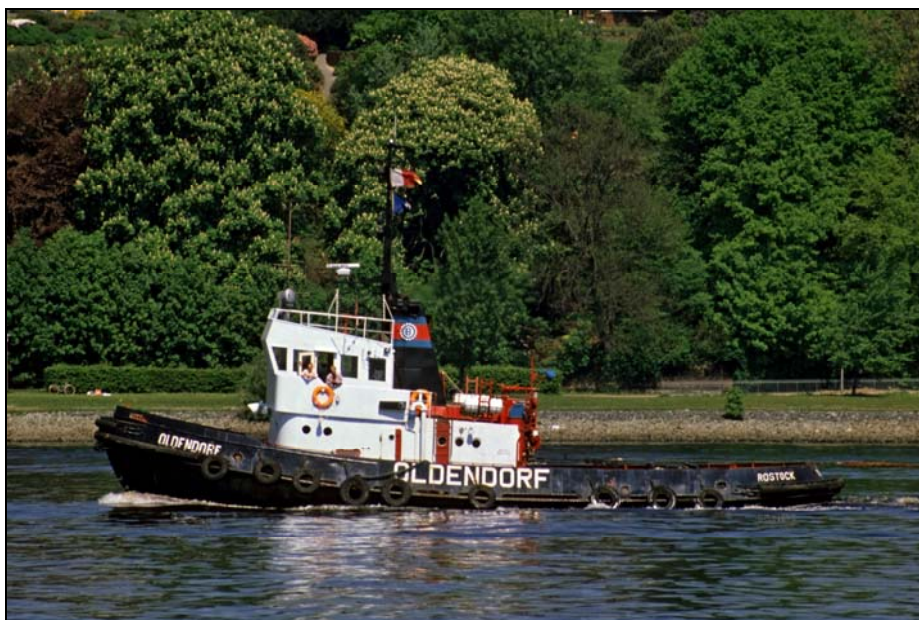
Figure 8: Sister vessel, the tug OLDENDORF

The photo of the sister vessel from a series of five, the tug OLDENDORF, shows the stage of construction prior to the conversion of the DIERKOW to the sailing vessel J.R. TOLKIEN.

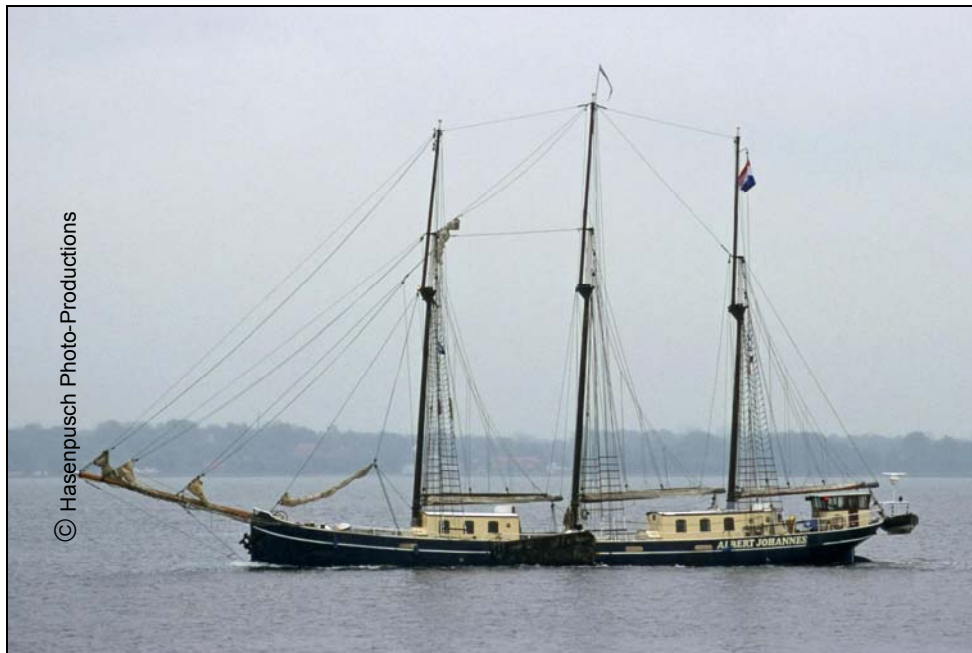
Figure 10: Photo of the ALBERT JOHANNES

No injuries, no pollutants escaped, damage to the rudder blade of the ALBERT JOHANNES and probably paint abrasions/dents in the bottom area

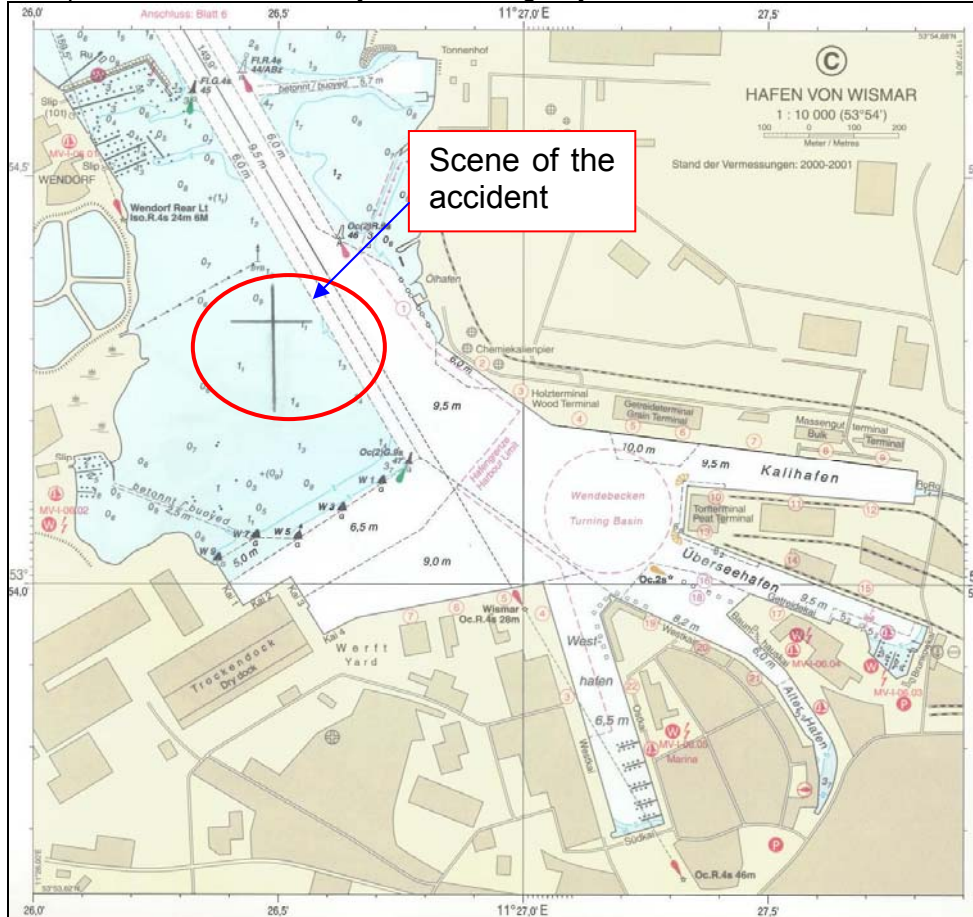
Figure 11: Chart of the port of Wismar

The accident involving the ALBERT JOHANNES was caused by a navigational miscalculation of wind conditions and the actual water depths outside the fairway in the port of Wismar. Added to that is the fact that with only two people with the requisite knowledge, the vessel was undermanned.

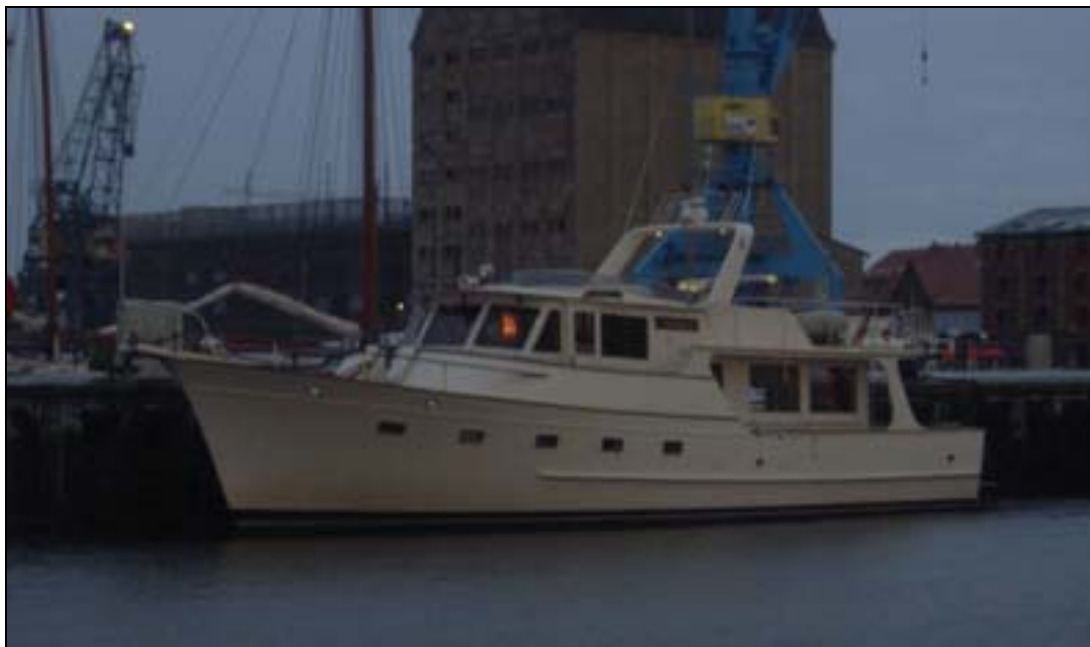
No injuries, no pollutants escaped, damage to the MY SPUTNIK 2 and paint abrasions on the SKYLGE.

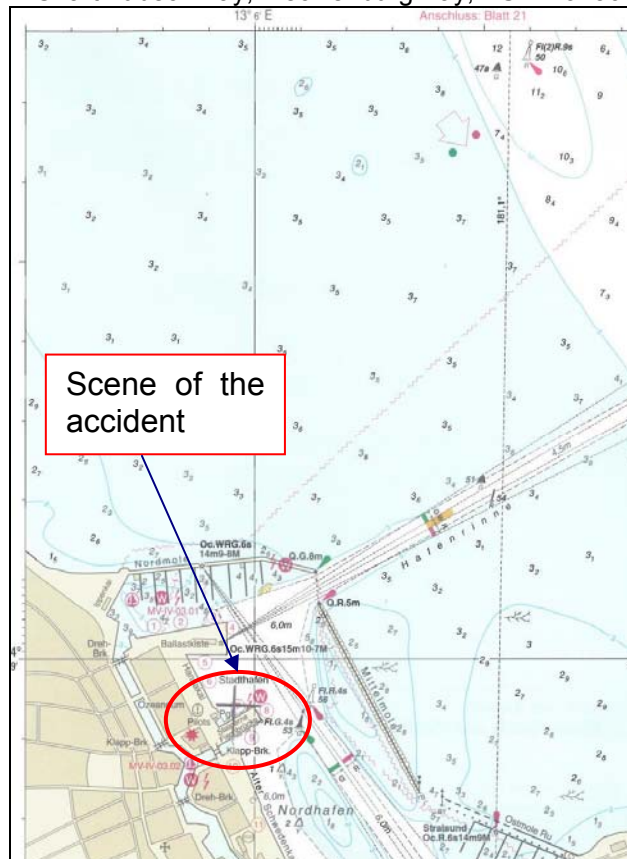
Figure 13: Chart of port of Stralsund

Type of marine casualty:	Marine casualty, collision
Date/time:	22 August 2010/1910
Location:	Stralsund Fischbrücke LP 7
Latitude/Longitude:	ϕ 54°18.9'N λ 013°05.9'E
Ship operation and voyage segment:	Casting off
Place on board:	Damage to shell plating
Human factors:	Yes, human error
