Investigation Report 523/10

Serious Marine Casualty

Collision in the Kiel-Holtenau siding

on 28 November 2010

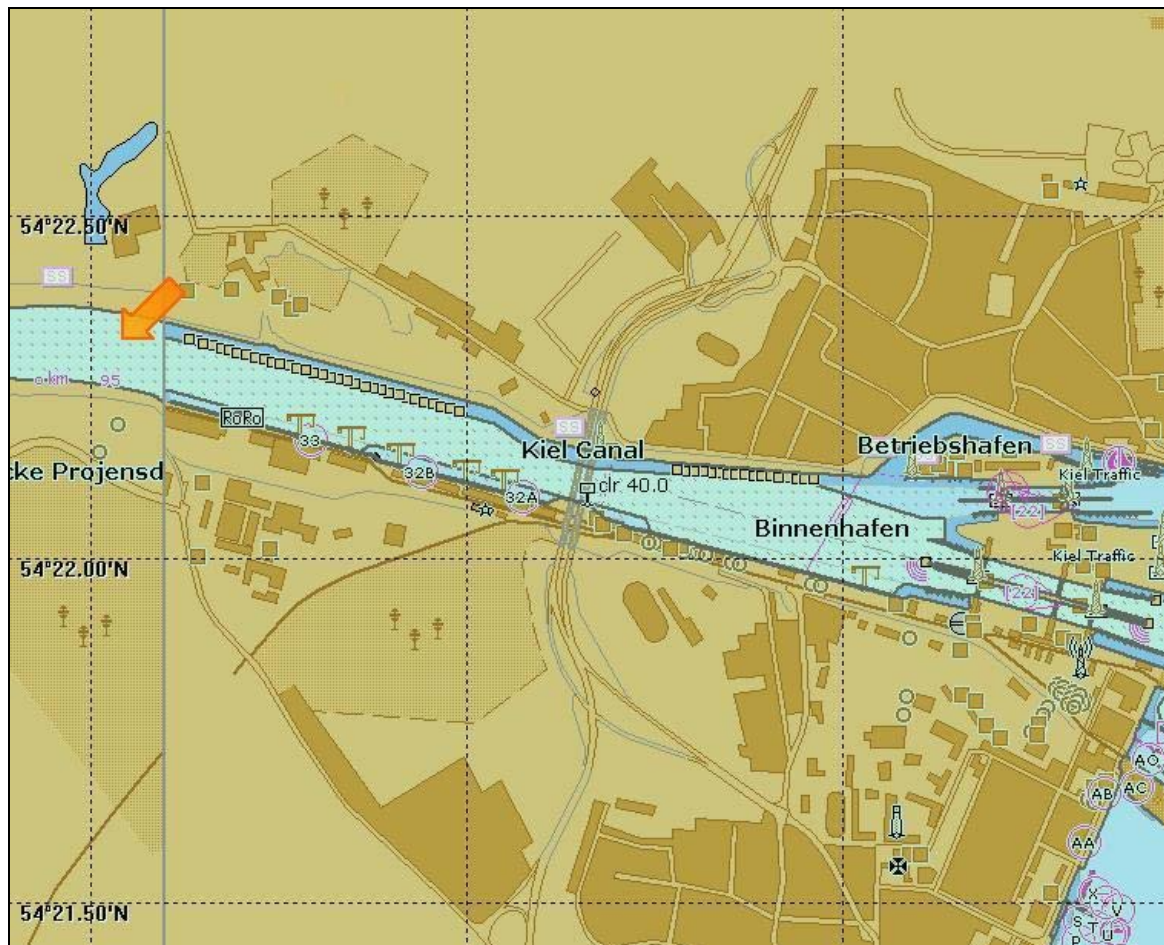
Figure 3: Scene of the accident, excerpt from ENC DE516200, DE421045, BSH

In Fig. 3, the collision is shown to scale. The vectors ahead of 1 min relate to the headings. The coloured lines in the fairway show the tracks of the vessels involved in the accident (Fig. 4). The black vector by the NATIONAL GLORY shows her drift to starboard and the line at her stern symbolises her rudder's angle to port. The lateral distance of 96.72 m relates to the 4 m contour line. The scene of the accident is situated north of the middle of the canal between the row of dolphins and the siding's exit signal mast.

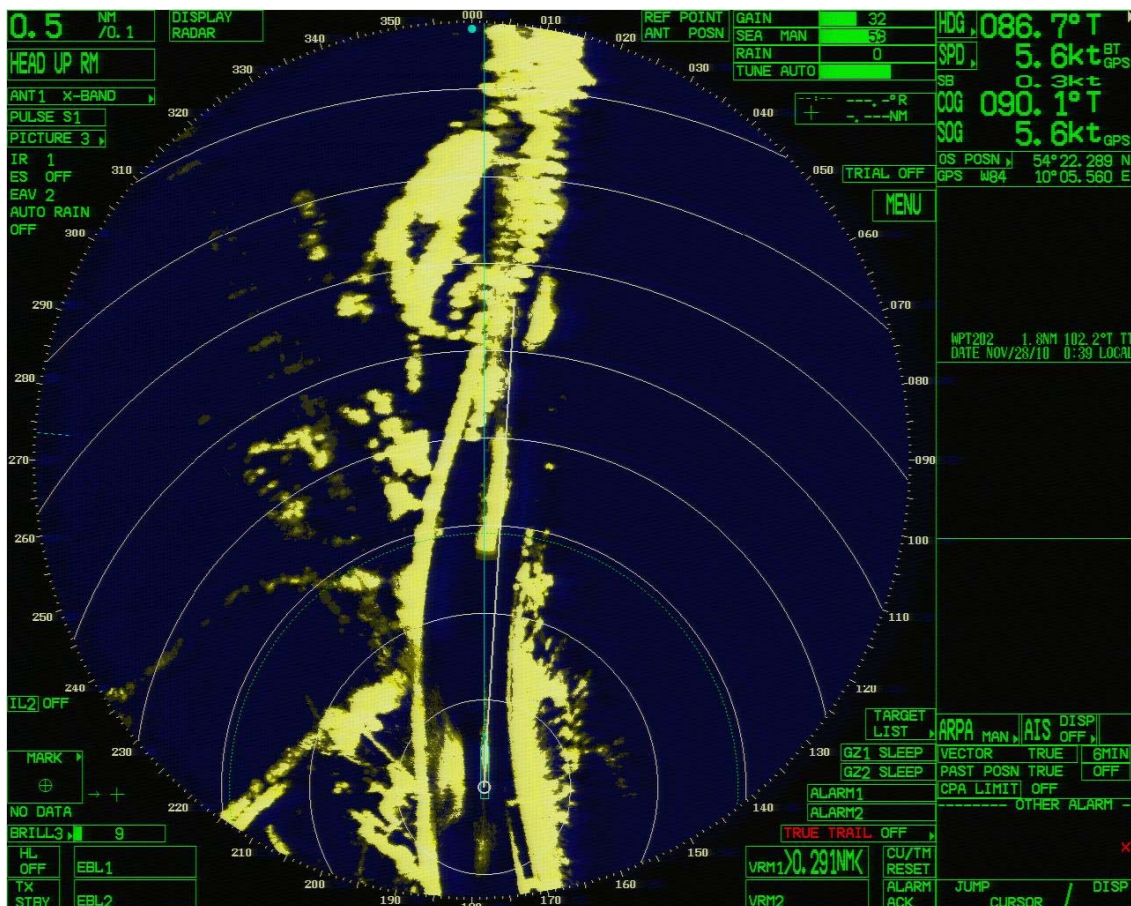
Figure 6: NATIONAL GLORY, 004000 system time

The radar image (s. fig. 6) at 004000 shows the passage of the NATIONAL GLORY at the bunkering bridge at Projensdorf and the SANDY RICKMERS. The X-band radar system is set to off-centre in relative head-up display mode at a range of 0.5 nm. One range ring represents 0.1 nm.

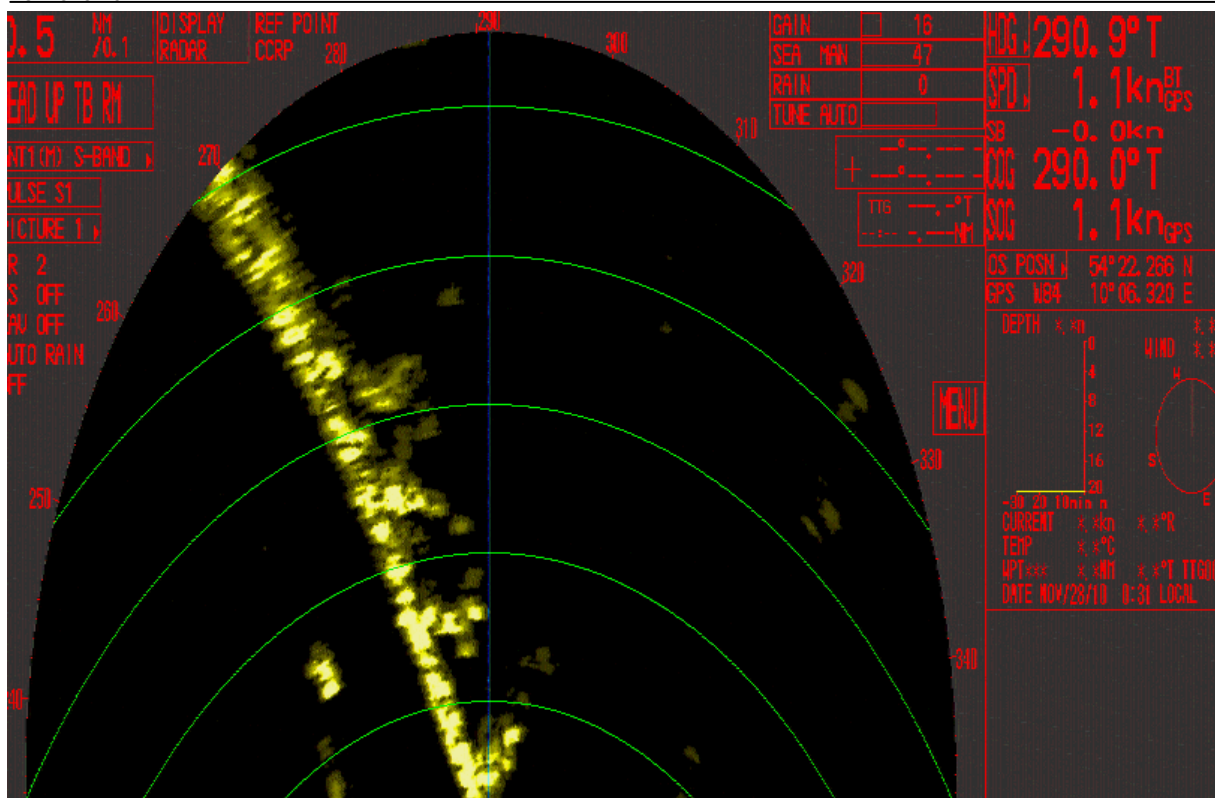
Figure 15: SANDY RICKMERS at 0031, end of the siding

⁴ The distortion and missing areas on the radar image are caused by the faulty installation of the VDR on the SANDY RICKMERS.

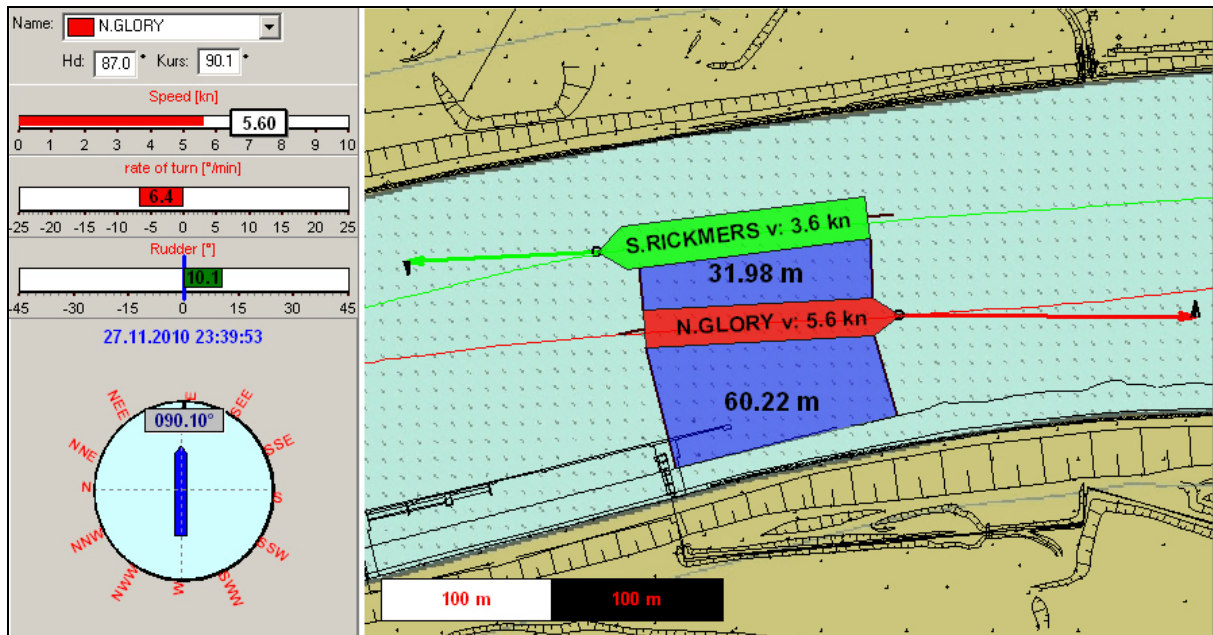
Figure 27: Encounter at 003953

Based on the rudder manoeuvres and changing ROT data of the NATIONAL GLORY, interaction between the vessels during the encounter of the SANDY RICKMERS and NATIONAL GLORY at the bunkering bridge at Projensdorf is detectable. This is to be expected because at amidships the passing distance is just 32 m at a speed of about 5.6 kts. A slight misalignment of the significantly slower oncoming vessel is discernible. The passing distance to the bank during the period of the encounter is about 60 m. This reduces to about 48 m as the sterns pass and is therefore considerably larger than the passing distance of the vessels. At this stage, the bank effect is not a decisive factor.

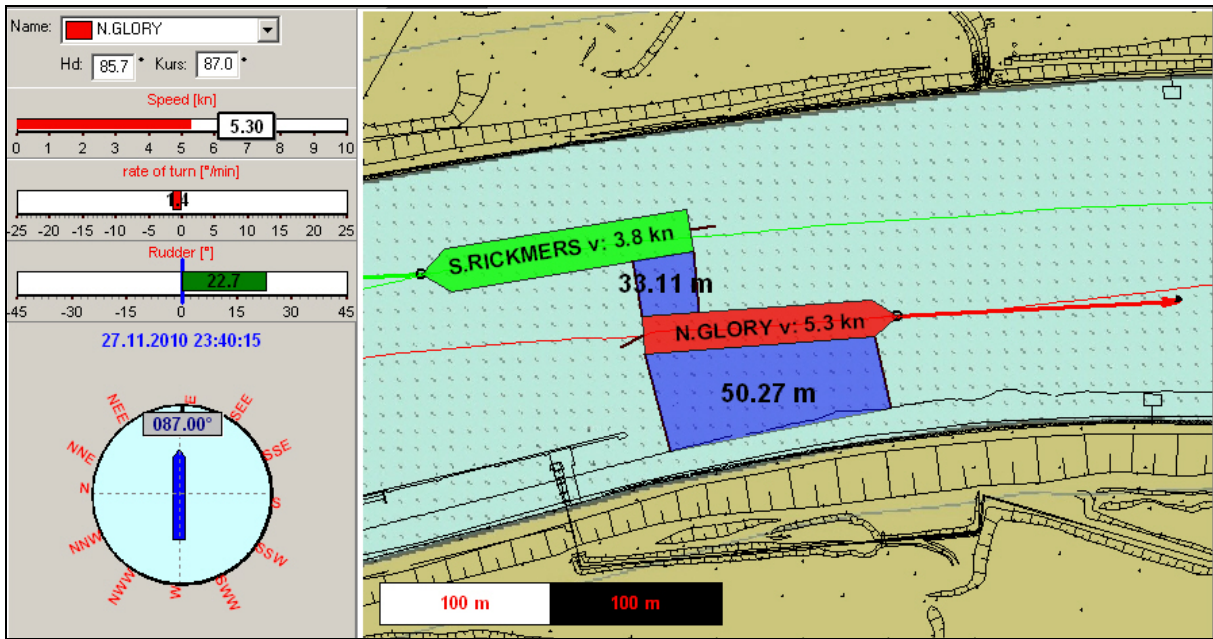
Figure 28: Encounter at 004015

Towards the end of the encounter, the vessel/vessel interaction is stronger than the bank effect (about 004015), but this is compensated by an appropriate helm setting on the NATIONAL GLORY.

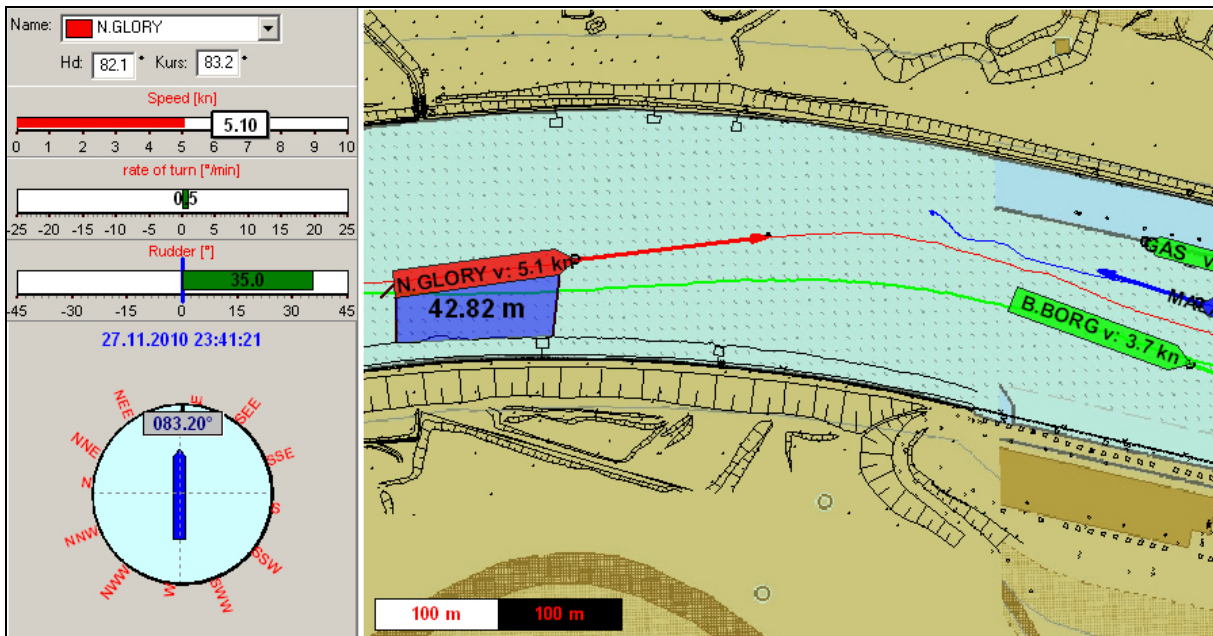
Figure 31: Situation at 004121

It was possible to stop the turn to port at 004121. The rudder is set at hard to starboard. In terms of hydrodynamics and ship flow (wake and/or propeller wash), due to the distance between the vessels as well as the low and decreasing speed of
