Investigation Report 102/11

Serious Marine Casualty

**Collision between the TMV ZAPADNYY and a
floating dock moored on the bank of the River
Weser belonging to the
Fr. Lürssen shipyard after an overtaking
manoeuvre involving the
TMV RHONESTERN and the TMV ZAPADNYY
on 5 April 2011**

15 August 2012

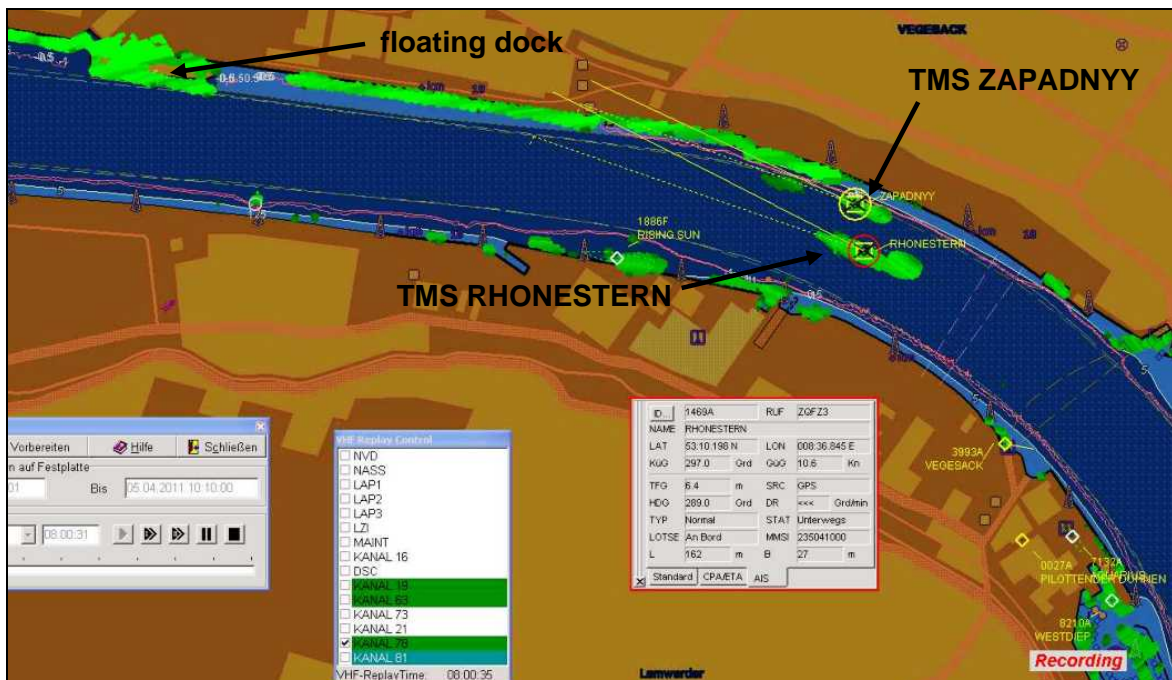
Figure 4: AIS/Radar of VTS Bremen at 080031⁷

The TMV ZAPADNY, laden with 3059 t molasses, and the TMV RHONESTERN each left her berth in the port of Bremen on the morning of the accident and proceeded on the River Weser in good visibility, calm weather and moderate traffic volume. They were navigated by their master with pilot advice and steered by a helmsman towards the North Sea. High tide was at 0458 and the next low tide was predicted³ for 1208, meaning that at the time of the accident the vessels were proceeding at about half tide, i.e., a maximum ebb stream of 1.5 to 2 kts. The speed of the RHONESTERN was approximately 14.5 kts up until about 10 minutes before the accident (**0754**). The ZAPADNY was proceeding ahead of her at 'full ahead' (river speed, approximately 10.5 kts).⁴ Due to her speed surplus, the RHONESTERN was continuously gaining on the ZAPADNY. At this point, the distance between the two vessels was still about 0.21 nm.⁵ The RHONESTERN subsequently reduced her speed. She overtook the ZAPADNY at between approximately **0758 and approximately 0803** at about 10.5 kts and with a steadily decreasing lateral distance⁶, which was ultimately considerably less than 50 metres (see **Fig. 4 f**). The stern of the RHONESTERN passed the superstructure of the ZAPADNY in the area of the exit of the bend at Vegesack (known in Germany as the 'Vegesacker Kurve').

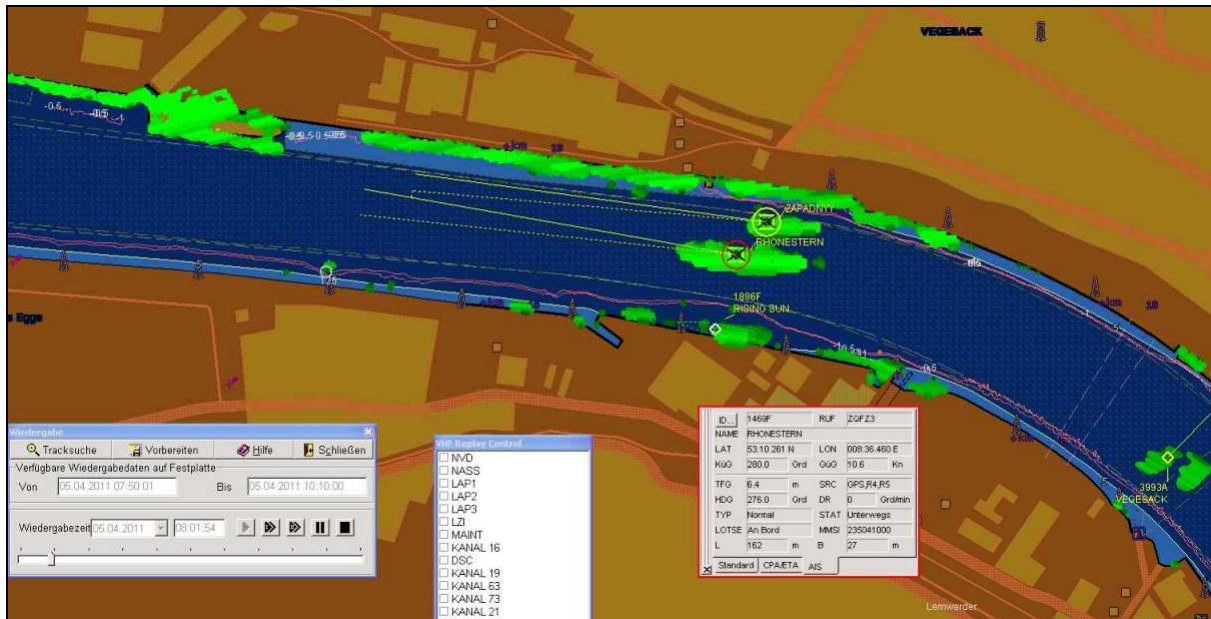
Figure 5: AIS/Radar of VTS Bremen at 080154

The ZAPADNY did initially not alter her rate of speed. Nevertheless, her speed over ground decreased – apparently as a result of hydrodynamic interaction between overtaking and overtaken vessel in the course of the overtaking manoeuvre – to a minimum value of 8.0 kts (**0801**) and then increased to a maximum of 12.1 kts (**0803**) within about 2.5 minutes. Due to this acceleration, which resulted in the ZAPADNY moving faster than the overtaking RHONESTERN temporarily, the sterns of the two vessels levelled out again (see Fig. 6 f). The fact that the ZAPADNY was, temporarily, actually faster than the RHONESTERN before the collision gave rise to erroneous accounts in the initial witness statements given by shipyard workers after the accident, which indicated that the ZAPADNY had reportedly overtaken the RHONESTERN.

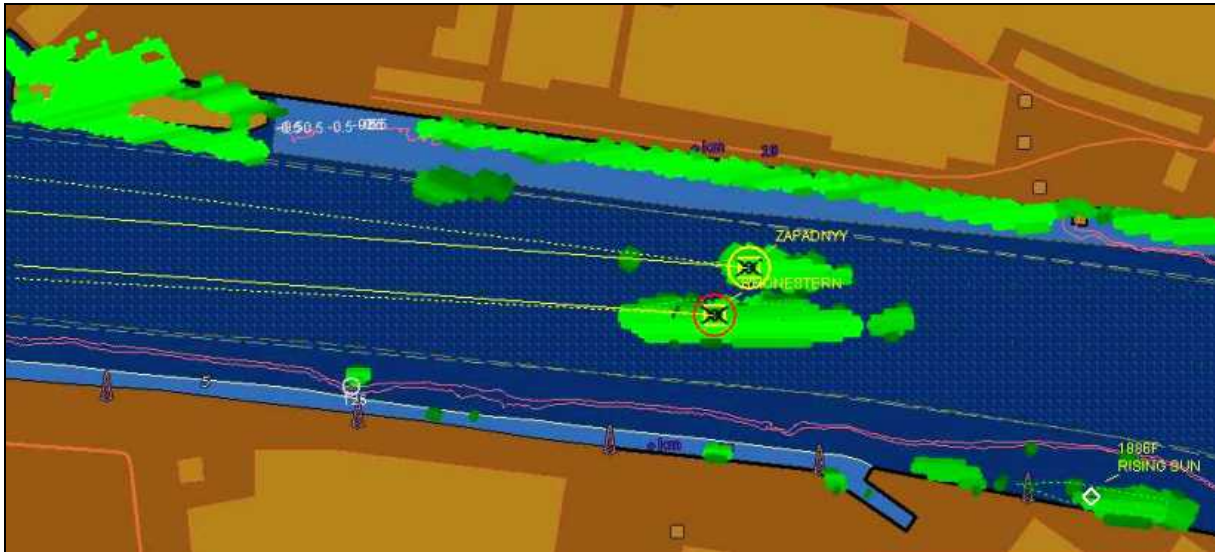
Figure 7: AIS/Radar of VTS Bremen at 080307

According to witness accounts the speed of the ZAPADNY was reportedly reduced to 'half ahead', after having discerned the aforementioned acceleration effect. In the period that followed, the ZAPADNY reportedly started to turn to starboard despite contra-rudder. Neither the subsequent hard to port rudder manoeuvre nor an increase in the speed of the ZAPADNY to 'full ahead' caused the vessel to respond noticeably or helped to prevent her from straying towards the northern bank (see Fig. 8 f).

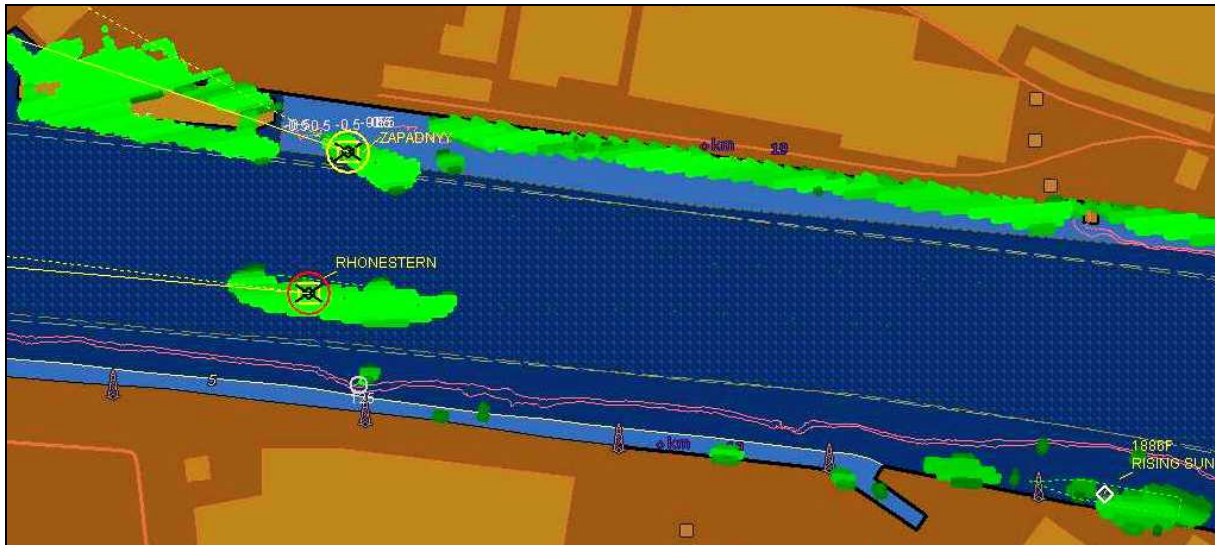
Figure 9: AIS/Radar of VTS Bremen at 080413

Finally, the engine was reportedly set to 'full astern' to at least soften the collision with the floating dock, which was no longer avoidable. At about 080425, the forecastle of the ZAPADNY collided with the front end of the floating dock, which was moored on the bank of the River Weser and belonged to the Fr. Lürssen shipyard (see **Fig. 10**).

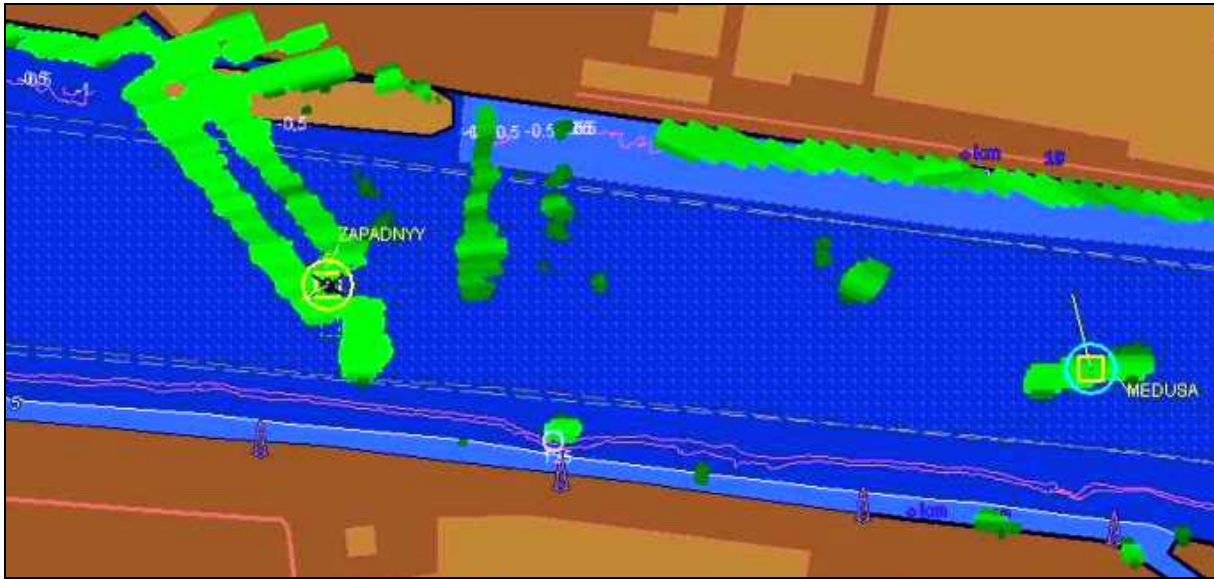
Figure 11: AIS/Radar of VTS Bremen at 080919

The RHONESTERN was not directly affected by the event playing out 'abeam of her' and therefore initially continued her voyage without further ado. The collision-induced forces acting on the floating dock caused the line anchoring points and various supply lines to tear off across a wide area. One side of the dock veered out together with the ZAPADNY, whose forecastle had ploughed into the front end of the dock, and then blocked the course of the River Weser for about two hours (see **Fig. 11 ff**).

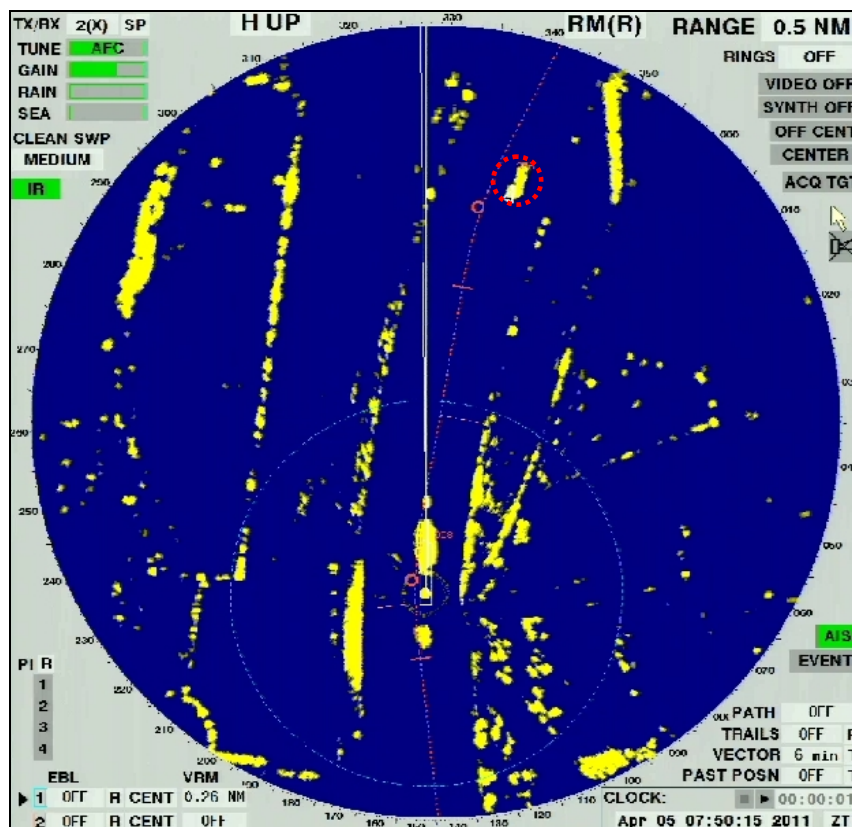
Figure 22: Traffic situation at 075015¹²

In all likelihood, the radar image did not play a decision-critical role in terms of aiding navigation on the bridge of the RHONESTERN on the day of the accident, at least in terms approaching and overtaking the ZAPADNYY. The accident occurred in daylight and good visibility, meaning it can be assumed that the pilot and ship's command were making key decisions based solely on visual observation. Nevertheless, **Figs. 22 ff** below, which were selected as examples, were included in the investigation report because they illustrate the course of the accident very well.

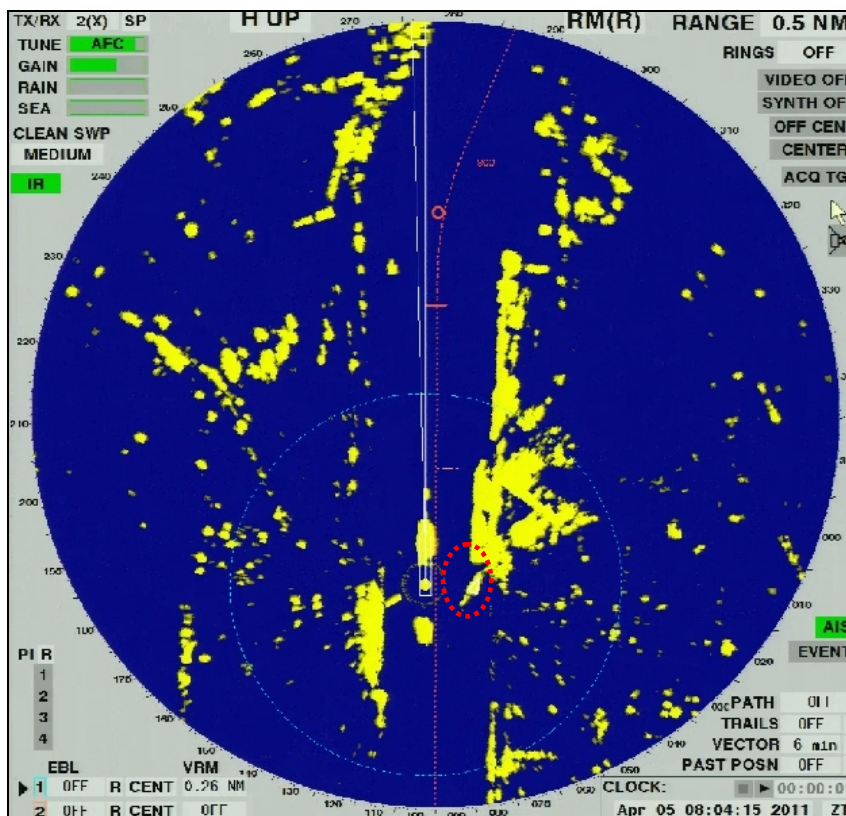
Figure 30: Traffic situation at 080415

The selected radar images show how the RHONESTERN converges with ZAPADNY. The representation of the radar echoes of the two vessels in **Figs. 27, 28 and 29** implies that the overtaking manoeuvre must actually have been almost completed when the ZAPADNY was suddenly accelerated to port in the direction of the RHONESTERN, before she veered off, apparently out of control, to starboard towards the bank of the river shortly after. Moreover, when looking at the course of the fairway visible on the radar, it also becomes, in particular, very clear that the overtaking manoeuvre was initiated in the area at which the bend at Vegesack starts, that it was executed throughout the radius of the bend, and that the ultimate development of the subsequent accident began at the exit of the bend.

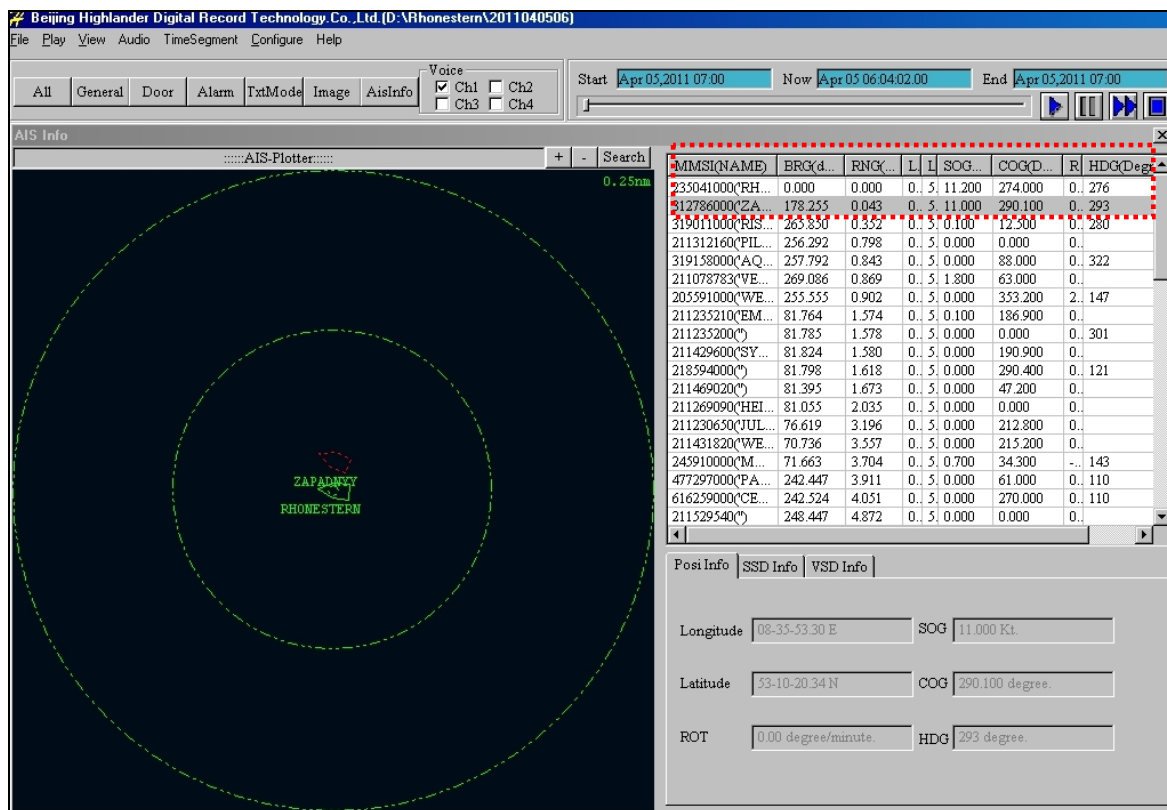
Figure 31: AIS data window from the VDR of the RHONESTERN at 080402 (example)¹³

It was also possible to read the changing distances between the two vessels from the AIS window in question (see RNG = range value in nm in the outlined area of **Fig. 31**). However, it should be noted that this refers to the antenna, respectively, system position of each vessel. Therefore, the location and configuration of these positions in relation to each other result in distance values between the side of each vessel, which may be significantly lower or significantly higher than the 'RNG values' displayed. Nevertheless, the 'RNG values' were also included in the following table because they provide evidence in relation to the convergence, parting and re-convergence of the vessels without a 'correction'.
