Investigation Report 140/10

Marine Casualty

**Contact with the embankment by
the MV SONORO and
collision between the MV SONORO
and MT SÜLLBERG
on the Kiel Canal (NOK)
on 18 April 2010**

16. January 2012

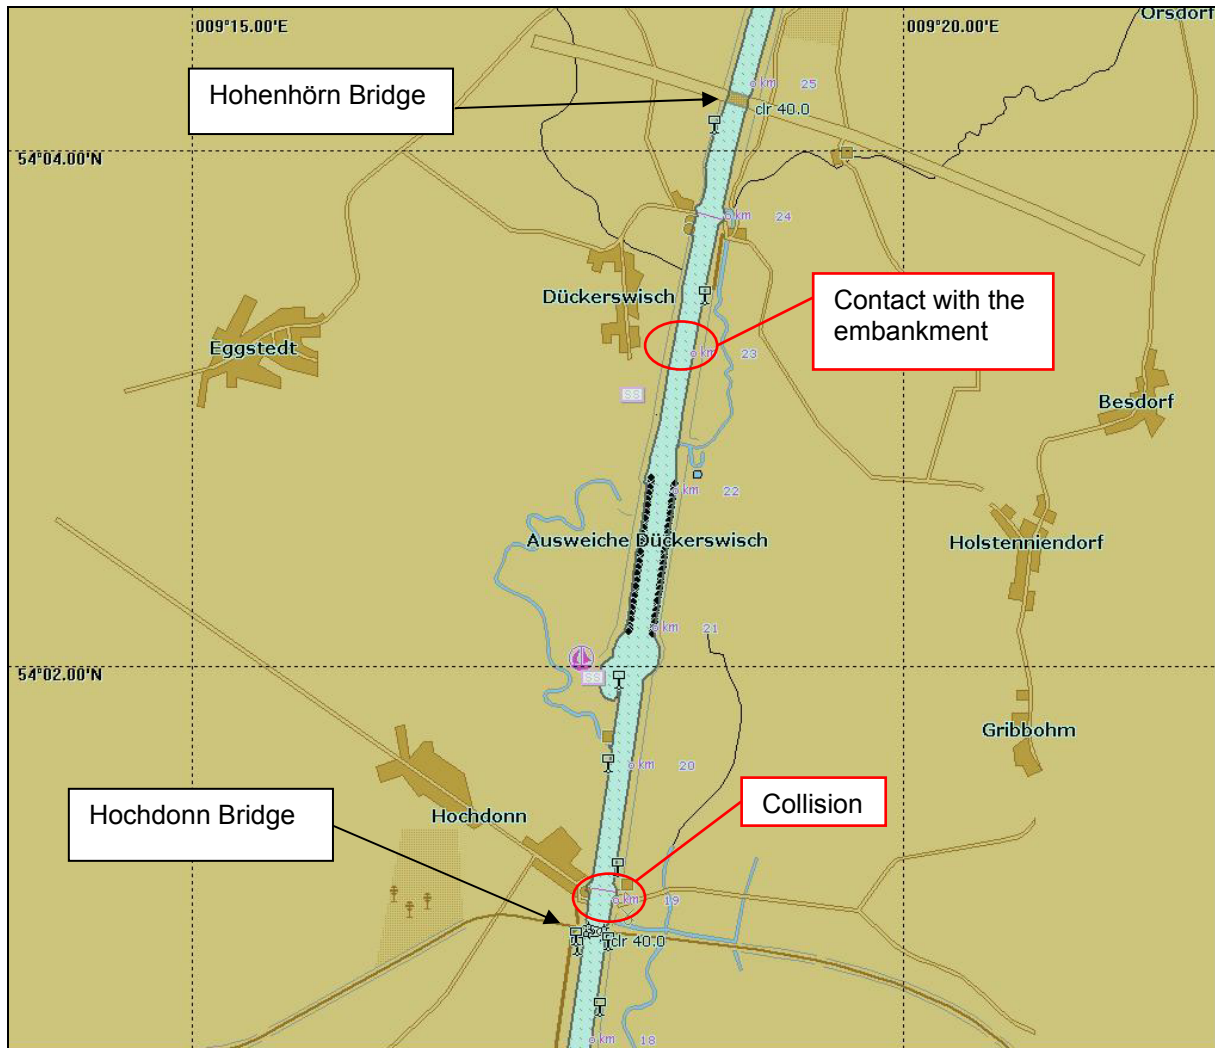
Type of marine casualty/incident:	Marine casualty, grounding of the SONORO
Date, time:	18 April 2010, 0310
Location:	Kiel Canal, km 23
Latitude/Longitude:	φ 54°03.25'N λ 009°18.40'E
Ship operation and voyage segment:	Estuary trading
Human factors:	Yes, human error
Consequences (for people, vessel, cargo, the environment and other):	Damage to the embankment at km 23, damage to the bottom shell of the vessel

Type of marine casualty/incident:	Marine casualty, collision with the MT SÜLLBERG
Date, time:	18 April 2010, 0405
Location:	Kiel Canal, km 19
Latitude/Longitude:	φ 54°0.15'N λ 009°17.90'E
Ship operation and voyage segment:	Harbour mode
Human factors:	Yes, human error
Consequences (for people, vessel, cargo, the environment and other):	SONORO: Damage to the bow, respectively, the bottom shell, damage to the embankment and a ramp at km 19; SÜLLBERG: Damage to the bow as well as a walkway and the wing on the port side

Figure 3: Nautical chart showing the scene of the accident

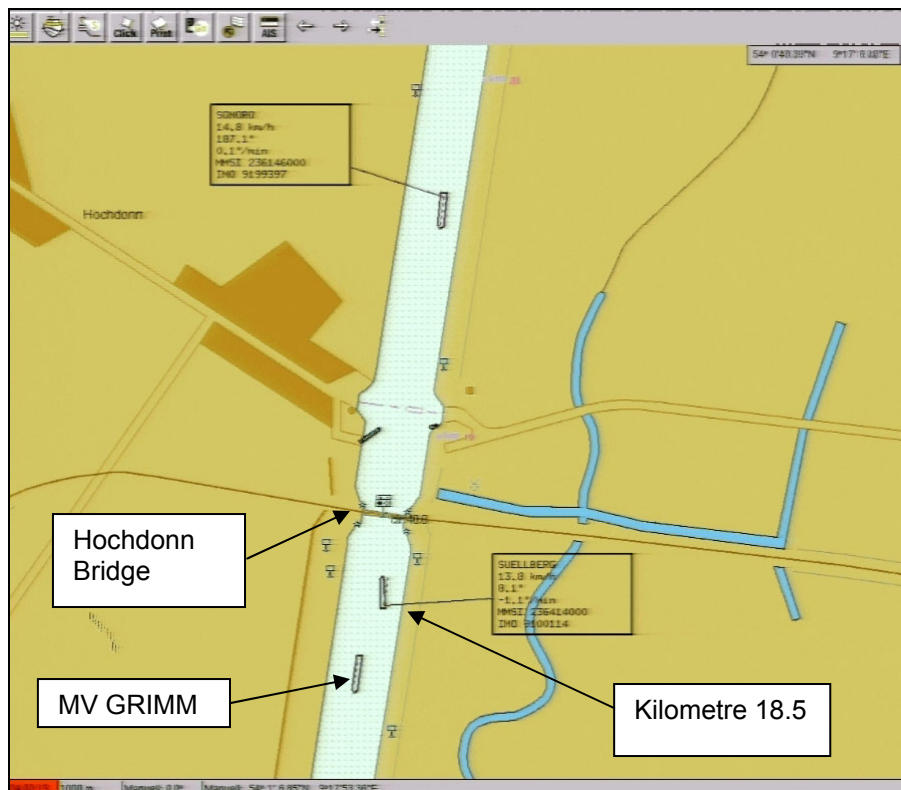
Figure 17: Time: 040319

The collision with the SÜLLBERG and subsequent contact with the embankment are shown below based on the AIS recording of VTS Brunsbüttel (Figures 17 to 25).

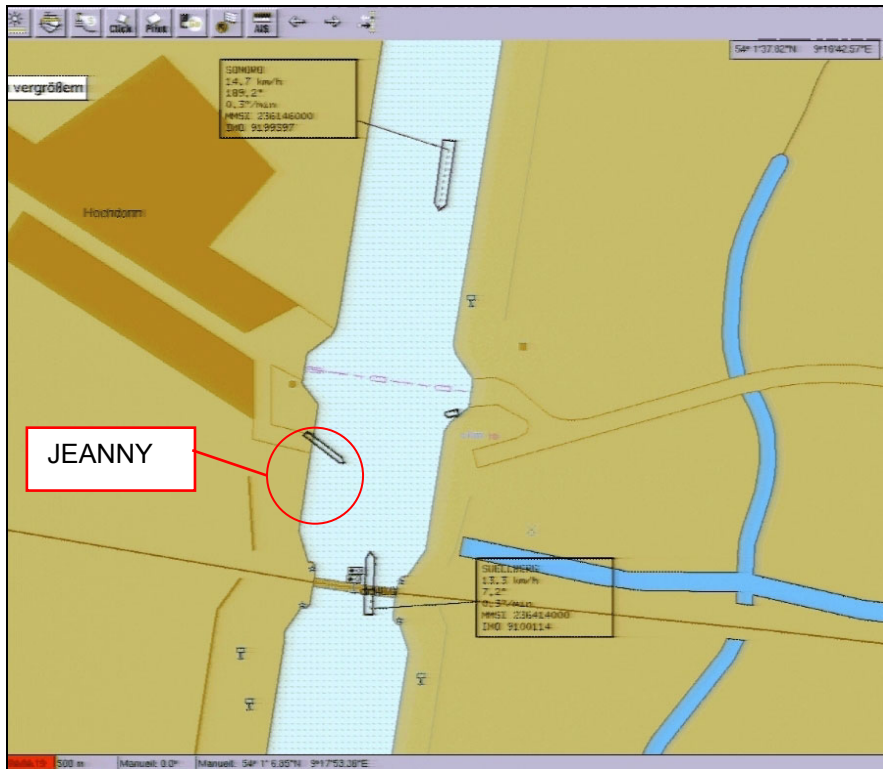
Figure 18: Time: 040419, motor vessel JEANNY⁵

⁵ The AIS signal of the JEANNY is shown here in Figures 17 to 25. This vessel was moored alongside the pier there for the whole of the incident. It was not affected by the collision. The changes in the presentation of the vessel are purely the result of jumps in the GPS position.

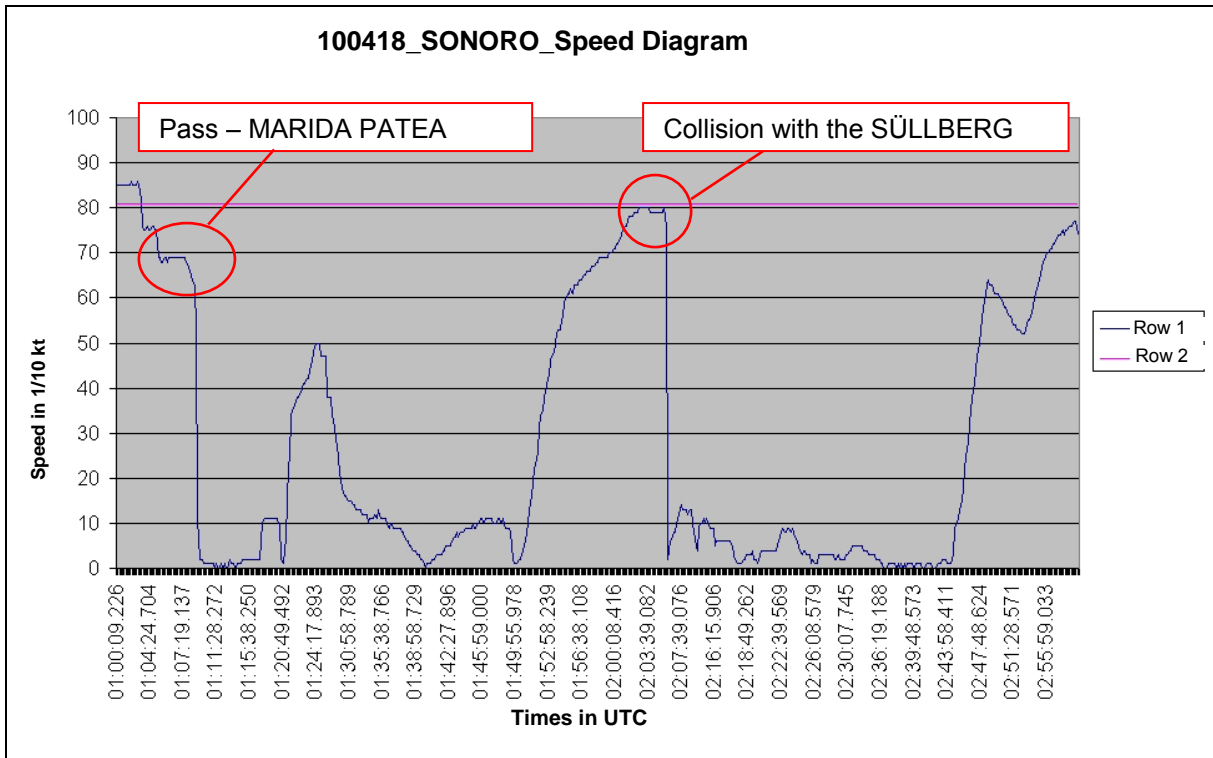
WSA Brunsbüttel created speed diagrams for the SONORO and the SÜLLBERG using data generated from the GPS and transmitted by the AIS.

Table 1: Speed of the SONORO from 030009 to 045559, row 1 = speed of the vessel, row 2 = maximum permitted speed
