Bundesstelle für Seeunfalluntersuchung
Federal Bureau of Maritime Casualty Investigation
Federal Higher Authority subordinated to the Ministry of Transport,
Building and Urban Development

Investigation Report 143/11

Very Serious Marine Casualty

**Death of a crew member
of the sailing yacht SPECIAL ONE
on 30 April 2011 off Fehmarn**

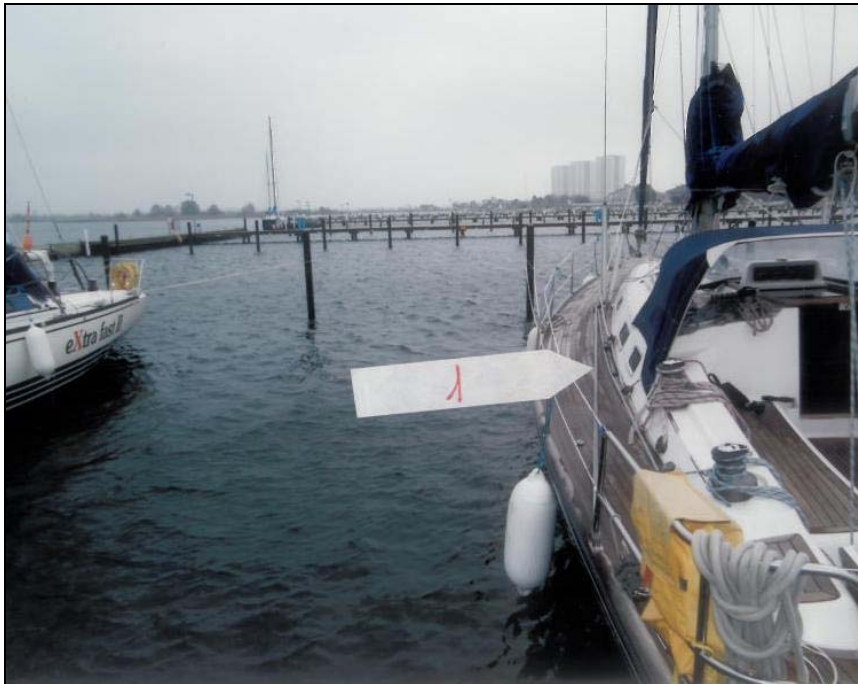
Lifelines are permanently mounted on both sides from the fore section to the cockpit as a safety measure if the cockpit has to be vacated in heavy weather. A sufficient number of safety lines were on board, which crew members could use to connect to the lifelines when leaving the cockpit.

Figure 4: Lifeline (1) on the port side, vessel in Burgtiefe

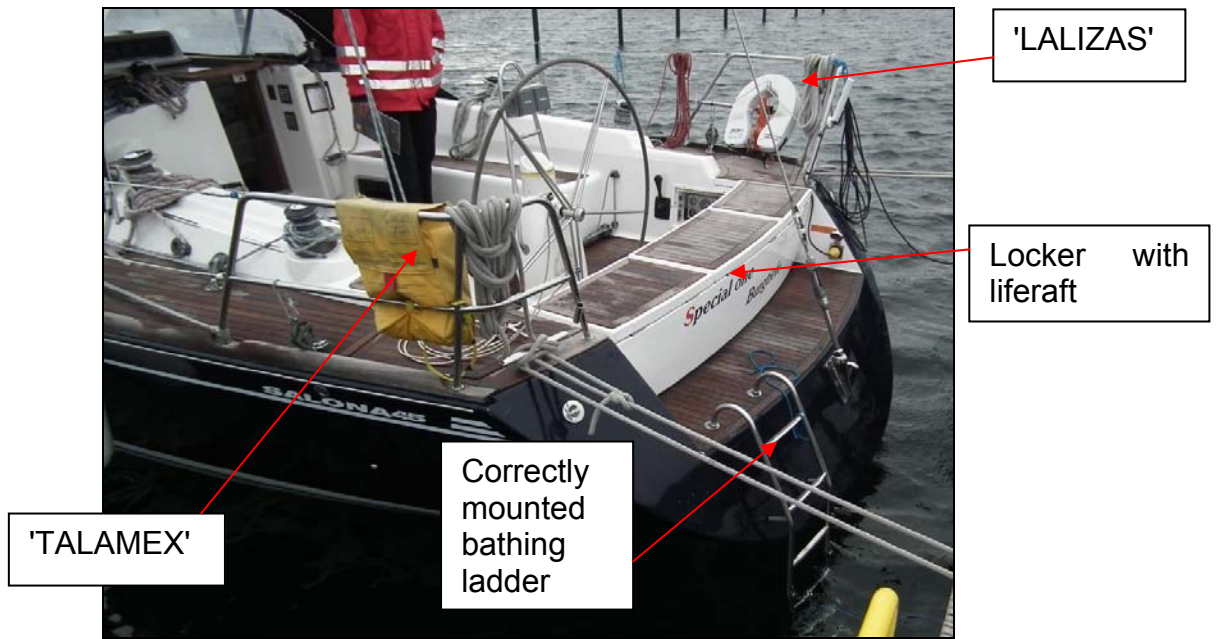
- buoyant rescue/recovery belt with 40 m of buoyant line, type Talamex Rescue System, mounted on the aft guardrail (port side);
- horseshoe-shaped buoyancy device with buoyant signal light, type Lalizas Horseshoe M.O.B.; rescue system mounted on the aft guardrail (starboard side)
- type ARIMAR INT 10 liferaft stowed behind the helm in the transverse locker;
- one boathook with a total length of 1.75 m and working length of 1.60 m.

Figure 11: View of the stern taken from aft

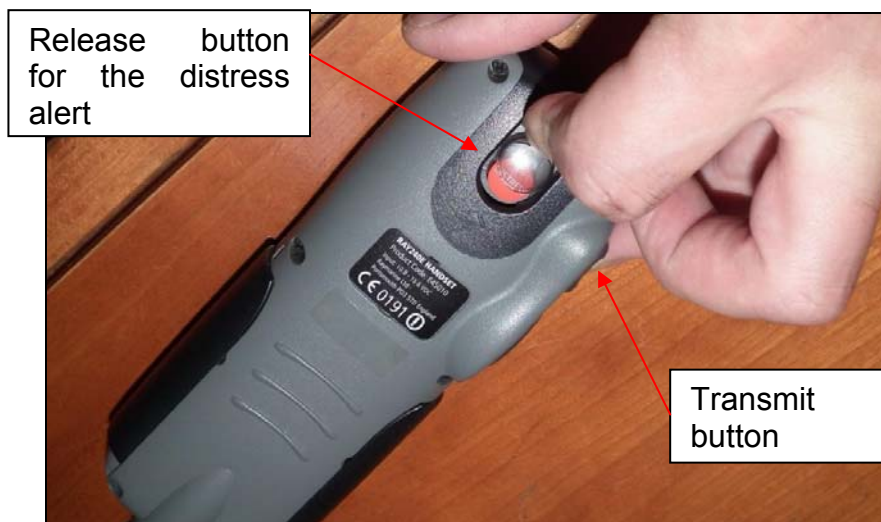
A type 'Ray 240E VHF' VHF marine radio is installed below deck on the starboard side at the navigation station. Amongst other things, the radio channel is selected and the volume of the internal speaker adjusted using the connected handset. The transmit button is on the side and the release button for the distress alert on the back of the handset.

Figure 12: Handset

To operate the distress alert, a transparent plastic cover must be actively pushed upward. A clearly visible red button labelled DISTRESS in white letters is located below that. The red button must be pressed for five seconds to trigger the distress alert.

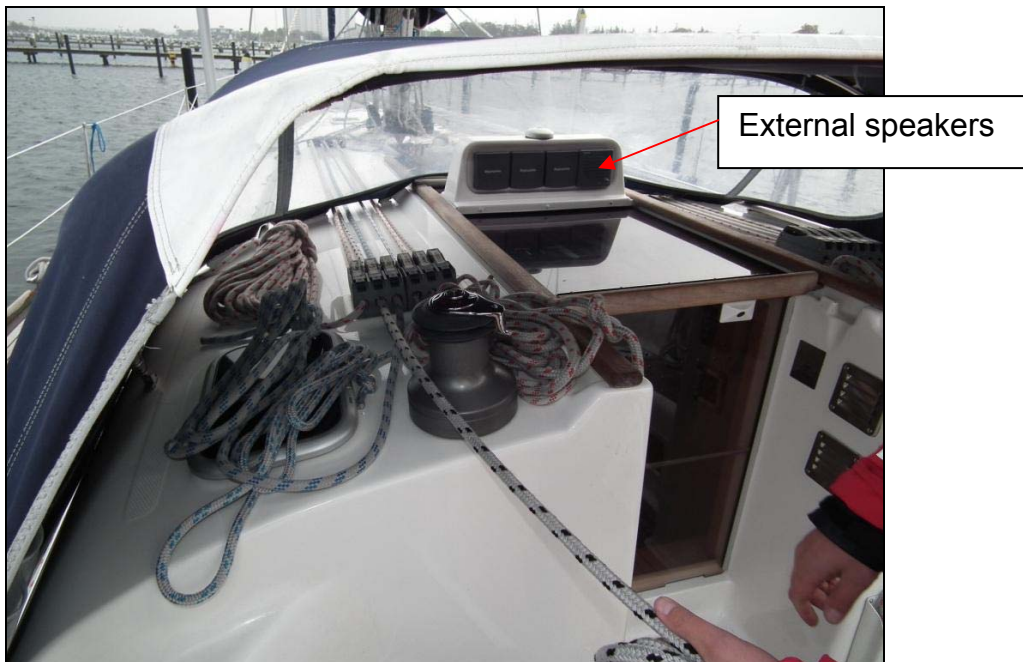
An additional external speaker is connected to the marine radio. The external speaker is located on the roof of the cabin and at the time of the investigation, the volume control was set at full volume. With this volume setting, the audible confirmation of the first distress alert should have been heard in the cockpit if the release button for the distress alert was operated properly.

Figure 13: View of the instruments outside

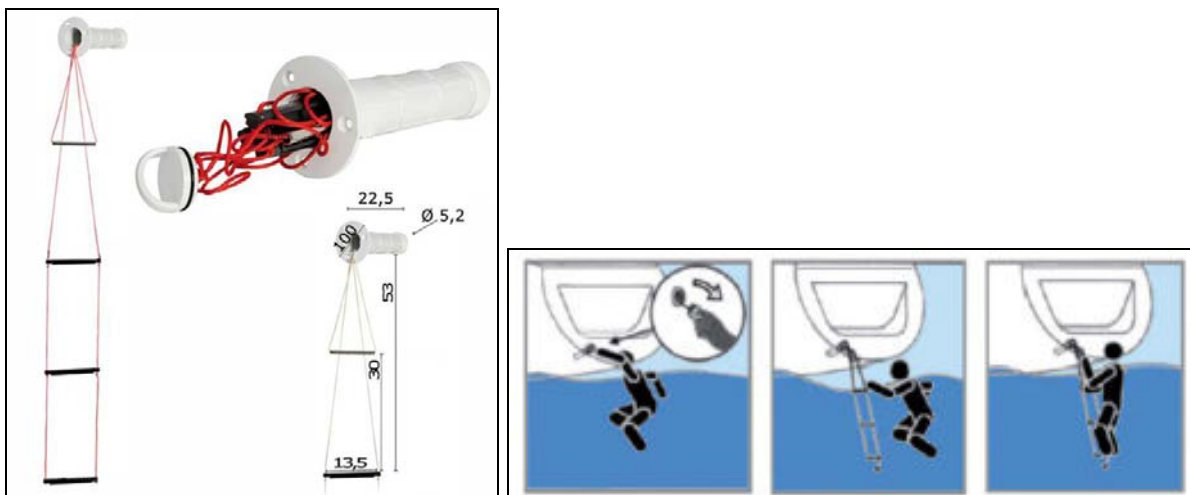
During the investigation, extendable telescopic ladders and a 3-step 'rope ladder system' permanently integrated with the transom, both often in combination with hinged bathing platforms, were included in the assessment of the fixed bathing ladders in accordance with DIN EN ISO 15085. The functional efficiency of this 'rope ladder system', which is installed just above the water surface, should be critically reviewed. In the case of this system, it is questionable whether the ladder could be used without additional handholds on the transom and by people whose physical condition is not very good.

Figure 20: Type 'Rope Ladder' rescue ladder

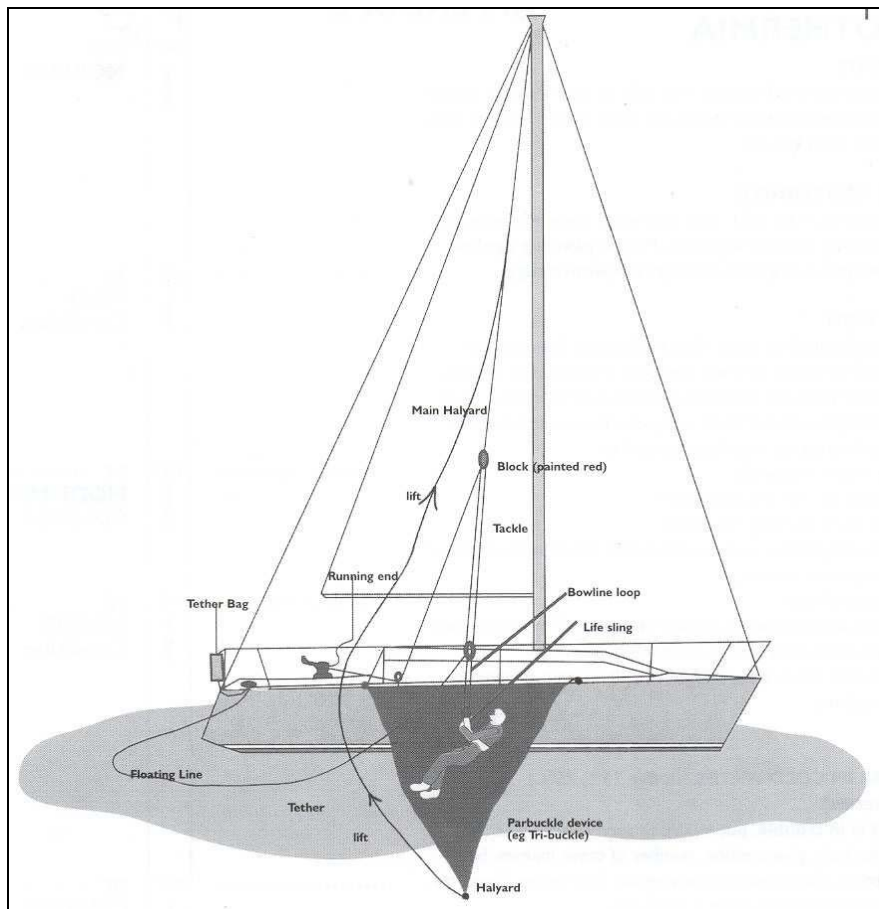
Thus far, the Safety Guidelines of the German Sailing Association have not been updated to account for the latest technology. However, other requirements for appropriate recovery equipment have already been set out in the regulations of the Offshore Racing Council. The Offshore Special Regulations of the International Sailing Federation (ISAF) for 2010-2011 recommend the use of the so-called 'Parbuckle Device' (or 'Tri-buckle Device') for recovering people from the water. This recovery equipment concerns a rectangular or triangular sail, respectively, scrambling net; two corners are attached to the deck and the other corner(s) to a halyard on the mast. The casualty is manoeuvred or dragged alongside into the triangle or net and then rolled onto the deck by hoisting the halyard.

Figure 21: Recovery sail/net

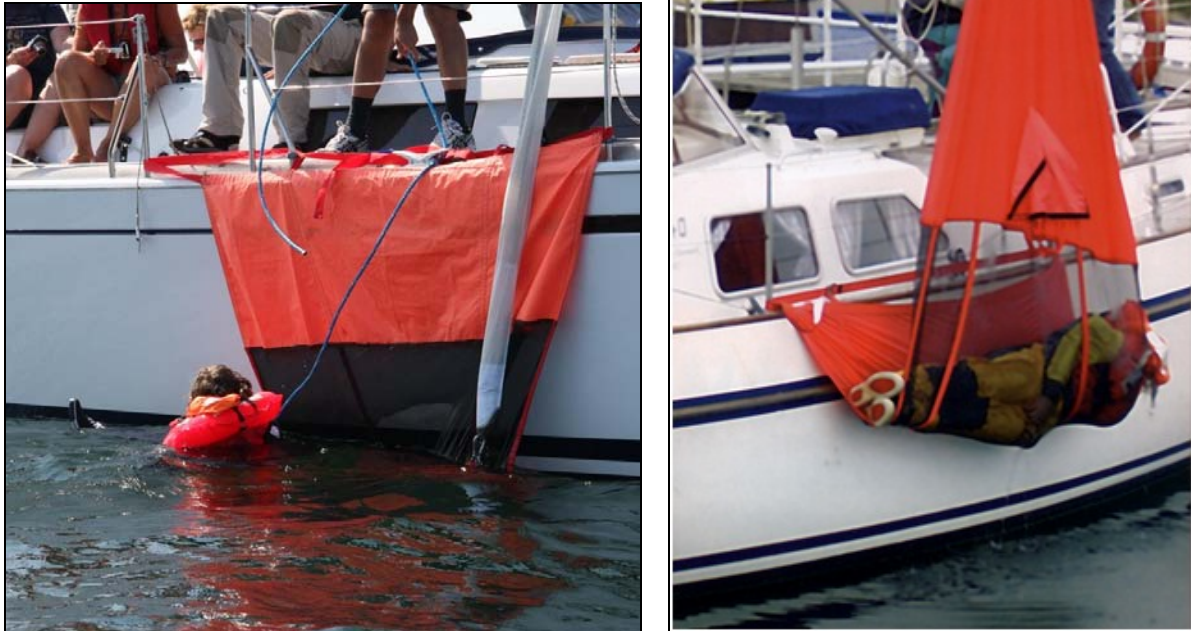
The Oleu Pickup Sail meets the requirements of the ISAF in accordance with Fig. 21 above and makes it possible to safely recover a person in the prone position, who is no longer able to assist actively:

Figure 22: Oleu Pickup Sail

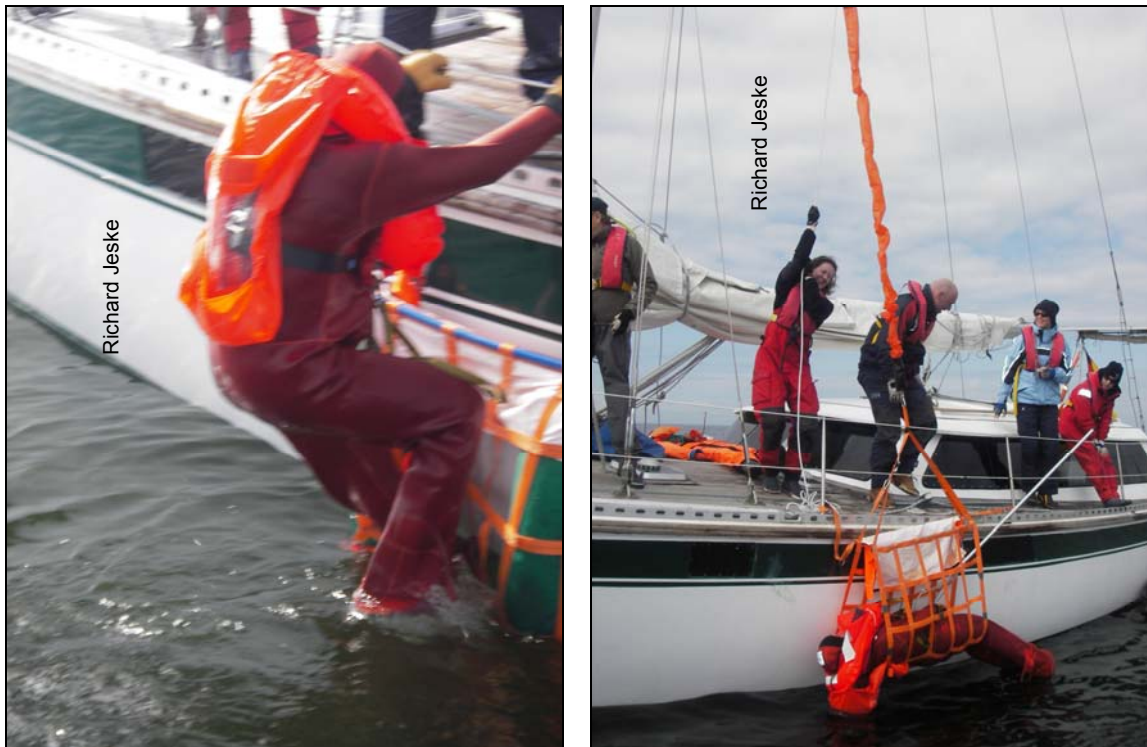
The WALDEN-WELL SAILING Berge- und Kletternetz (recovery and scramble net) is used as an example to illustrate the diversity of these different recovery systems. In the case of this recovery system, a red net, which is fixed to two points on the deck, is suspended overboard amidships where the yacht pitches least in swell.

If the person in the water is still able to participate in the recovery actively, then this recovery system is used as a scrambling net similar to a bathing ladder. However, the scrambling net can be used as a recovery net if the person is overweight or exhausted, for example. In this case, a halyard is attached to the lower end of the net, which forms a pocket with which the person can be rolled back on deck in a horizontal position. If recovery tackle is also attached (red tackle in Fig. 23, right), then the entire net can easily be hauled on deck without rolling by a woman with a normal physique (see Fig. 23, right). When combined with recovery tackle, this system represents a good option for recovering helpless casualties when the crew is very small.

Figure 23: Berge- und Kletternetz (recovery and scramble net)
