MARINE SAFETY INVESTIGATION REPORT

Joint investigation into the collision between the
Maltese registered general cargo

MARTI PRINCESS

Marine Safety Investigation Report No. 03/2012

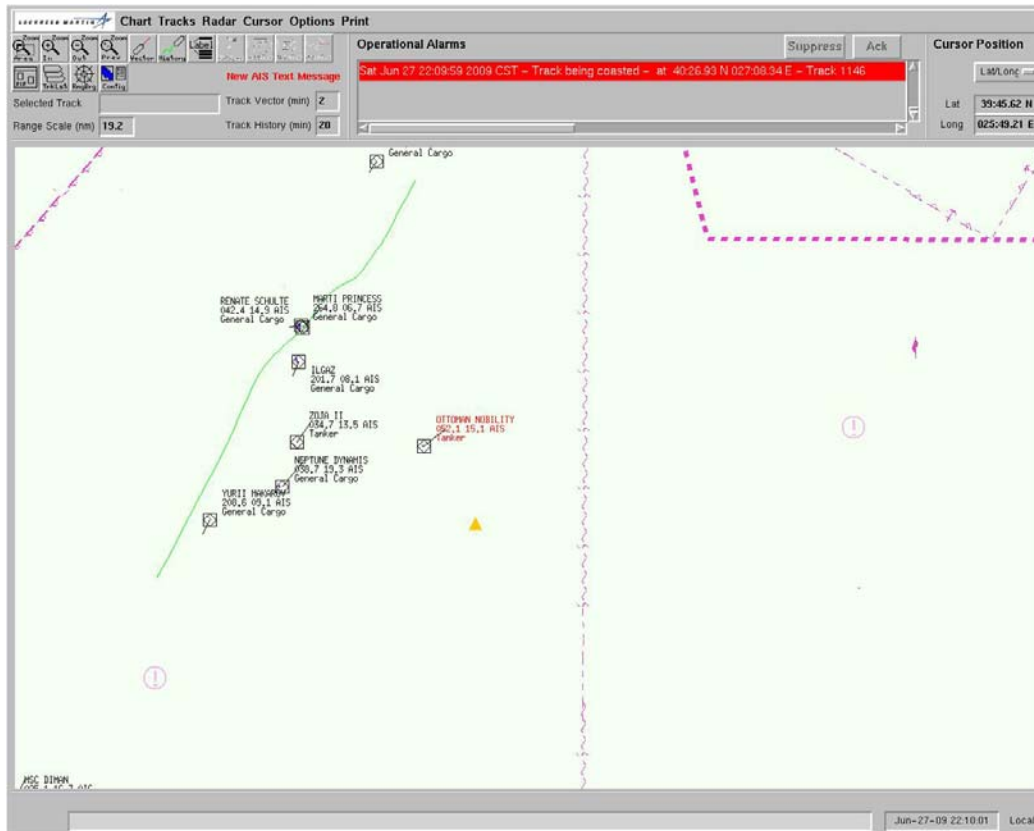
Figure 1.5x: Situation at 2210:01 (LT)

At about 2209, both ships began to take evasive actions but now, very close to one another, there was insufficient room to turn and avoid the collision. At 2210, both ships collided, with *Renate Schulte*'s bow striking the port side of *Marti Princess*'s cargo area and missing the accommodation block by a few metres. The impact caused severe damage to *Marti Princess* in way of cargo hold no. 2. *Renate Schulte* sustained damage in her bulbous bow area. Both vessels were unable to proceed and salvors were contracted to separate the two vessels. No injuries and no pollution were reported.
